Rainbow Beach  
Proposed Urban Development,  
Ocean Drive, Bonny Hills  
Preliminary Site Investigation

for St Vincent's Foundation Pty Ltd

November 2007

0072982

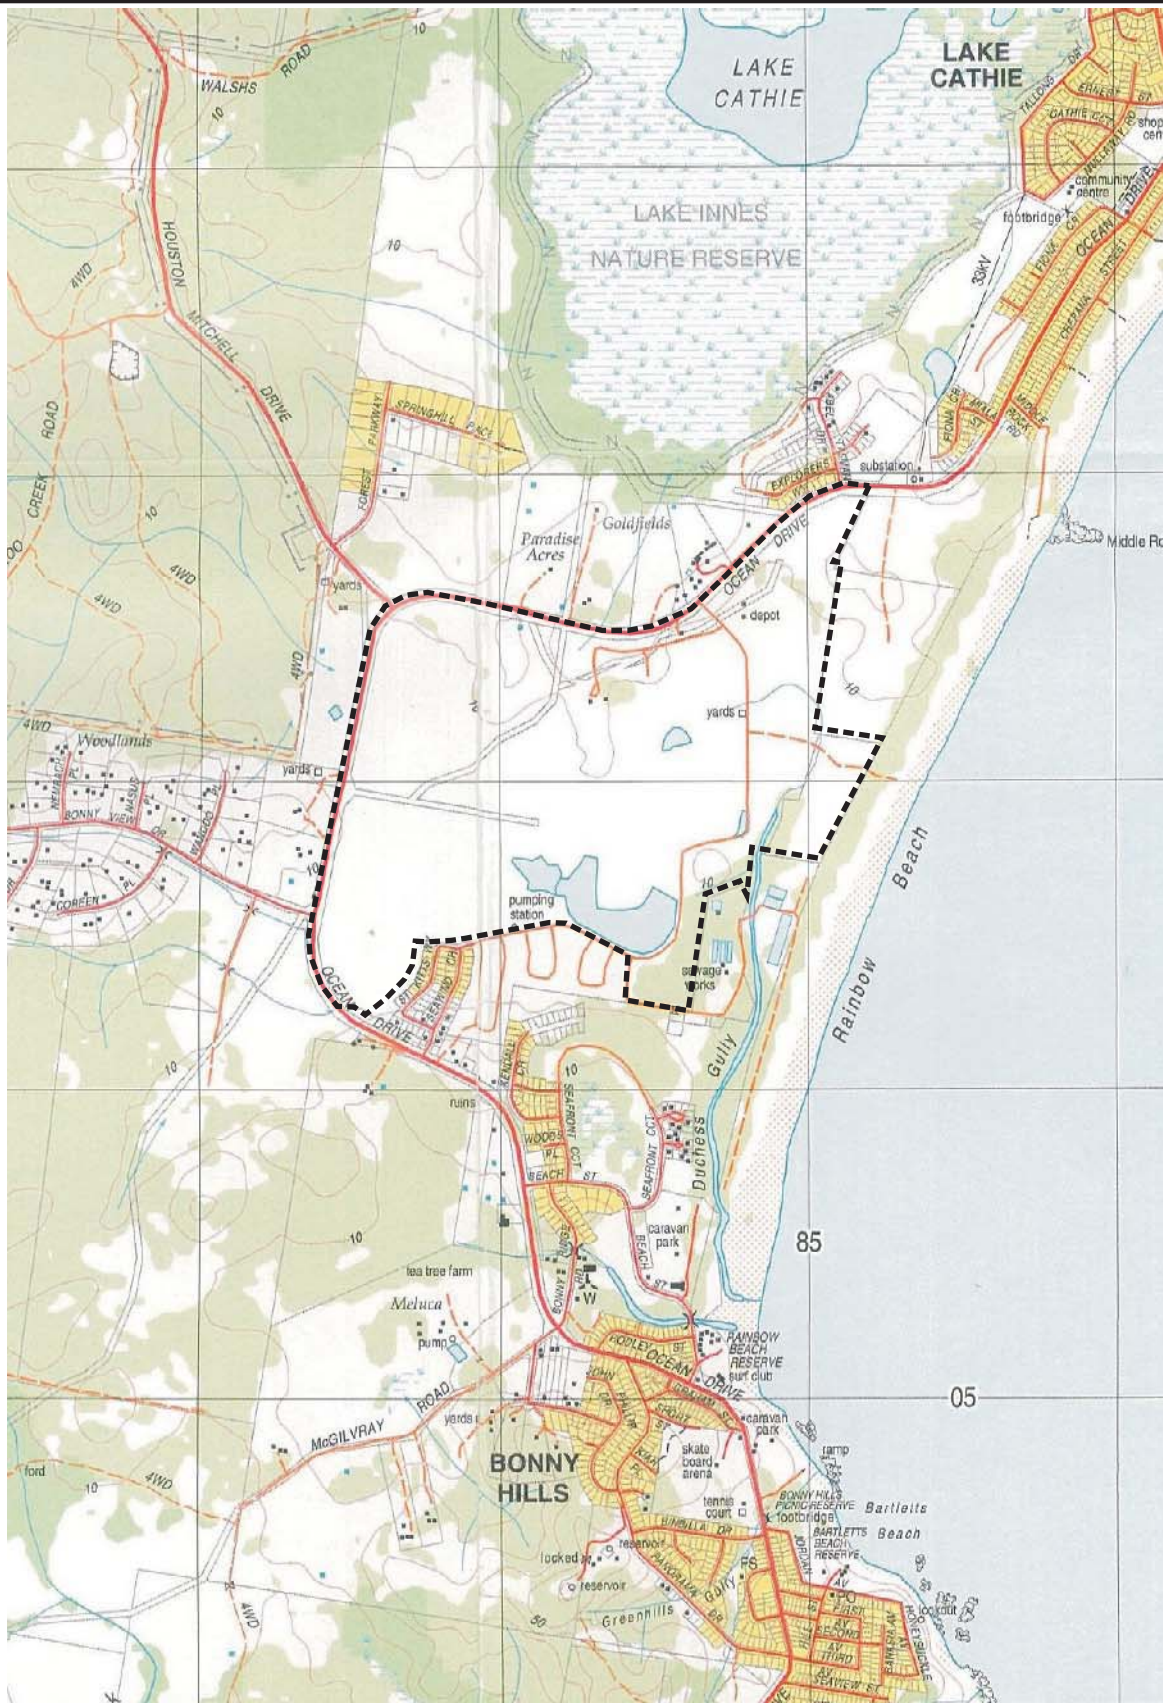
## Site Location

The site location is shown in Figure 1 of Annex A. A site concept plan for the proposed development is provided as Annex B.

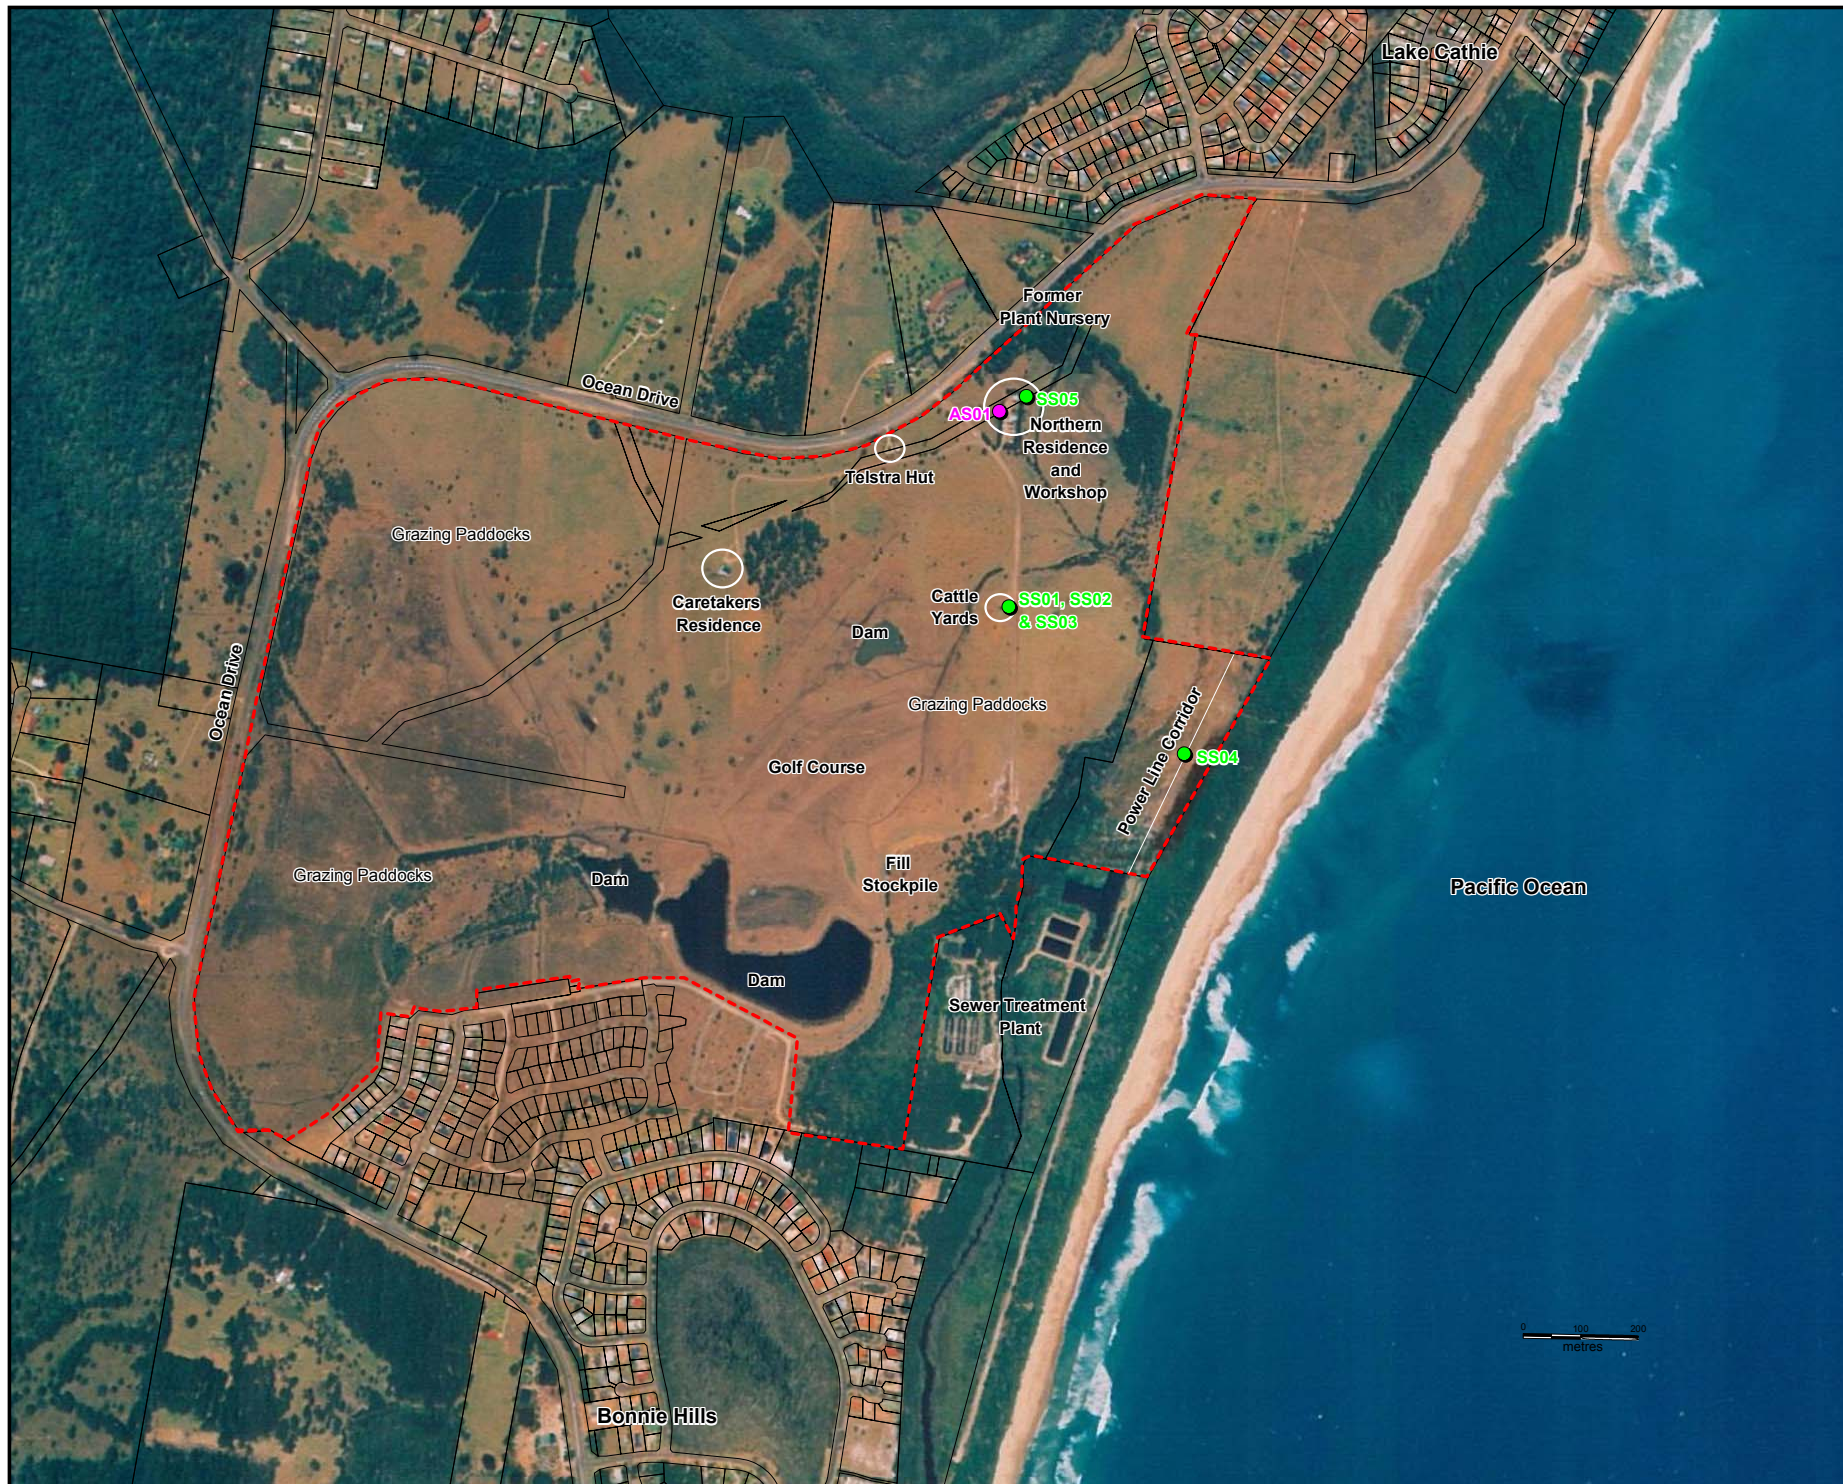
The site is predominantly cleared and has been used for farming in the past. There are two dwellings located on the property (refer to *Figure 2*), only one of which is still used as a residence. The other is used as a storage and work area for a native plant enterprise and is in a state of disrepair. A farm shed located at the northern residence houses farm machinery. The shed has a small workshop which stores small quantities of fuel, oil and farm chemicals.

The site layout is presented as *Figure 2 in Annex A*.

The site is primarily cleared and used for cattle and horse grazing. There are two dwellings located on the site as indicated on *Figure 2 in Annex A*, which are constructed with bonded fibre cement cladding. The northern dwelling is an old homestead that was observed to be in a state of disrepair. Fibre cement cladding was observed to be damaged in sections (refer to *Photograph 9 Annex G*) and not sealed (i.e. not painted). A sample of the cladding material was taken from an inside wall of this building. The southern dwelling appeared in good repair from the exterior.
