3.2.2.2 Beach Access

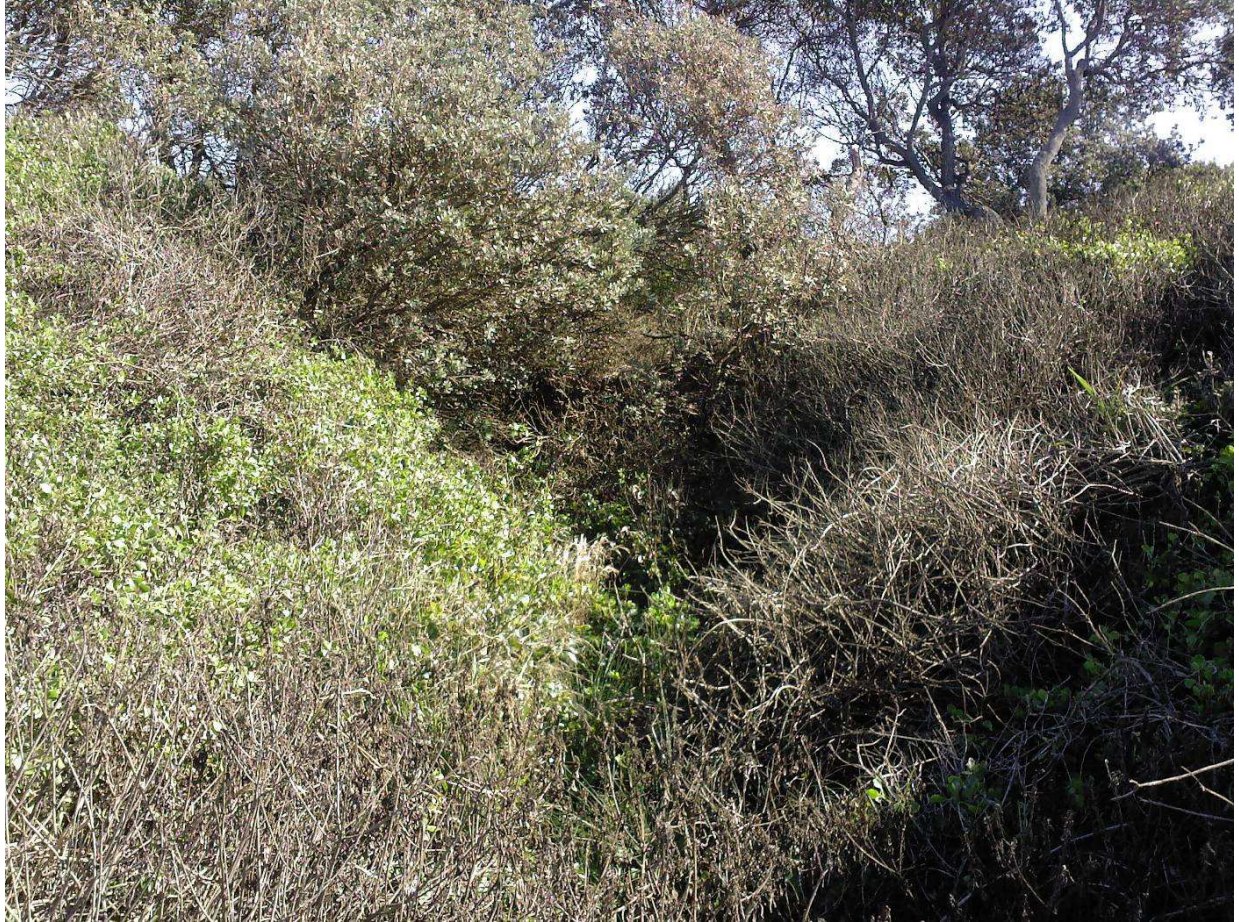
Photo 5: Bitou bush dominating gaps in the dune vegetation complex

This is one of many gullies in the dune system observed from the site's beach access north to Middle Rock.

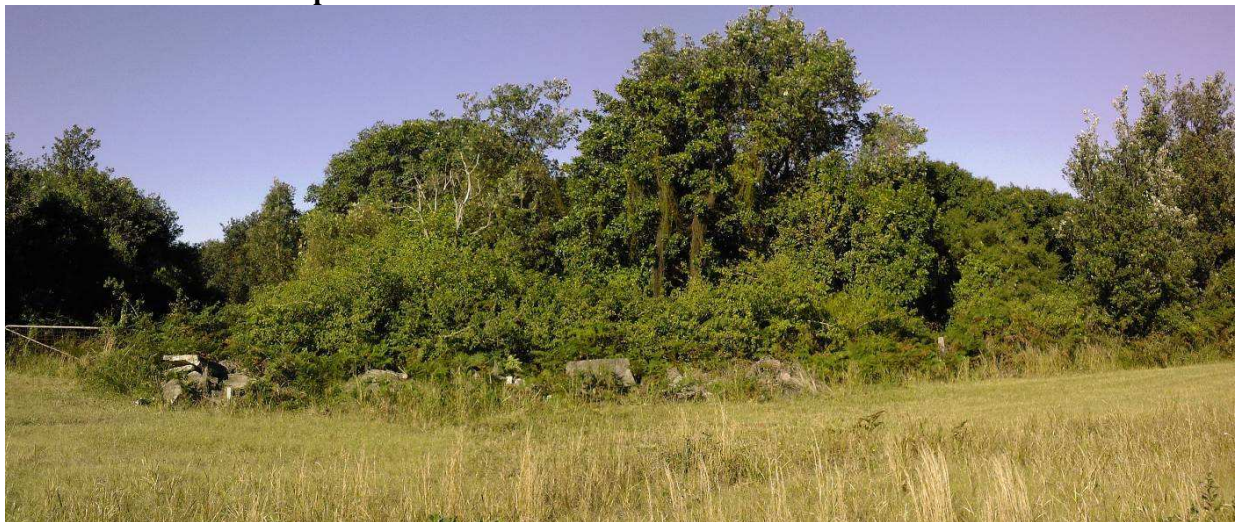
Photo 6: Dense Lantana patch at southwest corner of beach access.

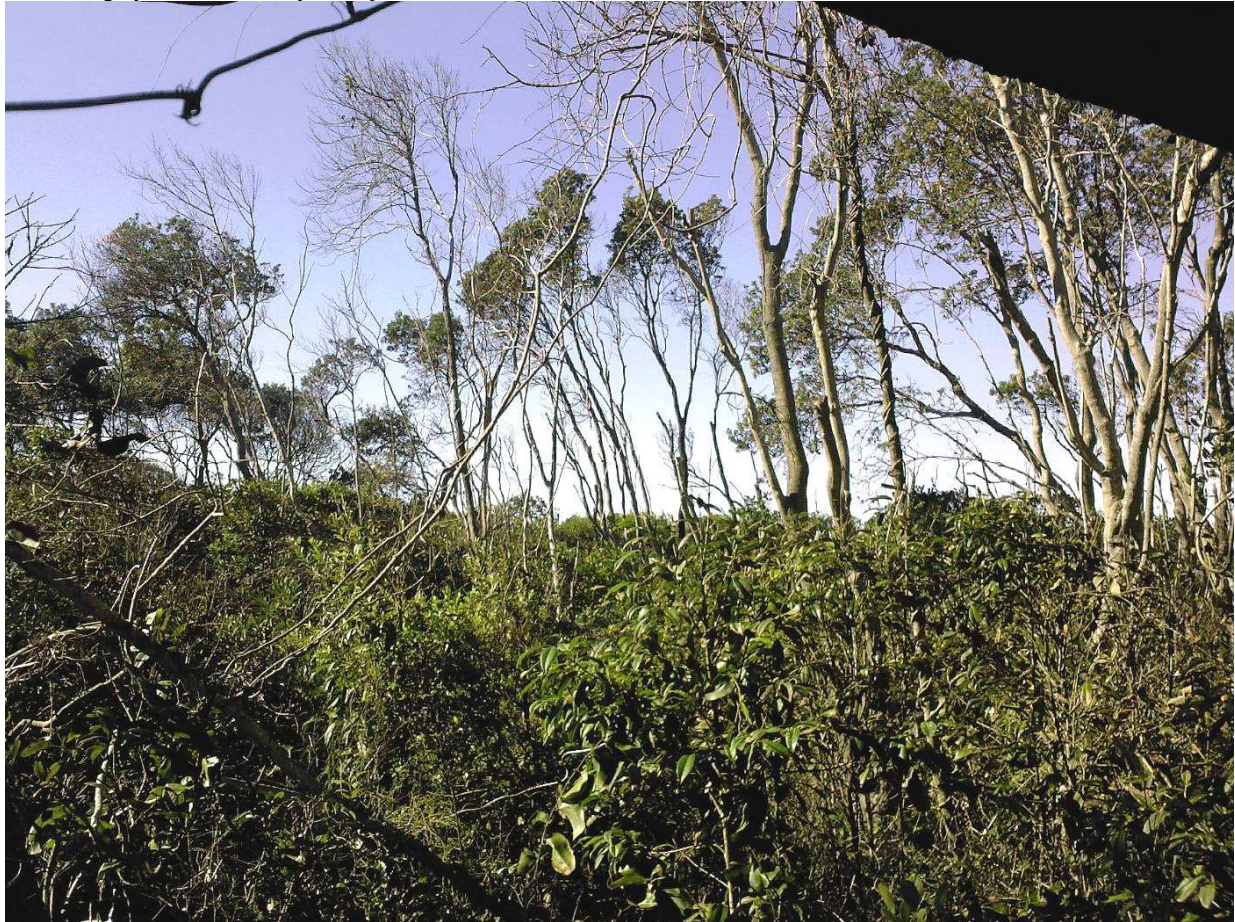
Photo 7: Littoral rainforest regeneration hampered by lack of screening vegetation by Bitou

The green vegetation is mostly rainforest species <2m high. The Banksia woodland is senescing but succession is retarded by the high exposure to maritime stresses due to lack of protective vegetation ie recruit Banksias, etc, which would normally precede this community on the foredune and provide a closed structure – not this open woodland structure caused by smothering by Bitou. This may end up as low stunted rainforest scrub due to maritime stresses.
