3.4 Existing Land Uses and Development

3.5 Topography, Slope and Stability

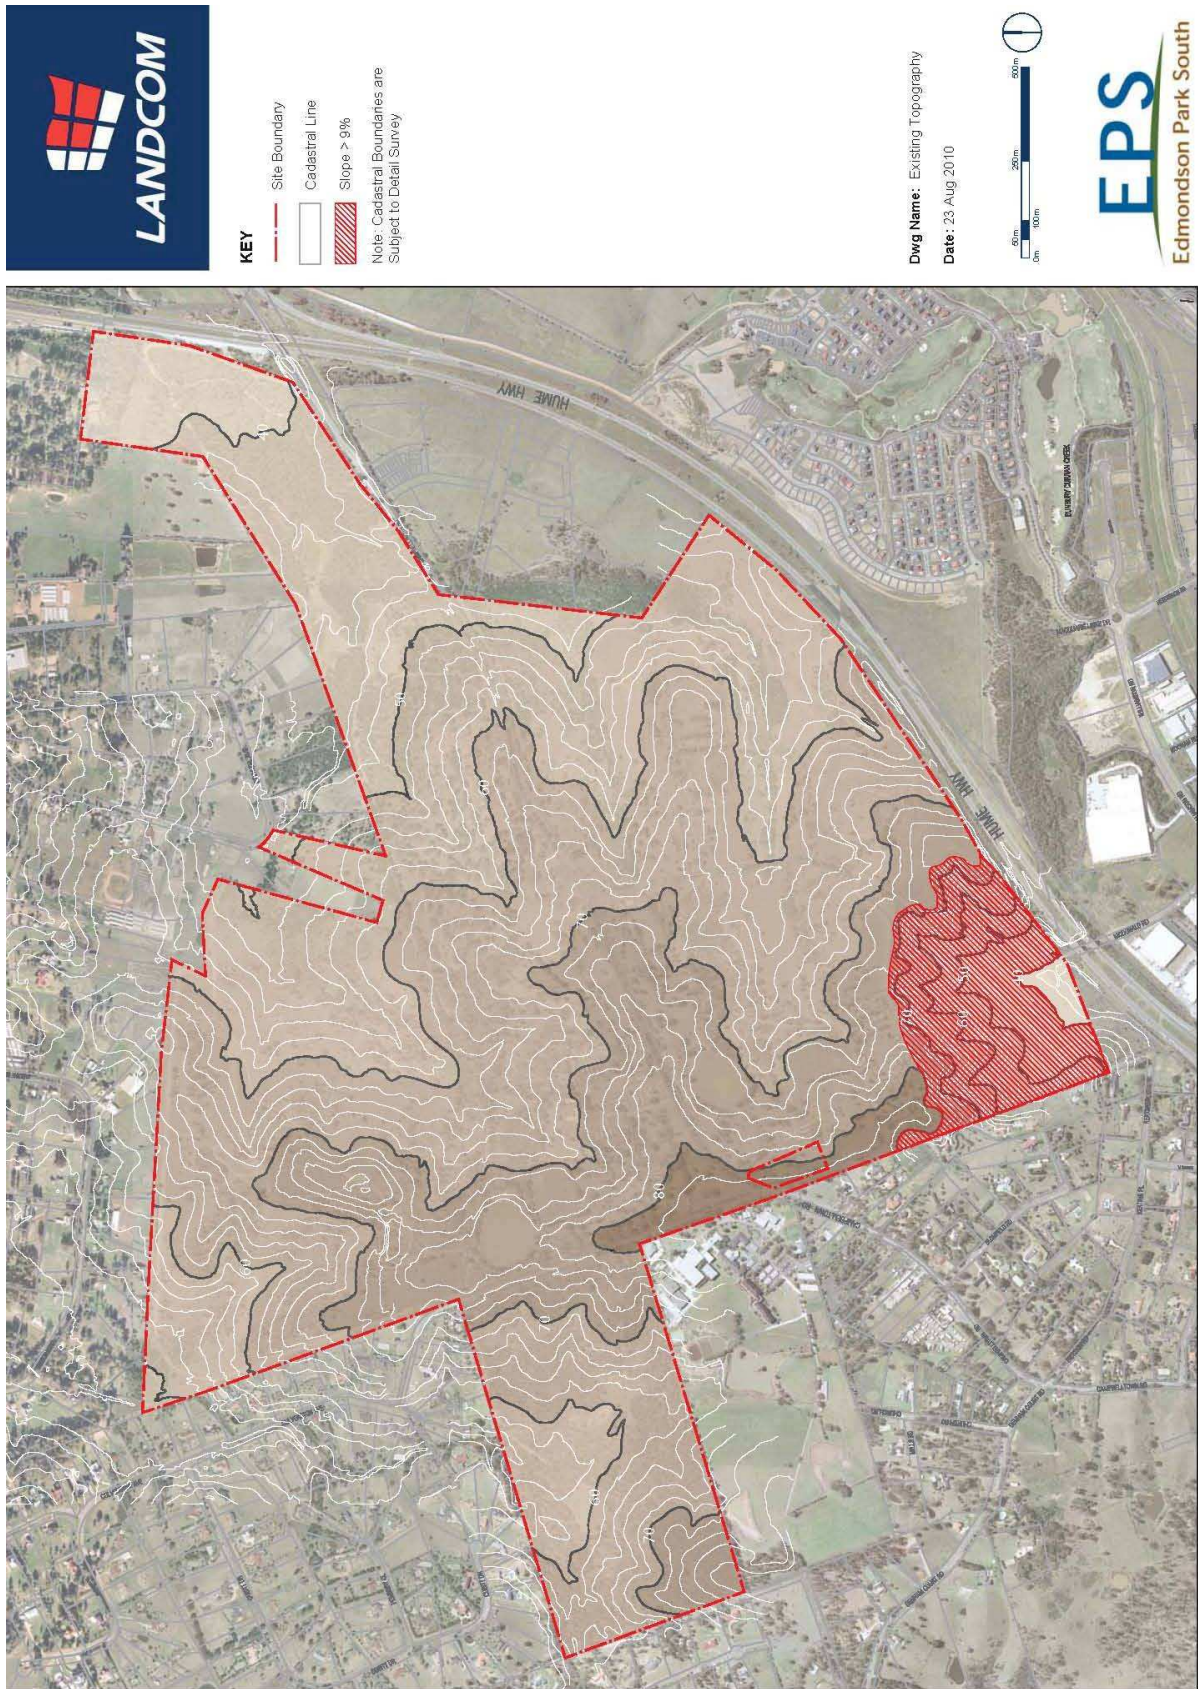
Figure 10 - Site topography and slope analysis

The site is undulating to steep. It slopes from its highest point (80 m AHD) at the intersection of Zouch and Campbelltown Roads to its lowest point (40 m AHD) at its eastern corner and to a similar elevation adjacent to the M5 Motorway in the south-west corner. The central portion of the site along Campbelltown Road forms a ridge with gentle falls to the north and south. A secondary ridge along Zouch Road gives the site an elevated western boundary.

The site topography is illustrated at **Figure 10**.

In terms of slope stability, the natural ground surface within the site is assessed to be generally as very low risk of instability with the majority of slopes between 0 degrees to 10 degrees gradient. Steeper slopes exist within the southern portion of the site. Previous investigations undertaken by Geotechnique in 2003 indicate the presence of shallow rock (0.7 m to 1.3 m depth) in this area. Soil slope instability is likely to be a low risk given the shallow cover of soil over rock and where slope angles are less than 15 degrees. **Figure 10** provides a site slope analysis.

The majority of the site is classified as either very low or low risk with respect to stability, with construction considered to be relatively straightforward. Slope stability is not considered to present a significant site constraint.

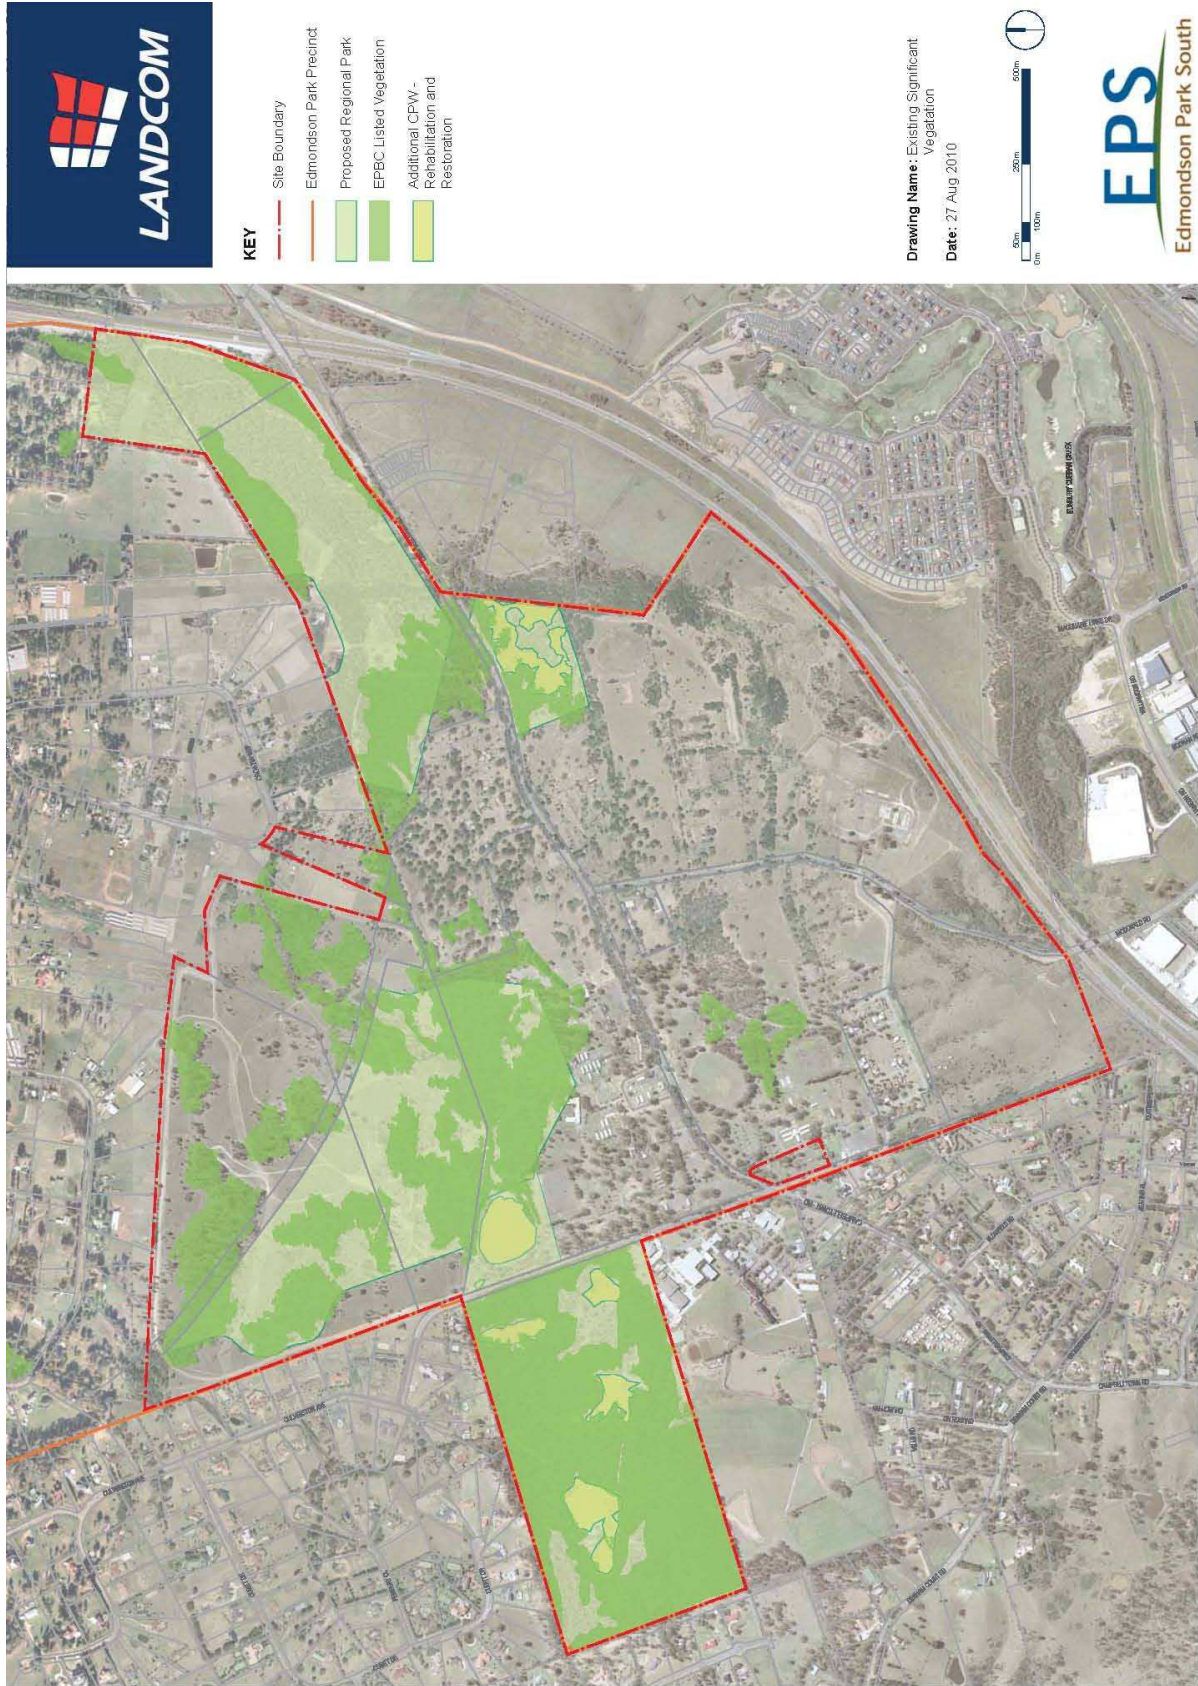
Figure 11 - Existing significant vegetation

The majority of the native vegetation on the site is Shale Plains Woodland, a sub-community of CPW. CPW is listed as a critically endangered ecological community under the TSC and EPBC Acts. This community is dominated by Grey Box (*Eucalyptus moluccana*) with Native Blackthorn (*Bursaria Spinosa*) being the dominant shrub species. The greatest diversity of this community occurs in the ground layer where a vast array of grasses, forbs and herbaceous species are present, most notably Kangaroo Grass (*Themeda australis*), Windmill Grass (*Chloris ventricosa*) and Saltbush (*Enardia spp.*).

A large area of Alluvial Woodland, part of the TSCA listed community River-Flat Eucalypt Forest on Coastal Floodplains occurs primarily along Maxwells Creek in the north-eastern part of the site. This community is dominated by a thick canopy of *Casuarina glauca* with a low diversity of understorey species present, the cover primarily comprising of *Microlaena stipoides*. As this community occurs in riparian environments it is typically subject to higher nutrient and water flows providing an environment that is favourable to a number of weed species. Wandering Jew (*Tradescantia fluminensis*) and Madeira Vine (*Anredera cordifolia*) are notable weed species occurring in this environment.

Existing significant site vegetation is shown at **Figure 11**.
