## **Site Audit**

**Part 2, 100-120 King Street,  
Randwick NSW**

for Sir Moses Montefiore Jewish Home  
October 2006

J0807.15R-rev0

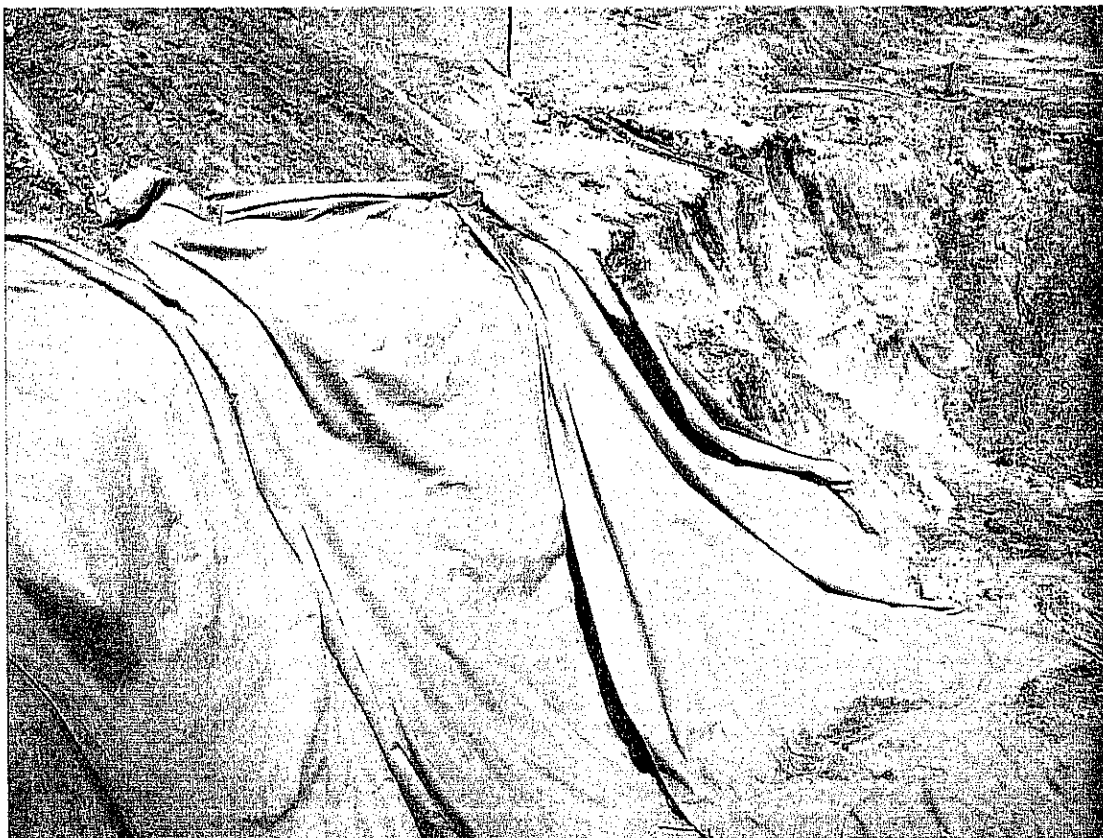
Plate 1: Lining the cell

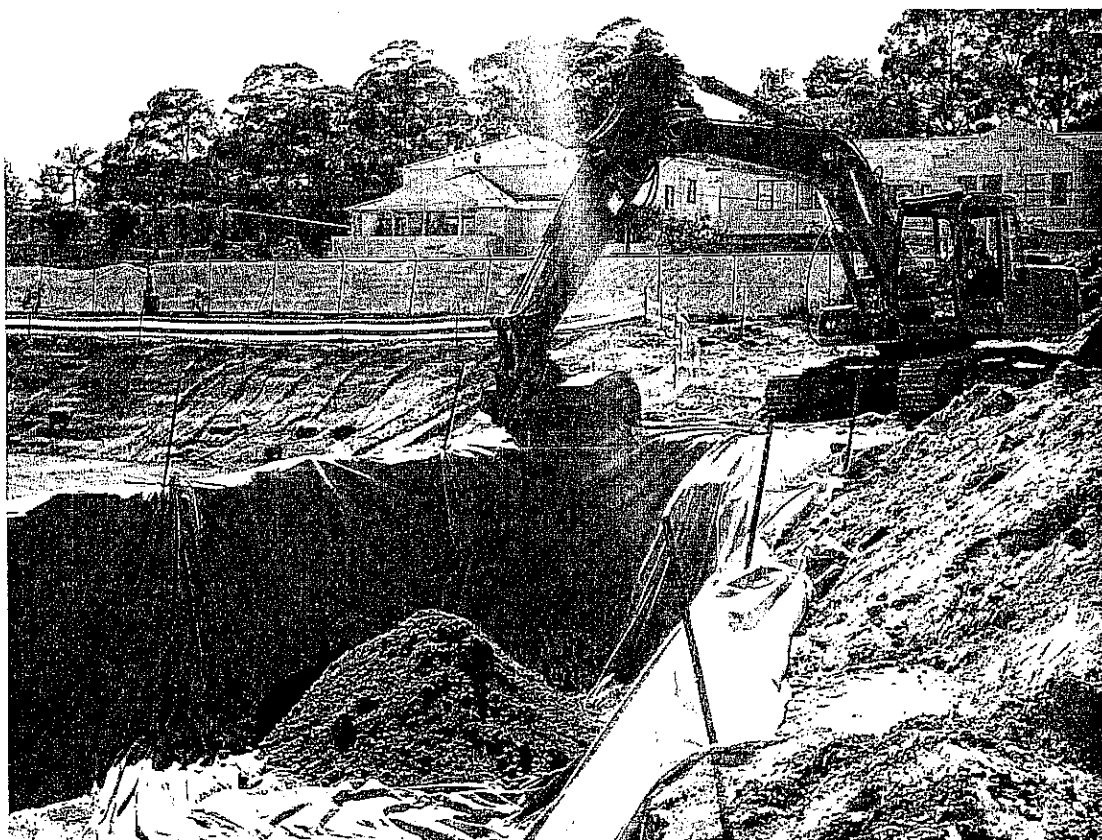
Plate 2: Placing material into Containment Cell

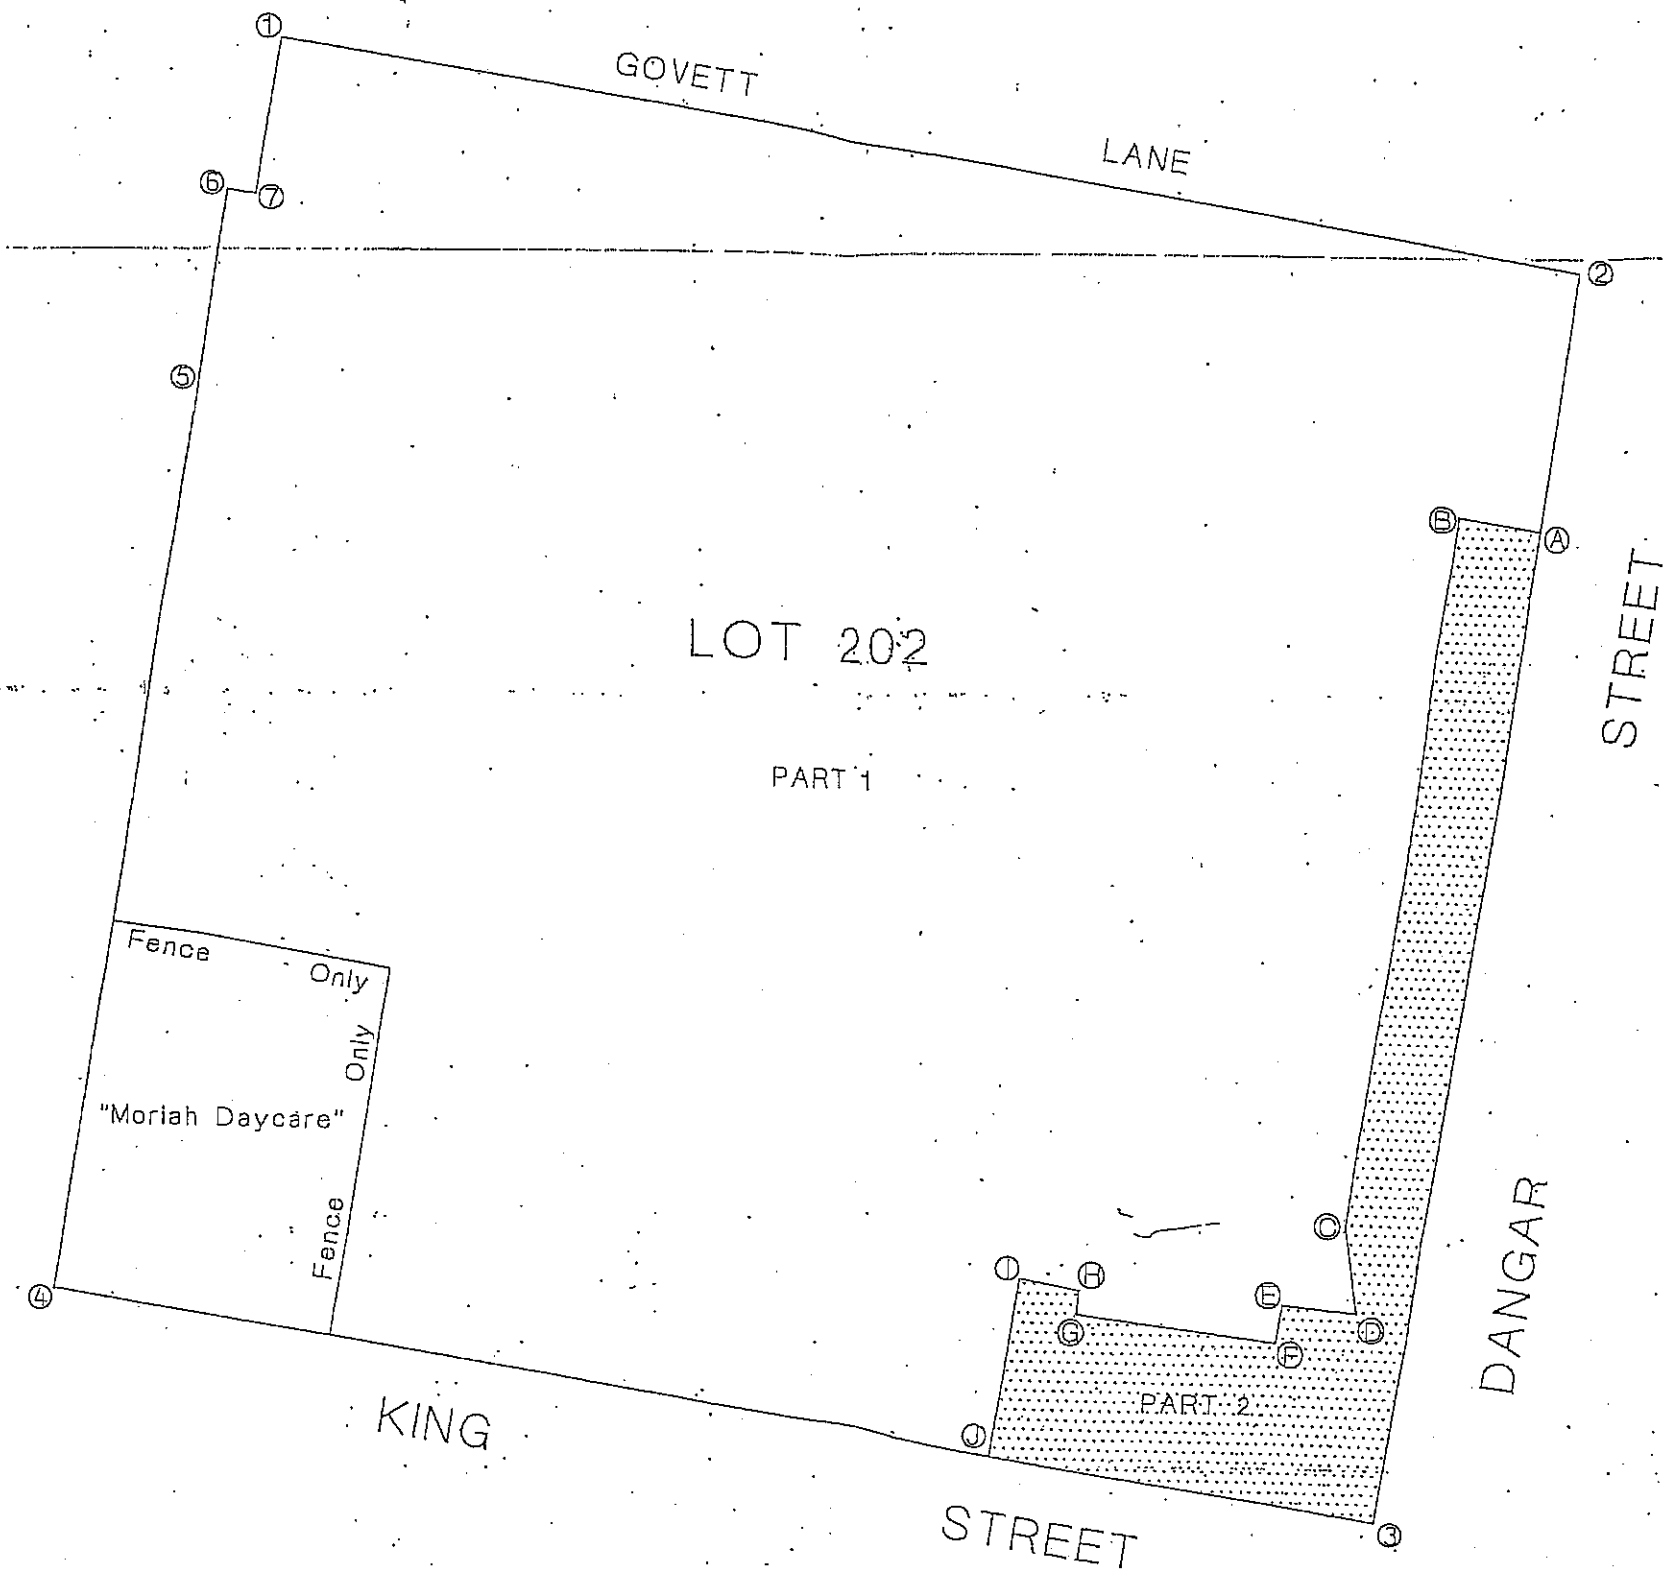
TABLE OF CO-ORDS		
POINT	EASTING	NORTHING
1	337058.68	6246924.26
2	337231.98	6246899.03
3	337208.58	6246736.20
4	337031.60	6246761.69
5	337048.90	6246880.90
6	337052.30	6246904.73
7	337055.82	6246904.23
A	337227.21	6246865.86
B	337216.19	6246867.35
C	337203.50	6246774.42
D	337205.32	6246763.29
E	337195.38	6246764.10
F	337194.56	6246759.12
G	337168.24	6246762.24
H	337168.49	6246765.29
I	337160.55	6246766.68
J	337157.40	6246743.54
