**PHASE 2 ENVIRONMENTAL SITE
ASSESSMENT
ALL SEASONS SALAMANDER SHORES
HOTEL
147 SOLDIERS POINT ROAD, SOLDIERS
POINT**

Report Date: 13 April 2010
Project Ref: ENVIWARA00284AB

**RE: PROPOSED HOTEL REDEVELOPMENT
ALL SEASONS SALAMANDER SHORES HOTEL
PHASE 2 ENVIRONMENTAL SITE ASSESSMENT**

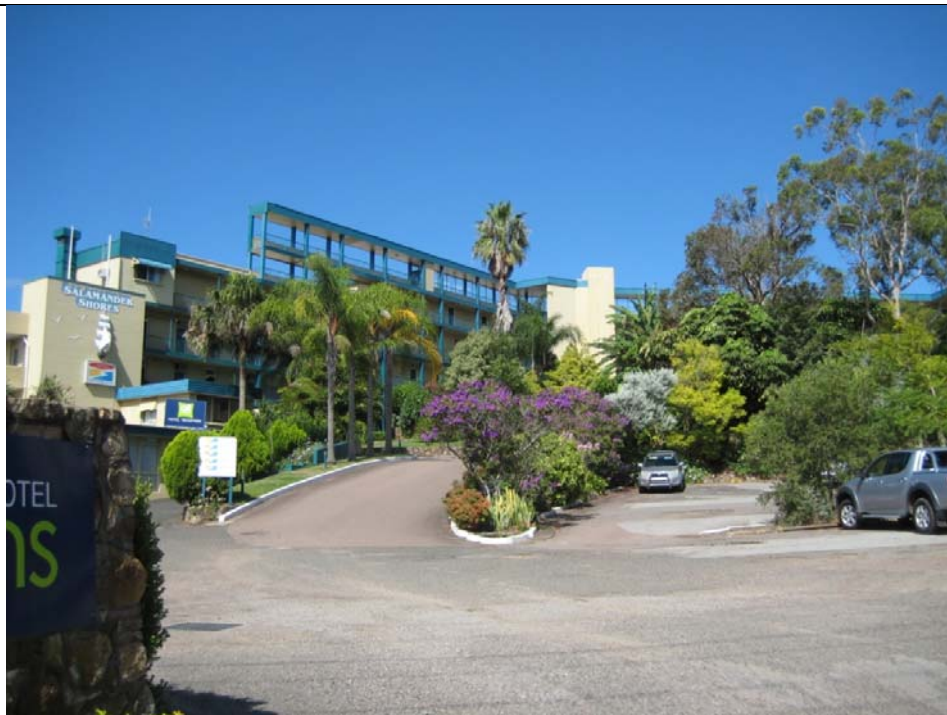
Photograph 1: The accommodation building and main carpark area of the Salamander shores Hotel, looking east from Soldiers Point Road.

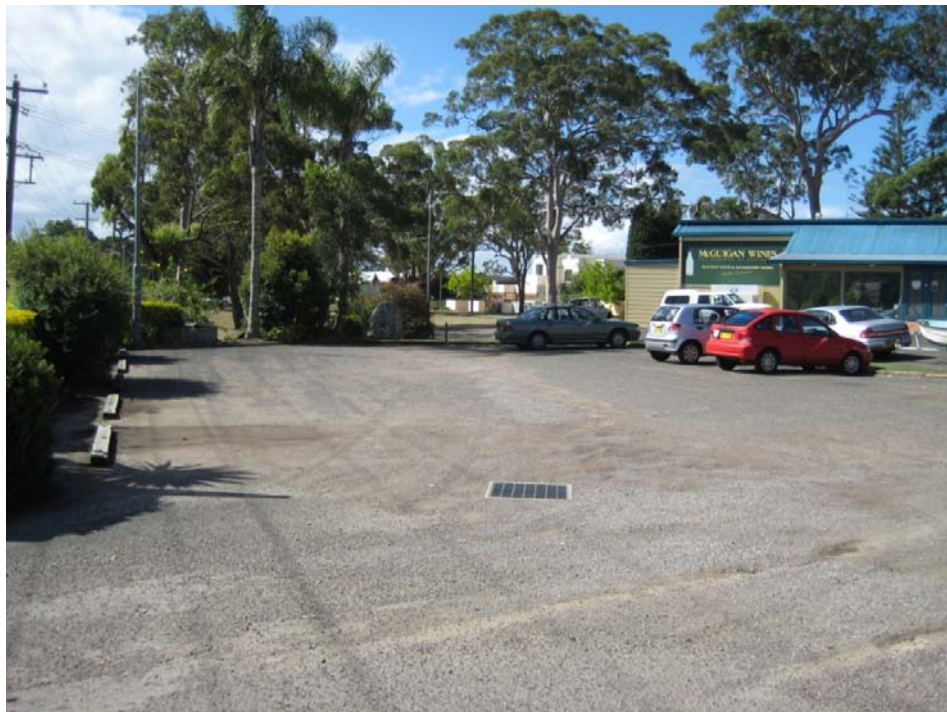
- The north-western section of the site is characterised by a bitumen carpark and a bar (Photograph 2);
- Garden beds were located around the accommodation building and carpark. Two groundwater monitoring wells were observed in and near the carpark (Photograph 3);

Photograph 2: The bitumen carpark in the north-western corner of the site

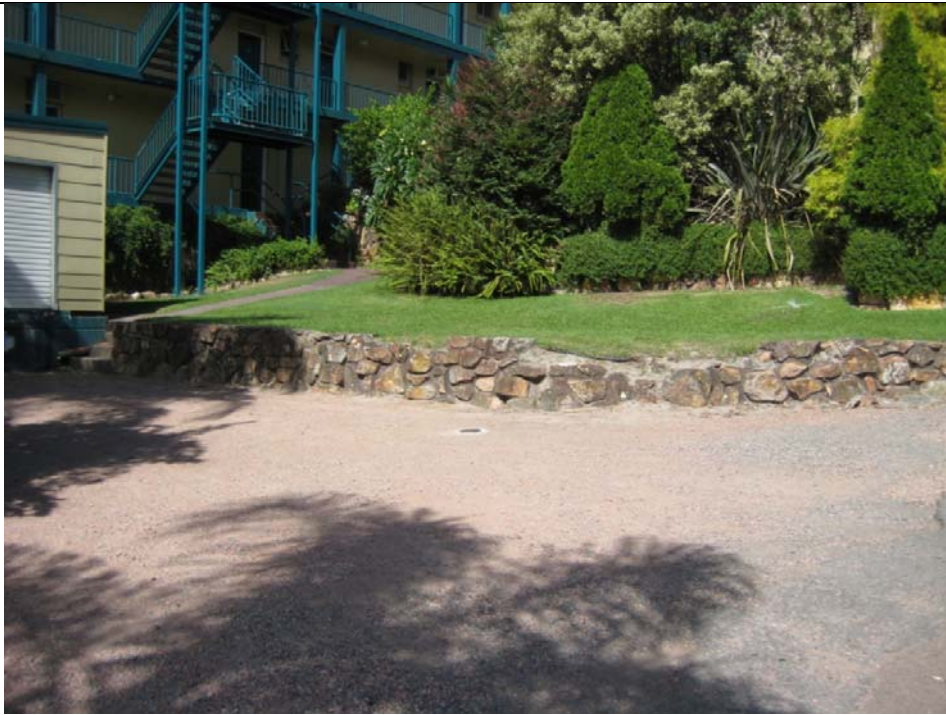
Photograph 3: Looking near the central portion of the main accommodation area of the hotel. Note the groundwater monitoring well (the circular object in front of the stone wall); one of two monitoring wells at the site.

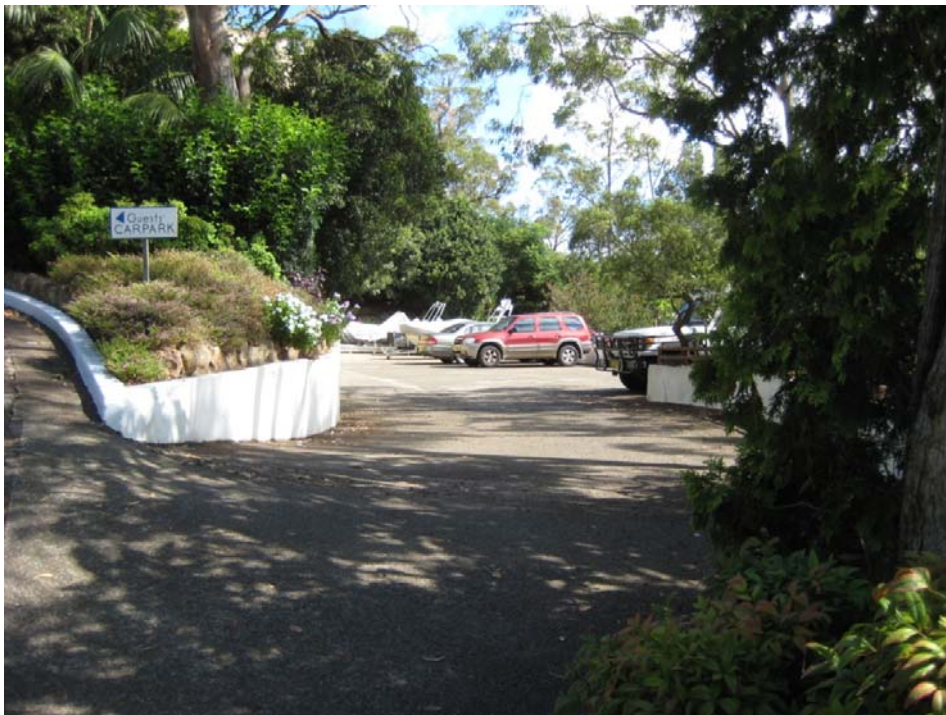
- An elevated concrete carpark was located adjacent to the south-western section of the accommodation building (Photograph 4);
- An undercover maintenance shed is located at the southern end of the accommodation building. The floor of the maintenance shed was observed to be concrete, with no visible cracks or staining (Photograph 5);

Photograph 4: A concrete carpark area located adjacent to the south-western section of the accommodation building.

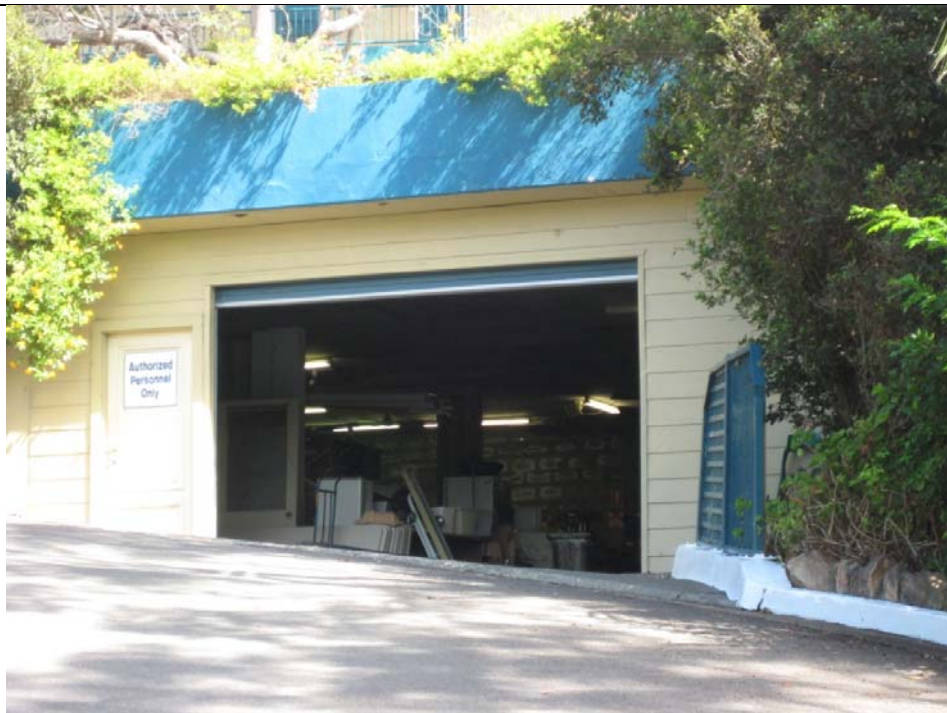
Photograph 5: The maintenance shed located at the southern end of the accommodation building. The floor of the maintenance shed consisted of concrete with no visible staining or cracks.

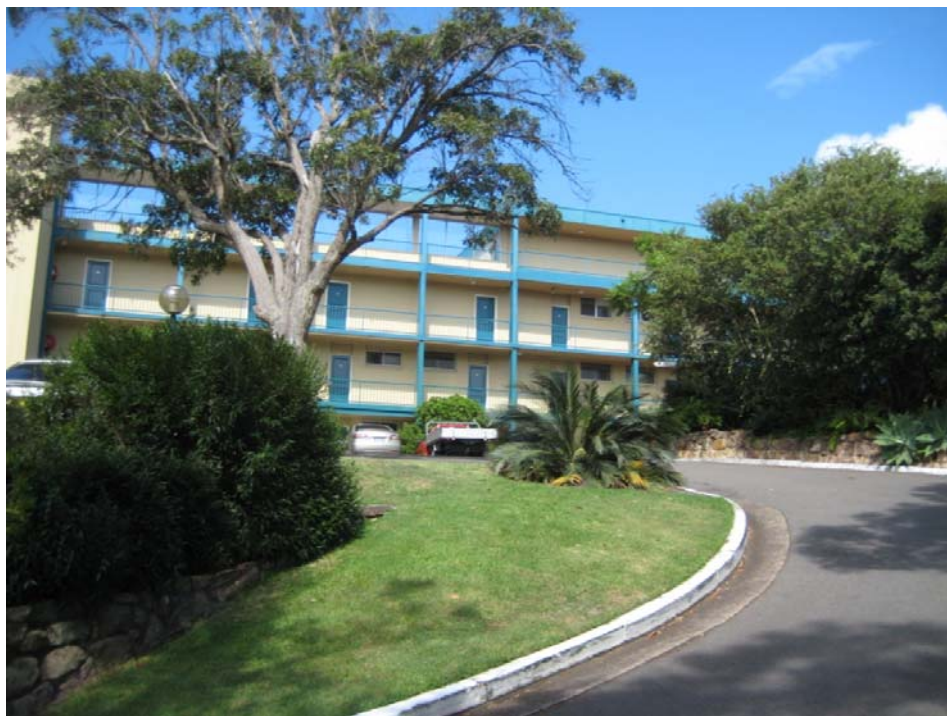
Photograph 6: Looking west towards the main part of the accommodation building (eastern side of site). This is the highest portion of the site.

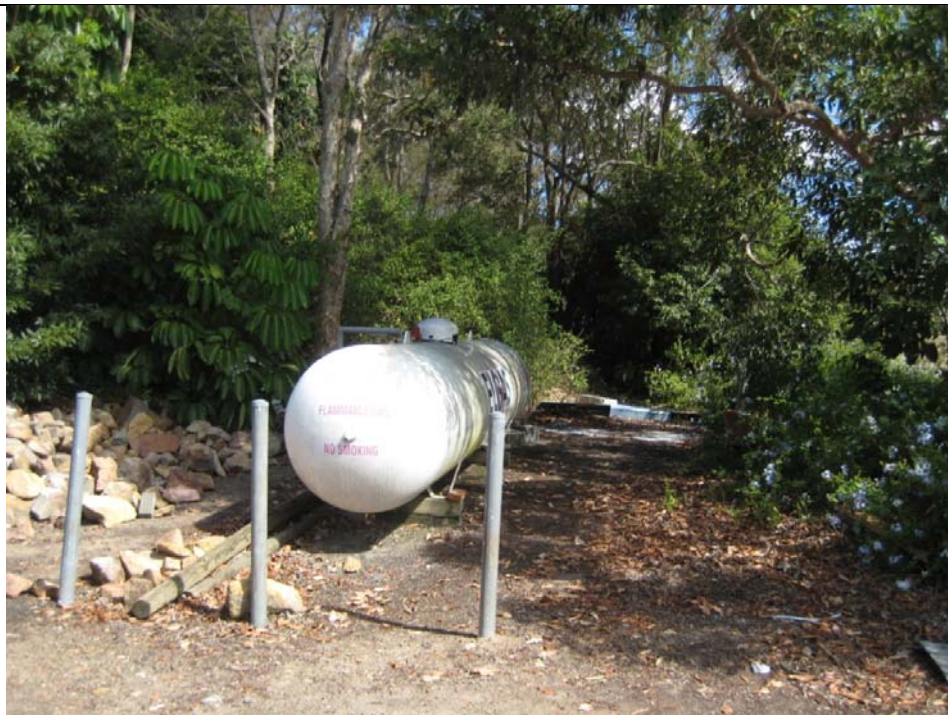
Photograph 7: The LPG AST located in the south-western section of the site.

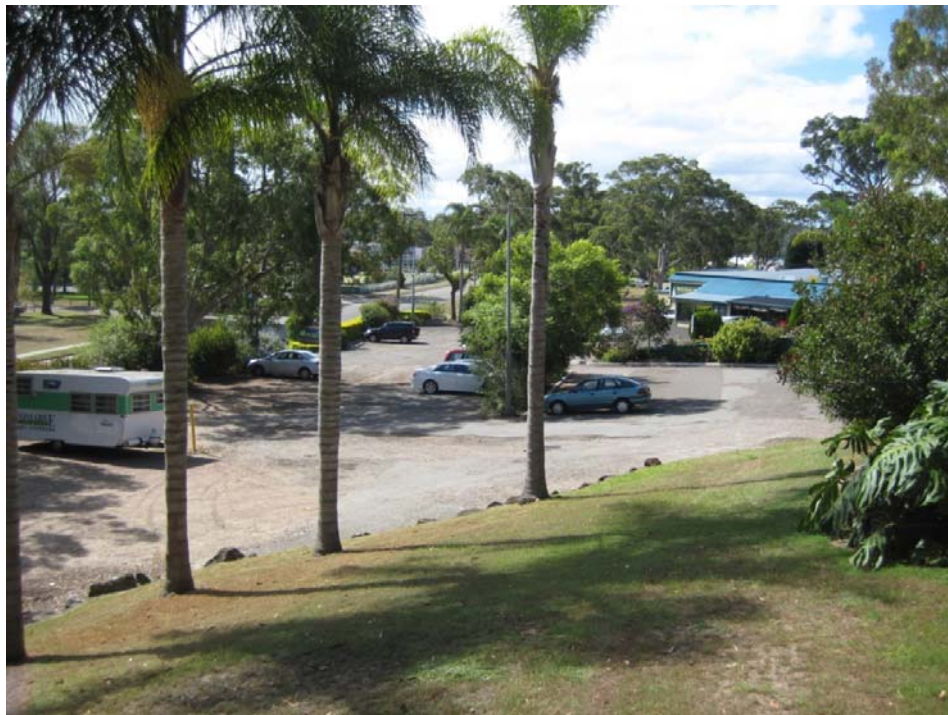
Photograph 8: Overview of the carpark areas of the hotel (western section of the site).

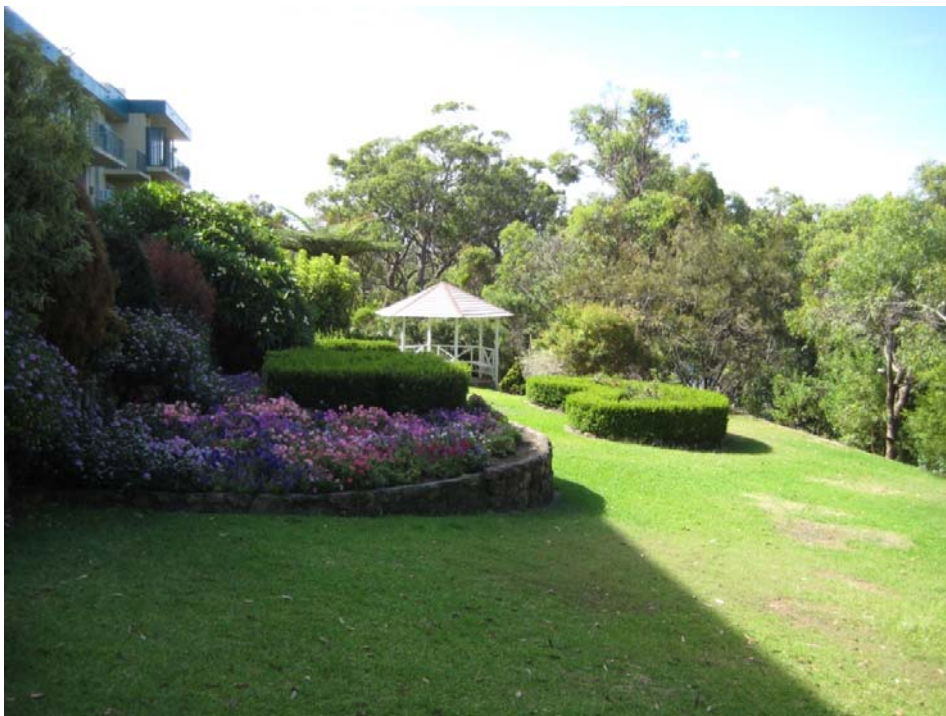
Photograph 10: Looking north along the eastern boundary of the site. This section is defined by a number of garden beds and a covered outdoor seating area.

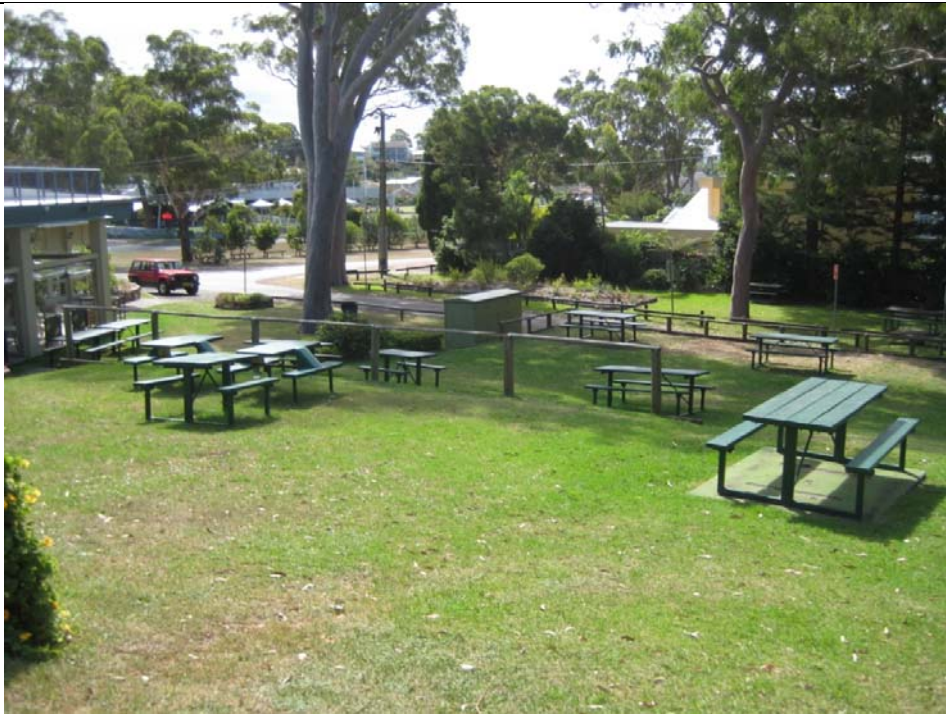
Photograph 11: The outdoor seating area in the north-eastern corner of the site.
