## Contaminated Land Assessment

**CONTAMINATED LAND ASSESSMENT**  
**FOR THE NORTH BYRON PARKLANDS PROJECT &**  
**CONCEPT PLAN APPLICATION**  
**AT**  
**NORTH BYRON PARKLANDS SITE, WOORYUNG, NSW**

**For: North Byron Parklands (on behalf of Billinudgel Property Pty Ltd)**  
**Report No.: EAL2709**  
**Date: 17 June 2010**

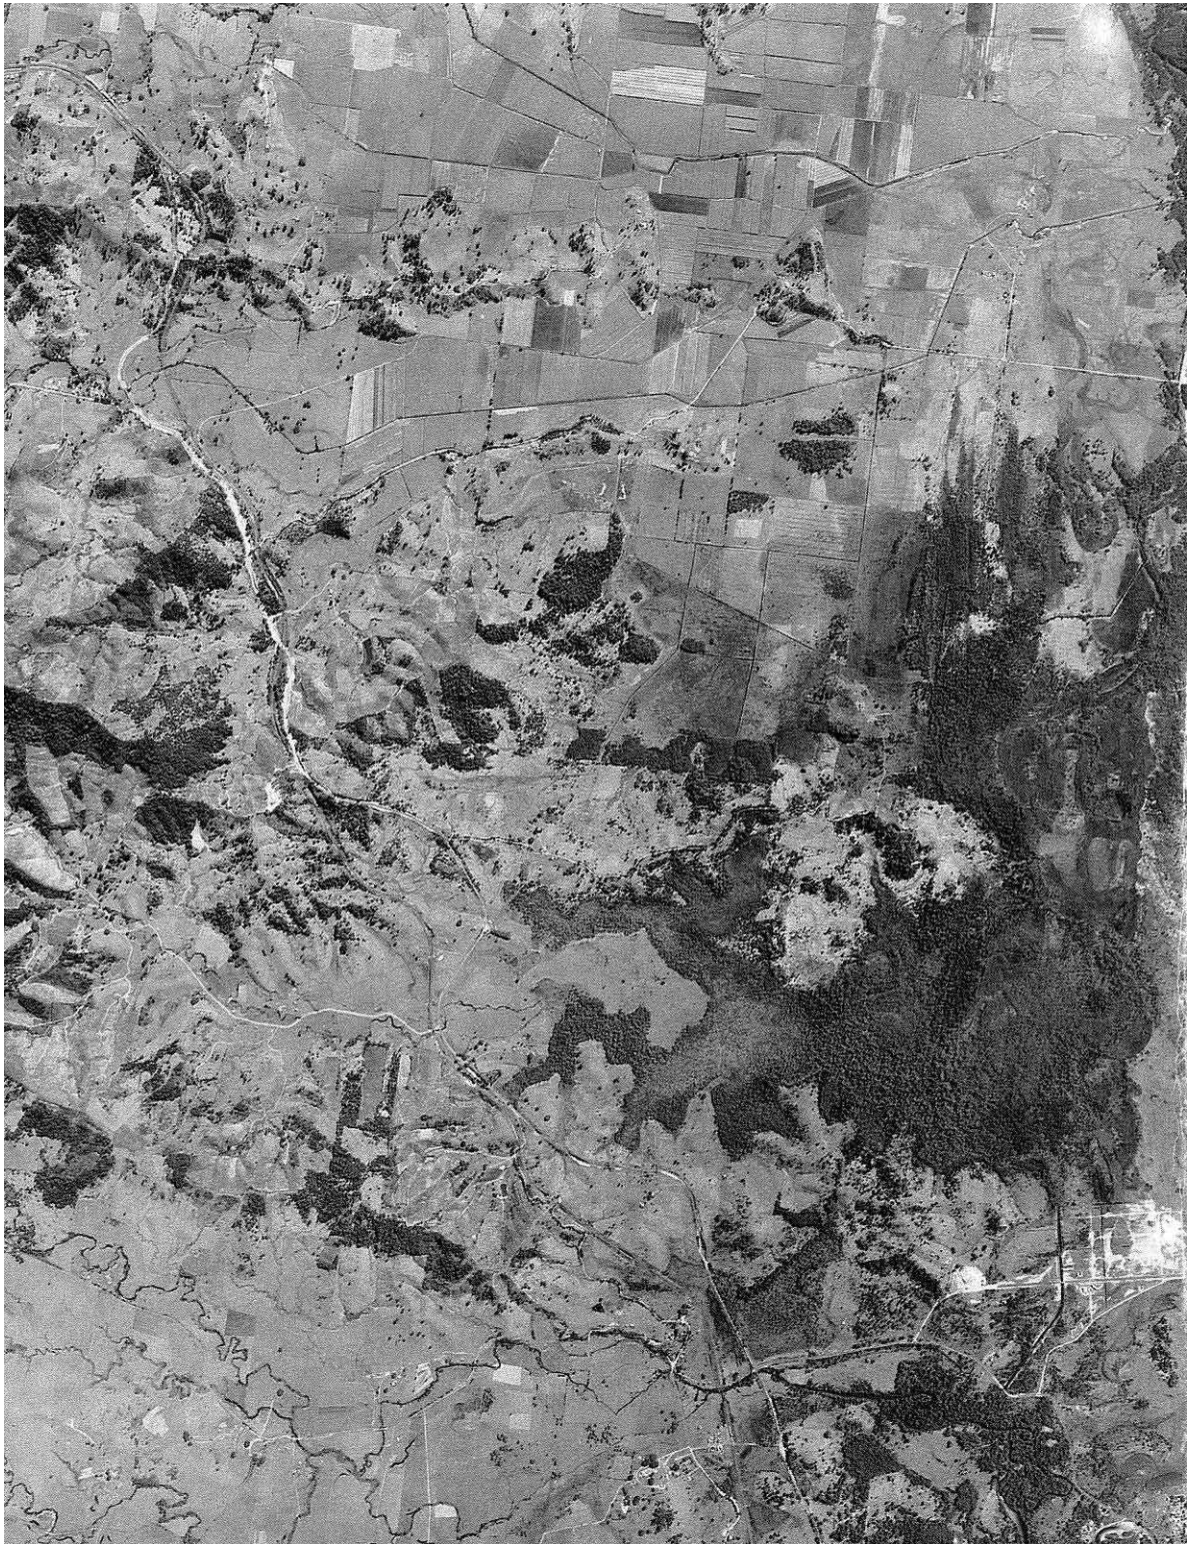
**Figure 3:** 1962 Historical Aerial.

Based on a review of a previous report on the site (Alderson and Associates 2007), and a review of historical aerial photography (1962, 1979 and 1987), the subject site has been used predominantly for low intensity agricultural purposes since at least 1947 (Alderson and Associates 2007). Past uses include dairy farming, some recent cropping for bananas (approximately 10 – 12 acres, for 3 – 4 years) which has now ceased, some cropping for sugar cane (low lying areas) and predominantly cattle grazing (recent years). Gradual re-colonisation of cleared lands by endemic tree species is evident. Two (2) rural-residential residences are known to exist within the bounds of the subject site. These are located south of the current study area, along Jones Road. One farm shed (colourbond) and one feed shed were identified within the bounds of the study area (constructed late 1980s/early 1990s). Remains of previous and now disused structures were not located within the current study area during this investigation.

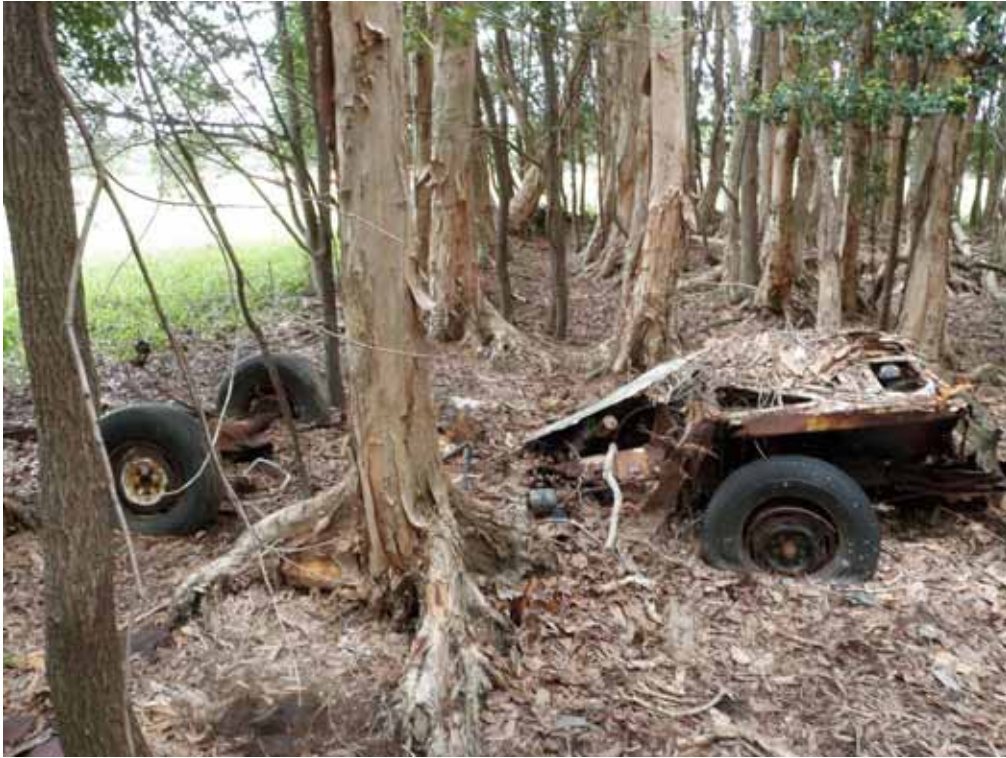
**Plate 1:** Photo of abandoned car body (Sampling point 66).

The individual sample taken from the vicinity of the car body was analysed for Total Petroleum Hydrocarbons (TPH) given fuels and oils could have leaked from the vehicle over time.

Contamination of soils surrounding the abandoned car body with Total Petroleum Hydrocarbons was identified (refer Table 9). This was anticipated as during degradation of the vehicle and its parts, oils and/or fuels would have been released. As the contamination is localised and the car body is contained within a section of Melaleuca forest, careful removal of the car and its parts should occur prior to the utilisation of the lands for their proposed purpose. Natural degradation and volatilisation of these compounds remaining in the soil should occur over time.

Analysis on a single soil sample taken from the vicinity of an abandoned car body (SP66) did indicate the presence of TPHs. Recommended remediation for this issue is the removal of the car body from within the Melaleuca Forest. Soils should be retained in situ as best possible. Natural volatilisation and degradation is anticipated to remediate the area over time. While no contamination was identified in the vicinity of other wastes located on the site, the removal of such wastes to a licensed landfill facility is recommended to minimise any future contamination issues on the site.
