**Arboricultural Impact Assessment
For
Proposed Development
At
University of Technology
Broadway Building
Ultimo NSW**

**University of Technology, Sydney
c/o Denton Corker Marshall Pty Ltd
49 Exhibition Street
MELBOURNE VIC 3000**

Ref: 2079AIA

September 2010

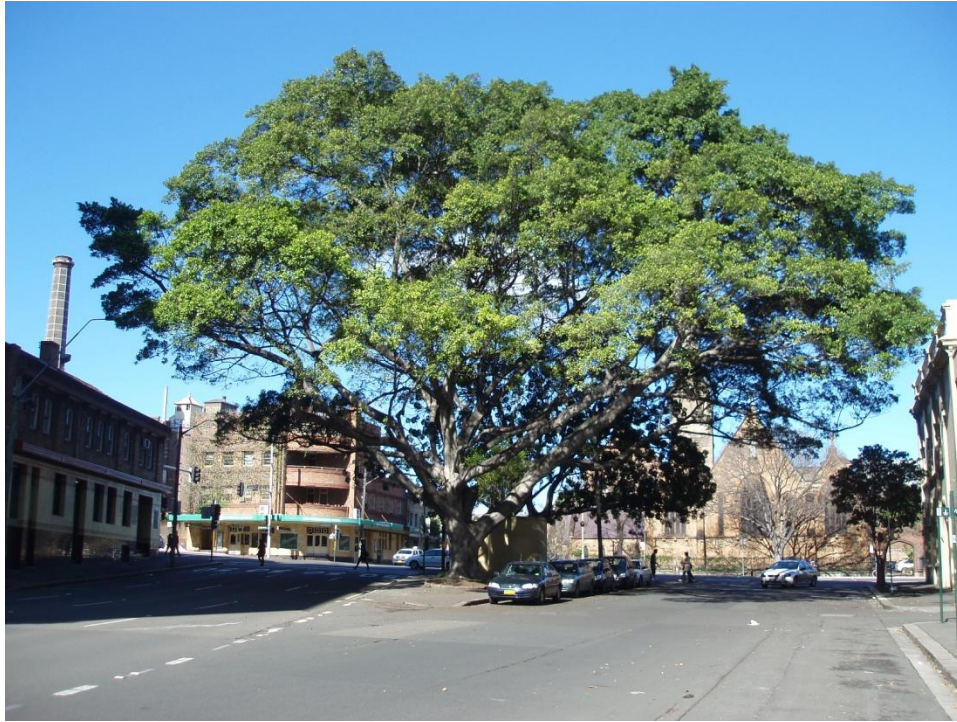
Photo A: Looking south east towards Tree 1, Hills Fig, *Ficus microcarpa* var. *Hillii*, listed as a Significant Street Tree (Precinct 14: Ultimo). The subject site is to the LHS.

- 4.2.1 Trees 1 and 2 located in the traffic island of Wattle Street are to be retained. The extent of the crown spread of Tree 1 (Hills Fig, *Ficus microcarpa* var. *Hillii*) is approximately 3 - 4 metres from the existing facade of the former Regent Hotel. The canopy of Tree 2 (Kaffir Plum, *Harpephyllum caffrum*) skews away from the subject site to the southwest. As the proposed development does not extend past the existing facade, demolition, excavation and construction works, including the erection of hoarding and/or scaffolding, are not likely to impact upon or require canopy pruning of Trees 1 and 2.

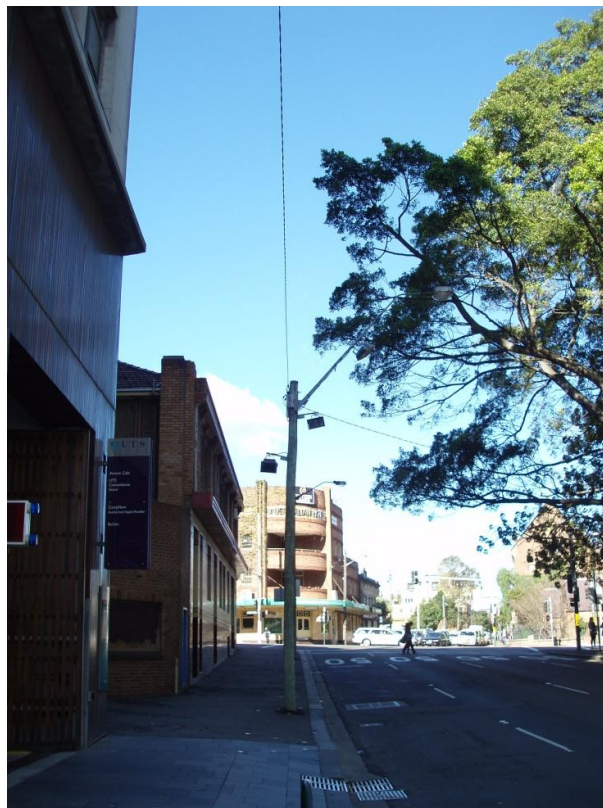
Photo B: Looking south towards Tree 1, showing the proximity of the crown spread in relation to the facade of the former Regent Hotel.

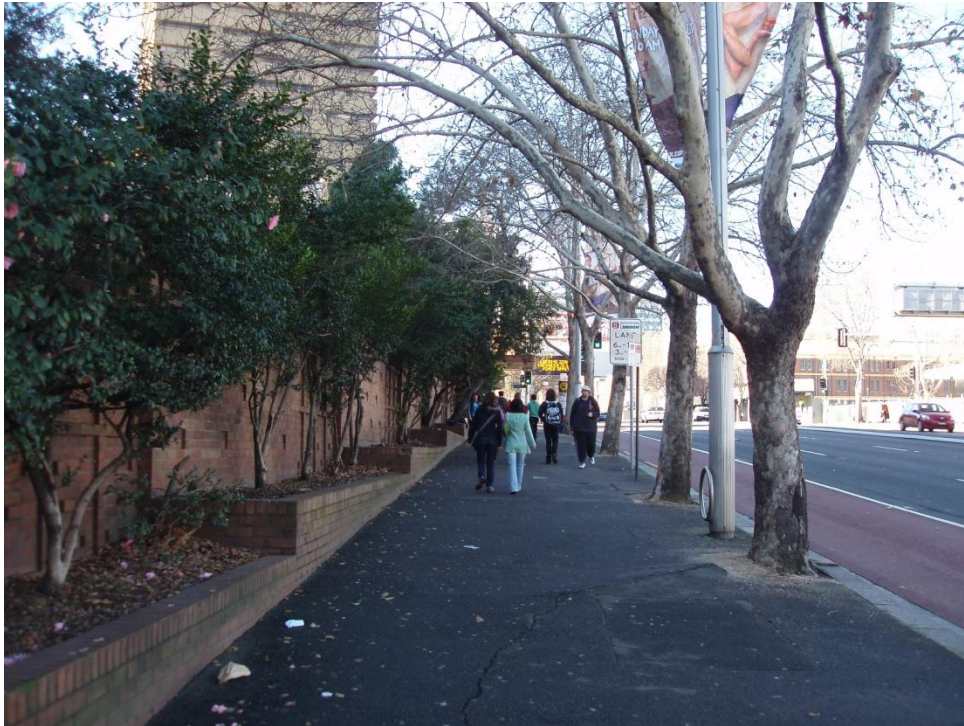
- Tree 2, Kaffir Plum, *Harpephyllum caffrum* is noted as:
- "Other tree components and associates".*
- 1.3.4 There was evidence that Trees 3 - 7, London Plane Tree, *Platanus x hybrida* located along the Broadway street frontage are causing localised uplift of the adjacent footpath pavement and stone kerb. These semi-mature trees are likely to be 12-15 years old. Some contained trunk wounds caused by passing trucks. The canopies of Trees 3-7 overhung the subject site, while this was not the case for Trees 1, 2, 8, 9 and 10. Refer to the Comments column of the Tree Schedule for further details.

Photo C: Trees 3 - 7 along Broadway frontage located adjacent to the existing wall and planter along south boundary. Note canopy overhang of southern boundary and root runs and pavement uplifting.

Trees 3, 4, 5, 6 and 7 (London Plane Tree, *Platanus x hybrida*) are located along the Broadway street frontage. It is expected that these trees will have most of their roots confined to the south of the site boundary by the foundations of the existing wall and planter. Feeder roots will be concentrated in the bedding sand layer beneath the existing footpath and underlying services easement.

Trees 3, 4, 5, 6 and 7 may require pruning to accommodate the piling at the southern boundary, the erection of hoarding, scaffolding, temporary crane access and the proposed building facade. As part of the approved demolition works, Type A Hoarding is required to be erected. Further, Type B Hoarding (overhead protective structure), scaffolding and possibly temporary crane access may be required to accommodate the construction and excavation works. To facilitate these works, consideration is to be given to minimising pruning of the crown of these trees.

Prior to the erection of any hoarding or scaffolding, the Project Arborist should be engaged to determine the extent of pruning required. The hoarding is to be compliant with City Of Sydney (CoS) *Policy for Design of Construction Hoardings*. As there is a requirement for Type B Hoarding along Broadway, conflicts exist with trunks and canopies of Trees 3 - 8. All possible efforts are to be made to minimise canopy pruning. The typical canopy spread of these trees is shown in Photo C.

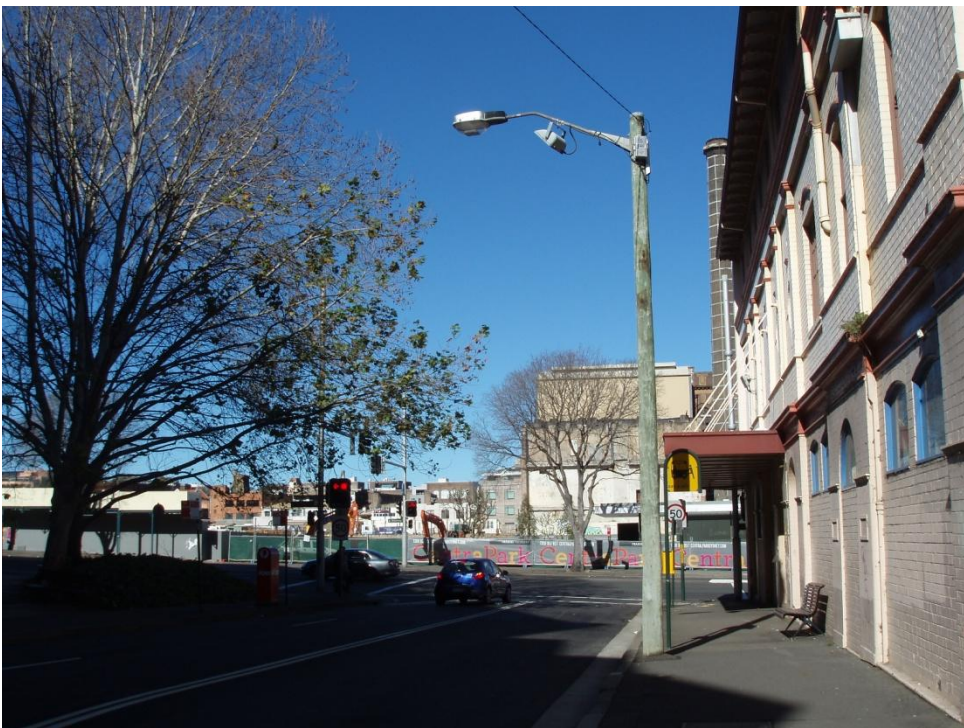
Photo D: Looking south towards Trees 8, 9 and 10 showing the proximity of the crown spread in relation to the facade of the Bradshaw Building on RHS.

Trees 8, 9 and 10 located in the verge east of Jones Street are to be retained and similarly, are not likely to be impacted upon the excavation and construction works, (including the erection of hoarding and/or scaffolding) and are not likely to require canopy pruning.
