**PRELIMINARY ENVIRONMENTAL SITE ASSESSMENT (PESA) AND SALINITY  
ASSESSMENT, CORNER OF BAKERS LANE AND MAMRE ROAD,  
ERSKINE PARK**

**Report PSM1473.R1 Rev2**

**August 2010**

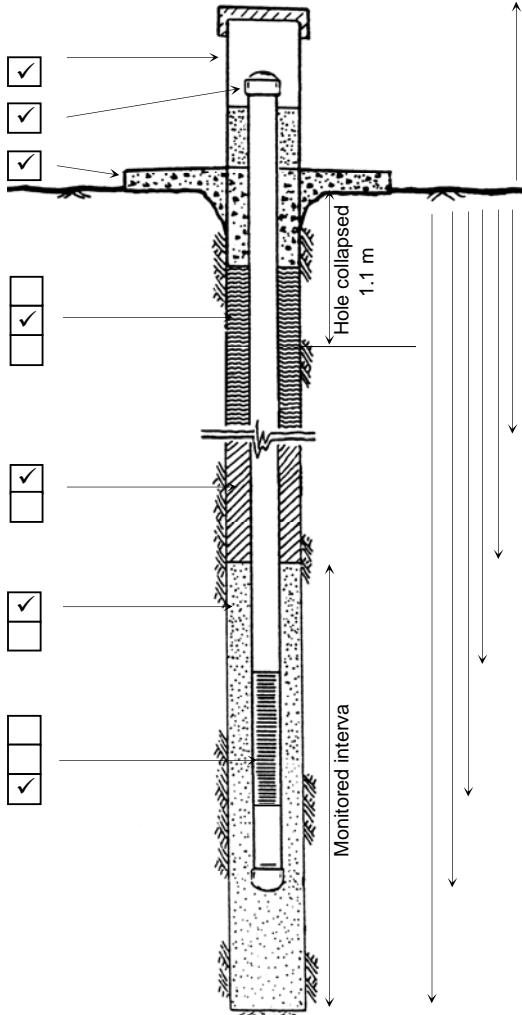
Height of stickup (m)	<u>Ground Level</u>
Gattic cover	<input checked="" type="checkbox"/>		
Plug	<input checked="" type="checkbox"/>		
Concrete collar	<input checked="" type="checkbox"/>	Diameter of PVC (mm)	<u>60 mm</u>
Back fill type:			
Cement bentonite	<input type="checkbox"/>		
Soil	<input checked="" type="checkbox"/>		
None	<input type="checkbox"/>		
Seal:		Depth to top of seal	<u>2.1 m</u>
Bentonite pellets	<input checked="" type="checkbox"/>		
Other	<input type="checkbox"/>		
Gravel type:		Depth to top of gravel pack	<u>3.6 m</u>
2-5mm gravel	<input checked="" type="checkbox"/>		
Other	<input type="checkbox"/>		
Perforation type:		Depth to top of screen	<u>4.1 m</u>
Drill holes	<input type="checkbox"/>		
Hack saw cuts	<input type="checkbox"/>		
40um machine slots	<input checked="" type="checkbox"/>	Depth to base of screen	<u>7.1 m</u>
		Depth to base of piezo	<u>7.1 m</u>
		Depth to base of gravel	<u>9.0 m</u>

COMMENTS:	20 kg bags of gravel

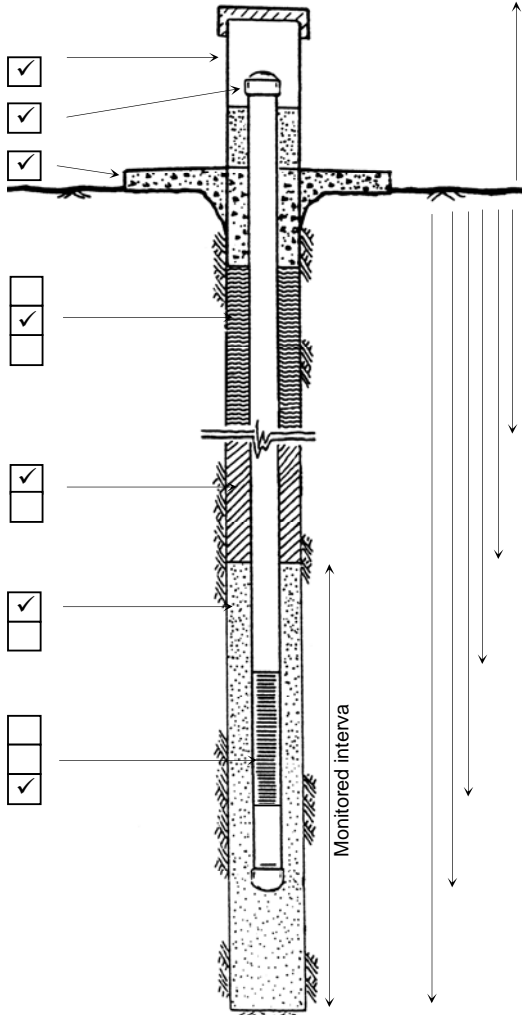
Height of stickup (m)	<u>Ground Level</u>
Gattic cover <input checked="" type="checkbox"/>		Diameter of PVC (mm)	<u>60 mm</u>
Plug <input checked="" type="checkbox"/>			
Concrete collar <input checked="" type="checkbox"/>			
Back fill type:			
Cement bentonite <input type="checkbox"/>		Depth to top of seal	<u>9.2 m</u>
Soil <input checked="" type="checkbox"/>			
None <input type="checkbox"/>		Depth to top of gravel pack	<u>10.4 m</u>
Seal:			
Bentonite pellets <input checked="" type="checkbox"/>		Depth to top of screen	<u>14.0 m</u>
Other <input type="checkbox"/>			
Gravel type:		Depth to base of screen	<u>20.0 m</u>
2-5mm gravel <input checked="" type="checkbox"/>			
Other <input type="checkbox"/>		Depth to base of piezo	<u>20.0 m</u>
Perforation type:			
Drill holes <input type="checkbox"/>		Depth to base of gravel	<u>21.5 m</u>
Hack saw cuts <input type="checkbox"/>			
40um machine slots <input checked="" type="checkbox"/>

COMMENTS:	20 kg bags of gravel

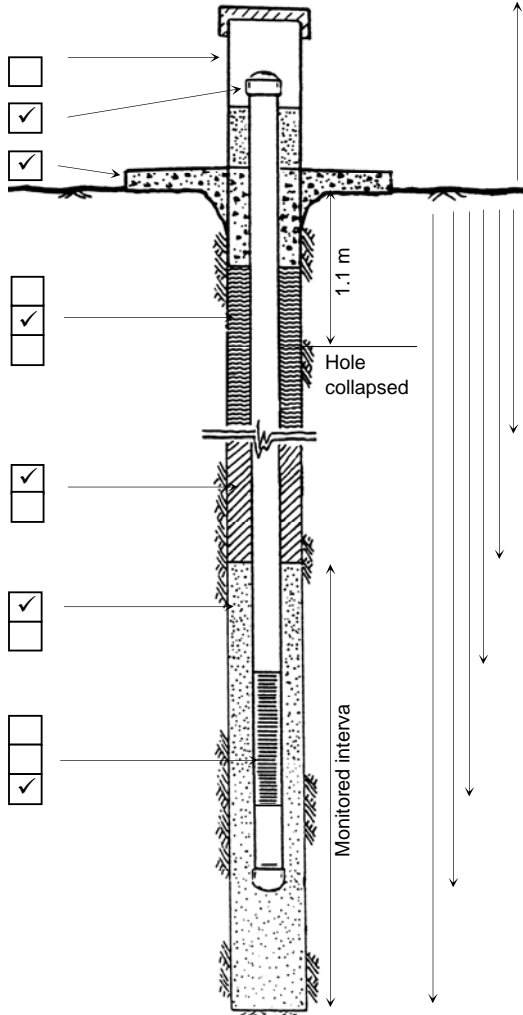
Height of stickup (m)	<u>1.0 m</u>
PVC cap	<input checked="" type="checkbox"/>		Diameter of PVC (mm)	<u>60 mm</u>
Concrete collar	<input checked="" type="checkbox"/>		Back fill type:	
	<input type="checkbox"/>		Cement bentonite	
	<input checked="" type="checkbox"/>		Soil	
	<input type="checkbox"/>		None	
Seal:			Depth to top of seal	<u>Ground Level?</u>
Bentonite pellets	<input checked="" type="checkbox"/>		Depth to top of gravel pack	<u>?</u>
Other	<input type="checkbox"/>		Depth to top of screen	<u>5.0 m</u>
Gravel type:			Depth to base of screen	<u>8.0 m</u>
2-5mm gravel	<input checked="" type="checkbox"/>	Depth to base of piezo	<u>8.0 m</u>	
Other	<input type="checkbox"/>	Depth to base of gravel	<u>8.1 m</u>	
Perforation type:				
Drill holes	<input type="checkbox"/>			
Hack saw cuts	<input type="checkbox"/>			
40um machine slots	<input checked="" type="checkbox"/>

COMMENTS:	20 kg bags of gravel
	Hole collapsed after pouring 1.5 bags of gravel, at 1.1 m deep
