**Contamination Assessment Summary
RISE Concept Plan – MP08-0234 application
Bilambil Heights
New South Wales**

Prepared for:
Terranora Group Management

September, 2010

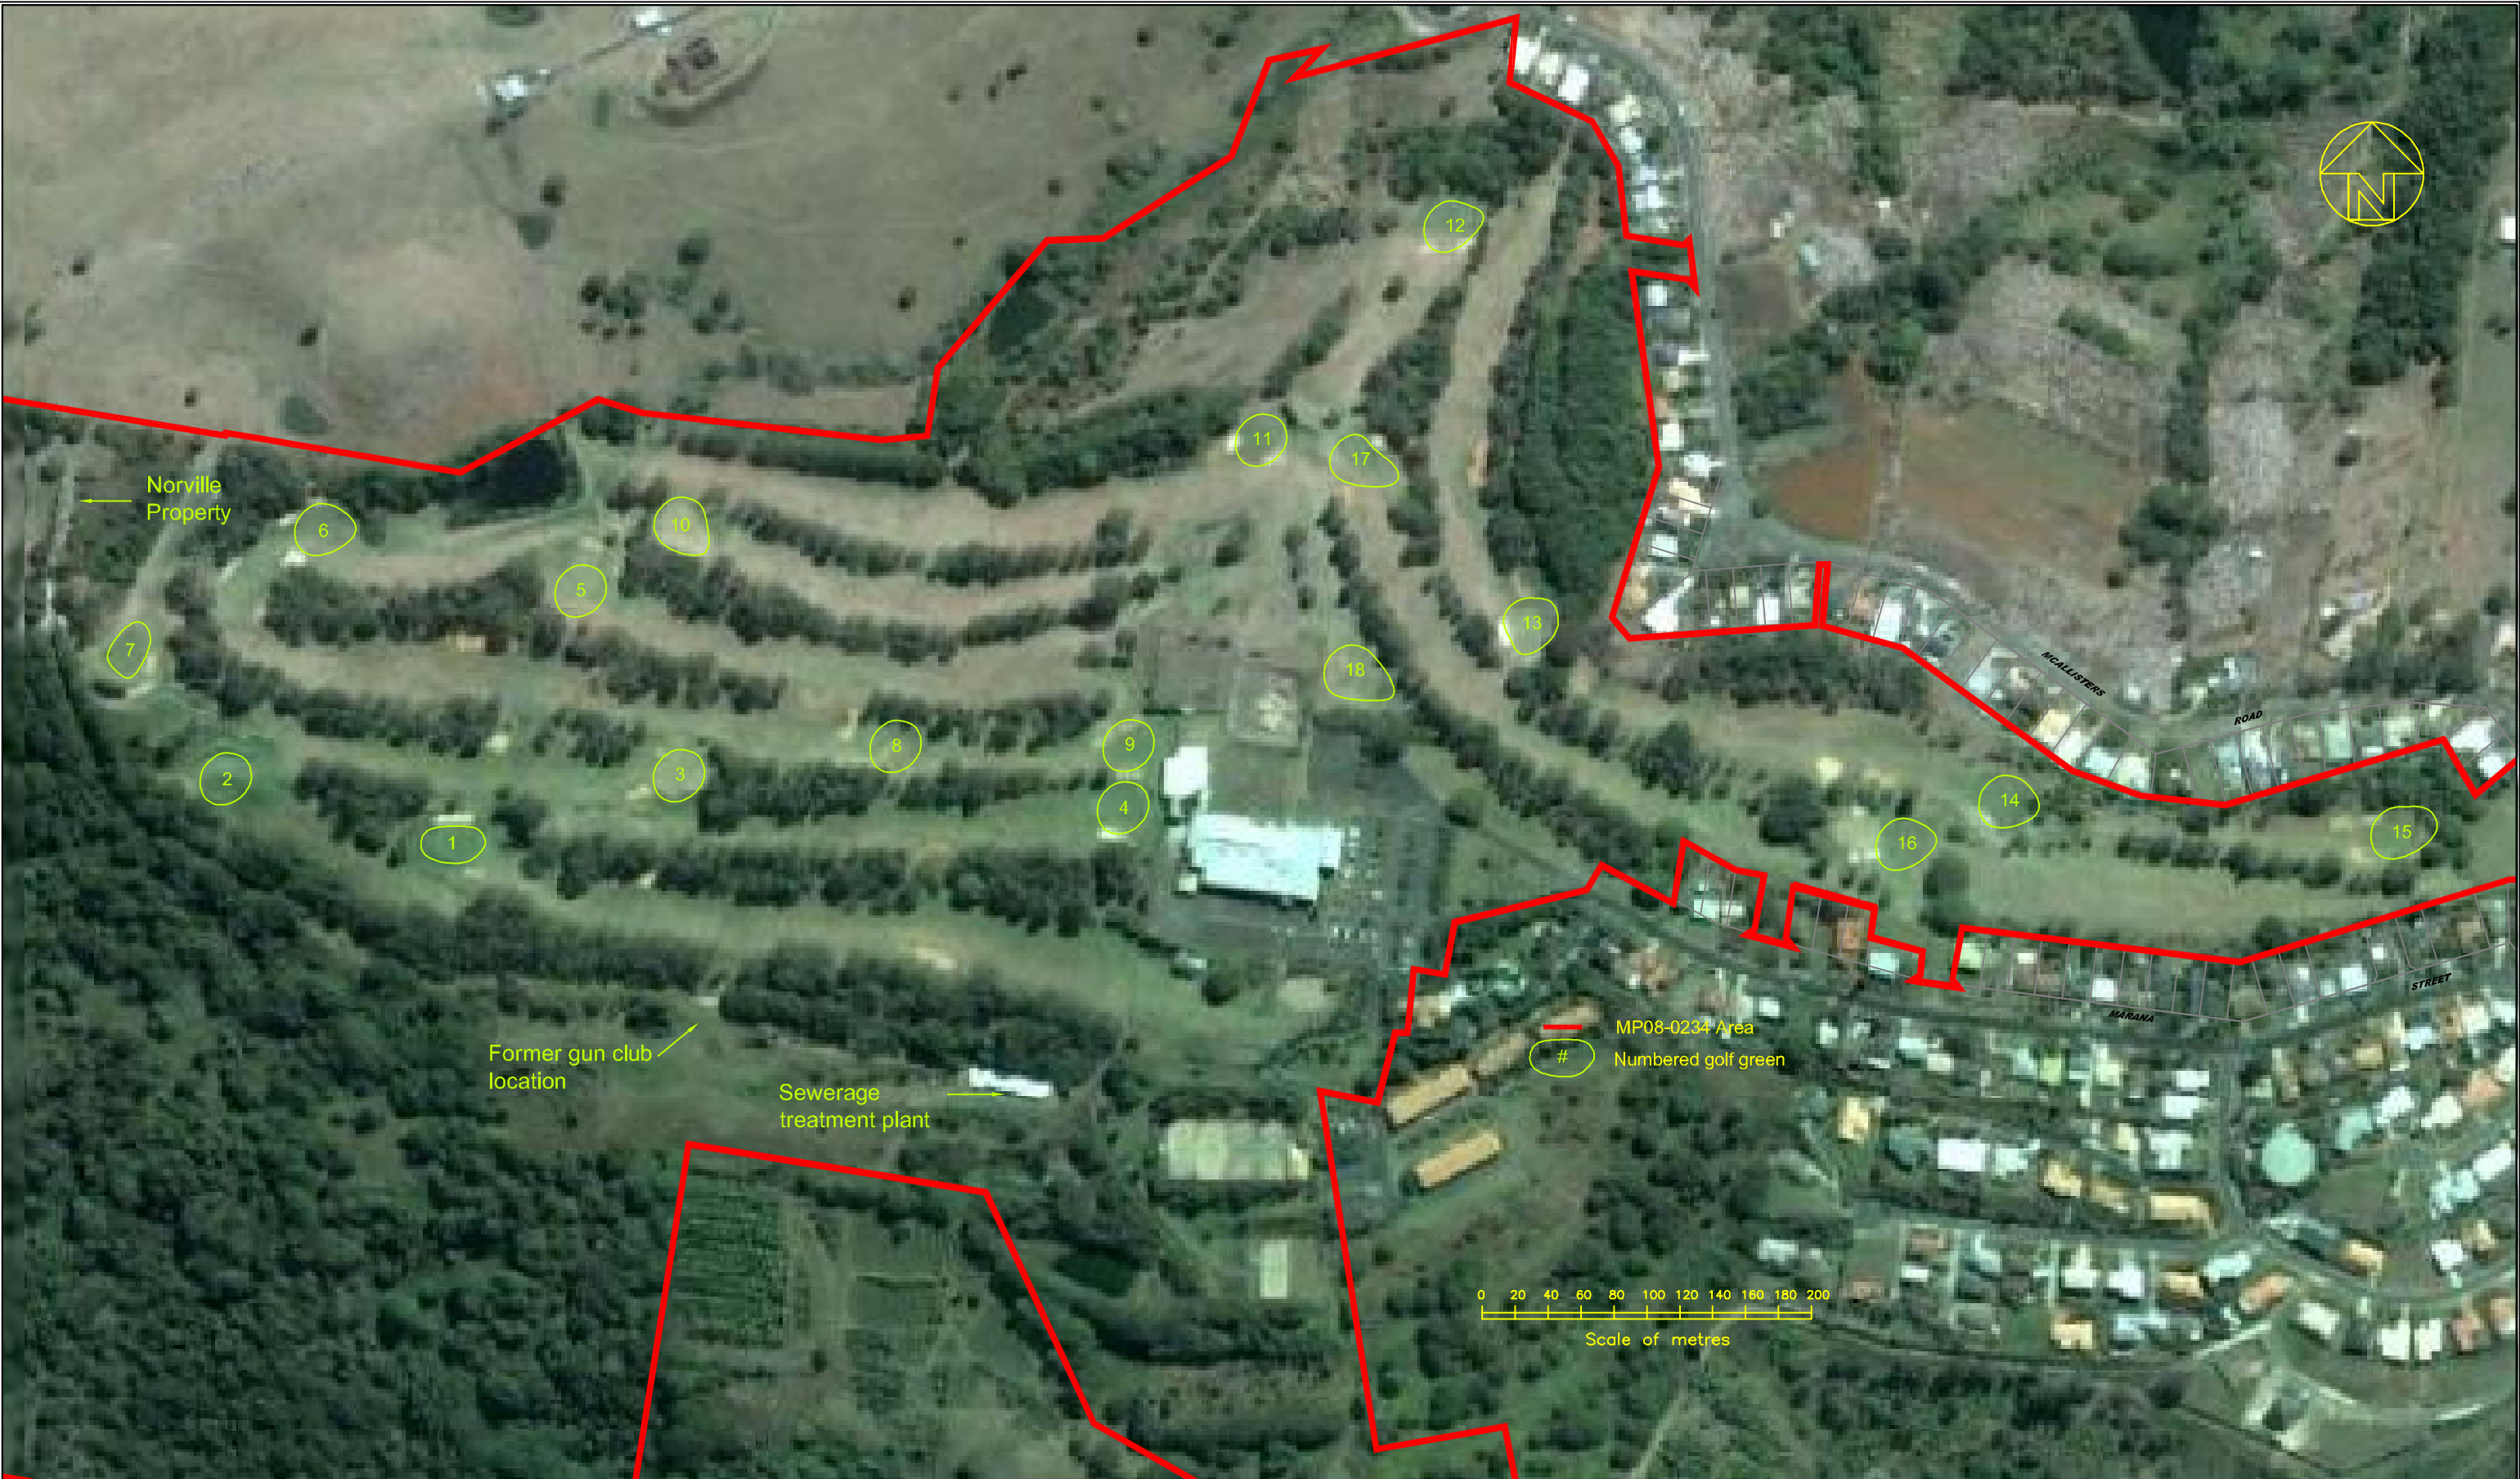
The HILs presented in the NEPM Guidelines state that the levels of Aldrin and Dieldrin for a composite of three (3) samples should not exceed 3.33mg/kg. As the Dieldrin concentrations exceeded the NEPM HILs guidelines within the greens on the 12th, 14th and 15th holes, remediation of this soil is required. The 16th green OC pesticide concentration (2.96mg/kg) is considered to be marginally elevated due to the composite sampling technique used and would be deemed subject to further investigation.

Figure GJ0495.4.3 shows the indicative locations subject to this contamination investigation

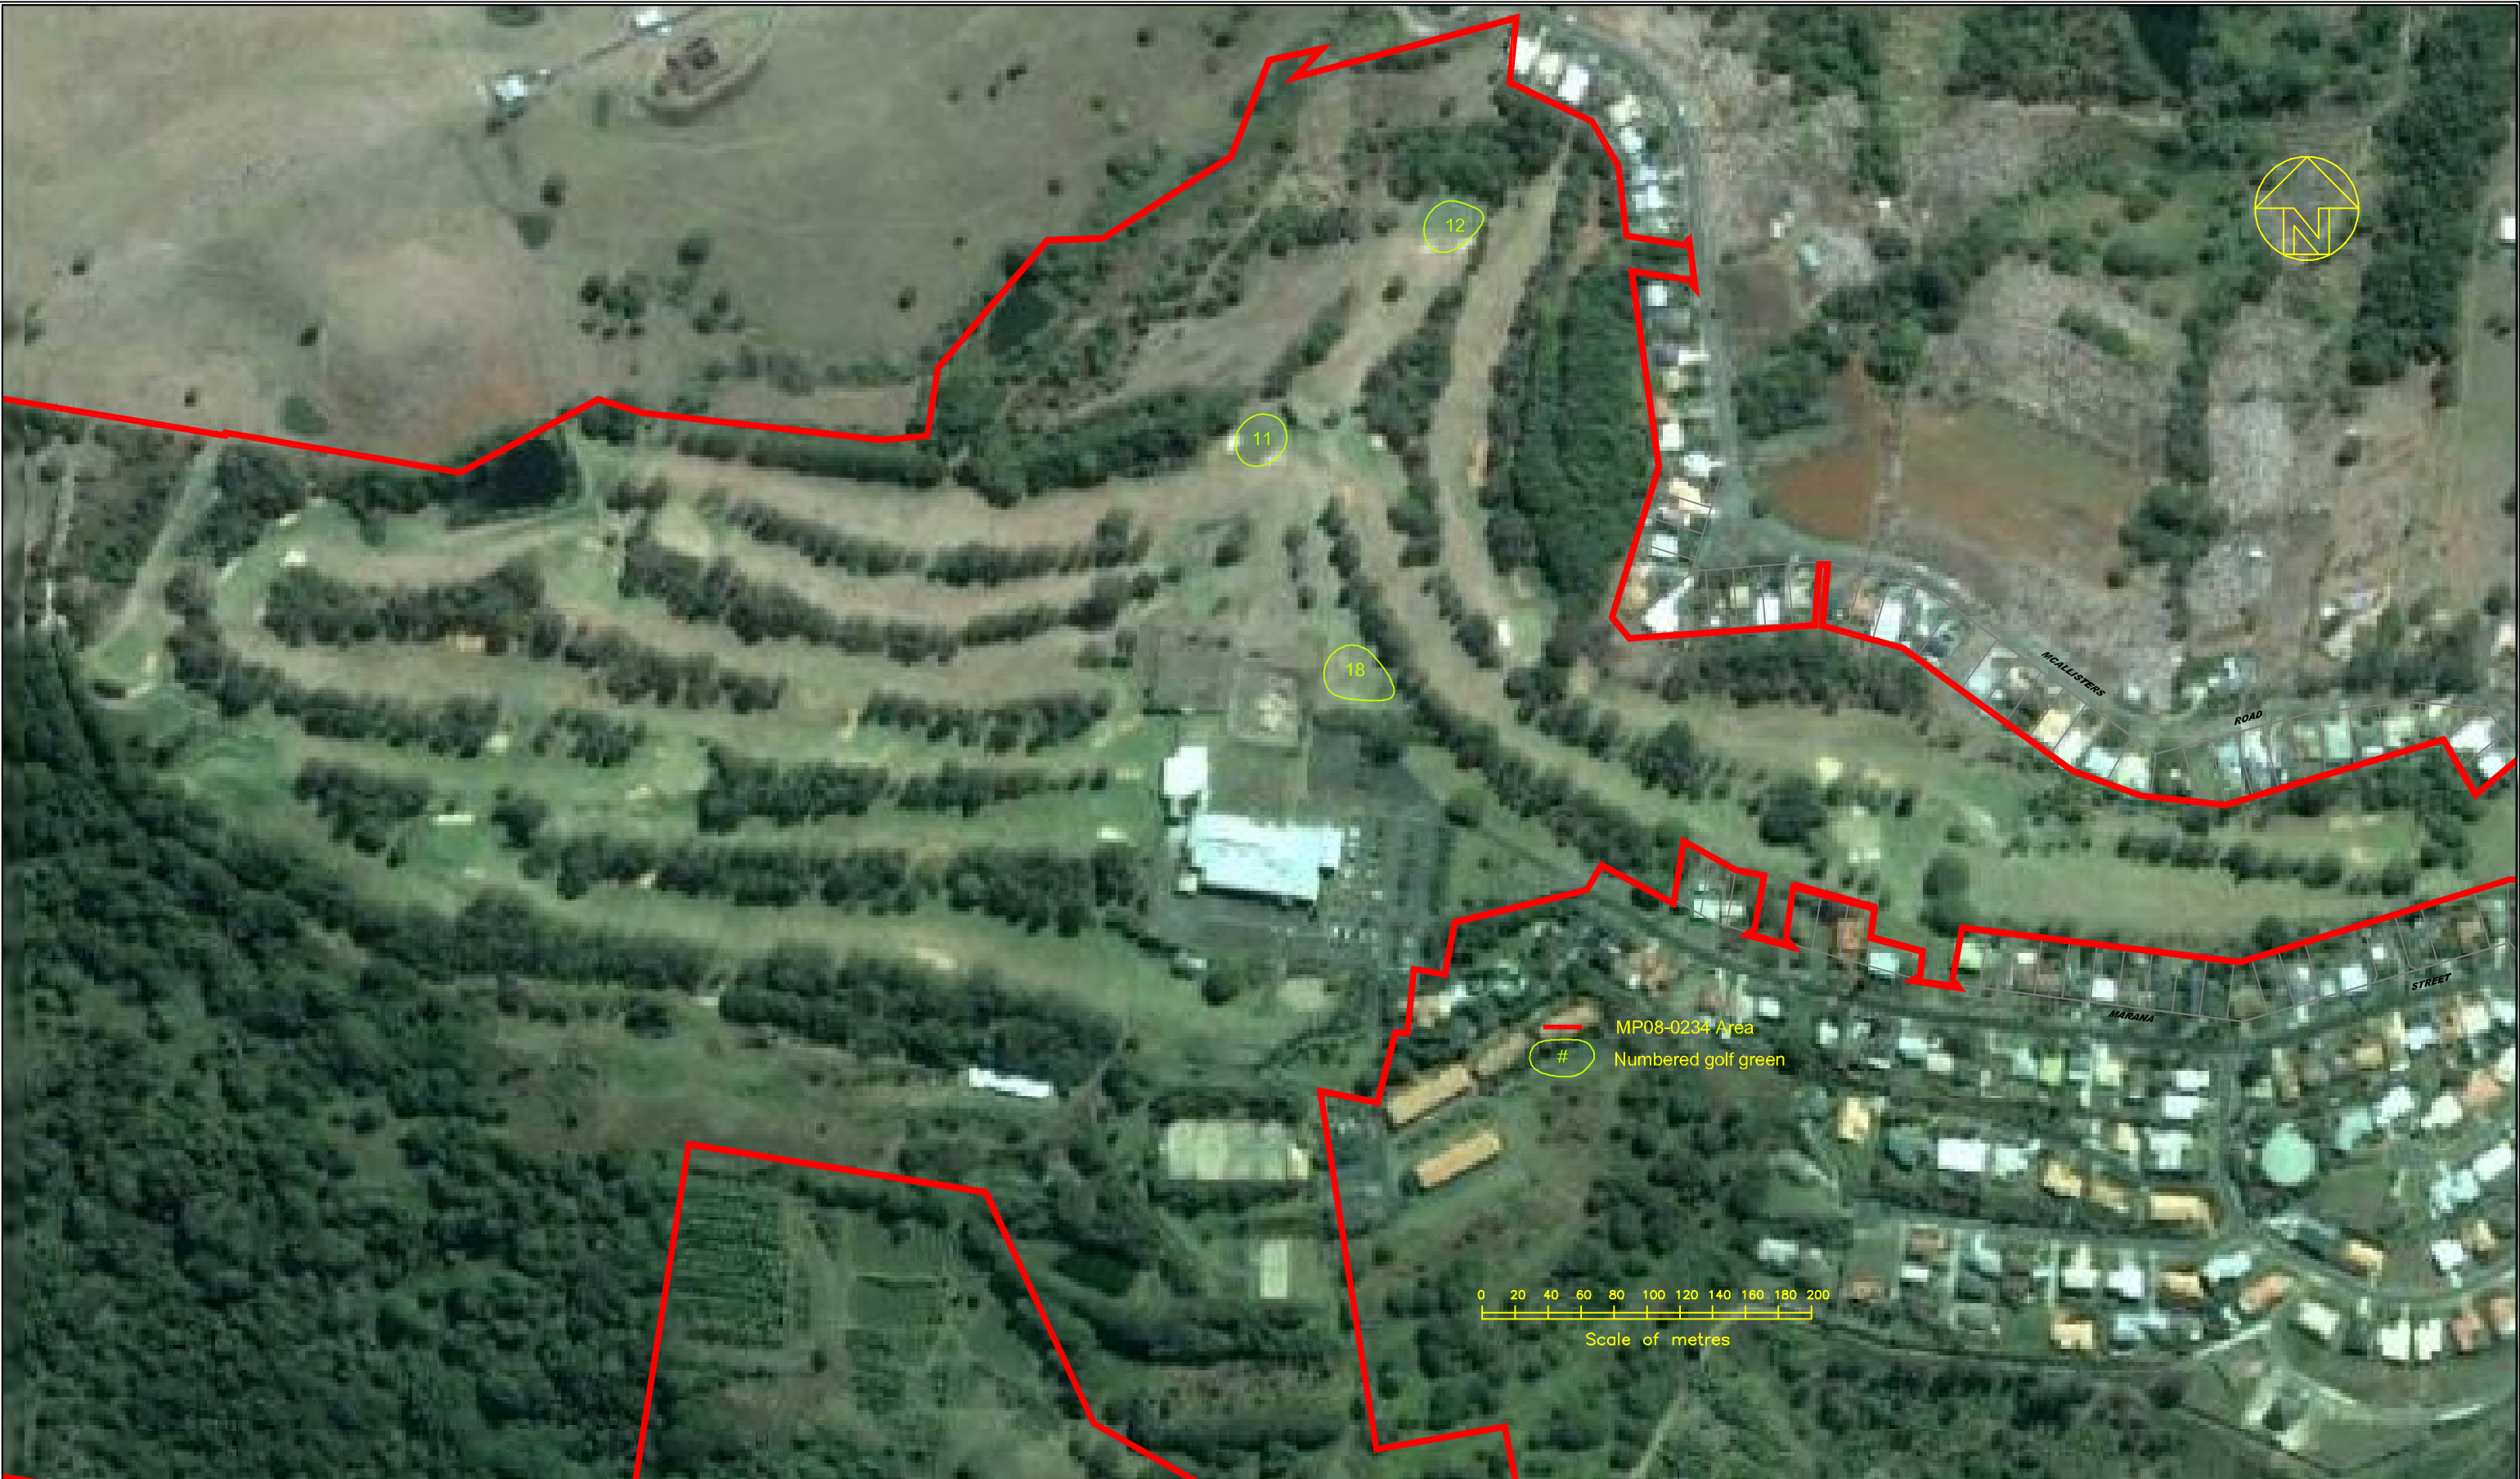
The HILs presented in the NEPM Guidelines state that the combined levels of Aldrin and Dieldrin should not exceed 3.33mg/kg. the Dieldrin + Aldrin concentrations were below the NEPM HILs guidelines for composite sampling.

Figure GJ0495.4.4 shows the indicative locations subject to this contamination investigation

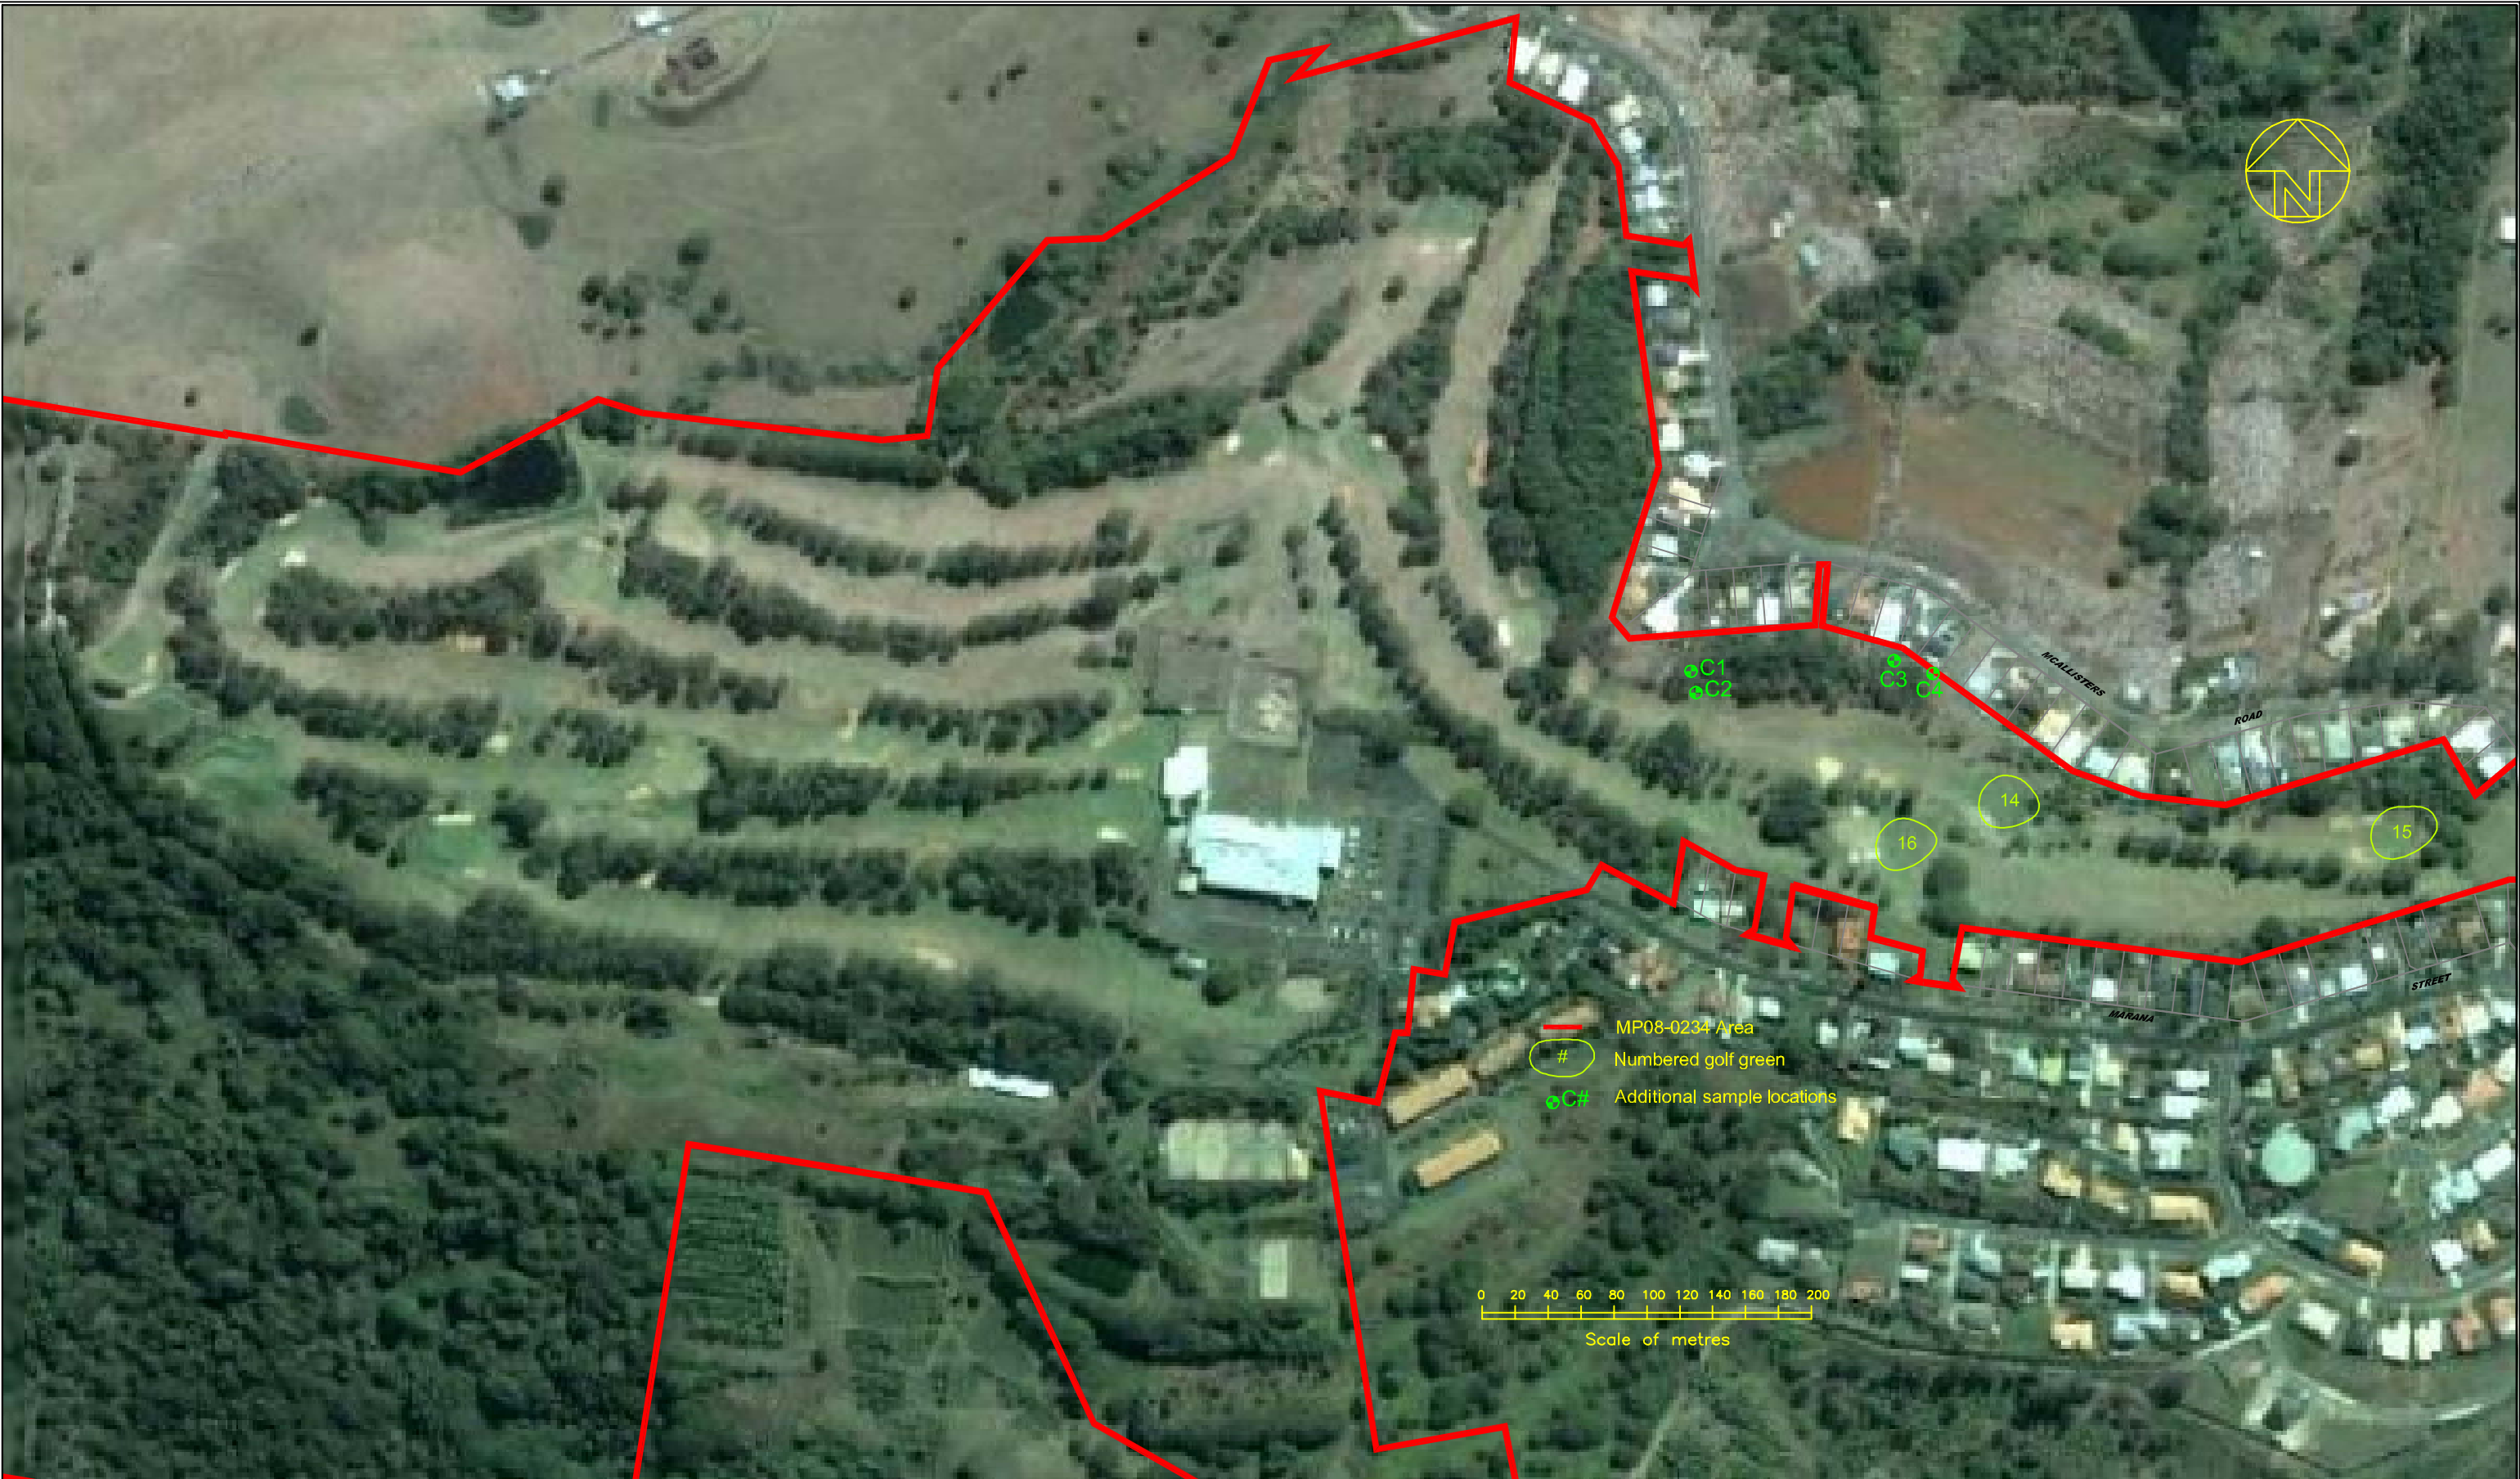
Laboratory results identified elevated combined Aldrin + Dieldrin concentrations of 8.76mg/kg (15th green). Although none of these samples exceed the HILs (10mg/kg), Dieldrin & Aldrin levels were at elevated concentrations in reference to the EILs.

Figure GJ0495.4.5 shows the indicative locations subject to this contamination investigation

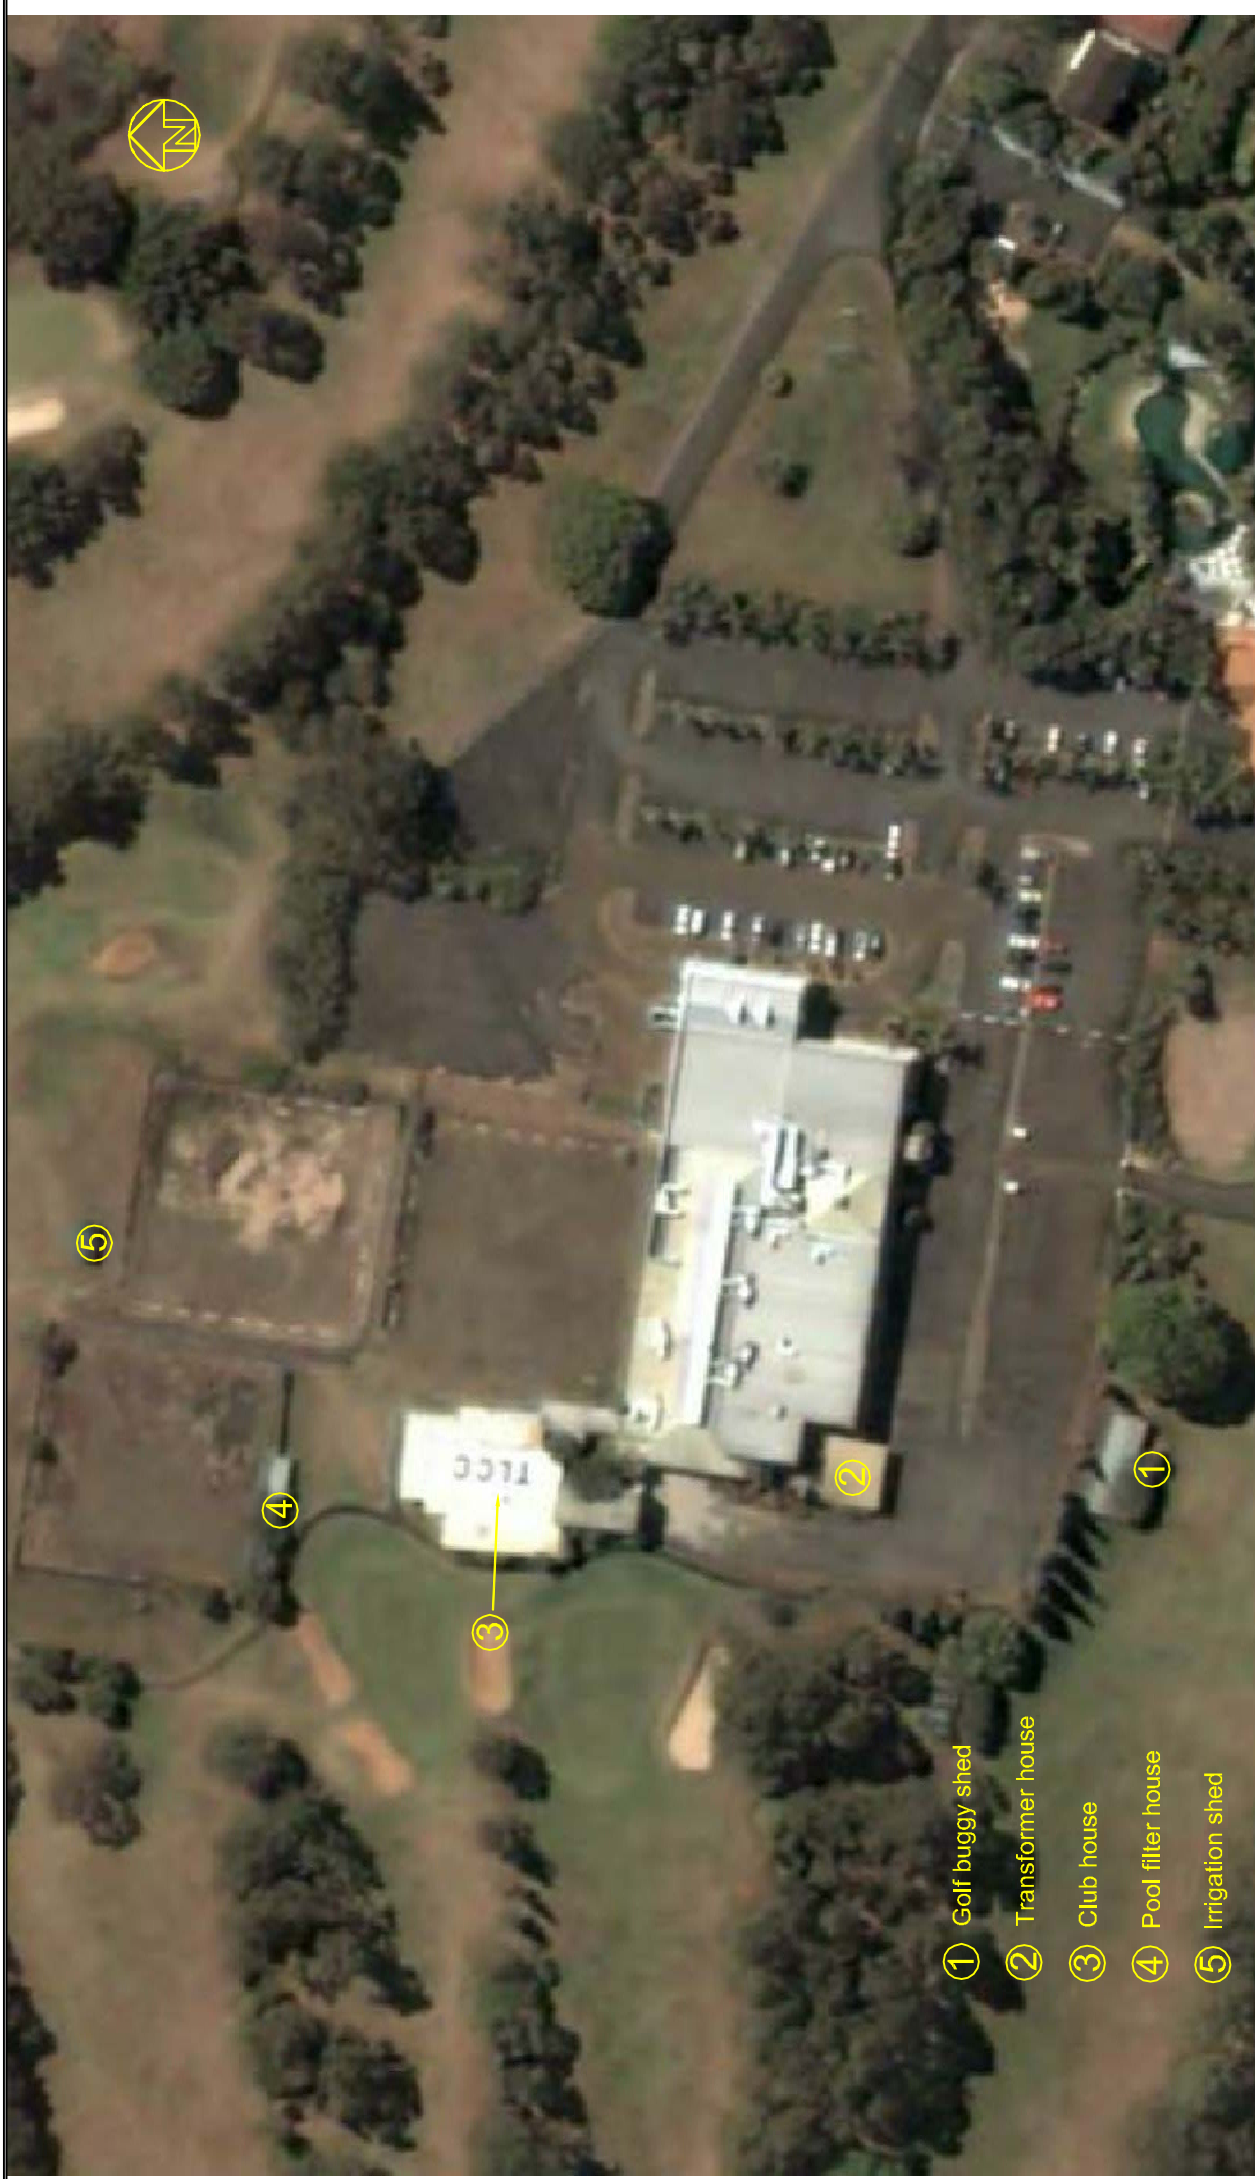
- ① Golf buggy shed
- ② Transformer house
- ③ Club house
- ④ Pool filter house
- ⑤ Irrigation shed

During a site inspection on May 3, 2007, G&S staff identified that the subject outbuildings were 'colourbond' or block structures founded on concrete slabs. It was therefore considered that the Tweed Shire Council's pre-demolition testing guidelines (for OC pesticides) would not be applicable and the investigation was therefore limited to sampling around the perimeter of the slabs for contaminants potentially associated with the former use of each of the outbuildings.

Figure GJ0495.4.6 shows the indicative locations subject to this contamination investigation

The report recommended that sub-slab investigations for OC/OP pesticides be undertaken on each of the outbuildings prior to the removal of the slabs, simultaneously with the investigation of the country club building proper.

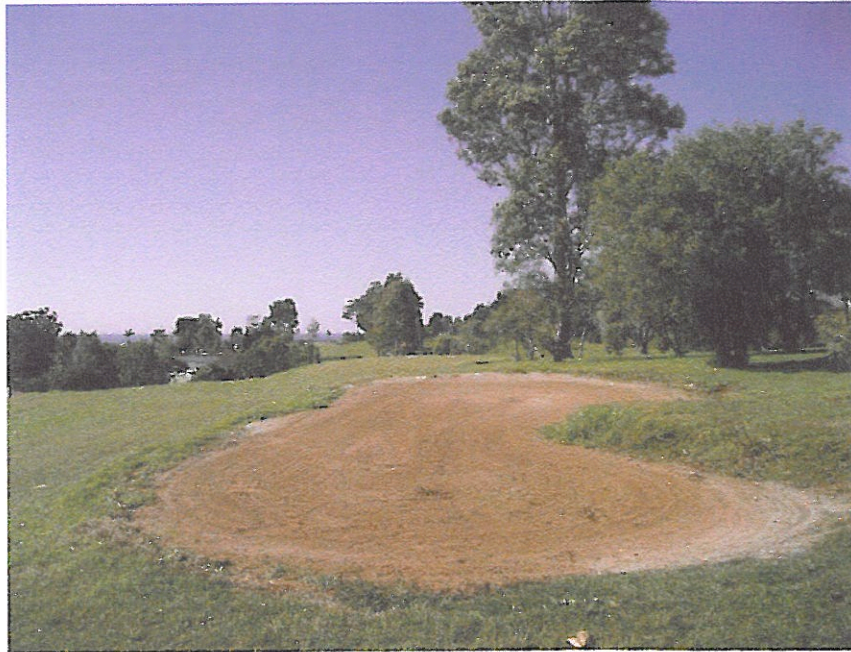
Plate 2. This view is from the centre of the site facing east and shows a sand bunker, golf green and northern fairway.

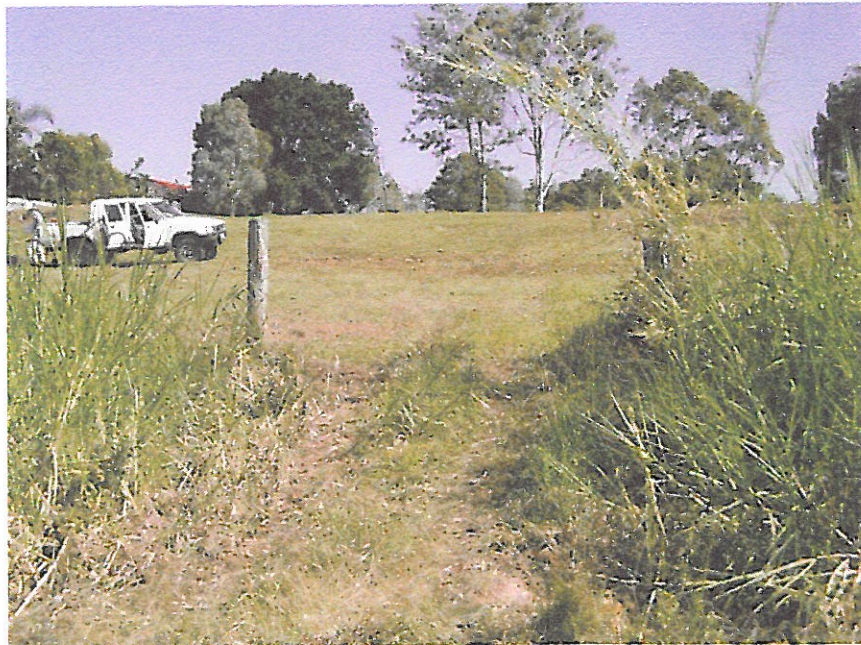
Plate 3. This photograph was taken from the eastern portion of the site bordering McAlisters Road. The view displays the easterly facing slope which appears to have been used as a former site access.

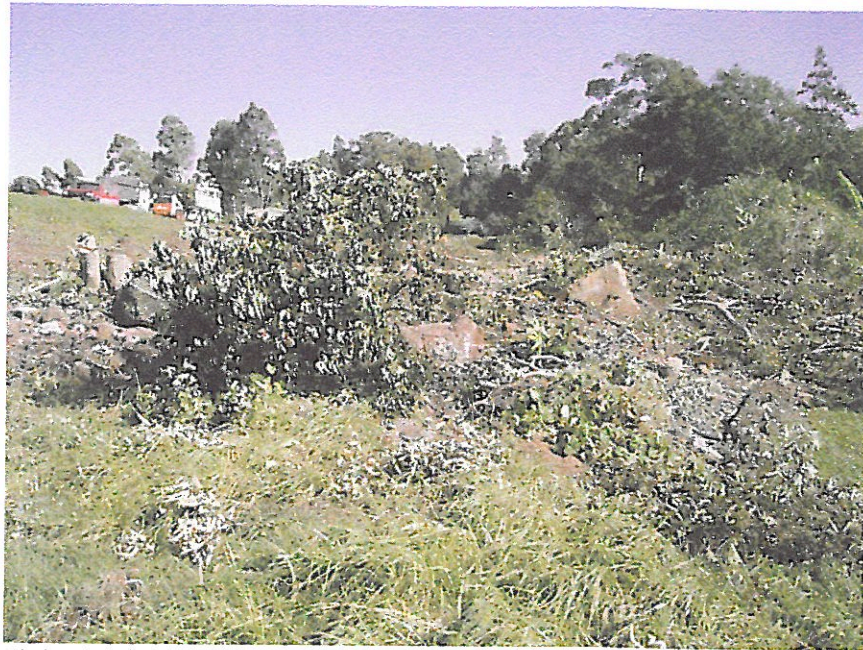
Plate 4. Displays the boulder stockpile location which was located on the northern site boundary. Tree maintenance works in the immediate area of the stockpile limited further inspection of this area.

- A stockpile of rocks and a small amount of miscellaneous waste material was identified at the northern portion of the site. It is likely that this material originated from clearing of the land during the construction of the golf course and could include some remnants from previous structures on, or in the vicinity of, the site. It is therefore recommended that the contents be further investigated, catalogued and sampled for asbestos, arsenic, OC and OP compounds to establish the contaminant potential. This would be done as part of a stage 2, detailed site investigation. Based on these results, further inspection may be required during the excavation of the stockpiled area and representative samples collected and analysed for contaminants by suitable qualified scientists. These actions would confirm whether or not the stockpile material was free of likely contaminants.

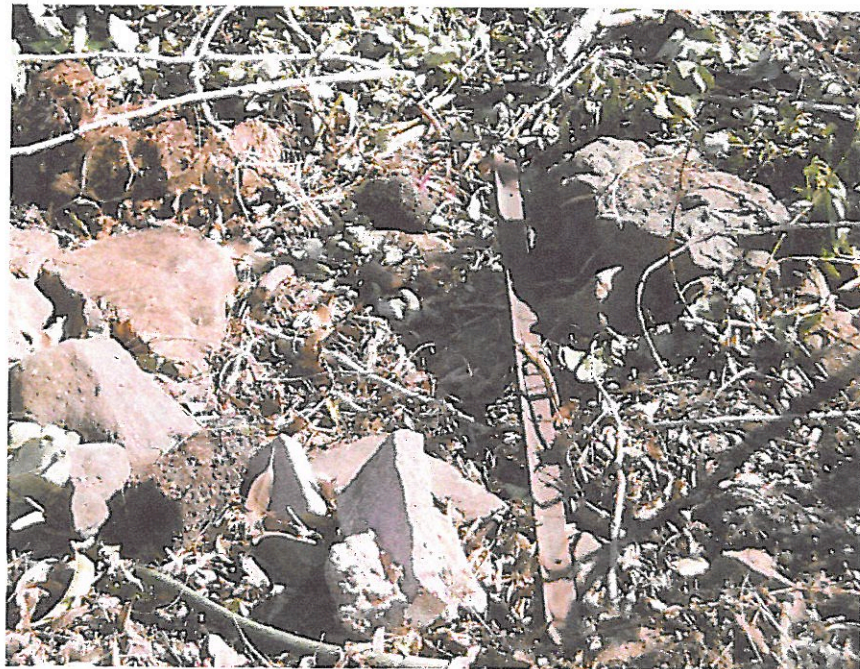
Plate 5. Displays a portion of the contents of the boulder stockpile materials. This photograph identifies boulders, concrete fragments, and a steel rod (star picket).
