## **Coal & Allied**

### **Report for Lower Hunter Lands Project**

**Gwandalan: Marine Baseline  
Assessment of Lake  
Macquarie**

**October 2010**

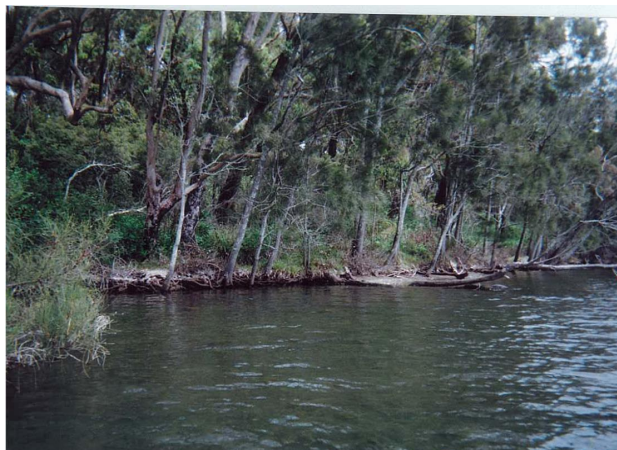
**Figure 1 Gwandalan Site 1**

The marine environment along the proposed development site at Gwandalan has a bank that slopes very steeply and is stabilised by high levels of vegetation cover. The banks of the shore exhibit very little erosion with any areas experiencing wave and tidal action largely stabilised by root balls, large woody debris and bank vegetation that reaches the bank margins. The benthic sediment is composed largely of gravel (55%) with good sand (30%) and pebble (cover (25%). The marine environment adjacent to the site close to the banks is a shallow shelf that slopes slowly at 15 metres from shore to 1.5 metres depth by 25 metres from shore. The very steep nature of the shoreline, stable bank structure and shallow inshore nature of the receiving environment characterise the marine environment at this site. Seagrass beds are well established close to shore and provide good benthic stability.

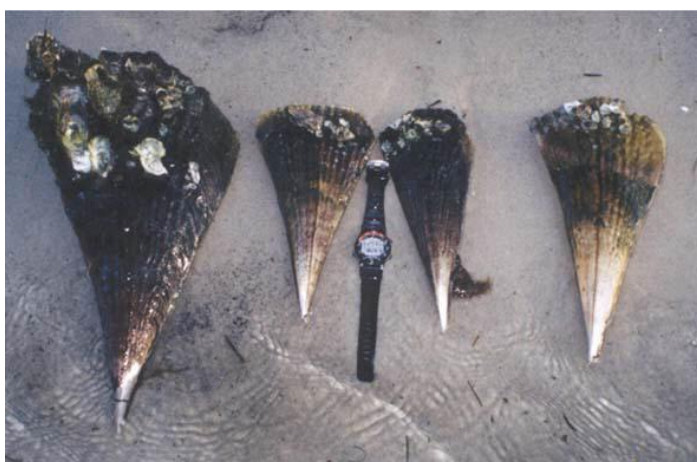
**Figure 2 Razor Clams**

A large number of *Pinna bicolor* or Razor Clams were present along the shallow shoreline margins. These native clams bury themselves in the sediment with the top three centimeters of shell exposed. This species has recently become more prolific within Lake Macquarie recently due to an exceptional rate of survival of razor clam larvae three to four years ago. It seems that the population of razor clams is likely to fall again, unless favourable conditions return.

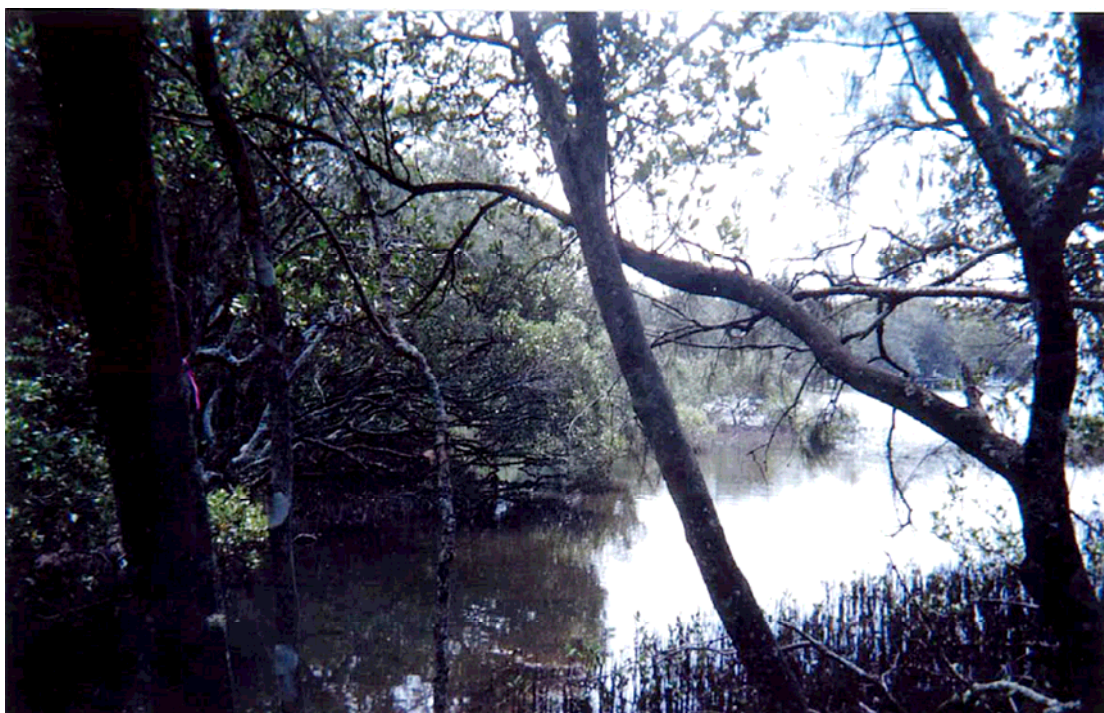
**Figure 1** Gwandalan Mangroves

Mangroves *Avicennia marina* were present along the northern shoreline and along the small creek near the park. The mangroves are not extensive with a limited band of trees along the shoreline widening to the north to a couple of metres in density. This species of mangrove has a very wide tolerance to ranges in temperature conditions, tidal inundation levels, moisture, salinity and substrates making this species extremely hardy and able to tolerate harsh conditions.

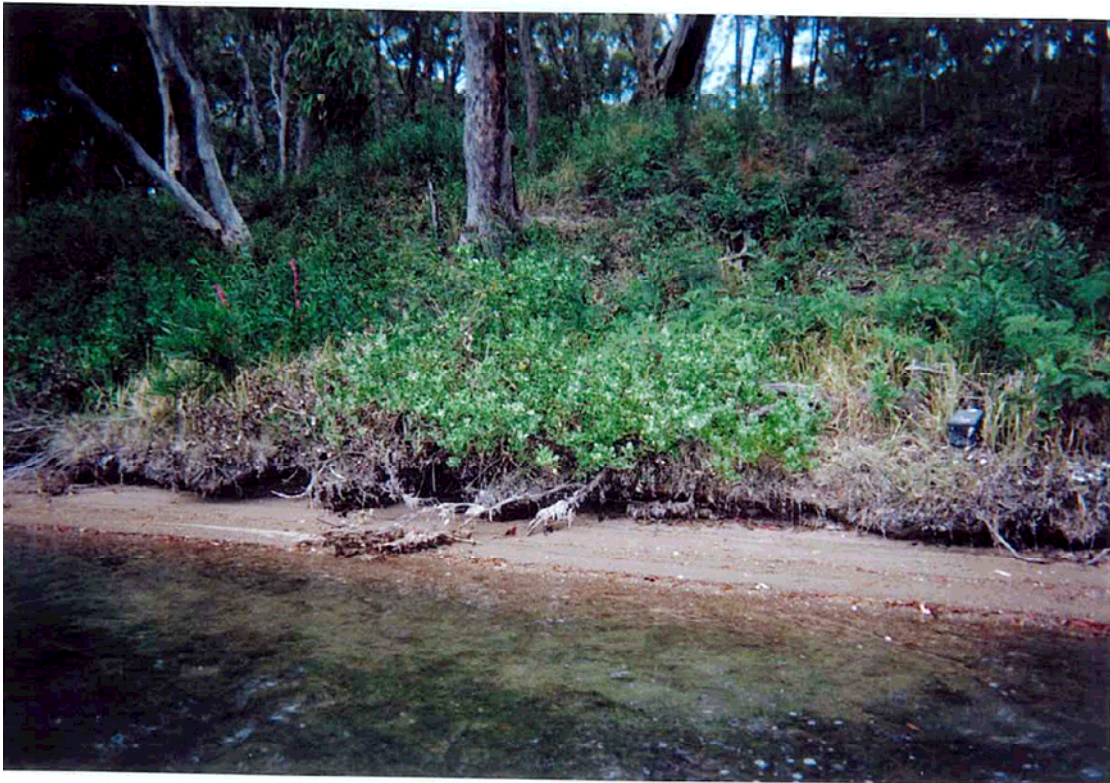
**Figure 3** Gwandalan – Bank 1

The site at Gwandalan currently has limited impacts on the estuarine receiving environment. The site has however been cleared along most of the banks but due to the shallow slope of the bank and stable nature of the foreshore the risk from erosion is considered low.

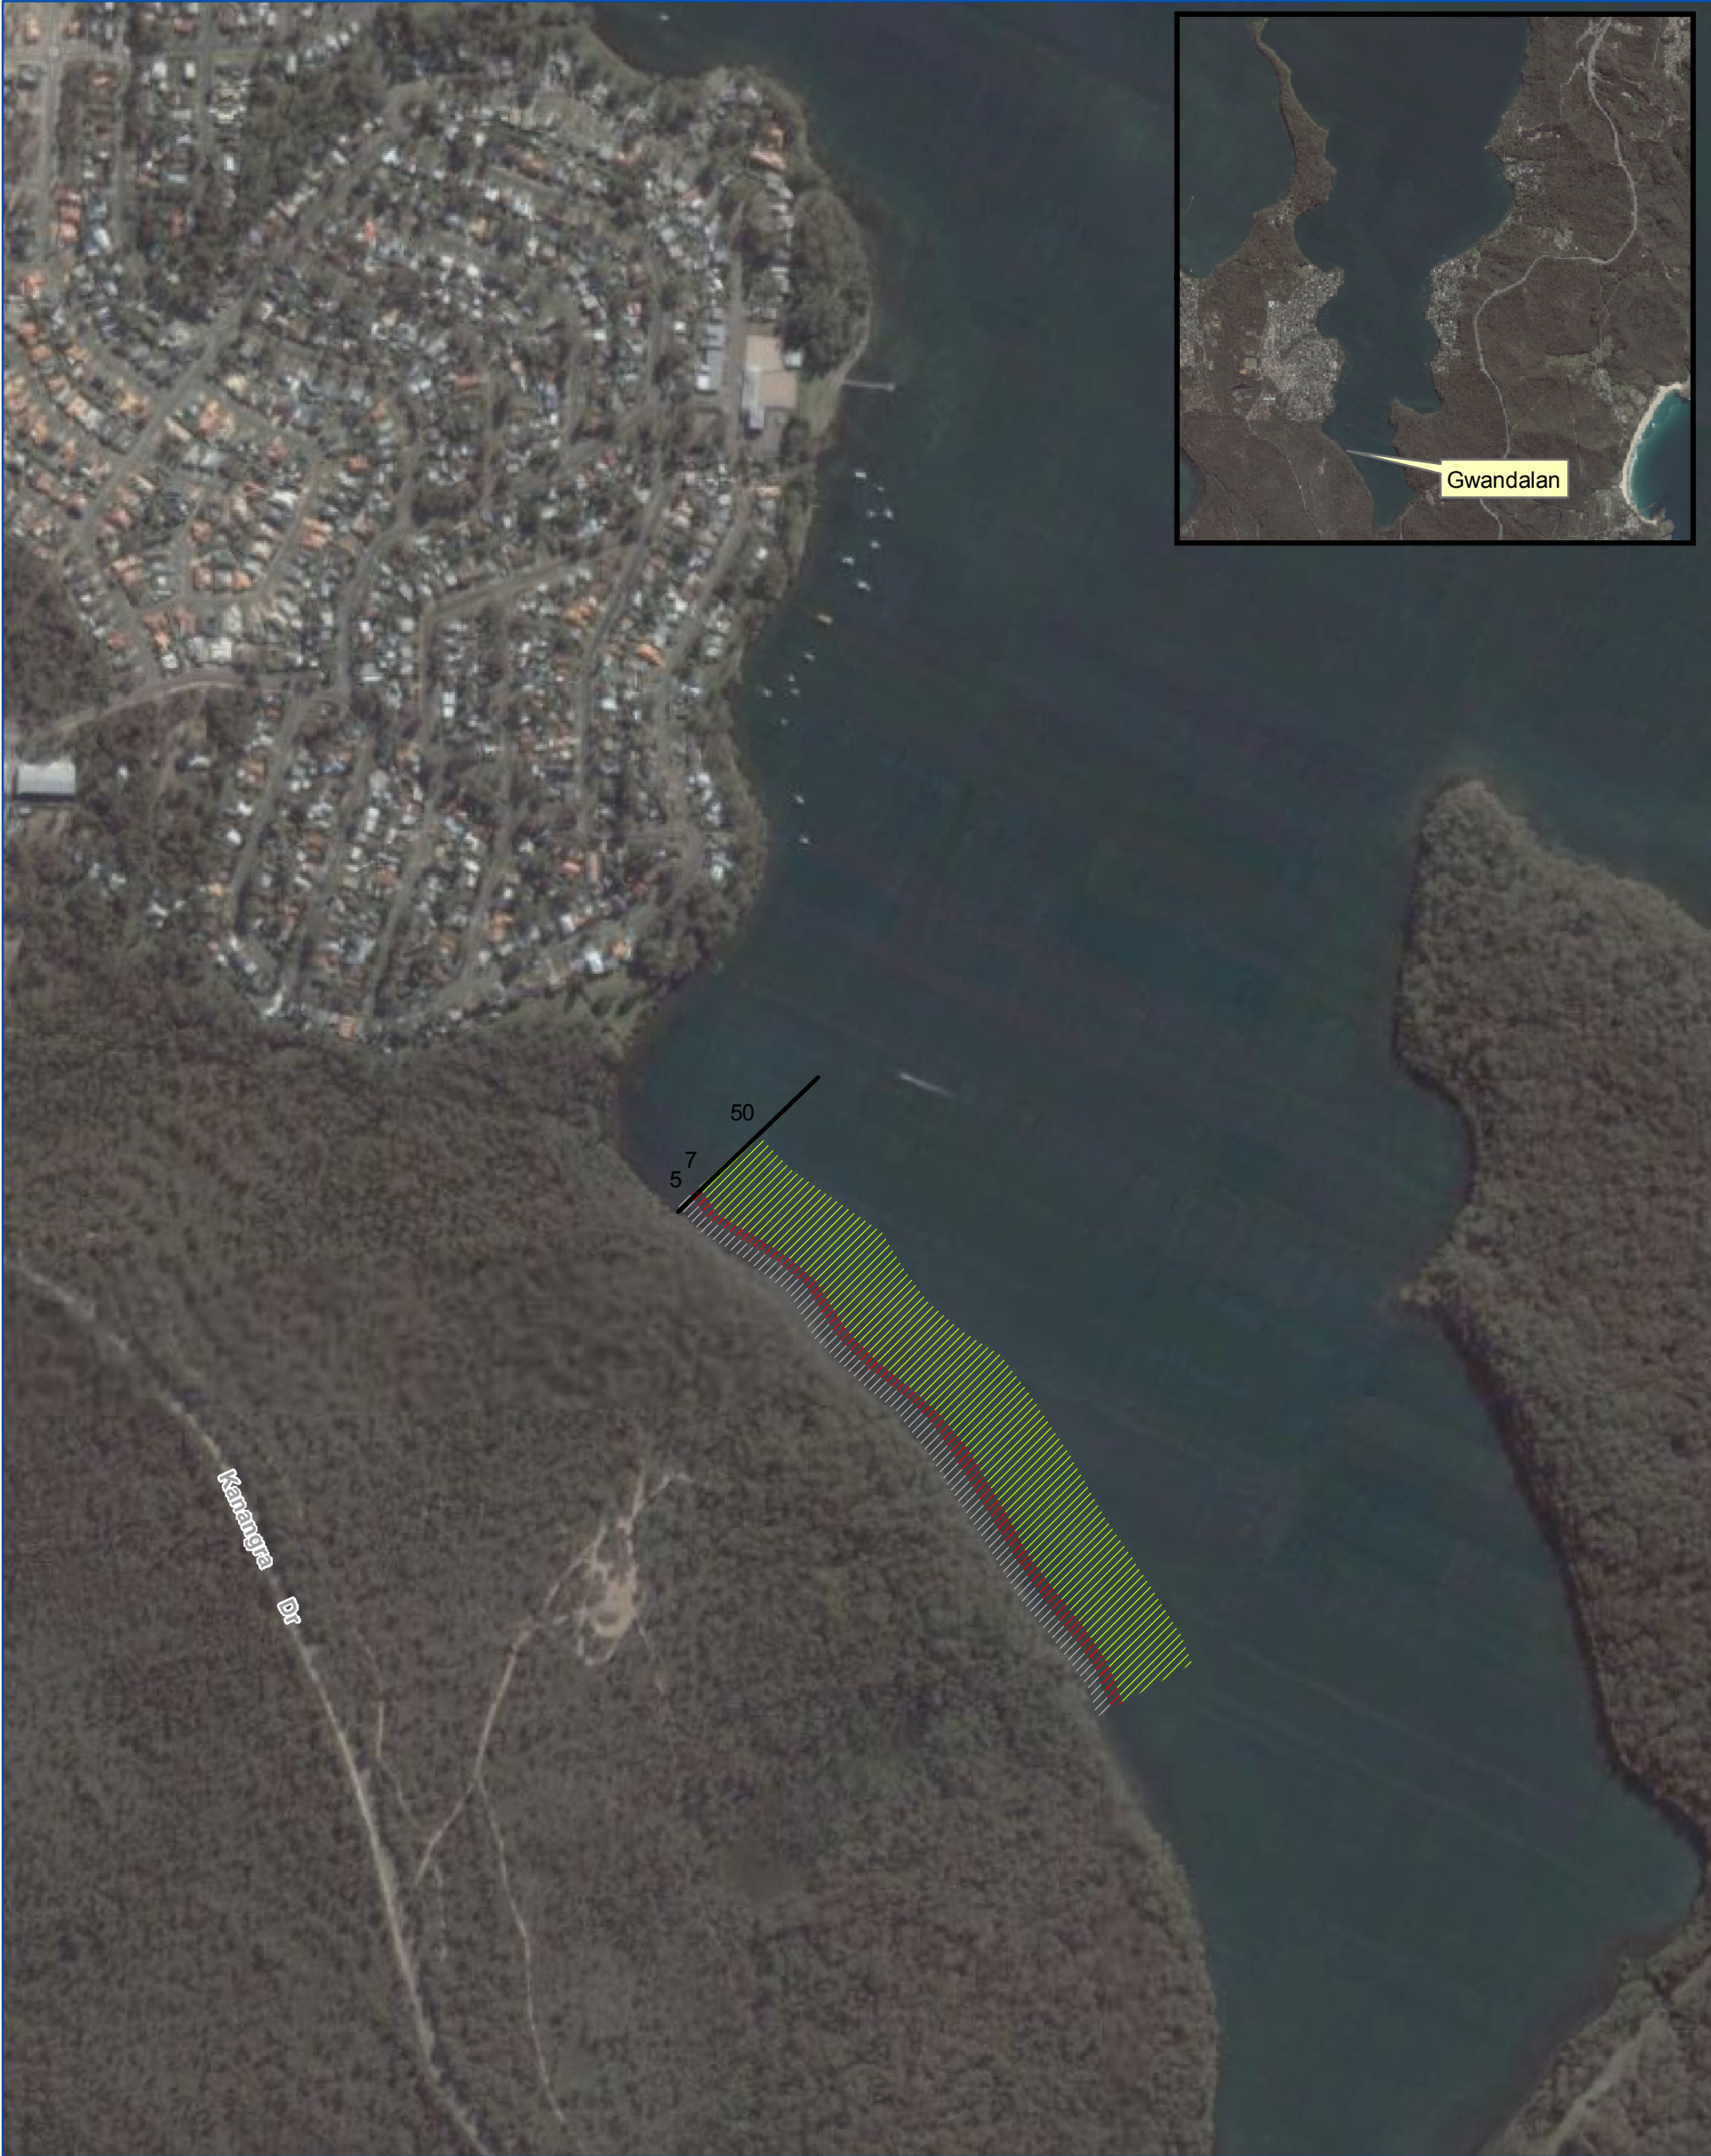
# Seagrass Map

Two taxa of seagrass *Zostera capricornia* and *Halophila* sp were observed at the site. Appendix B presents the density and abundance of the seagrass community adjacent to the site. Largely the seagrasses extend as continuous mats to approximately 50 meters from shore where the plants begin to thin to occasional single rhizomes before petering out towards the center of the bay. . The beds are mostly thick and continuous from between 10-40 meters from shore where the depth is 0.5-1.5 meters in depth.
