**PHASE 2 MINE SUBSIDENCE**

**RISK ASSESSMENT**

**PROPOSED RESIDENTIAL SUBDIVISION**

**CATHERINE HILL BAY**

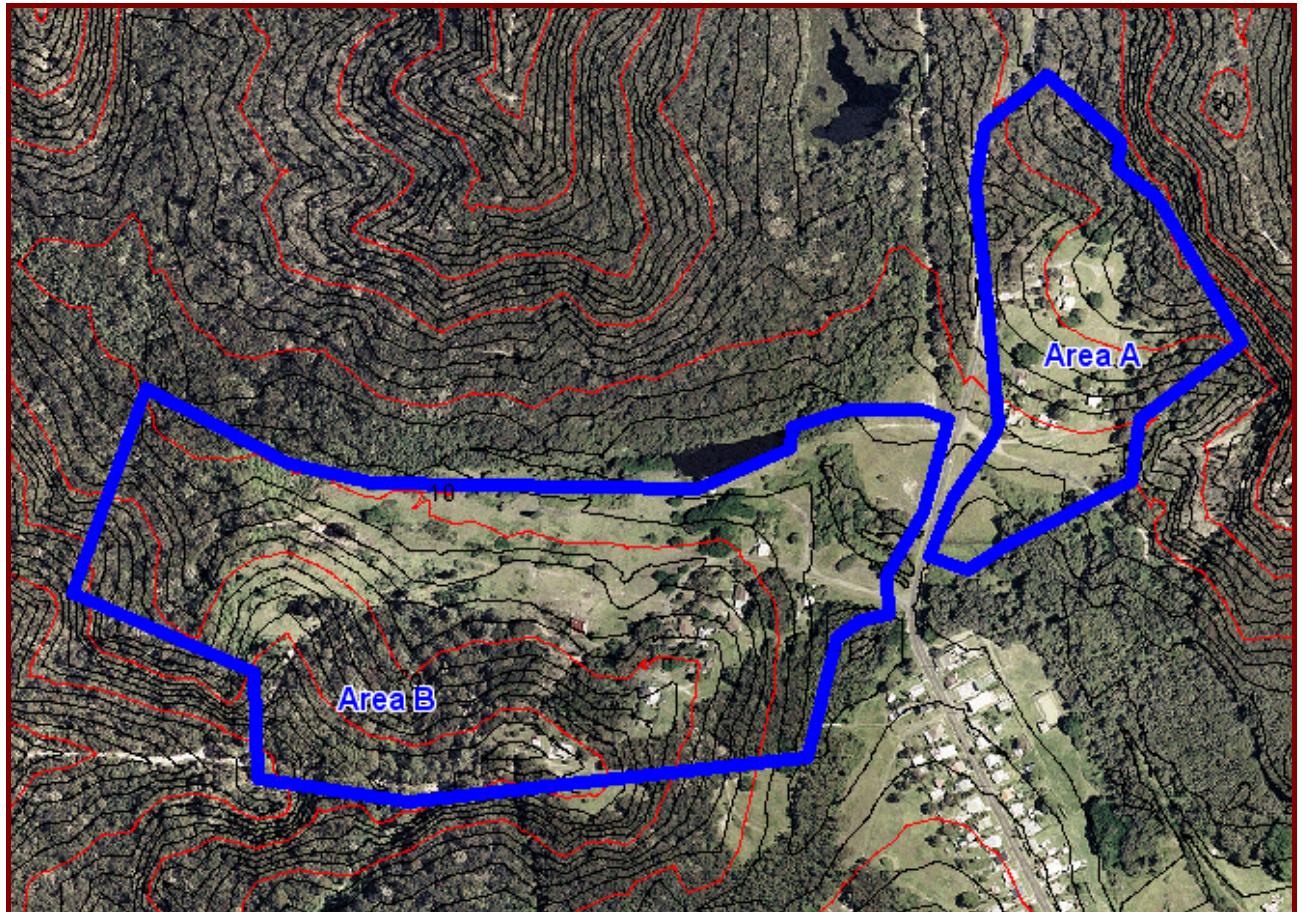
Figure 1 – Proposed Development Areas

- **Area A:** This is an area at the north of the overall site, on the eastern side of Flowers Drive with an overall area of 7.32 ha;

- **Area B:** this includes the former Pit E and is situated north of the Middle Camp township on the western side of Flowers Drive. The area has an irregular shape with an overall area of about 20.88 ha.

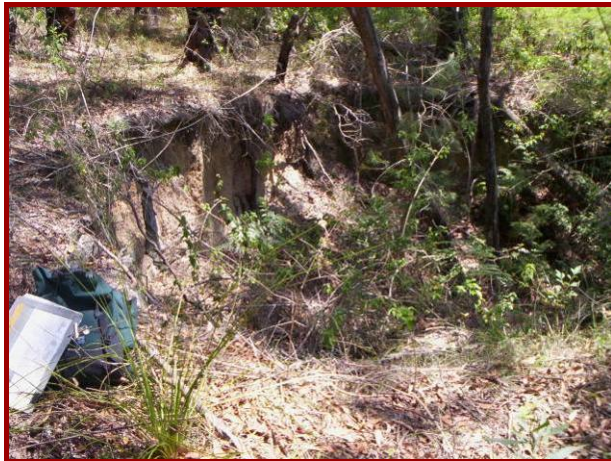
**Photo 1 – Pothole**

The walk over assessment identified a mine subsidence pothole with overall dimension of about 8 m by 13 m and 3 to 4 m deep (Photo 1) and number of likely potholes (Photo 2) on the western parts of Area B. The approximate location of the pothole is shown on Drawing 1.

One well developed pothole has been observed on site, over an intersection of the workings, to the west of Bore 5B, where the depth of cover is about 10 m. A second possible pothole was observed about 15 m south west of Bore 7, where a shallow (less than 0.5 m deep) depression was noted, in an area where the depth of cover is probably about 15 m.
