Googong Township water cycle project

Environmental Assessment

**GOOGONG WATER CYCLE PROJECT  
ECOLOGICAL ASSESSMENTS -  
TERRESTRIAL FLORA AND FAUNA**

**Document No:** CN 2112972009-001

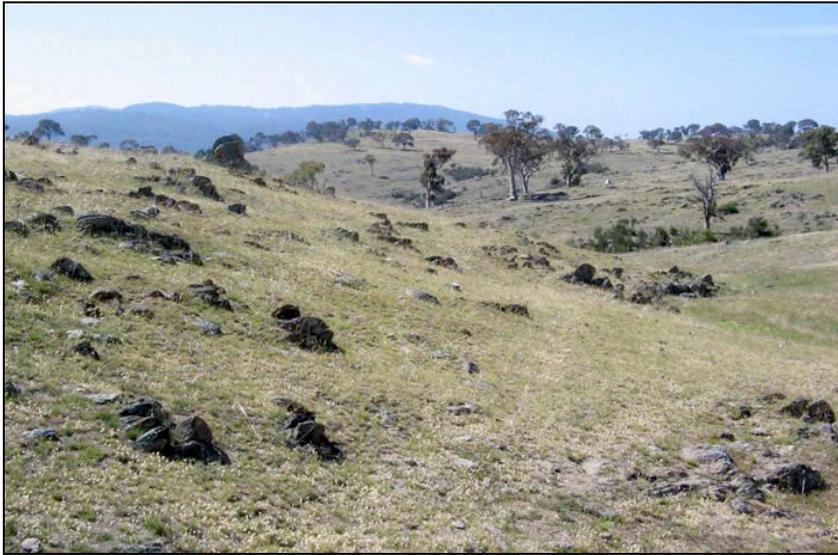
The grasslands, both regularly grazed and infrequently grazed paddocks, are estimated visually to be 30-40% bare ground, due to compaction, trails of herds of animals and continuing disturbances (**Plate 2**). Non-native pasture grasses (viz. *Phalaris aquatica*, *Bromus* spp., *Lolium* spp., *Poa* spp., *Avena* spp., *Agrostis* spp., *Holcus lanatus*, *Hordeum* spp., *Paspalum dilatatum*, *Eragrostis* spp., etc.) dominate the grassland landscape (**Plate 3**).

**Plate 2. Degraded grassland habitat dotted with occasional trees**

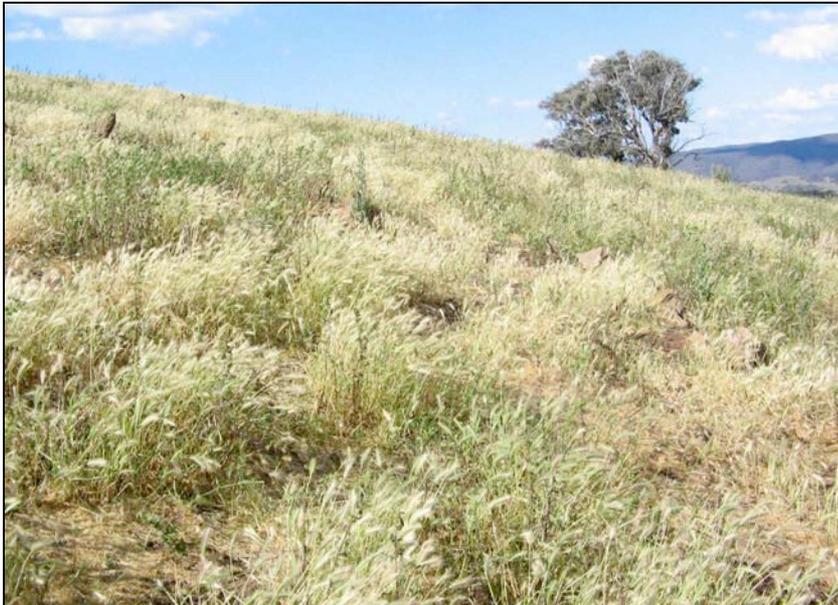
**Plate 3. Barley Grass infested paddocks, Reservoir Hill**

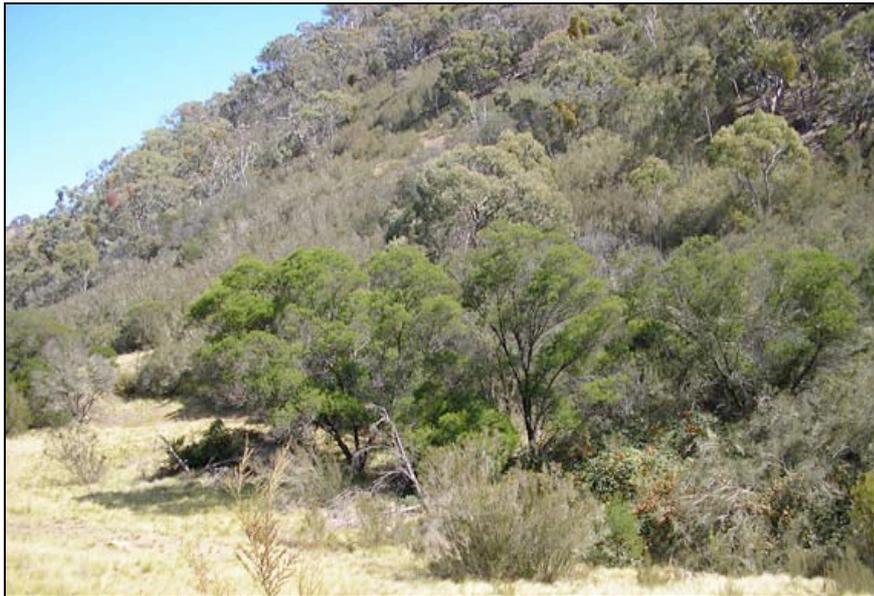
**Plate 4. White Box-Yellow Box-Blakely's Red Gum Woodlands and Derived Grasslands in the vicinity of the creek in the lower-middle section**

On either side of the Googong Creek, the vegetation is essentially 'White Box-Yellow Box-Blakely's Red Gum Garssy Woodland and Derived Native Grassland' community, which is listed as critically endangered, nationally. The dominant canopy trees, a mix of Yellow Box (*Eucalyptus melliodora*), Brittle Gum (*Eucalyptus mannifera*), Red Box (*Eucalyptus polyanthemos*), Scribbly Gum (*E. rossii*), Apple Box (*E. bridgesiana*), Yellow Box (*E. melliodora*), Red Stringybark (*E. macrorhyncha*) and Broad-leaved Peppermint (*E. dives*) characterise the EEC (see **Plate 4**).

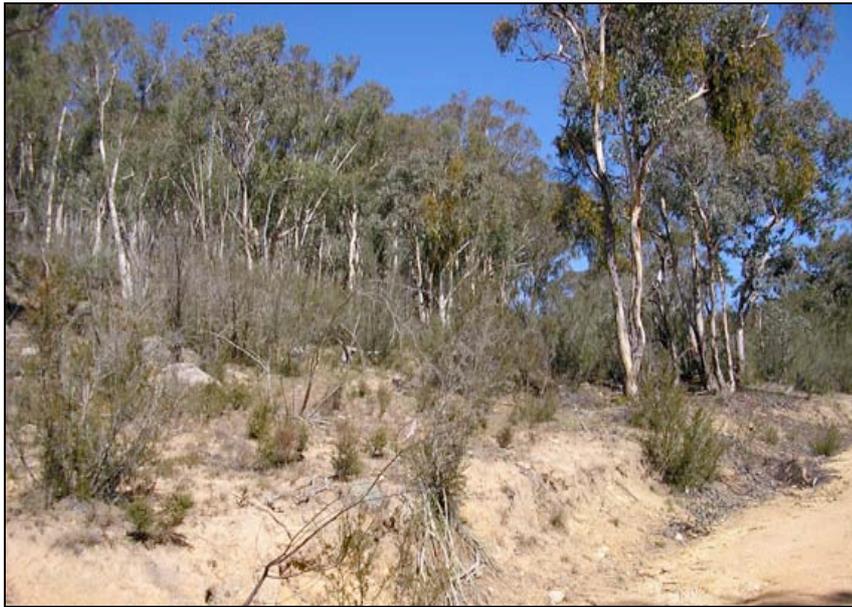
The Googong Creek vegetation has been disturbed in the past by the construction of access ways, maintenance roads and fire trails associated with the Googong WTP's infrastructure. These disturbances are ongoing, and have led to serious deterioration of conservation values in some sections (**Plate 5**).

**Plate 5. Areas in the lower-middle section of Googong Creek, showing the same woodland vegetation, but in a relatively poor state due to disturbances**

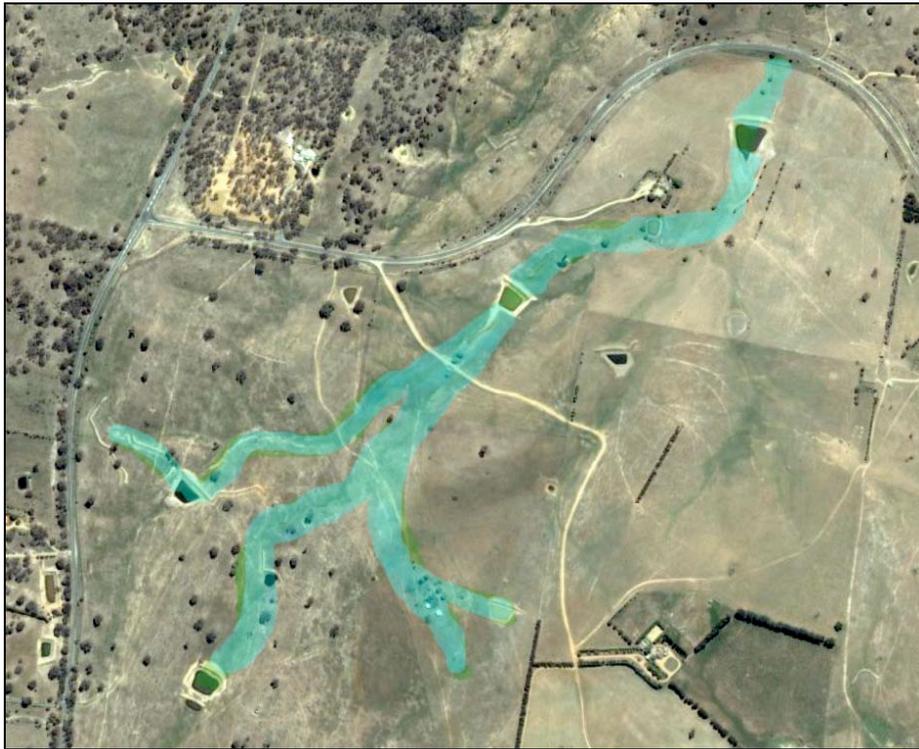
As shown in **Plate 6**, the area is characterised by heavily degraded pasture, with only a few scatterings of Yellow Box (*Eucalyptus melliodora*), Red Box (*E. polyanthemos*), Poplars (*Populus* spp.) and Willow (*Salix* spp.) trees. Non-native pasture grasses (*Phalaris aquatica*, *Phalaris minor*, *Bromus* spp., *Lolium* spp., *Poa* spp., *Avena* spp., *Holcus lanatus*, *Hordeum* spp., *Paspalum dilatatum*, *Eragrostis* spp., etc.) are common. Despite the presence of grassland, the general area is about 40% bare ground, due to over grazing and compaction.

**Plate 6. General area surveyed for drainage lines and basins**

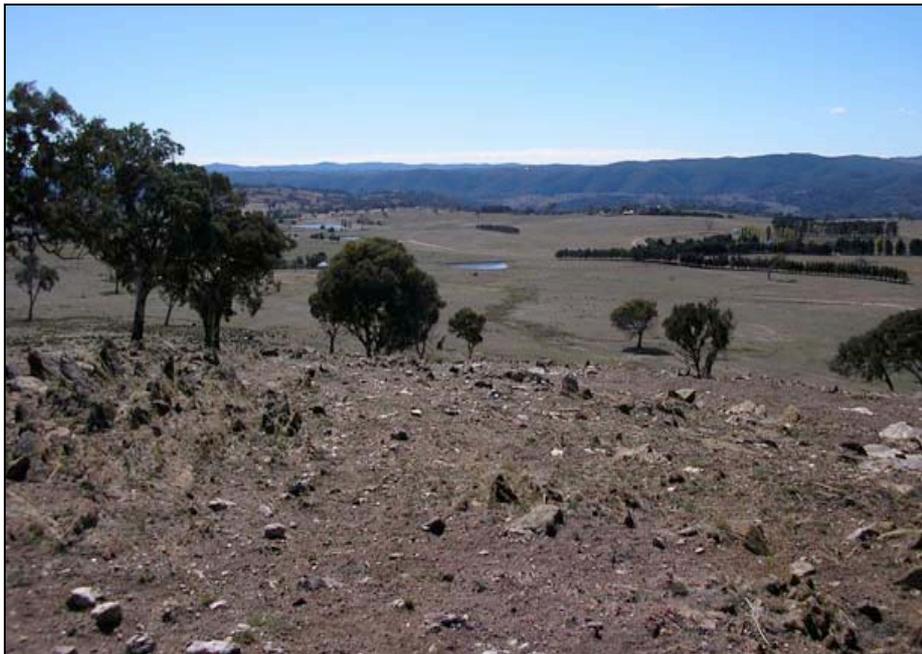
**Plate 7. Reservoir Hill - eastern side landscape, looking north, showing rocky outcrops and isolated Gum trees**

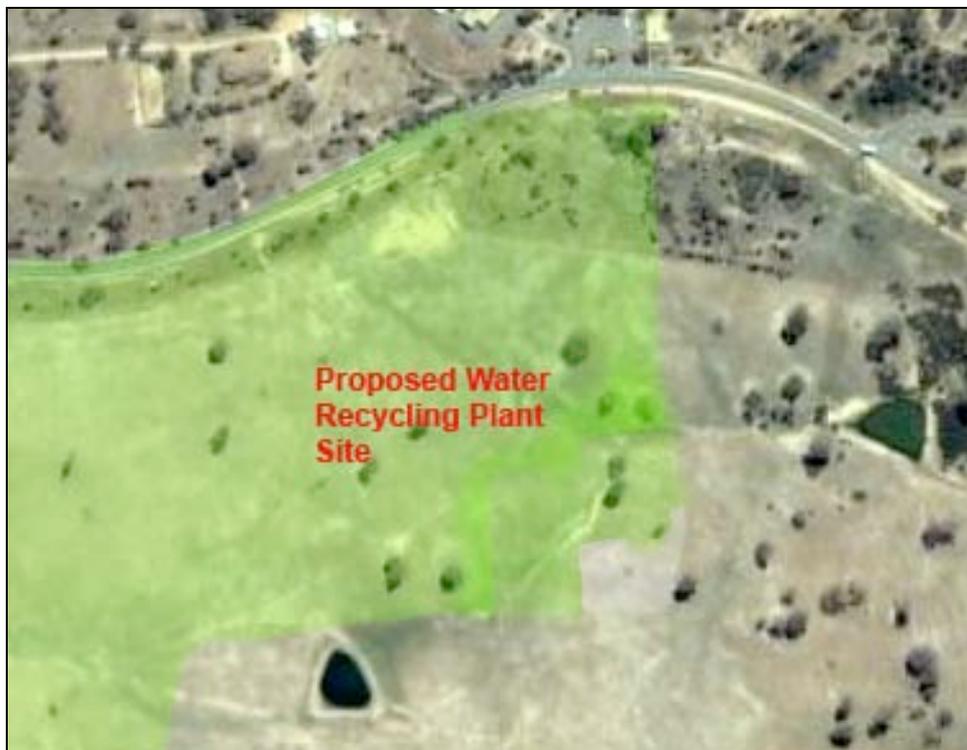
**Plate 8. Area surveyed - proposed location of Water Recycling Plant**

The proposed WRP site (**Plate 8**), the SPS sites and the rising mains corridor for rising mains are also characterised by heavily degraded pasture, and are essentially similar in terms of their vegetation. The landscape, which is gently undulating, has a few farm dams, rocky outcrops, depressions and drainage lines and a scattering of Gum trees.

The area to the north of the WRP site, adjacent to the Googong Dam Road (**Plate 8**), has been revegetated in the recent past. This area has both juveniles and older *Eucalyptus* trees and several well-established Acacias (viz. Silver Wattle - *Acacia dealbata*, Green wattle - *A. mearnsii*, Black Wattle - *A. decurrens*), Red-leaved Wattle - *A. rubida*) and Wedge-leaf Wattle - *A. pravissima*) and many bushes of Burgan (*Kunzea ericoides*).

A variety of non-native pasture grasses (viz. *Phalaris* sp., *Bromus* spp., *Lolium* sp., *Poa* spp., *Avena* spp., *Holcus lanatus*, *Hordeum* spp., *Paspalum dilatatum*, *Eragrostis* spp., etc.) and *Poa* tussock is present at these sites; however, due to heavy grazing pressure, their cover is low. Minor patches of native Wallaby Grasses (*Austrodanthonia* spp.) Spear Grass (*Austrostipa scabra*) also occurs, mixed with the introduced species.

A wide variety of common ground cover forbs (viz. *Wahlenbergia* spp., *Trifolium* spp., *Acetosella vulgaris*, *Rumex* sp., *Persicaria* spp., *Polygonum arenastrum*, *Dianella revoluta*) occur on the sites, but they are heavily grazed and their cover is negligible.

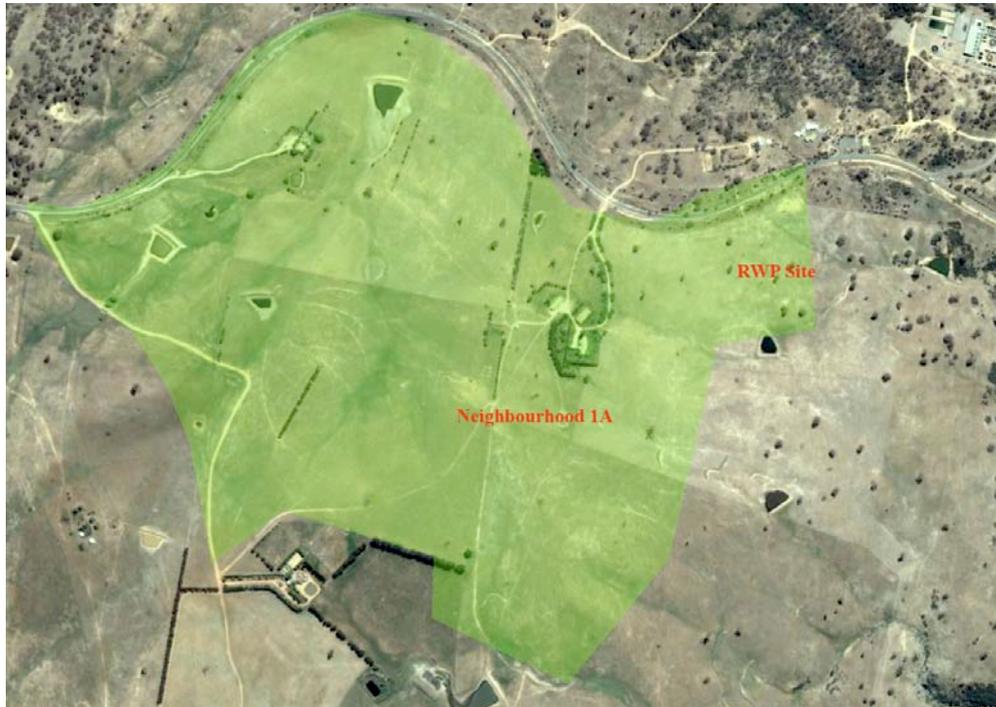
**Plate 9. Area surveyed - Neighbourhood 1A**

As shown in **Plate 9**, the area is characterised by heavily degraded pasture associated with pastoral agriculture and the homesteads. Clearing has been intense in the past, which has left behind only a few scatterings of Yellow Box (*Eucalyptus melliodora*) and Red Box (*E. polyanthemus*) trees.

Despite the presence of grassland communities, the general area is estimated as about 20% open, bare ground, due to over grazing and compaction.

A variety of common ground cover forbs (viz. *Wahlenbergia* spp., *Trifolium* spp., *Acetosella vulgaris*, *Rumex* sp., *Persicaria* spp., *Polygonum arenastrum*, *Dianella revoluta*) occur across NH1A, but their overall cover is negligible.

Weed species, typical of degraded pasture (viz. various kinds of Thistles - *Cardus* spp., *Centaurea* spp., *Carthamus lanatus*, *Cirsium vulgare*; St. John's Wort - *Hypericum perforatum*, Sheep's Burr - *Acaena ovina*; Bidgee Widgee - *A. novae-zelandiae*; Parsley Piert - *Aphanus arvensis*, and Mullein- *Verbascum* spp.) are widespread and common across the NH1A site.

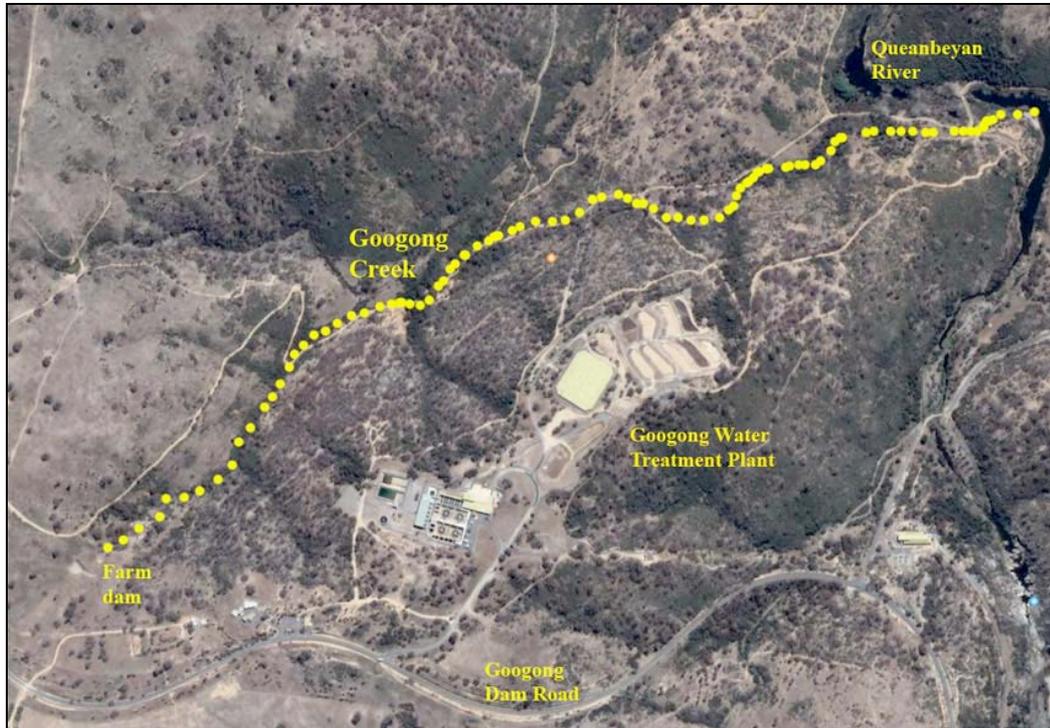
As discussed in **Section 5.2.2.1**, the proximity of the Googong Creek vegetation to the Googong WTP (**Plate 10**) results in continuing disturbance, as access ways and fire trails associated with the water infrastructure are regularly maintained (also see **Plate 5**). The vegetation is therefore representative of high-level fragmentation of the previous Sclerophyll Woodland/forest.

**Plate 10. Location of Googong Creek**

The understory vegetation is generally sparse and disturbed in many locations, through the gullies, which are steep. Erosion of varying degrees and collapsing of banks is common, mainly adjacent to the trails that criss-cross (**Plate 10**) the area.

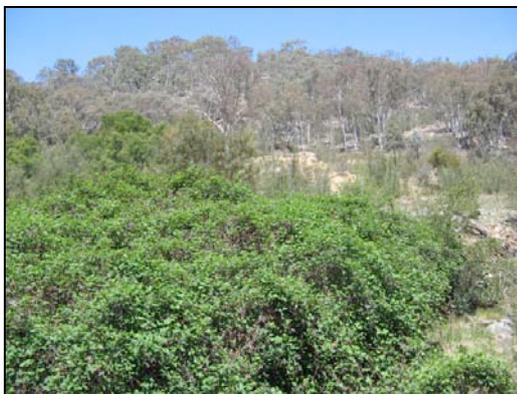
Adjacent properties and past land uses (i.e. pastoral agriculture) have also had a major impact on the creek's vegetation. Blackberry (*Rubus fruticosus*) infestations are serious in the creek; heavy infestations cover about 10-15% of the length of the creek (**Plate 11**).

**Plate 11. Blackberry (*Rubus fruticosus*) infestations along Googong Creek**

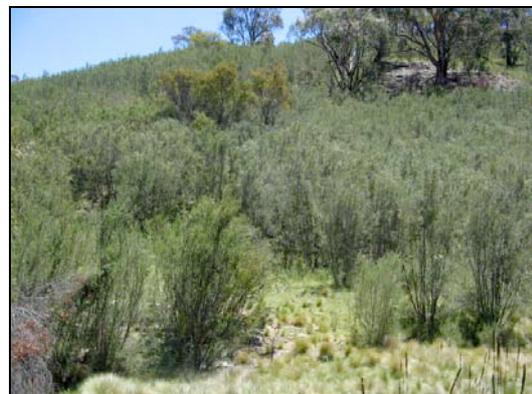
Burgan (*Kunzea ericoides*) dominates the understorey of more than half the length of the creek. In the lower and middle sections, the cover achieved by Burgan is greater than 75% on either side of the creek banks (**Plate 12**). Burgan infestations, as well as Serrated Tussock (*Nasella trichotoma*) infestations, intergrade with the Box-Gum Woodlands.

**Plate 12. Burgan (*Kunzea ericoides*) infestations of the Googong Creek**
