Port Macquarie-Hastings Council

Area 14 Stage 1B Groundwater Study, Lake Cathie, NSW

P0601504JR01-V03
July 2007

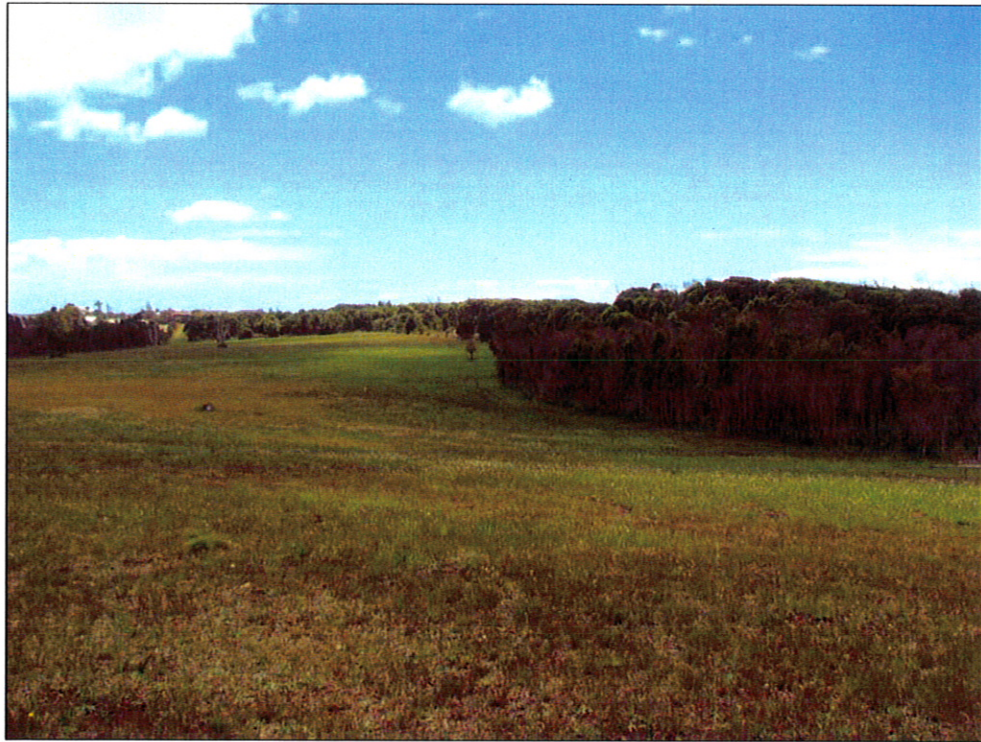
Figure 1: View towards north of sub-catchments C3 and C4 indicating low gentle gradients at lower portions of the site.

Site 0.5 contours were provided by Hastings Council and are relied upon for the purposes of this investigation. Further to this, surface levels at each of the installed piezometers were surveyed by King and Campbell Pty Ltd. Site survey data are provided in Attachment B and indicate that the western portion of the site is generally dominated by a relatively steep north-south aligned ridge with grade ranging between 10-20 %. To the east of the ridge, the site is relatively flat with grades of < 10 % grading towards the beach (see Figure 1).

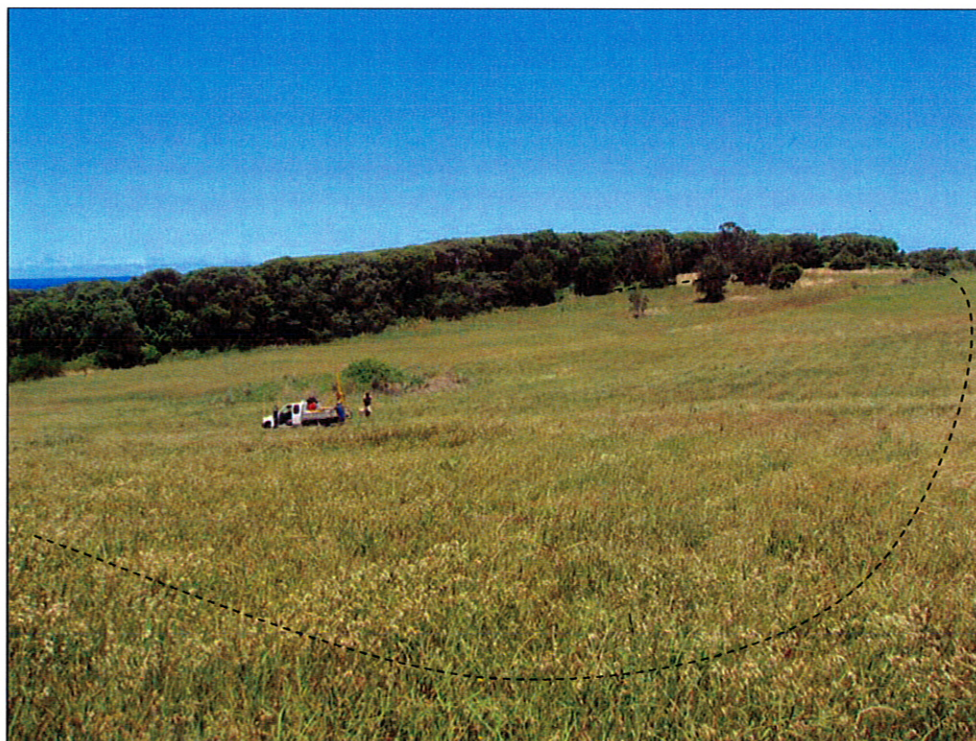
Figure 2: View towards south of sub-catchment C2 (delineated with dashed line) with existing farm dam located at middle foreground.

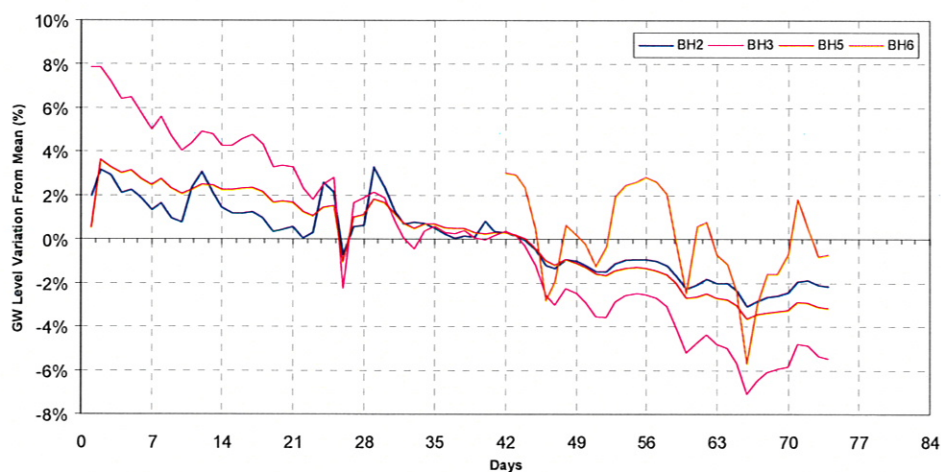
Figure 5: Variation in relative groundwater level (with respect to mean level observed at each piezometer) during primary monitoring period (day 0 = 23/11/2006, day 74 = 4/2/2007).

In order that monitoring results could be compared between piezometers, daily data were 'normalised' by dividing the daily observation by the mean of the observation period, and expressing this as a percentage deviation from the mean. Results are provided in Figure 5 and show that for all piezometers, including the later period for BH6, there is a similar gradual decline in water level. This suggests that local groundwater levels, whilst varying in height and absolute level variations, respond in a similar way to local environmental conditions.

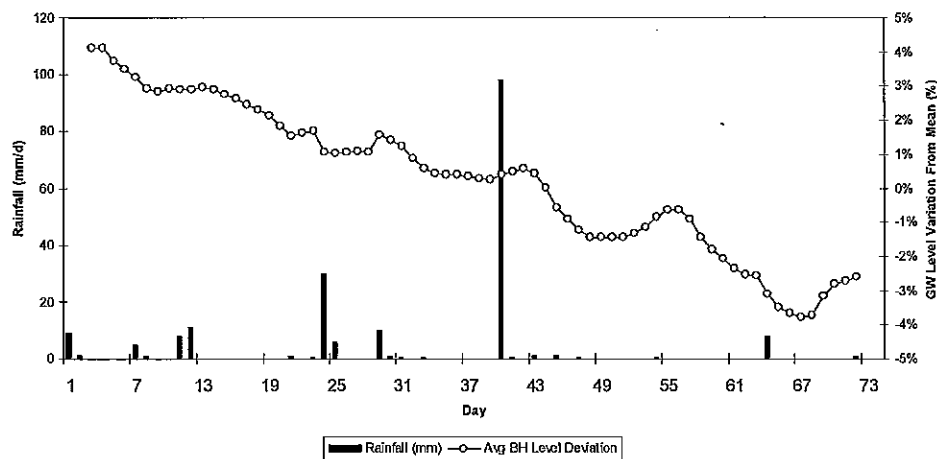
Figure 8: Site mean 'normalised' groundwater level variation (expressed as a 5 day running average) plotted in relation to rainfall during the primary monitoring period.

Historical daily rainfall data for the monitoring period were obtained from the Bureau of Meteorology's Port Macquarie climate monitoring station. Figure 8 provides a plot of mean 'normalised' groundwater level (ie. daily percent variation from observation period mean) variations across the site against daily rainfall. No apparent direct relation exists between rainfall and immediate site groundwater level fluctuations.

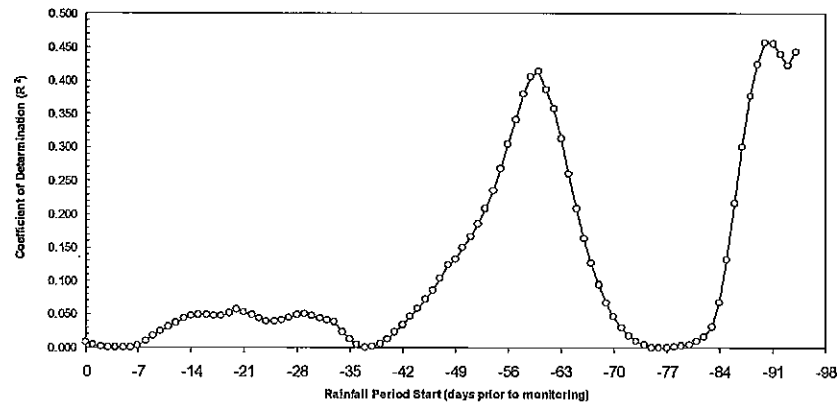
Figure 13: Lagged correlation function between site mean 'normalised' groundwater level variation (expressed as a 5 day running average) and antecedent rainfall total over 28 day block.

In addition to the above analysis, lagged correlation functions between antecedent rainfall and groundwater level fluctuations were prepared for rainfall running totals of 7, 14, 21 and 28 day time 'blocks' (see Figure 10, Figure 11, Figure 12 and Figure 13). To explain this procedure, for example, groundwater level on day 'n' is correlated to the total rainfall falling during the period ' $n-t$ to $-(t-P)$ ' where 't' is the lag period in days prior to monitoring and 'P' is the period over which rainfall is totalled. This approach allows the effects of slower responses to rainfall totals over the historical record to be investigated.

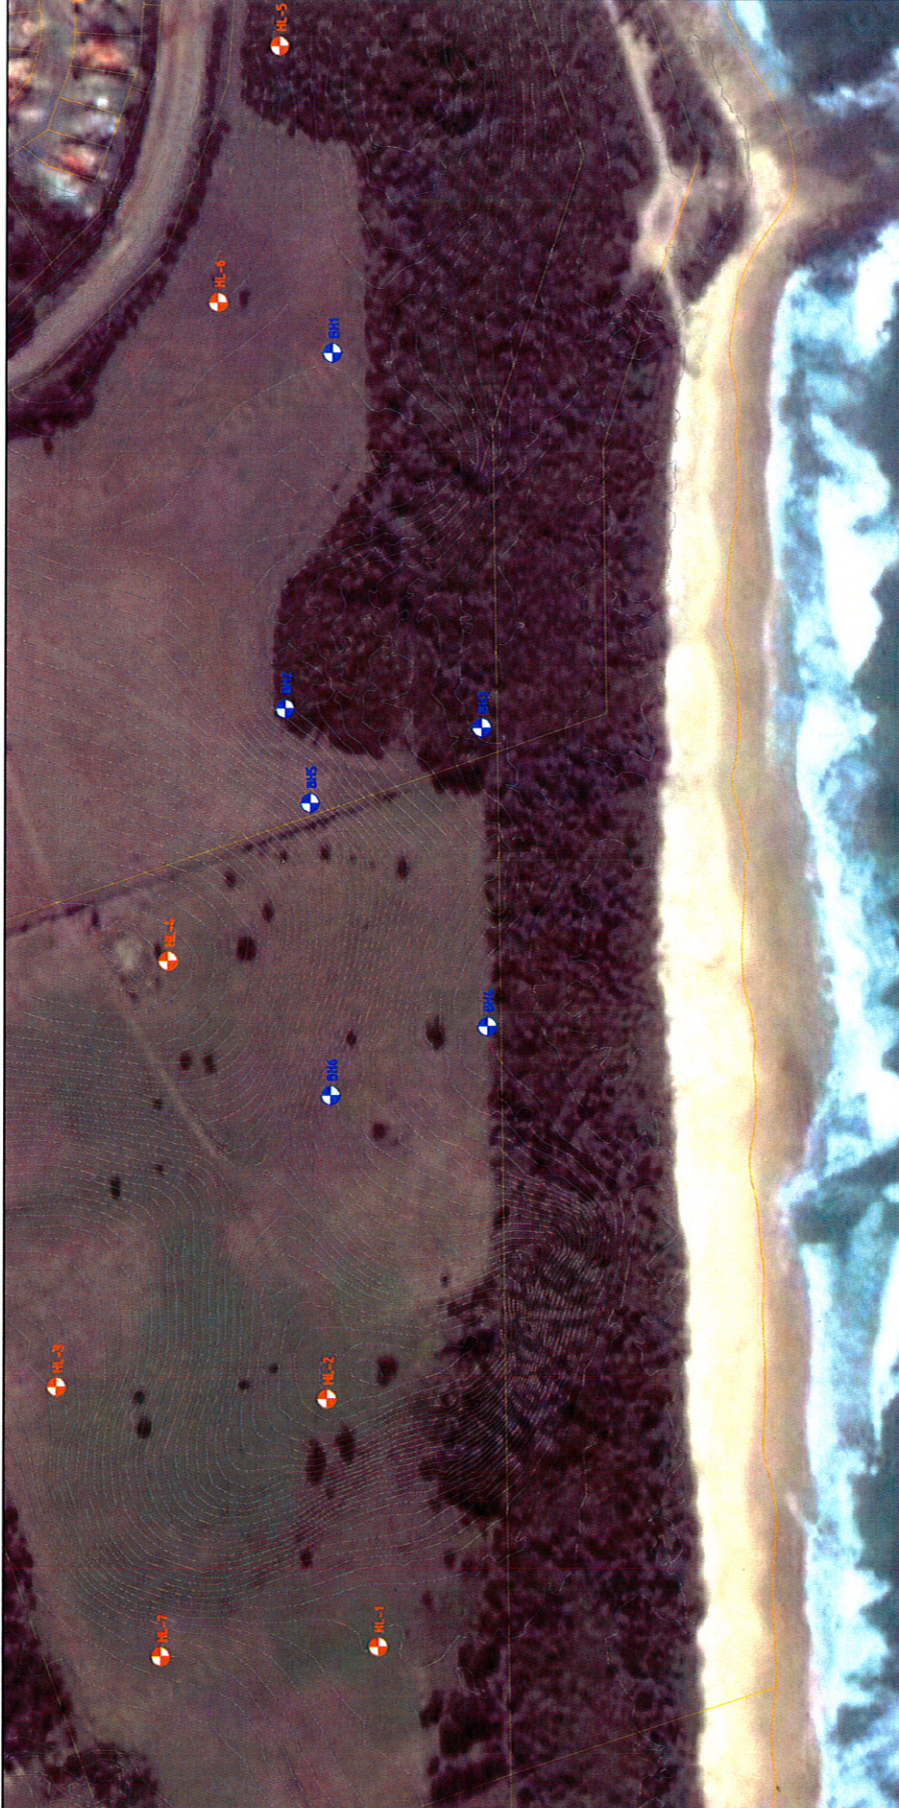
**HACKETT LABORATORIES TEST PIT LOCATION (FEBRUARY 2001)**

Groundwater was only observed at test-pit 6. Unfortunately surface levels for the investigation pits was not provided as part of the Hackett Laboratories report. Based on the presently available survey data, test-pit 6 is situated at approximately 11 – 11.5 mAHD. It is not possible from the report data to determine whether the observed groundwater represented a likely groundwater level or a temporary level associated with saturated surface soils.
