Stage I & II Environmental Site Assessment 396 Lane Cove Road & 1 Giffnock Avenue Macquarie Park, NSW

22 June 2006

Australand Industrial No.122 Pty Ltd

HLA-Envirosciences Pty Limited

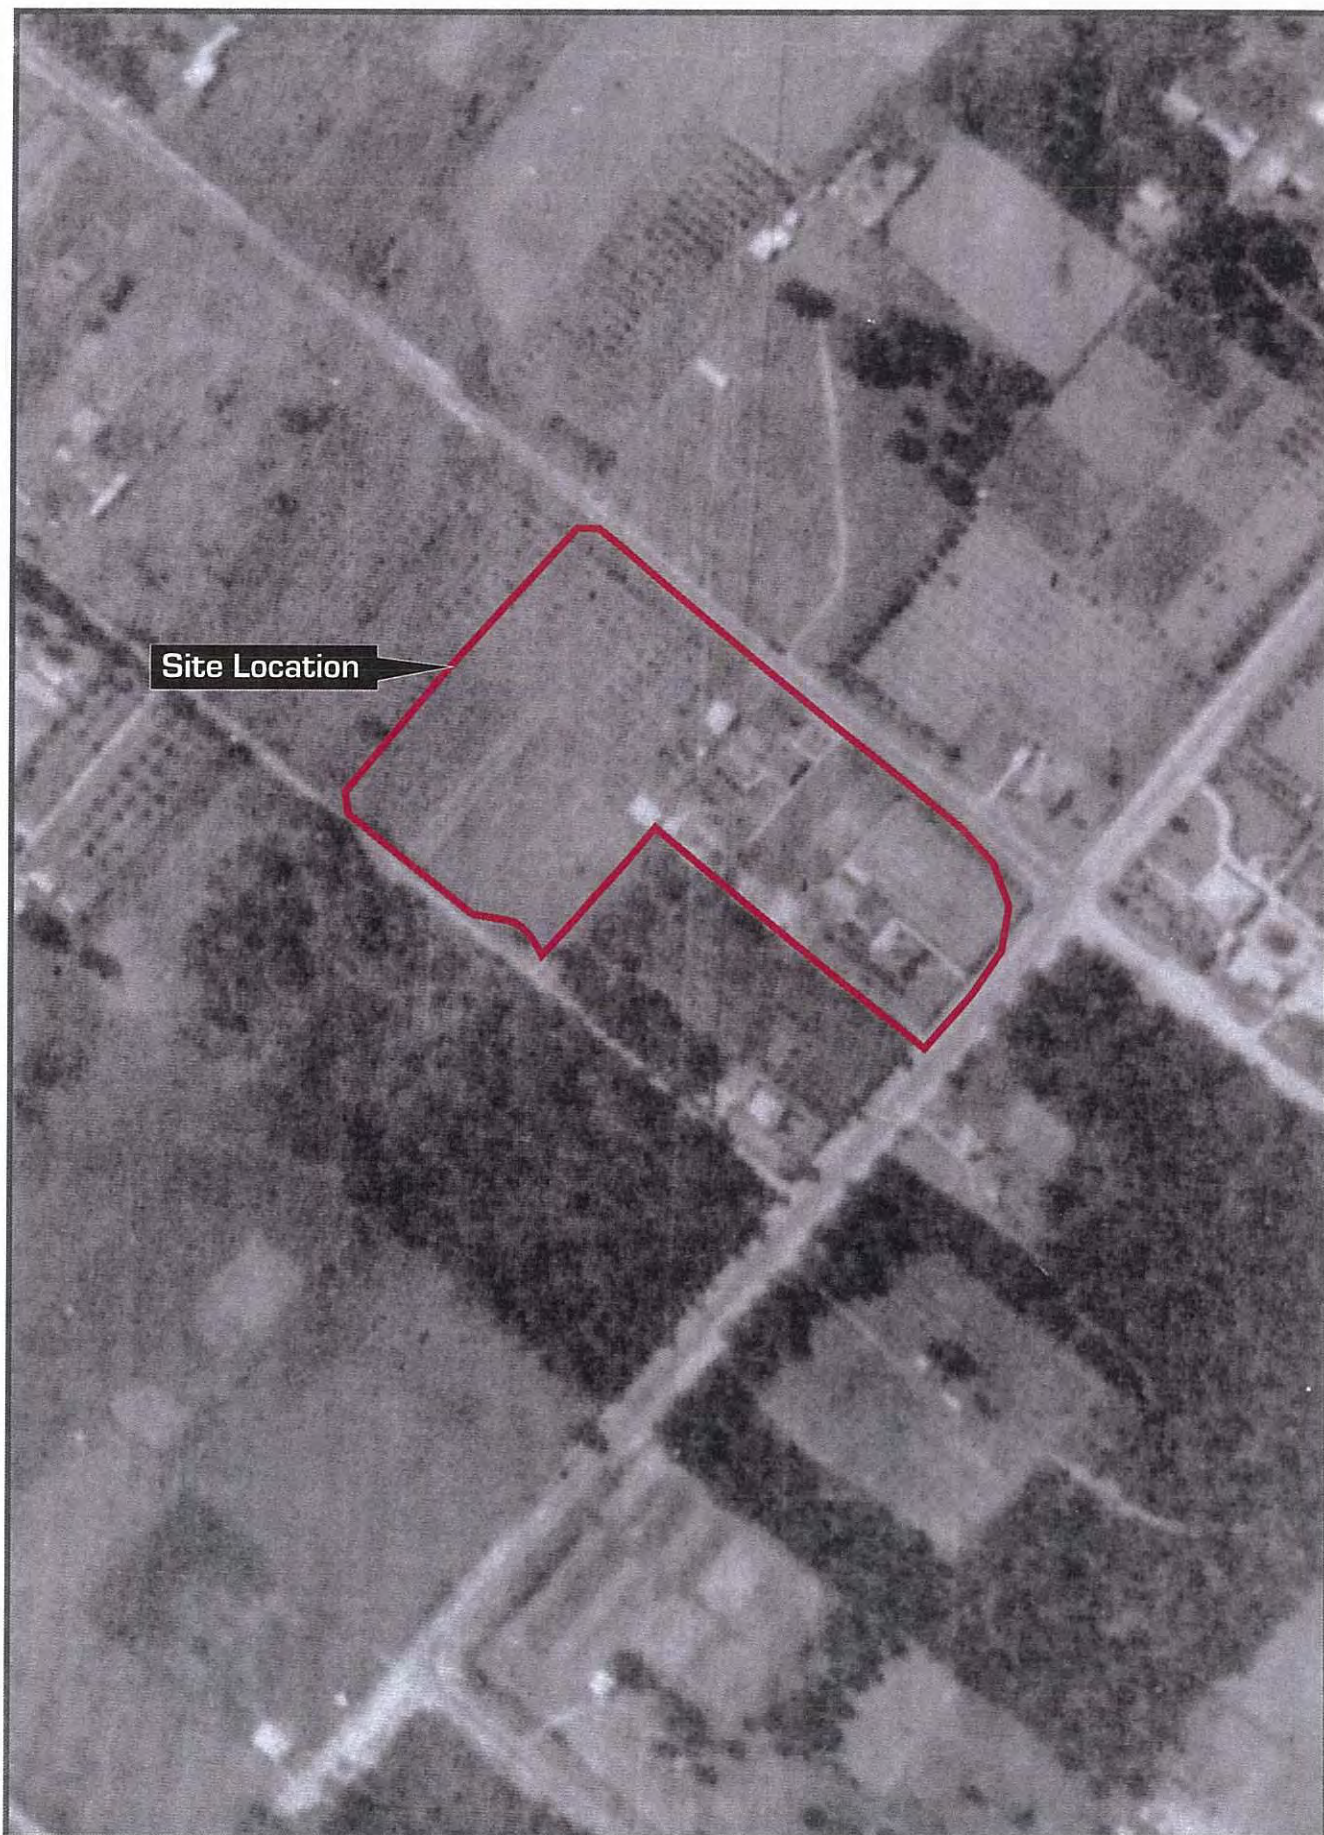
1930 Aerial Photograph
Australand Industrial No.122 Pty Ltd
 Corner 396 Lane Cove Road & 1 Giffnock Avenue
 Macquarie Park NSW 2113
 Phase I & II Environmental Site Investigation

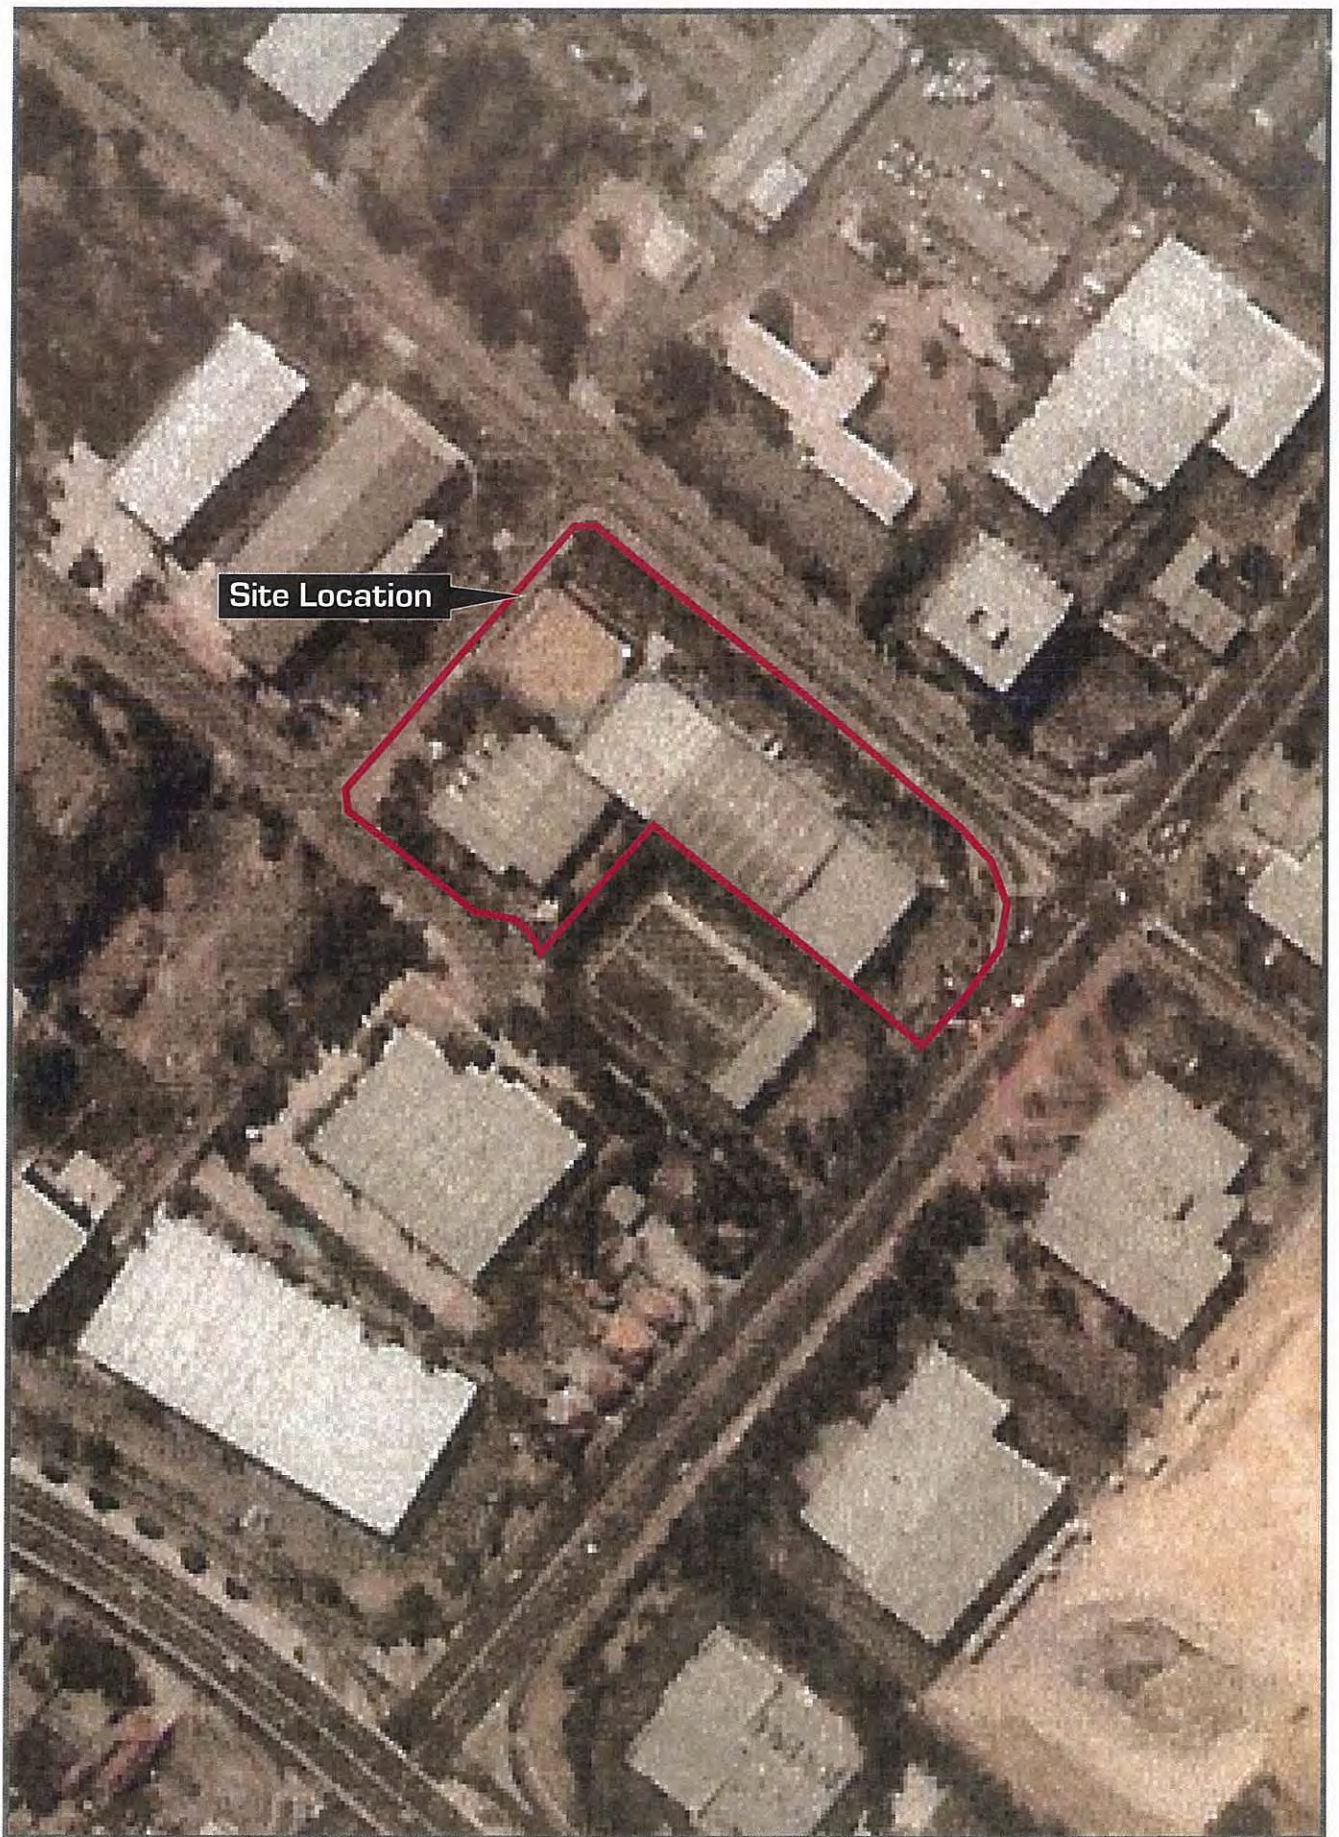
1986 Aerial Photograph
Australand Industrial No.122 Pty Ltd
 Corner 396 Lane Cove Road & 1 Giffnock Avenue
 Macquarie Park NSW 2113
 Phase I & II Environmental Site Investigation

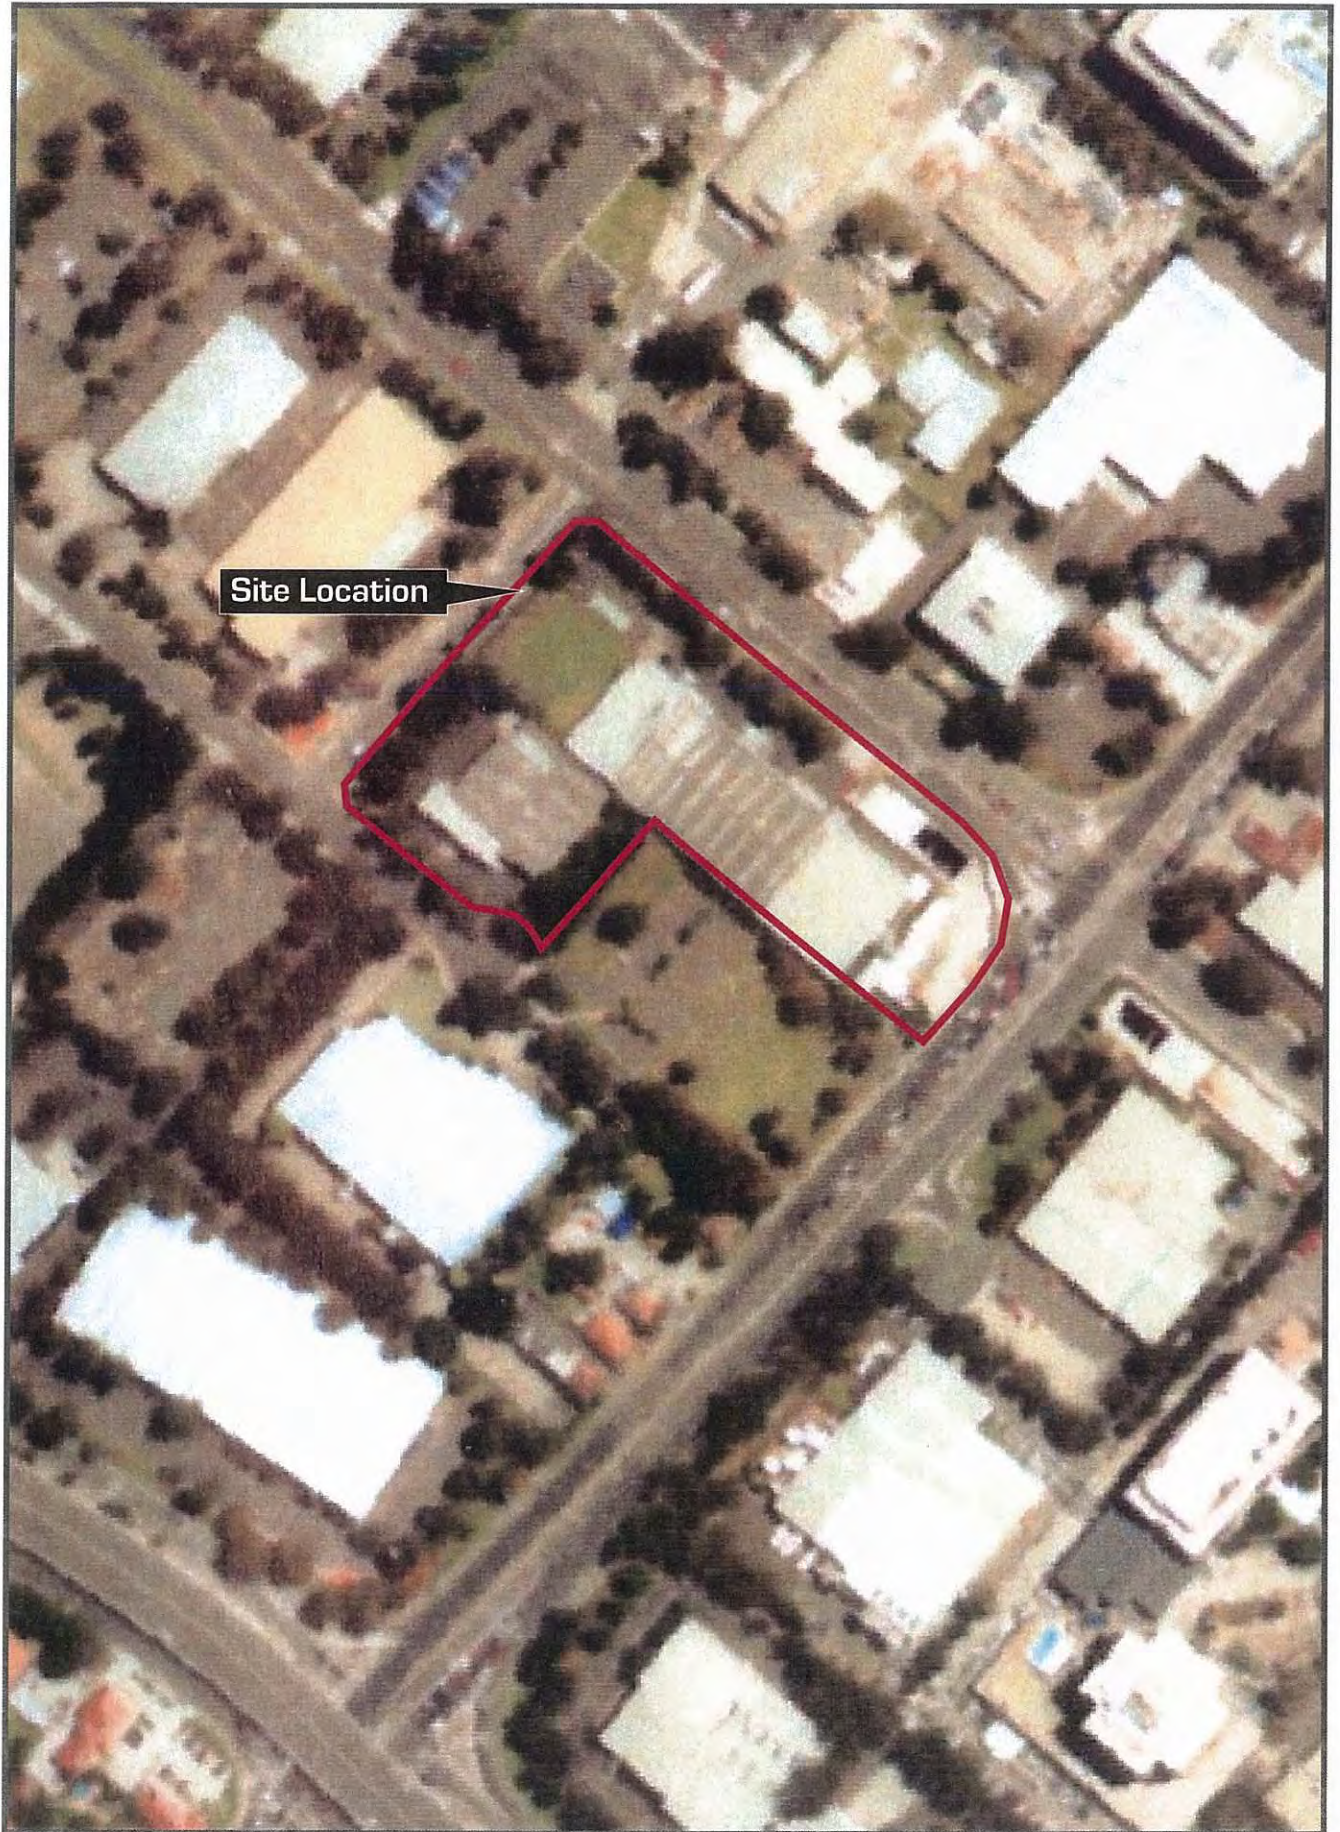
2005 Aerial Photograph
Australand Industrial No.122 Pty Ltd
 Corner 396 Lane Cove Road & 1 Giffnock Avenue
 Macquarie Park NSW 2113
 Phase I & II Environmental Site Investigation

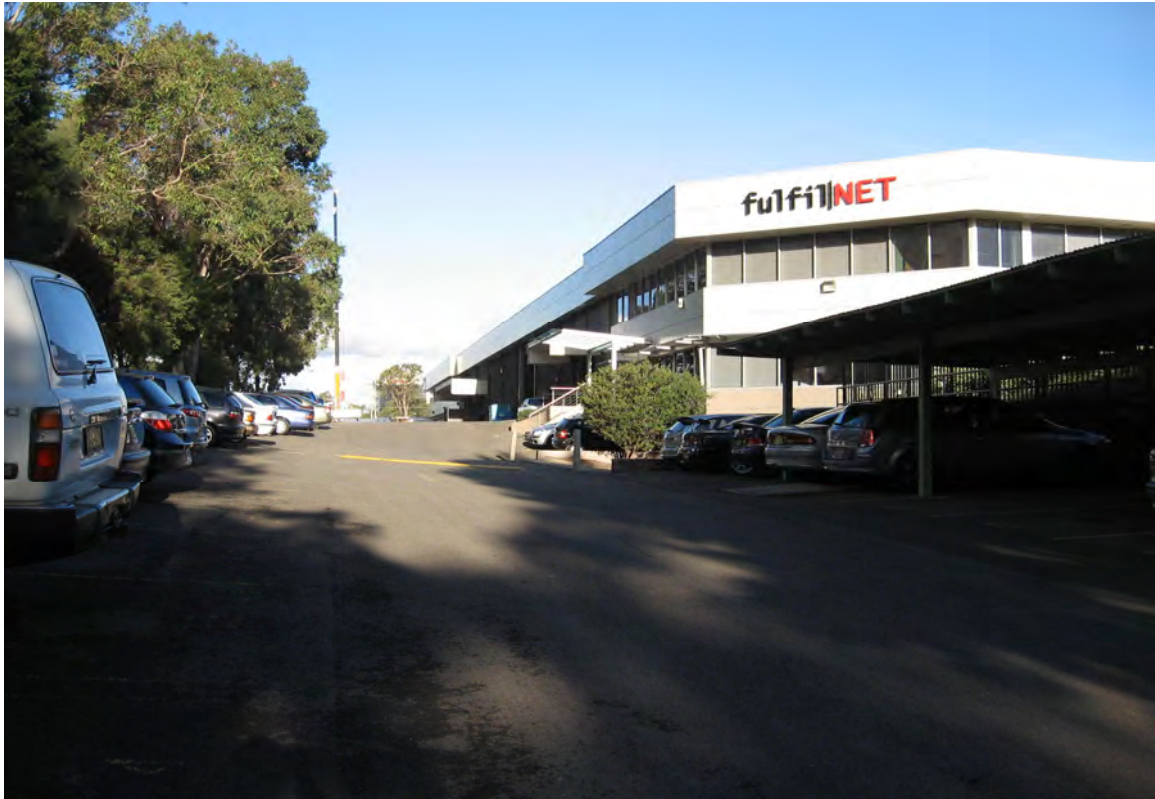
**PLATE 1**

- An office and mechanics work shop building occupies the south western portion of the property. The eastern and western portions of the building comprise office space while the centre portion of the building houses a warehouse and a mechanics workshop for MAN B&W (Plate 1);

Site building at 396 Lane Cove Road property.

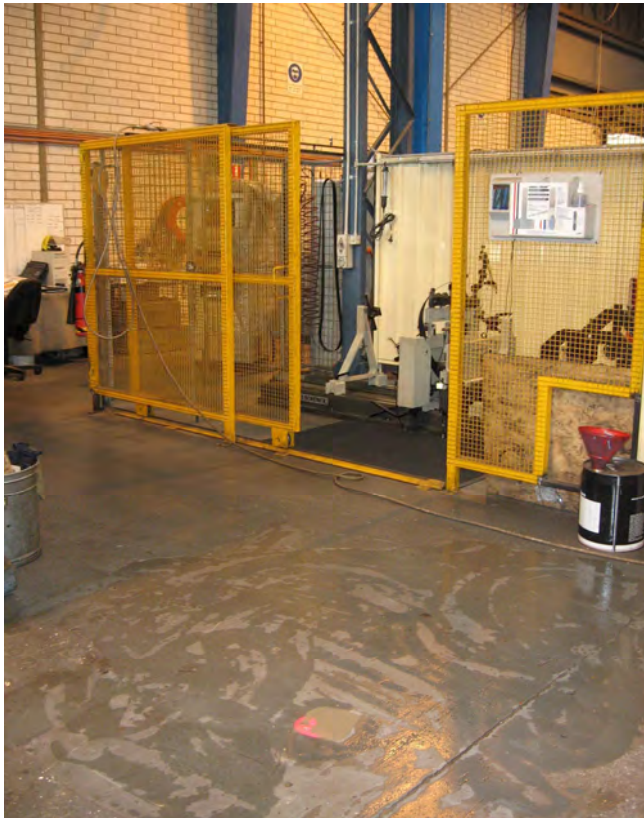
**PLATE 2**

- The concrete floor within the MAN B&W workshop area was noted to be in good condition and was covered with an epoxy sealant (Plate 2);
- Oils drums were observed within the MAN B&W workshop. No staining of the floor of the workshop was observed and operations within the workshop appear to be clean;

MAN B&W Diesel workshop

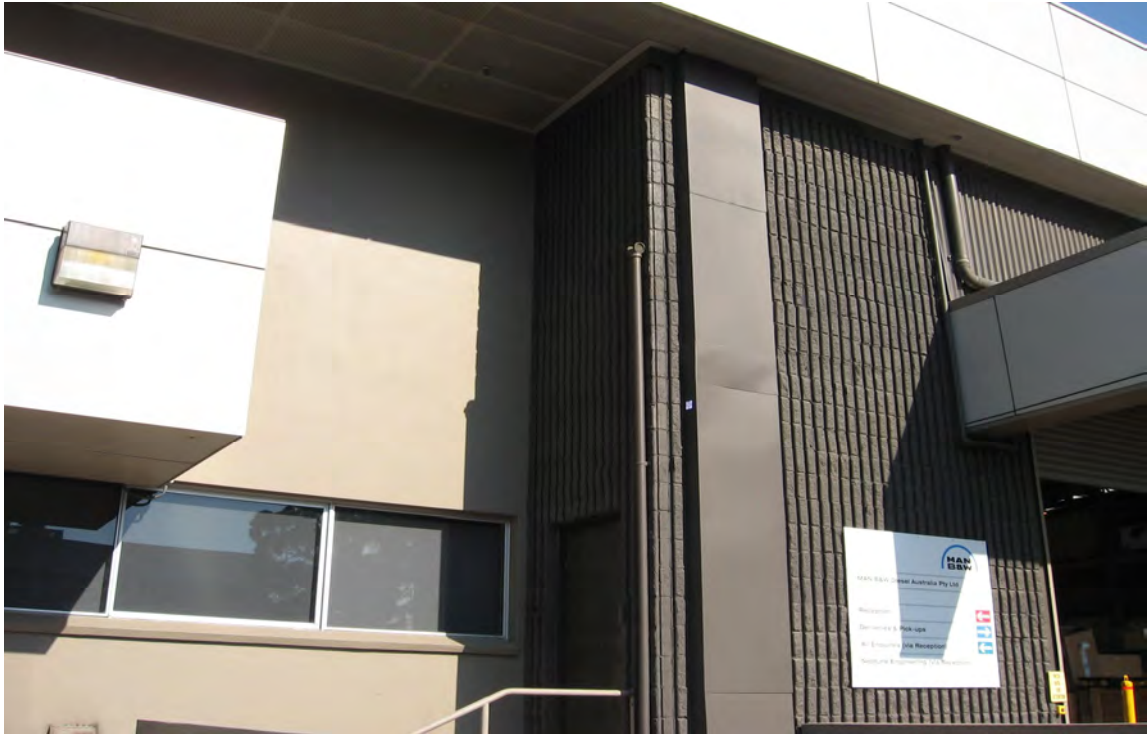
**PLATE 3**

- A basement level car park exists at the north western end of the Site building;
- A vent pipe suggesting the presence of a UST was observed adjacent to the air conditioning plant along the north eastern boundary of the building. No evidence of UST fill or dip points were observed (Plate 3);

Based on site observations, anecdotal information and the results of the intrusive investigation it is considered likely that a UST exists beneath the air conditioning plant in the north east portion of the 396 Lane Cove Road property. The exact location, size and contents of the UST are not known. Although concentrations of COPC were generally below the assessment criteria, the presence of petroleum hydrocarbon impacted soil in borehole BH16 at a depth of 2.0 m bgs indicates that the integrity of the UST may have been compromised. As such, the existence of the UST presents a potential future environmental liability to AI 122.

Vent pipe above air conditioning compound in north east corner of 396 Lane Cove Road property.

- The UST be decommissioned by removal, if possible, which would allow for the excavation of impacted soils (if any), and appropriate sampling of the UST pit excavation to validate removal of contaminated soil. Excavated contaminated soils could be remediated through on-site landfarming techniques. The remediated soil could then be returned to the excavation. Alternatively, the excavated soil could be disposed off-site to an NSW EPA licensed facility. Additional sampling and analysis would be required to evaluate the waste classification of materials associated with the UST; and
- ACM and associated impacted soils located on the south west boundary of the 396 Lane Cove Road property be removed from site by appropriately licensed asbestos removal contractors.

- UST is between 5000 L to 10000 L capacity;
- The air conditioning plant has been removed enabling unrestricted access to the UST; and
- Removal and off-site disposal to a landfill facility of a nominal volume of 50 to 75 m³ hydrocarbon contaminated soils as solid waste.

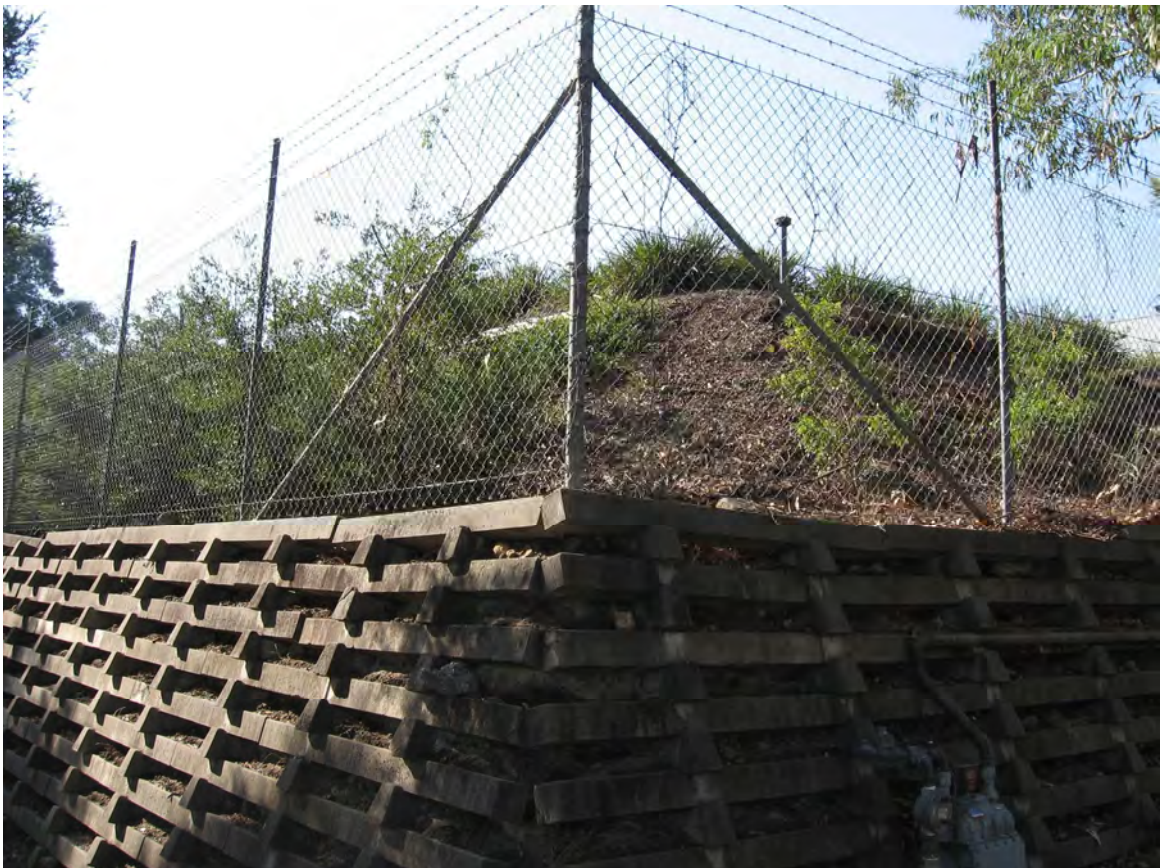
**PLATE 4**

- A raised helipad was observed in the north western portion of the Site. The helipad was surfaced with turf and appeared to be constructed from soil fill material to a level approximately 4 m above grade (Plate 4). Inspection of the cribblock retaining wall fronting Coolinga Street indicated materials comprised clay, shale and crushed sandstone. The source of fill material in the helipad is not known, however it is potentially sourced from the Site as a result of cut and fill operations associated with the construction of the underground basement car park;

Helipad embankment in south western corner of 396 Lane Cove Road property.

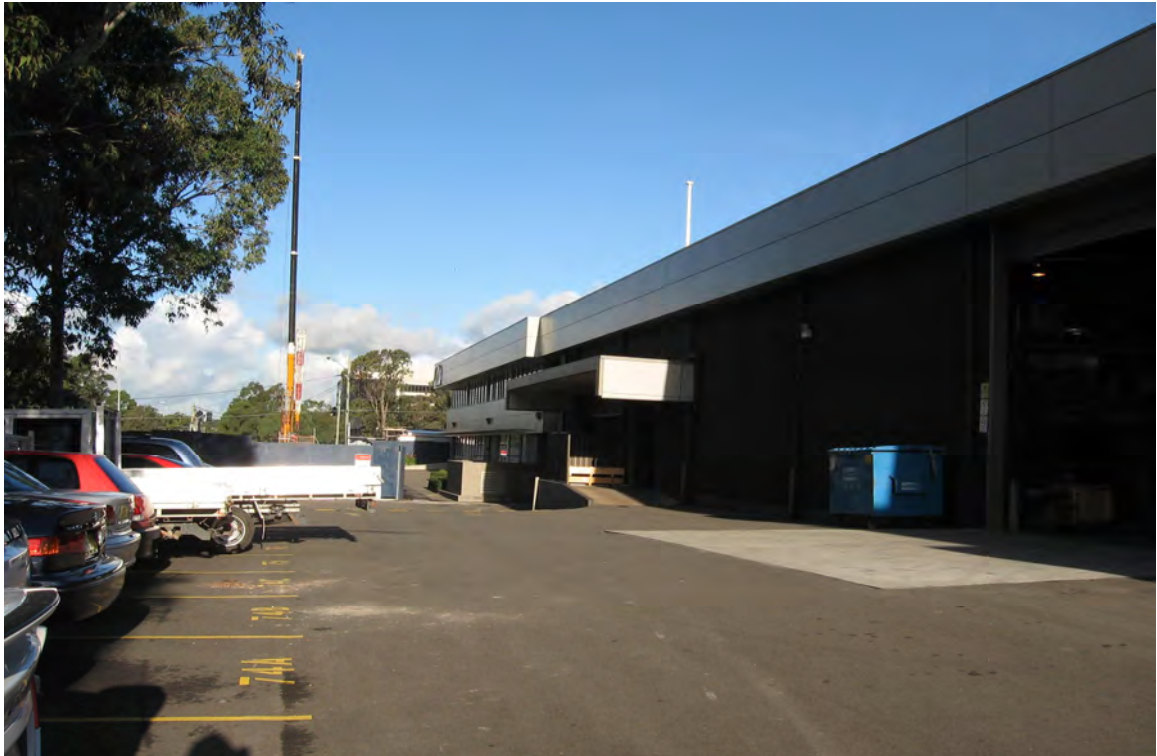
PLATE 5

- An electrical substation lies midway along the north eastern site boundary. No staining was observed around the substation;
- An asphalt paved carpark area adjacent to the north eastern edge of the building appears in good condition (Plate 5);

Bitumen covered car park area on 396 Lane Cove Road property.

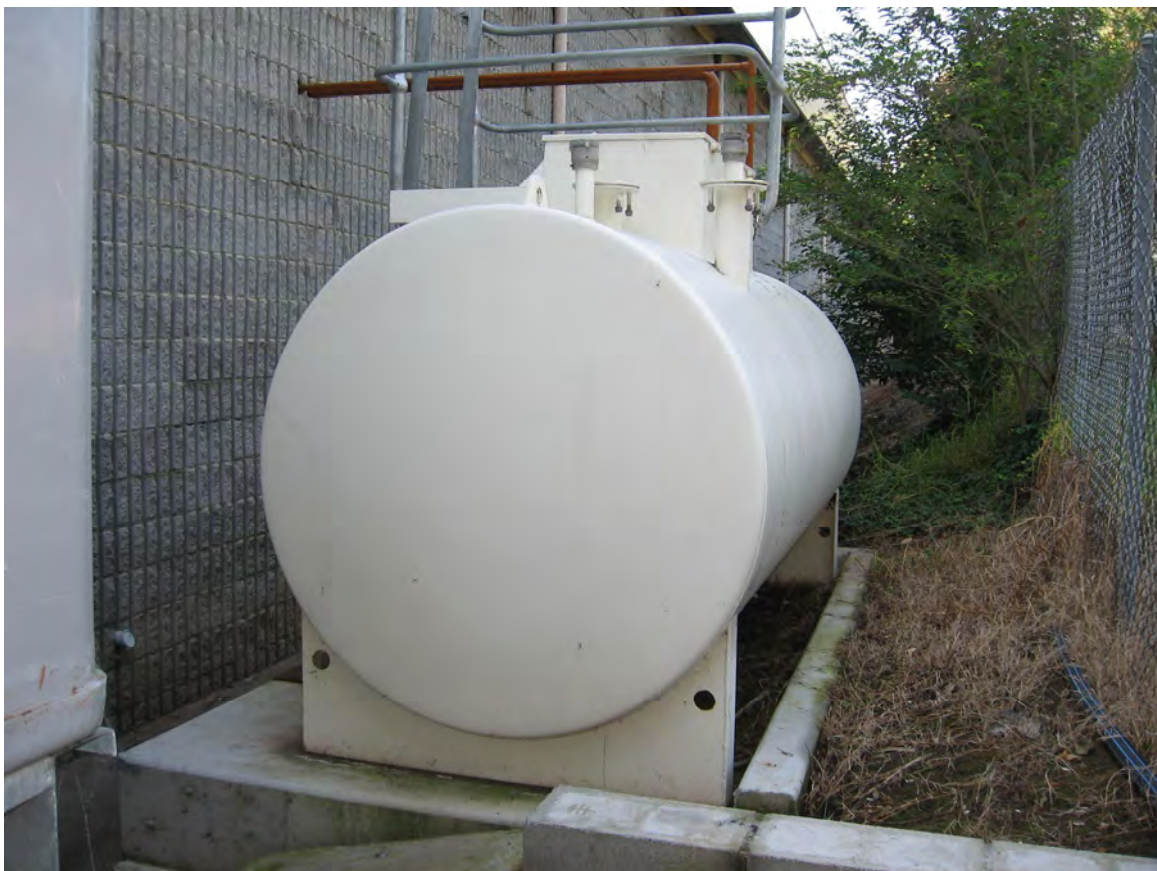
PLATE 6

- The MAN B&W Diesel operations include a spray painting booth, a diesel engine testing facility, a research and development facility and general diesel engine repair workshop;
- An Above Ground Storage Tank (AST) is located midway along the south western edge of the building (Plate 6). Based on anecdotal information (Cres James), this structure was installed approximately one year ago. The AST is located on a concrete pad. No visible evidence of leaks or spills were noted. The AST appeared to be in good condition; and
- Possible asbestos containing material fragments were observed within a limited area midway along the south western boundary of the Site (Plate 7).

Above Ground Storage Tank on south eastern boundary of 396 Lane Cove Road property.

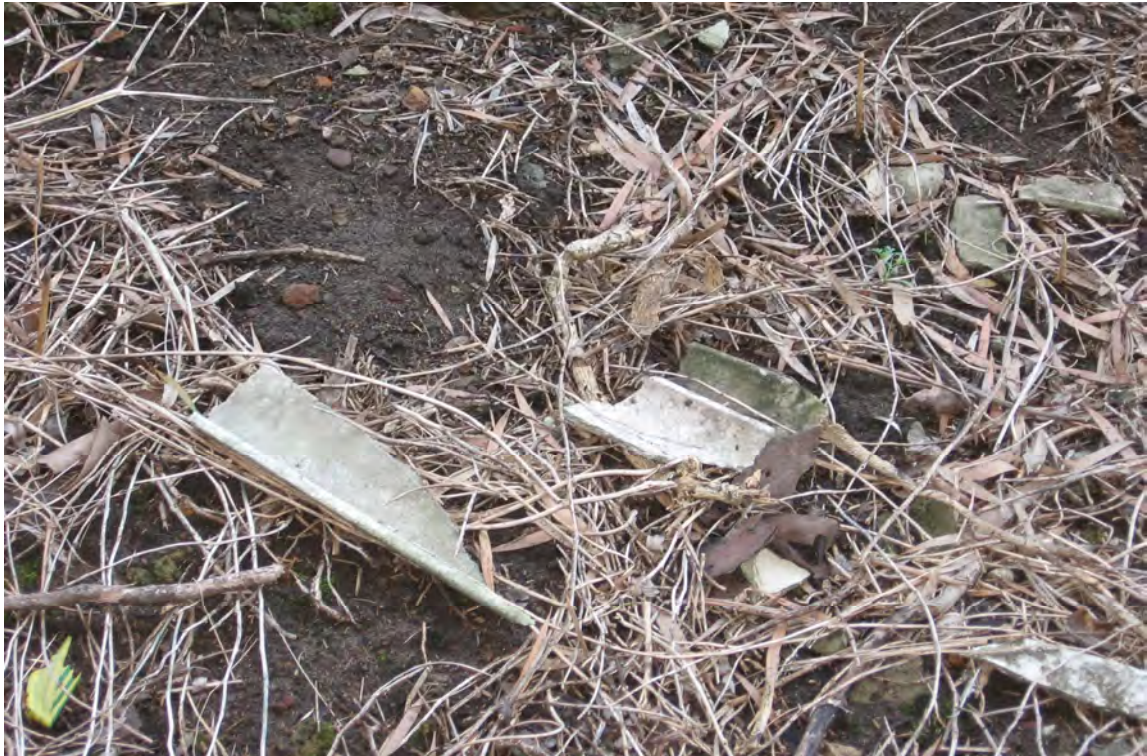
PLATE 7

- Area of broken potential asbestos containing fragments located on the south western boundary of the 396 Lane Cove Road property.

Analytical results confirm that the fragments of cement sheeting on the 396 Lane Cove Road property contain asbestos. The fragments appear in reasonable condition and cover an area of approximately 2m x 2m.

Asbestos containing material on south western boundary of 396 Lane Cove Road property.

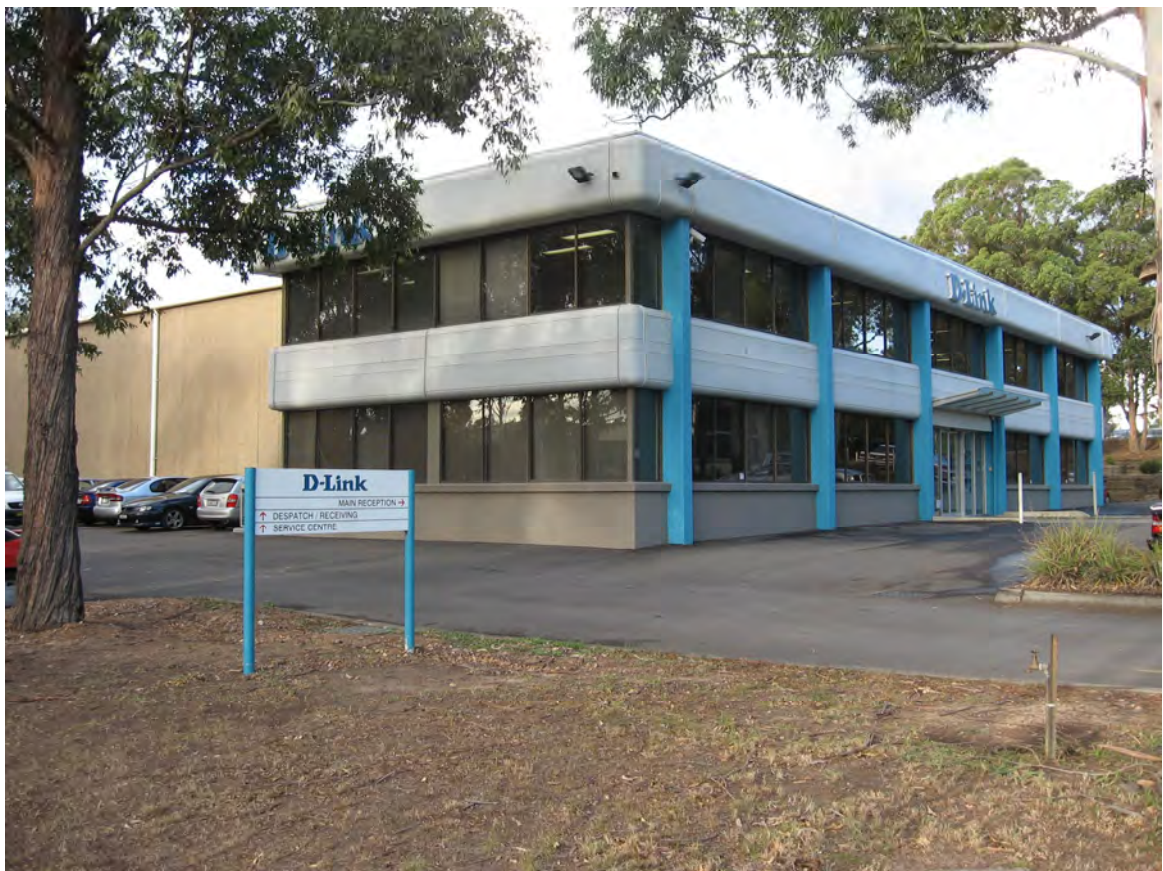
PLATE 8

- A warehouse and distribution building constructed from concrete panels and glass is located centrally in the north eastern portion of the Site. The concrete floor of the warehouse was noted to be in good condition (Plate 8);

Office/warehouse building at 1 Giffnock Avenue property

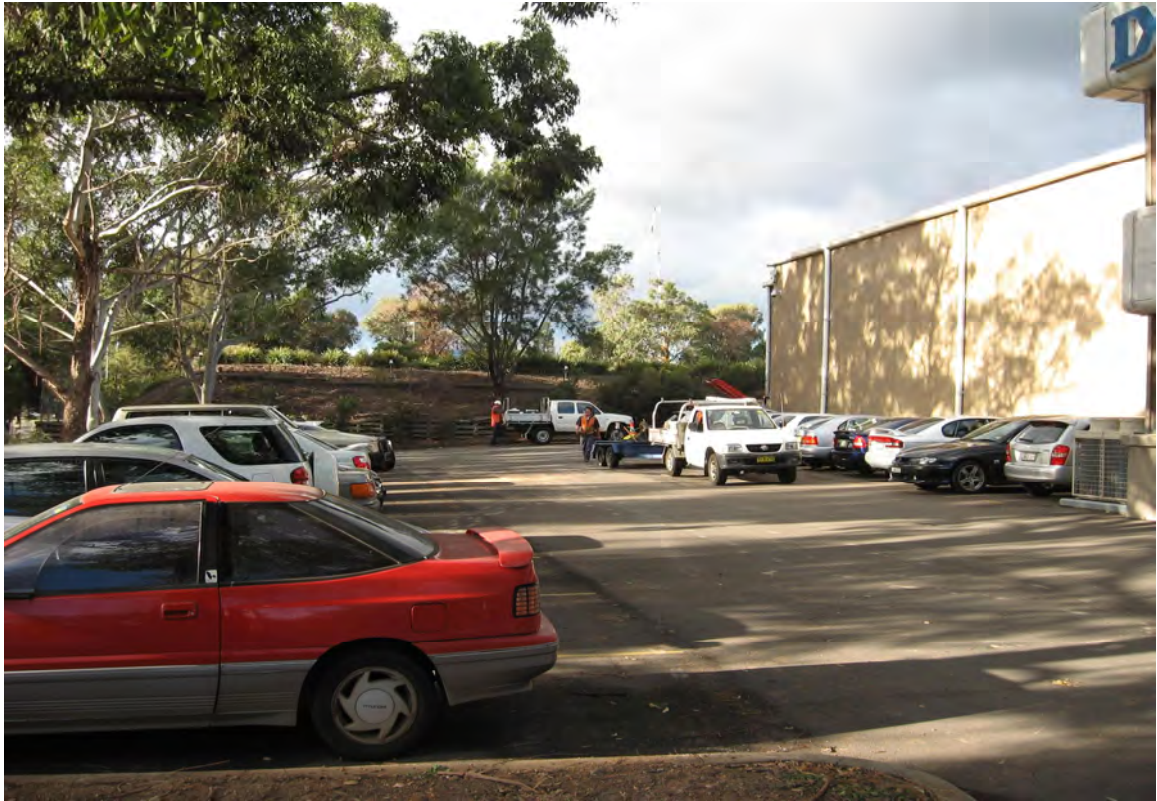
**PLATE 9**

- The warehouse is used to store electrical communication products. No manufacturing was observed on Site;
- An asphalt paved carpark area adjacent to the north west and south west edge of the building appears in good condition (Plate 9) ;

Bitumen covered car park area at 1 Giffnock Avenue property.

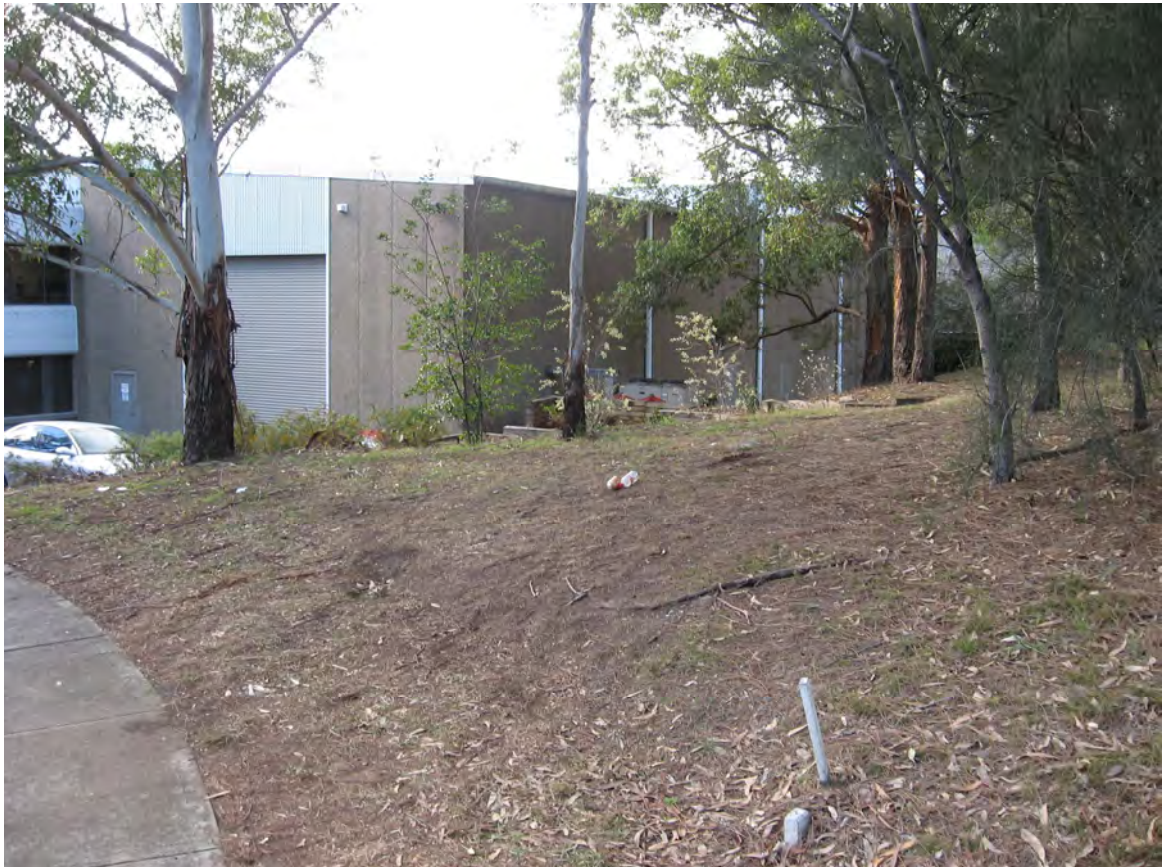
**PLATE 10**

- Garden areas beyond border the south east, north west and south west boundaries of the Site. No signs of stressed vegetation were observed (Plate 10);

Garden area 1 Giffnock Avenue property

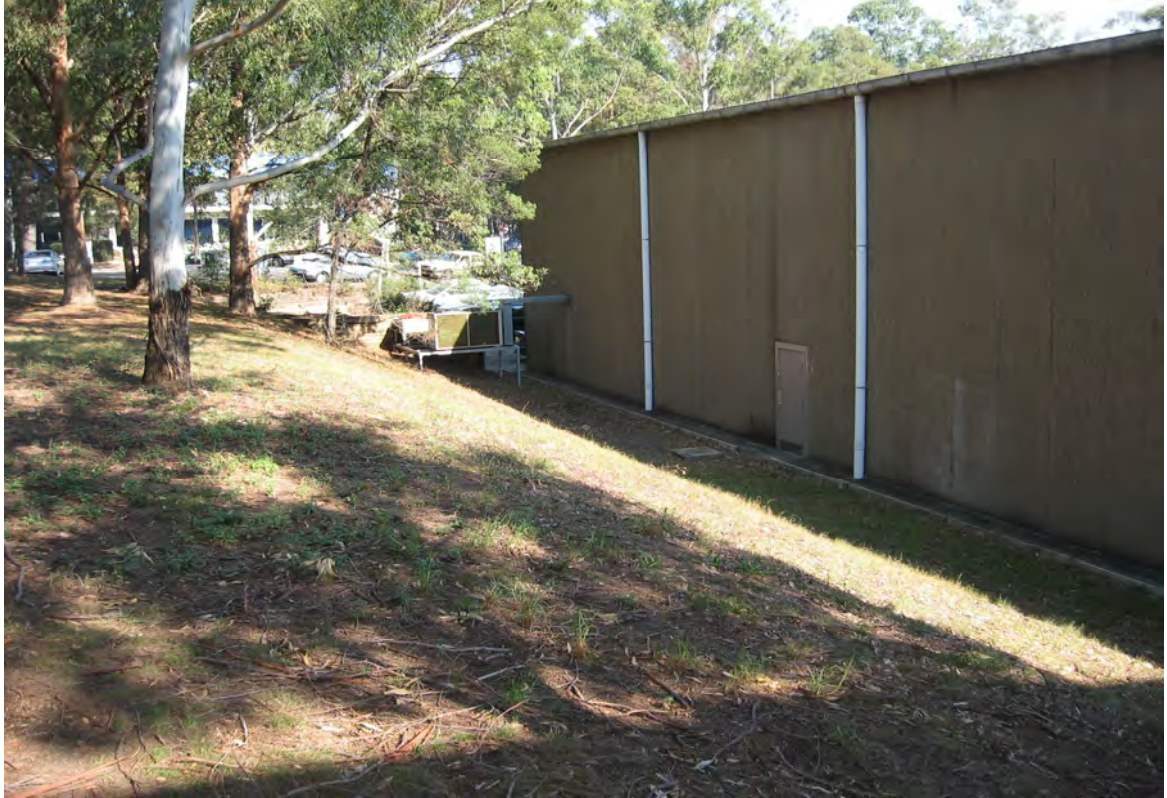
**PLATE 11**

Embankment on south eastern boundary of 1 Giffnock Avenue property
