Contamination

North Penrith

Assessment Report

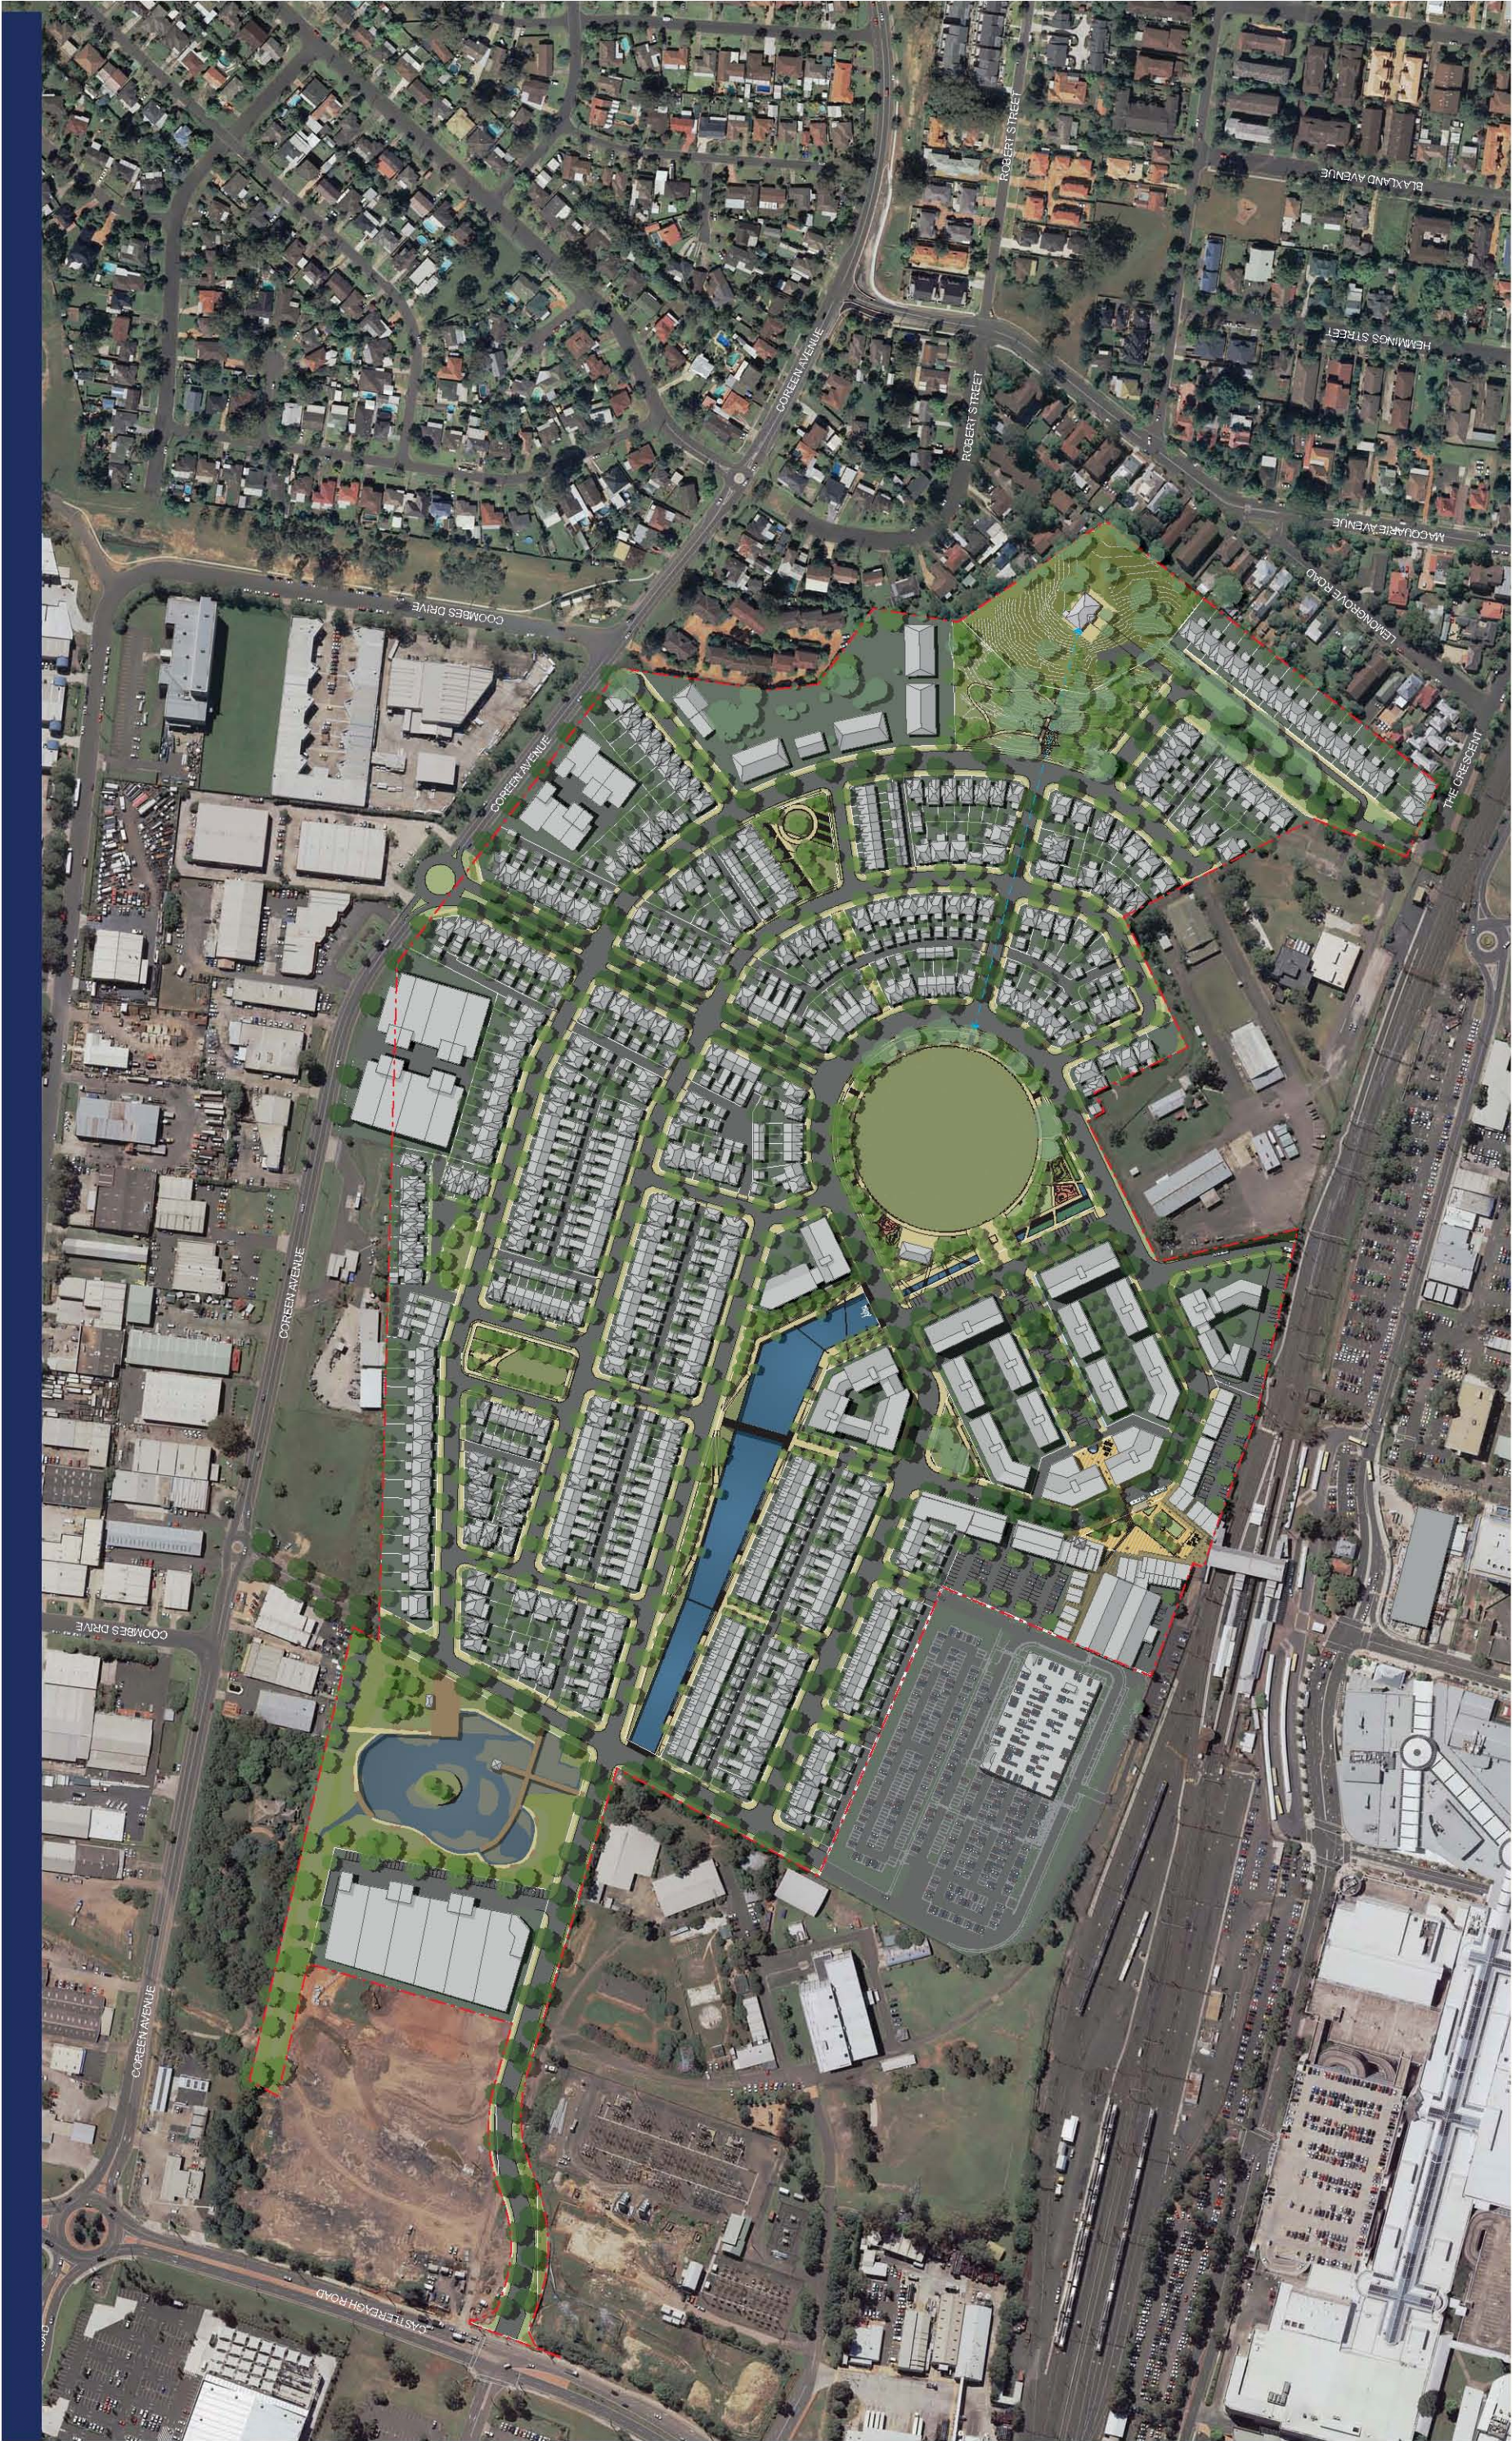
Appendix 1: Concept Plan

ILLUSTRATIVE CONCEPT PLAN

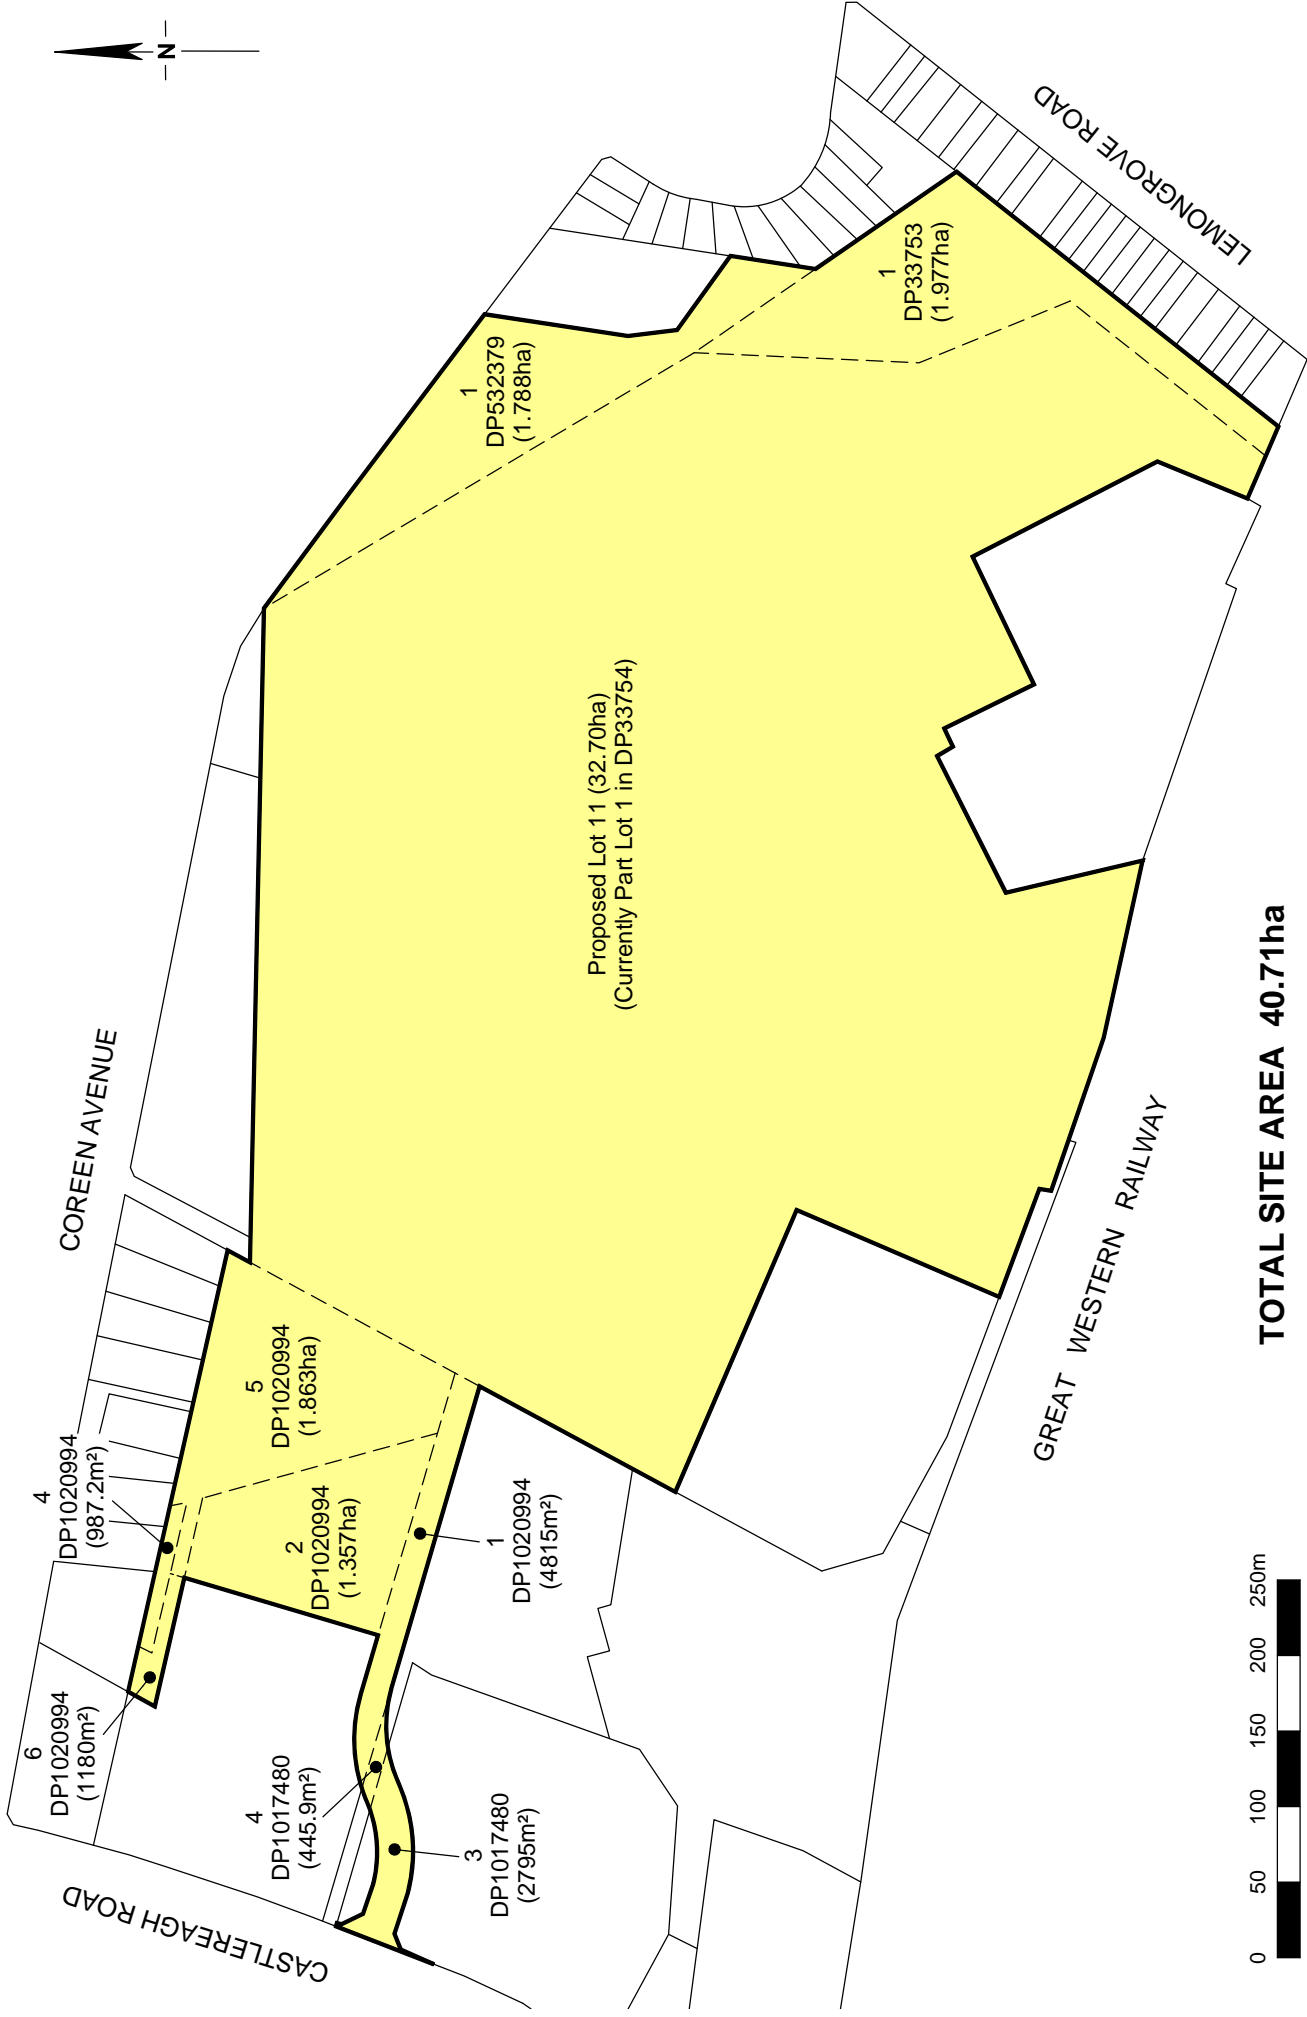
Appendix 2: Site Boundaries Plan

TOTAL SITE AREA 40.71ha

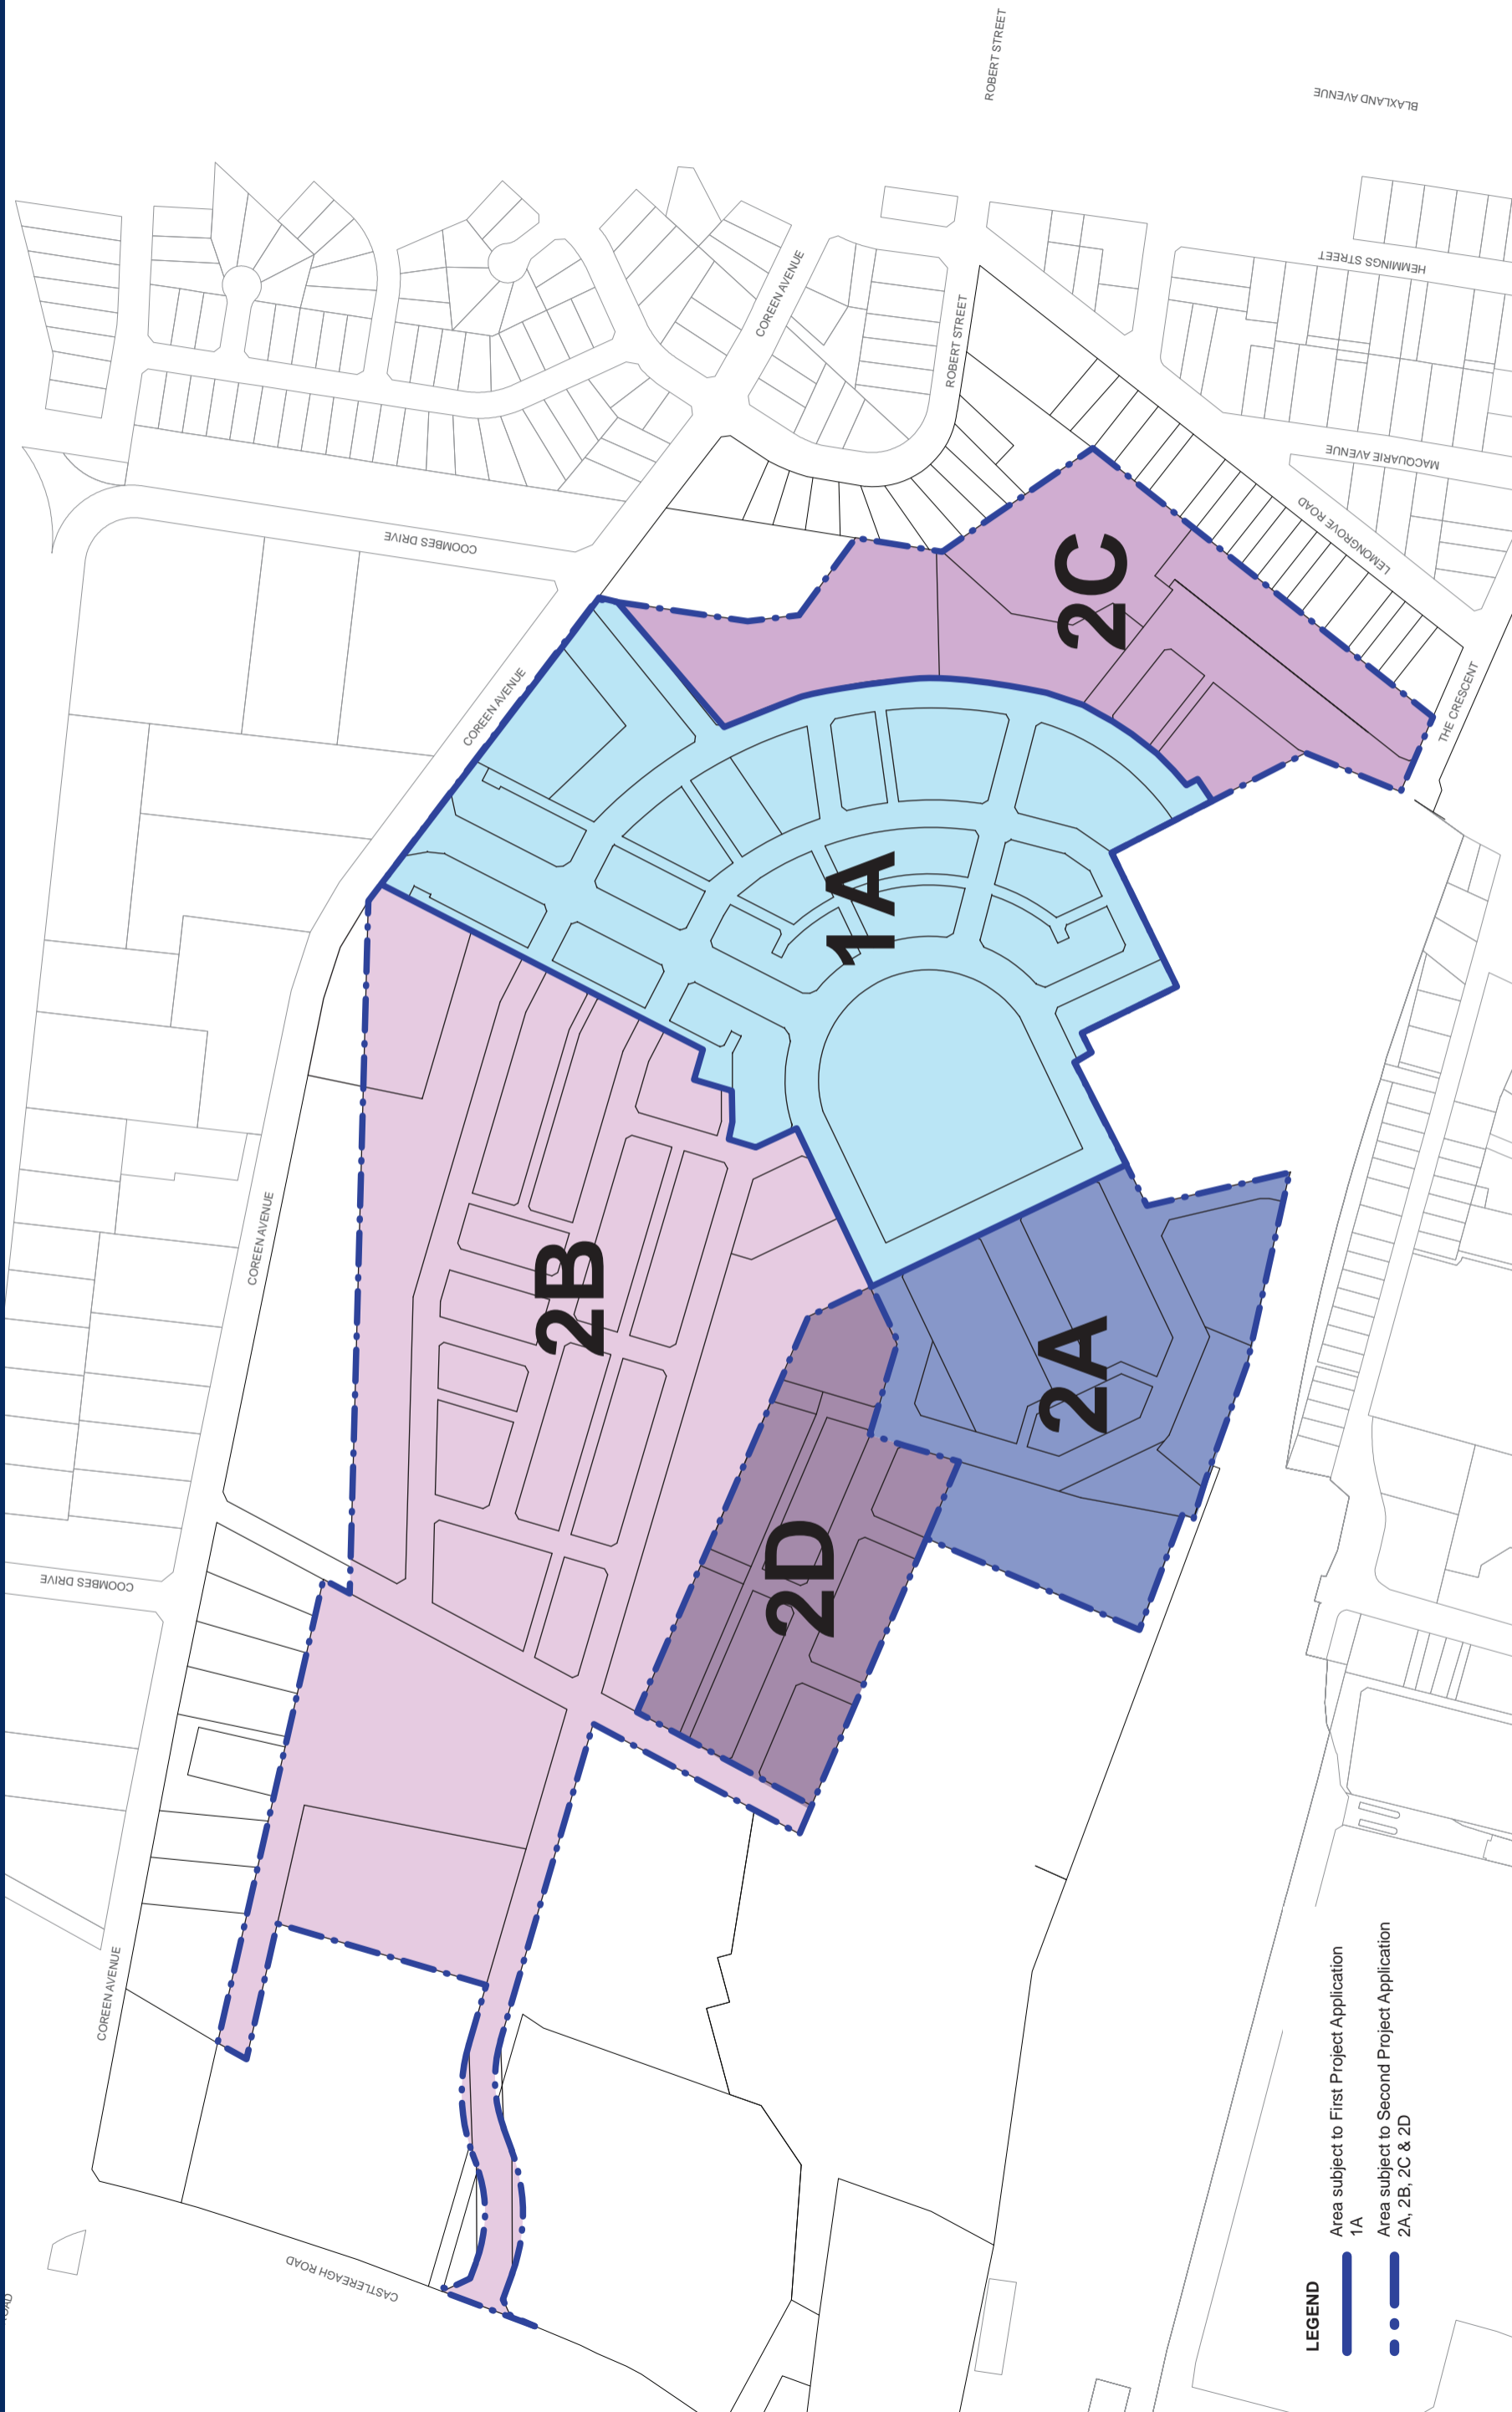
Appendix 3: Stage 1 Project Application Area Plan

LEGEND

Area subject to First Project Application
1A

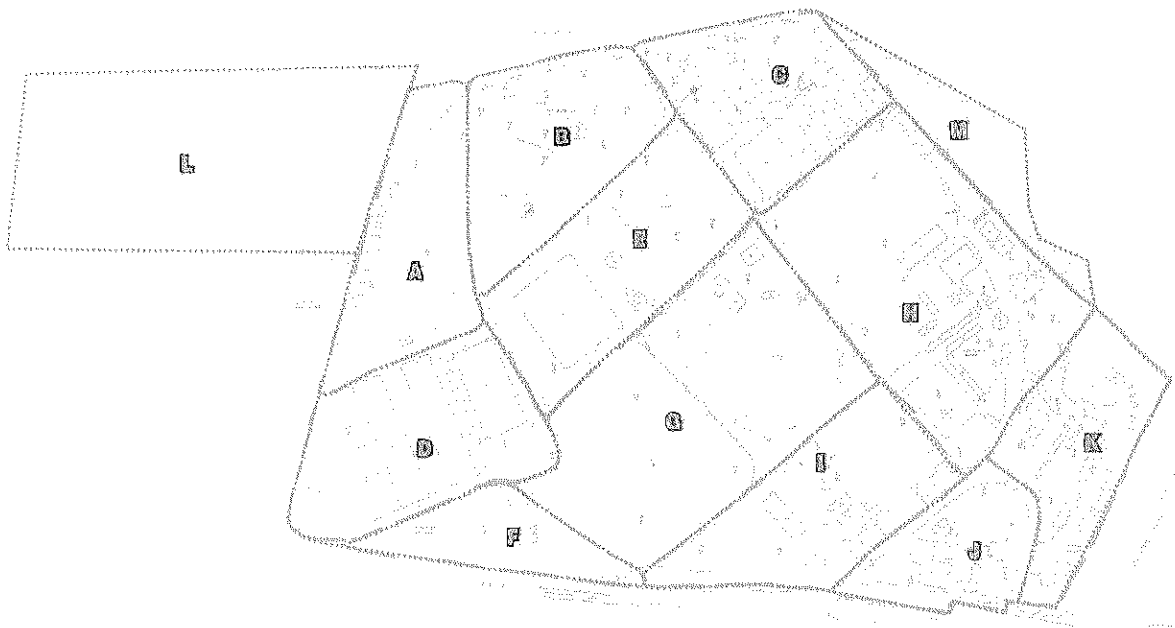
BOUNDARIES OF ENVIRONMENTAL DOMAINS

THORNTON PARK CONTAMINATION ASSESSMENT

KEY
Boundary of Environmental Domain

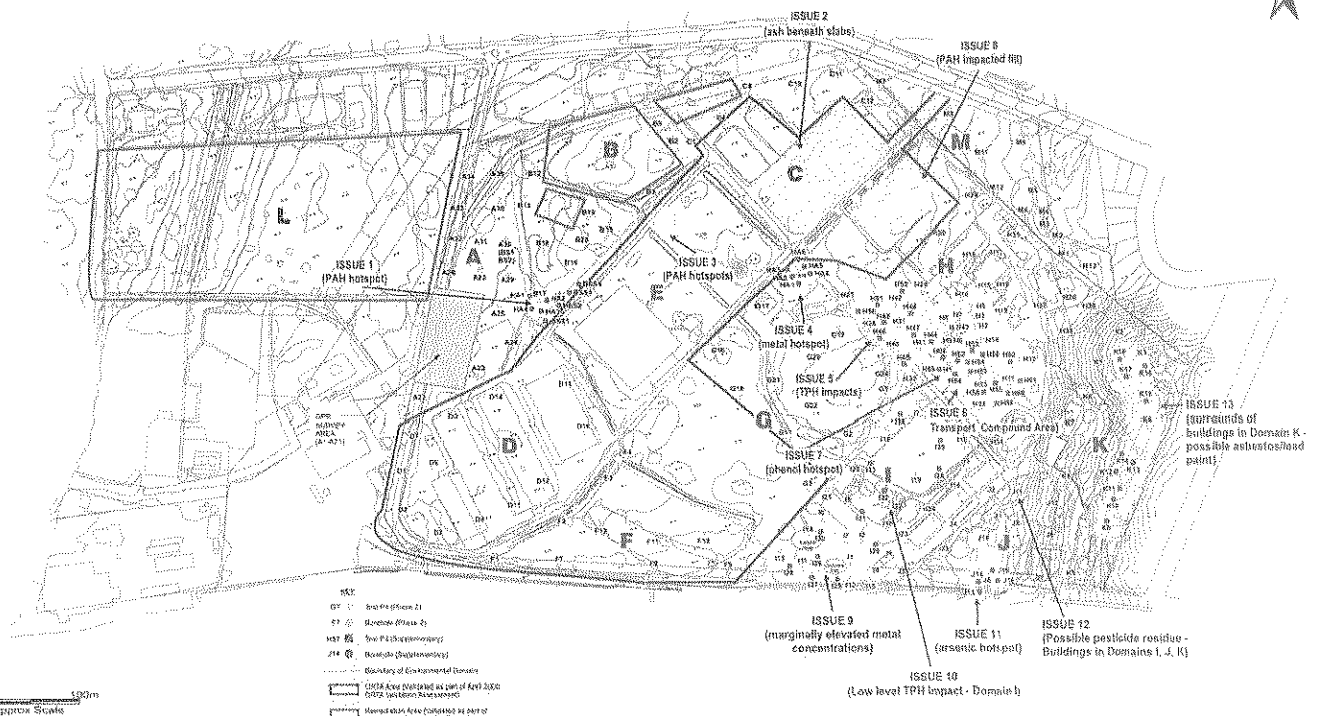
GENERAL LOCATION OF CONTAMINATION ISSUES

THORNTON PARK CONTAMINATION ASSESSMENT - PHASE 2 AND SUPPLEMENTARY WORKS

KEY
Boundary of Environmental Domain
Issue 1 (PAH hotspot)
Issue 2 (ash beneath slabs)
Issue 3 (PAH hotspots)
Issue 4 (metal hotspot)
Issue 5 (TPH impacts)
Issue 6 (benzene hotspot)
Issue 7 (marginally elevated metal concentrations)
Issue 8 (arsenic hotspot)
Issue 9 (PAH impacted fill)
Issue 10 (Low level TPH impact - Domain I)
Issue 11 (Possible pesticide residue - Buildings in Domains I, J, K)
Issue 12 (surrounds of buildings in Domain K - possible asbestos and paint)

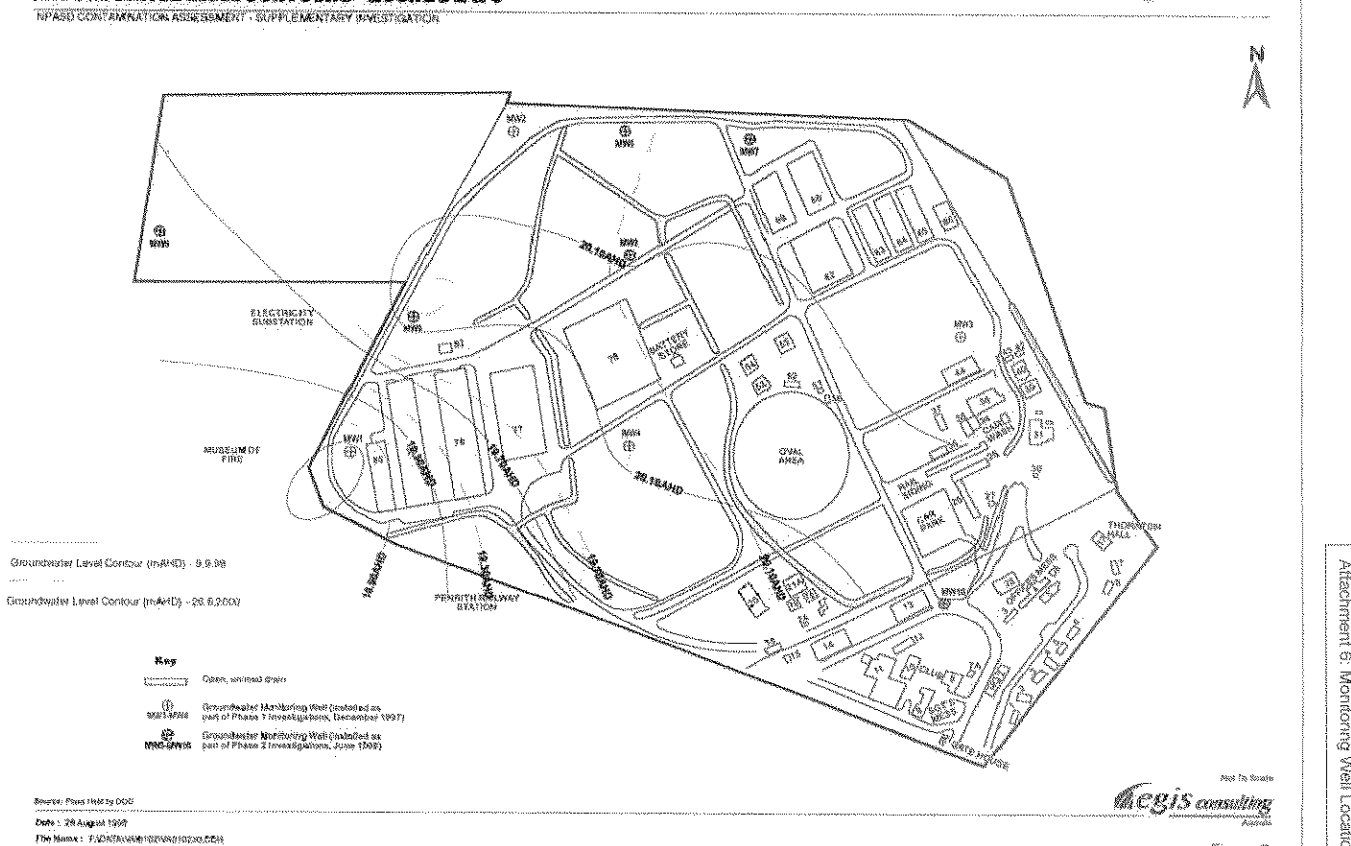
GROUNDWATER LEVEL CONTOURS - BOUNDS 2 & 3 THORNTON PARK CONTAMINATION ASSESSMENT - SUPPLEMENTARY INVESTIGATION

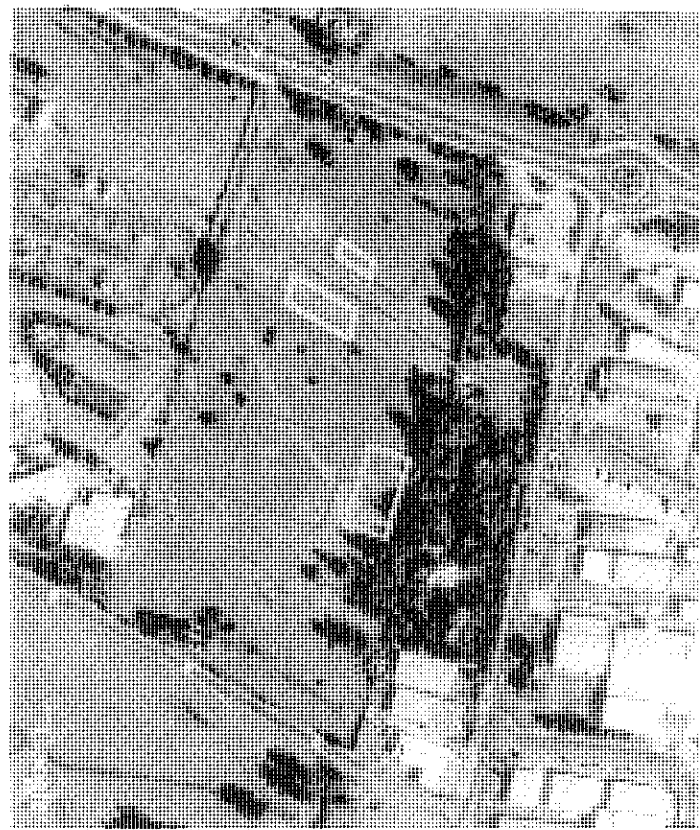
/Attachment – Site Layout

- KEY**
- ☐ Approximate Location of Accesses Treatment Area
 - ☐ Approximate Location of Original Grey Sand Stockpiles
 - ☐ Approximate Location of Original Orange Sandy Clay Stockpiles
 - ☒ Air Sampling Location
 - ☐ Approximate Location of Stockpiled Remediated Material
 - ☐ Driveway Path

This section summarises the results of analysis of the orange clay stockpiles. The grey stockpiles were found to contain elevated concentrations of metals, petroleum hydrocarbons and polycyclic aromatic hydrocarbons, and were removed from site. The chemical results are therefore not considered further in this review. The orange clays were proposed for remediation by removal of asbestos and reuse.

I undertook a site inspection on 27 July 2007. At that time, the first batch remediation had been completed and soil had been stockpiled. The second batch remediation was in process. I noted:

- Grids were marked out and raking and picking was being undertaken systematically
 - The soils were clays with clods, which make raking to the full depth difficult
 - The stockpile of remediated batch 1 material contained some brick, pieces of wood and plastic
 - Some pieces of fibro were noted in the scraped area where the stockpiles were originally located. (The validation report notes that these were later removed).
- My observations were consistent with the information presented in the validation report.

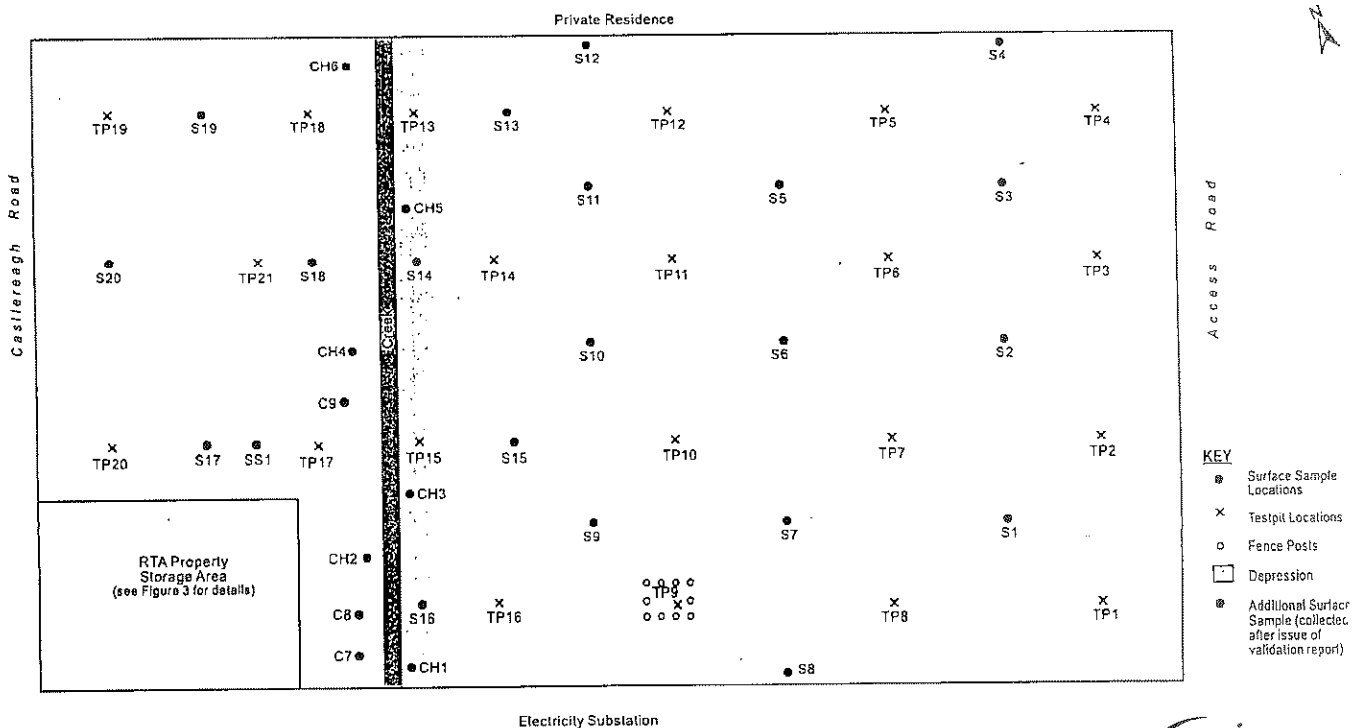
SAMPLING LOCATIONS

NPASD LOT 11

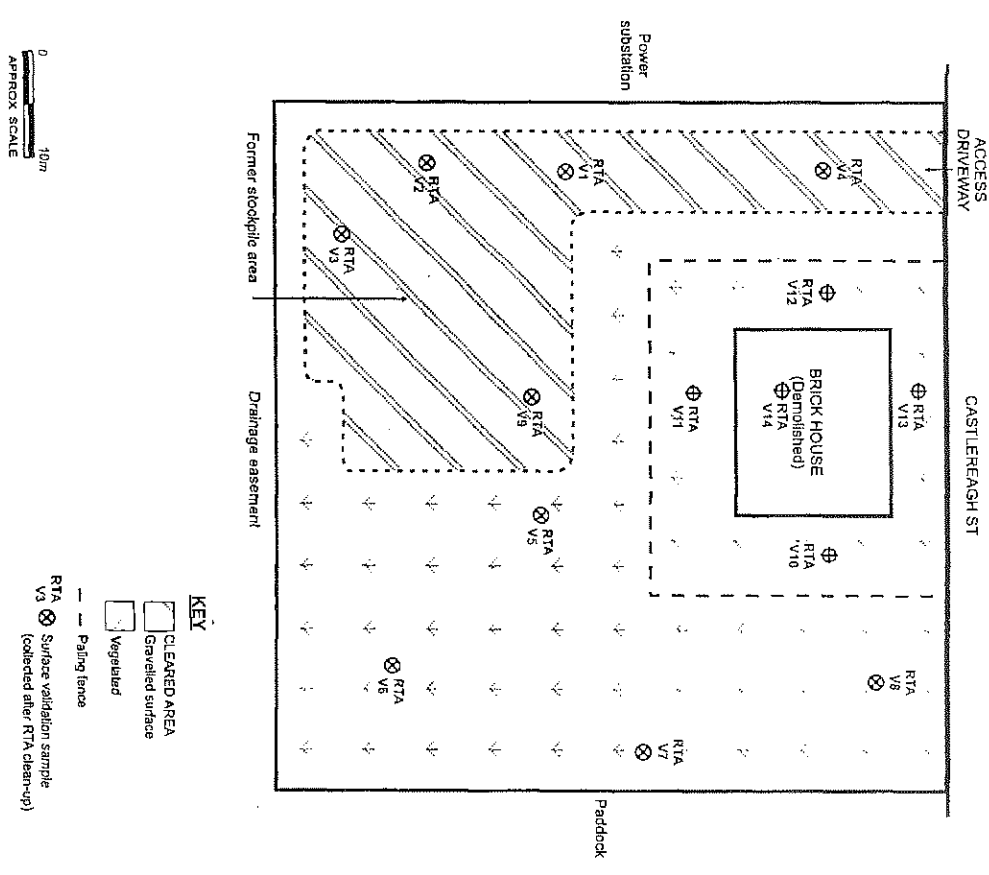
Figure 2

SITE LAYOUT AND VALIDATION SAMPLES

FORMER RTA COMPOUND (NPASD LOT 11)
