GEOTECHNICAL ASSESSMENT

PROPOSED MULTI-STOREY DEVELOPMENT

**1,1A & 5 AVON ROAD AND
4 & 8 BEECHWORTH ROAD, PYMBLE, NSW**

Ref: 23513Wrpt Rev1

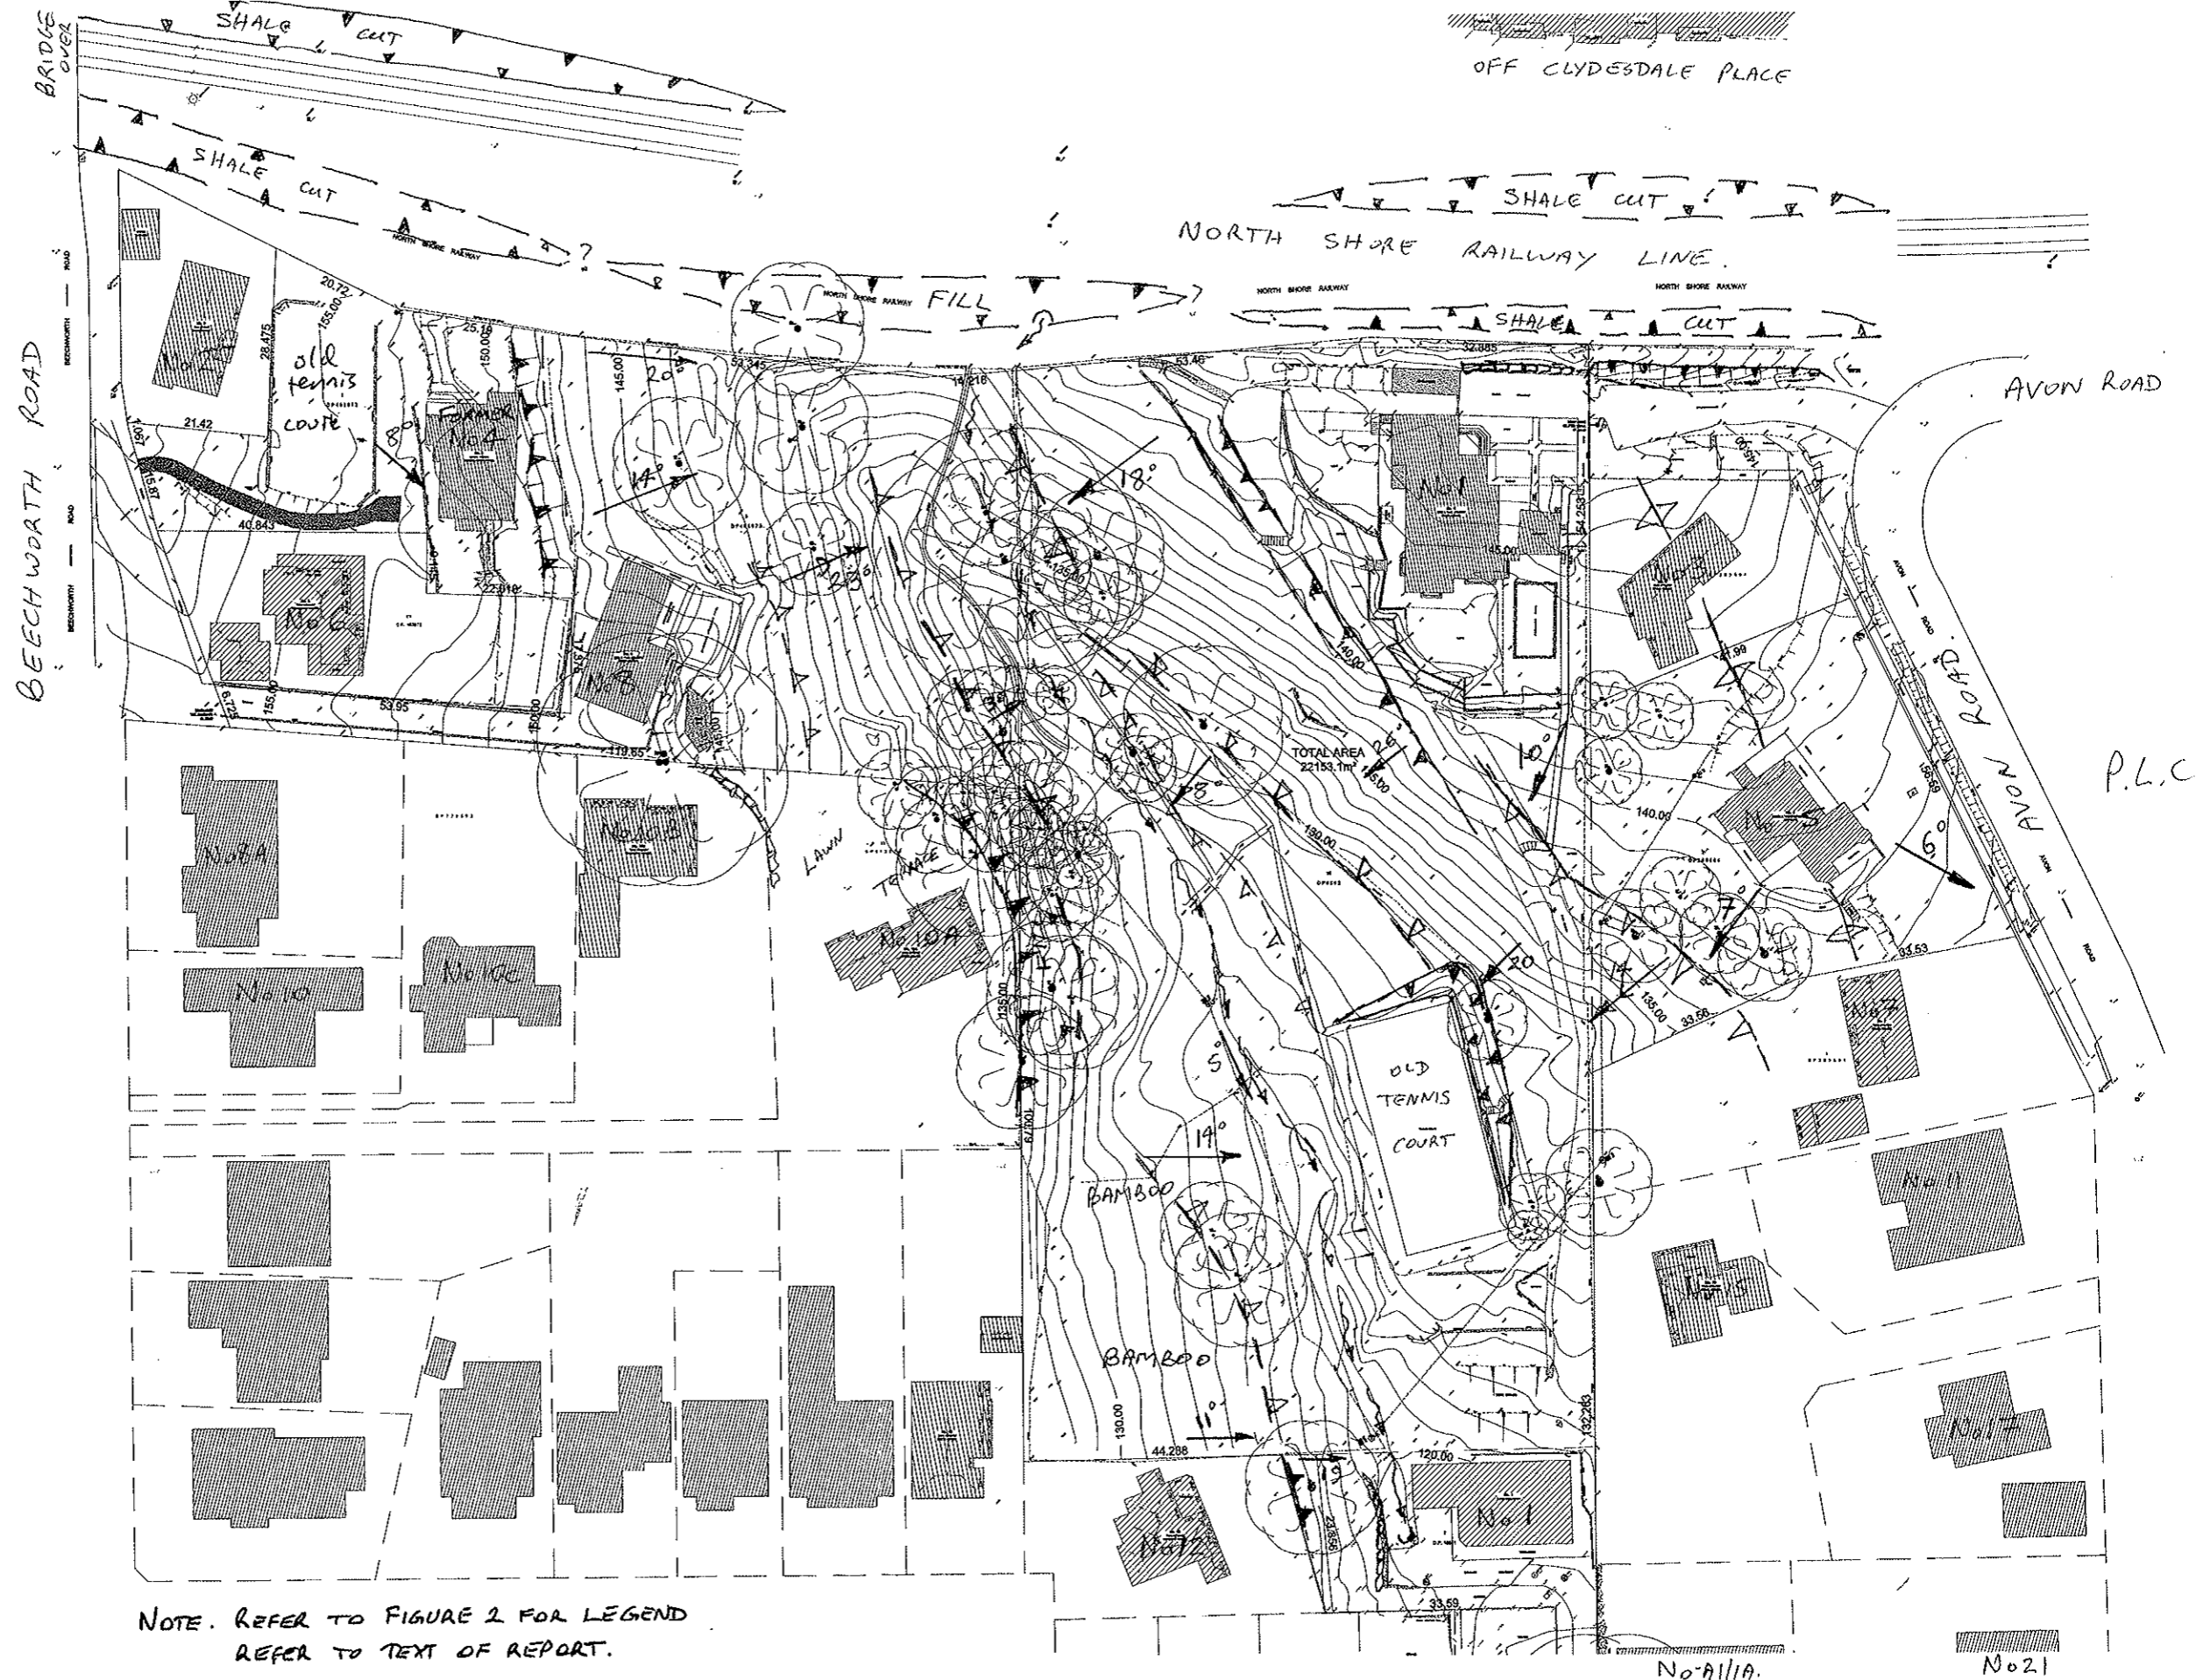
NOTE: FEATURES SHOWN
IN RAIL CORRIDOR
ARE ONLY VERY
APPROXIMATE FOR
LOCATION/EXTENT.

NOTE. REFER TO FIGURE 2 FOR LEGEND
REFER TO TEXT OF REPORT.

This report presents our geotechnical assessment of the proposed development site comprising the existing numbers 1, 1A and 5 Avon Road, and 4 and 8 Beechworth Road, Pymble, as shown on the attached Figure 1. The assessment was commissioned by Mr Jim Neale in response to our Proposal (Ref: P31535Wemail) dated 2 October 2009.

Existing residential dwellings are present on the lots around the perimeter of the development site, as indicated on Figure 1. The condition of these existing dwellings varies and localised cut and fill appears to have taken place during a past development.

The building on No 1 has not been examined for evidence of cracking. The area surrounding this dwelling has been extensively modified by past landscaping. Some of the landscaping features are shown on the survey plan (Figure 1). Sandstone block retaining walls are present around the terraced areas on the western side of the dwelling and, where visible, appeared to be in reasonable condition.

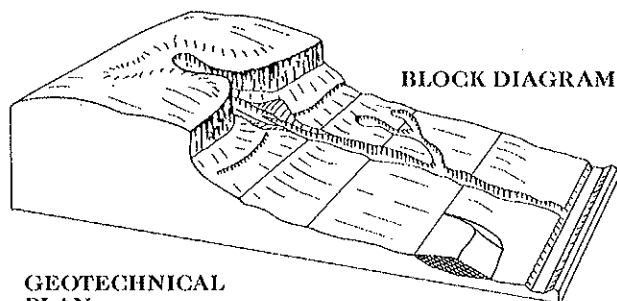
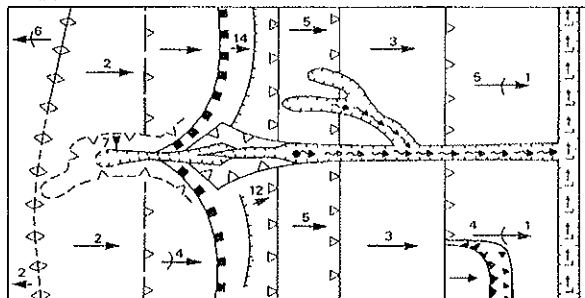
Report No. 23513W Figure No. 2

EXAMPLE OF USE OF TOPOGRAPHIC SYMBOLS:

GEOTECHNICAL PLAN

GEOTECHNICAL MAPPING SYMBOLS

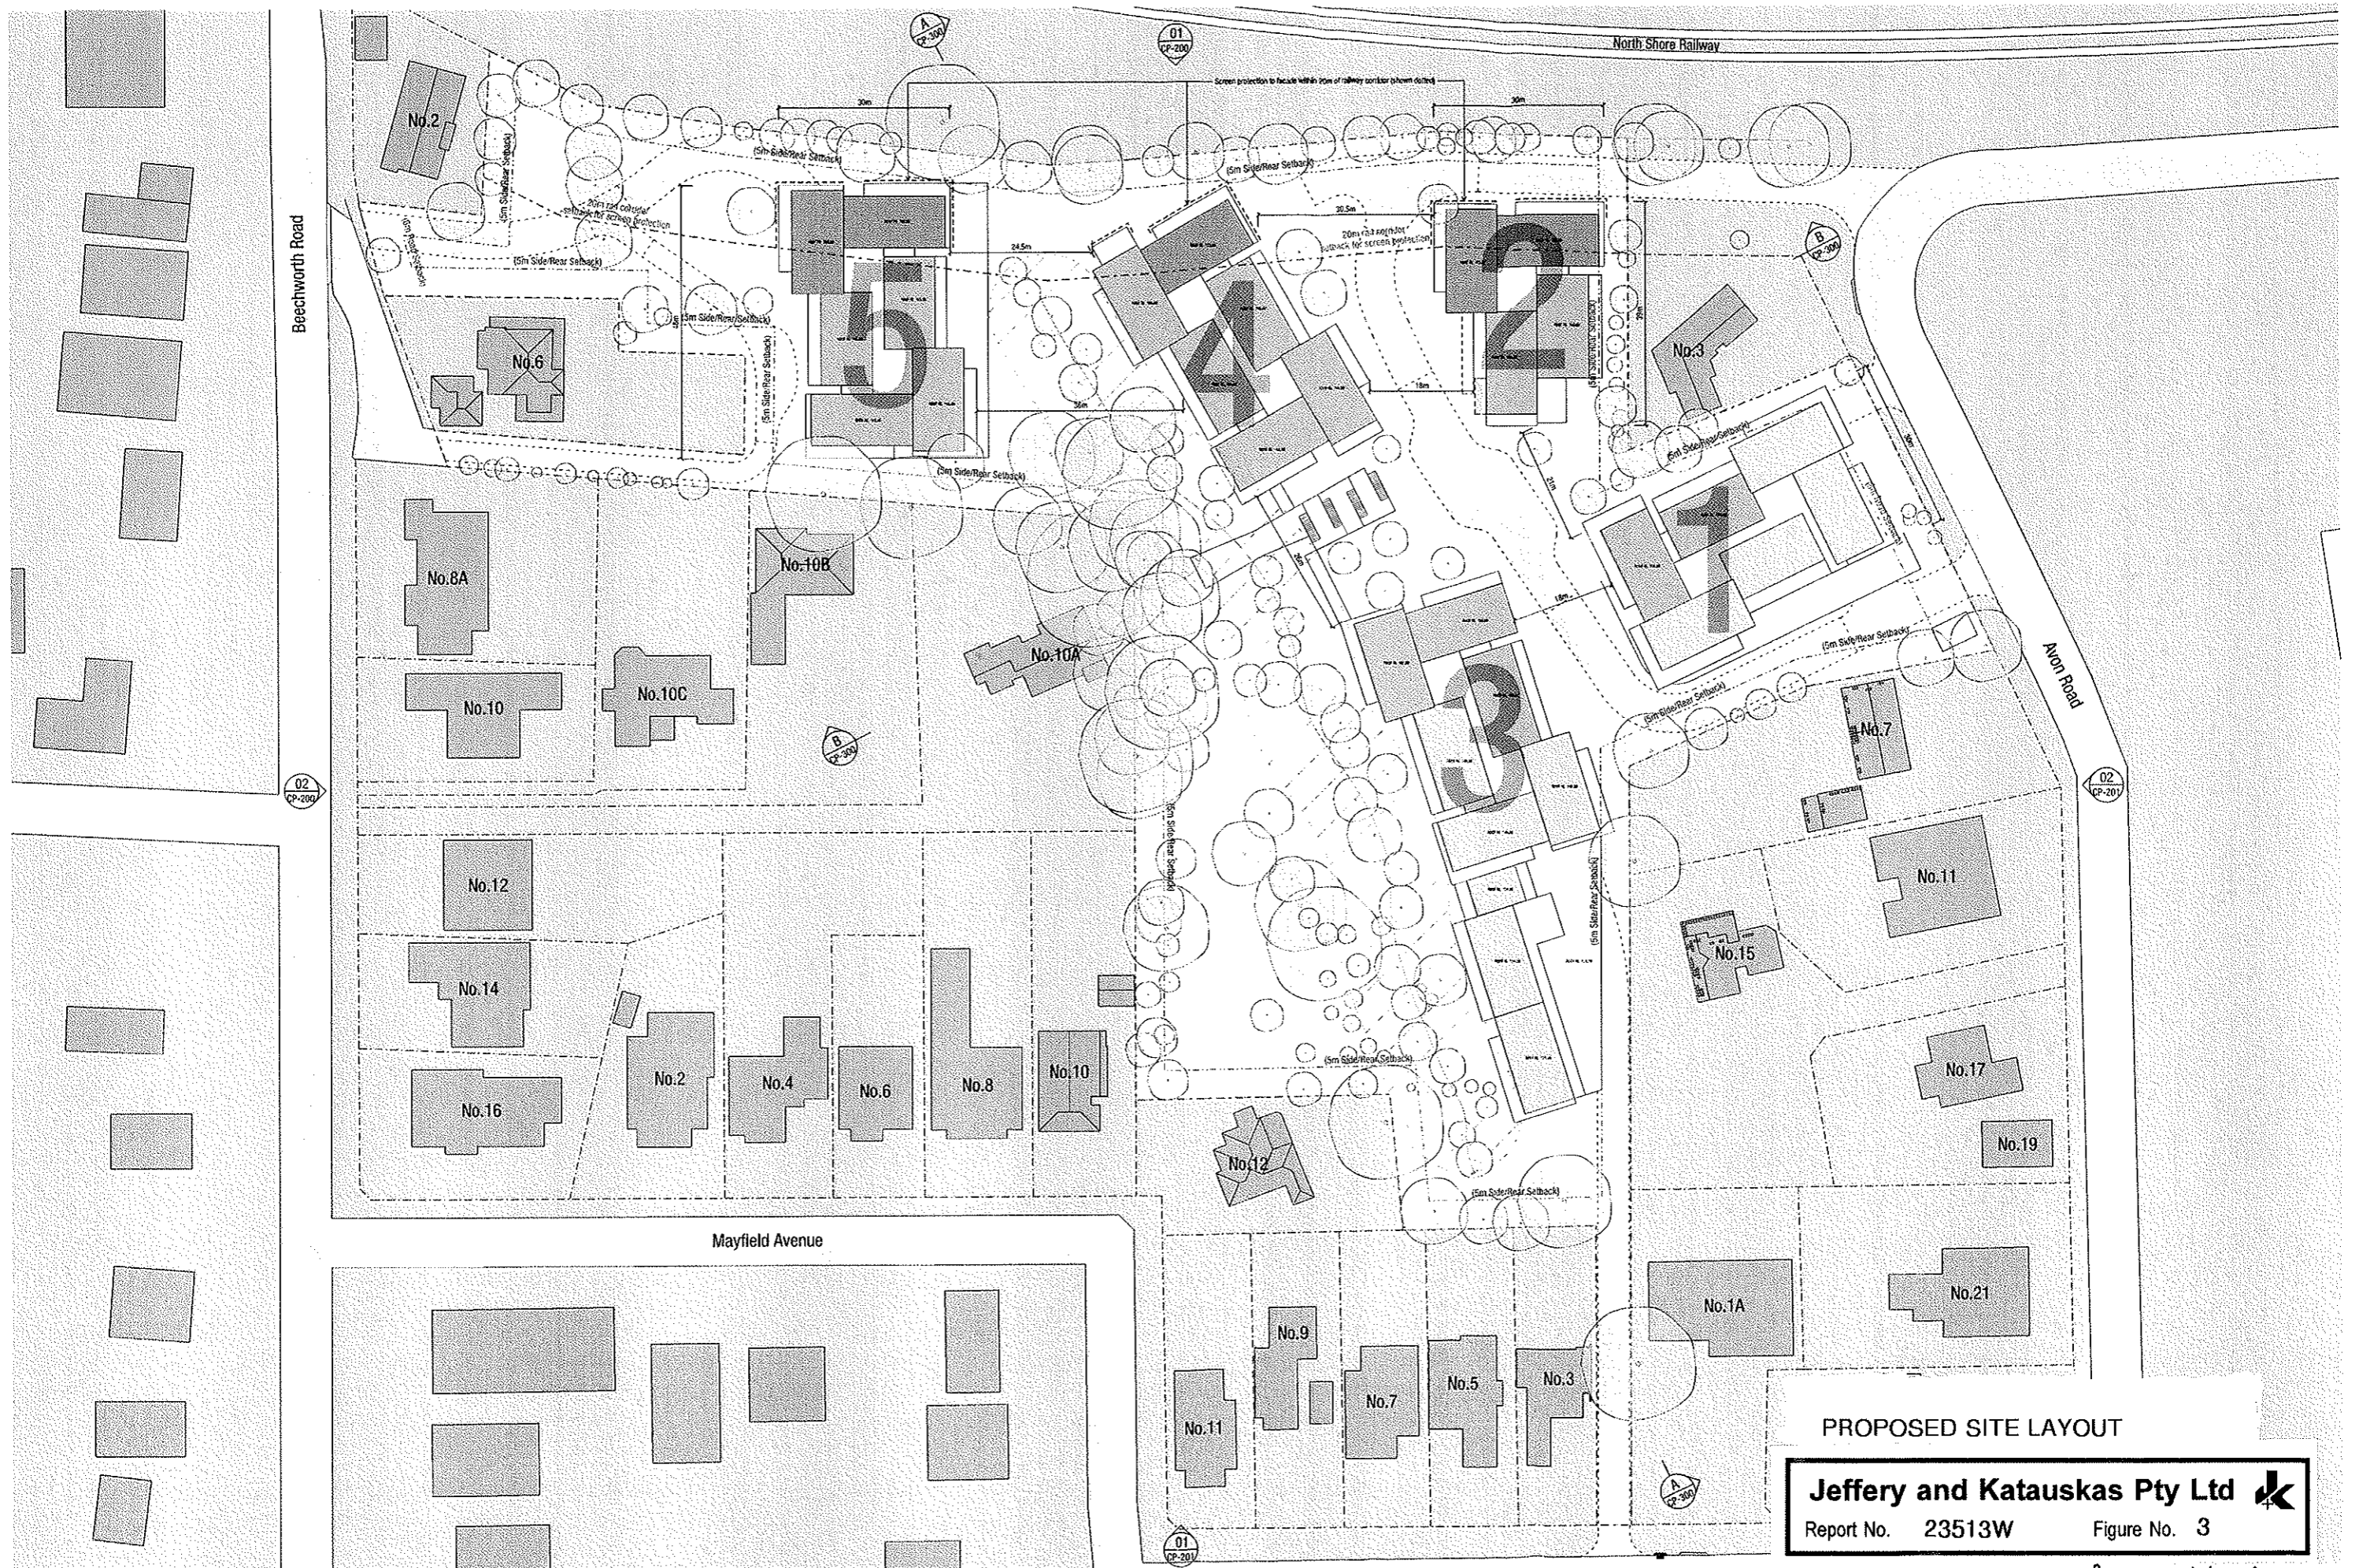
Jeffery and Katauskas Pty Ltd
 Report No. 23513W Figure No. 3

PROPOSED SITE LAYOUT

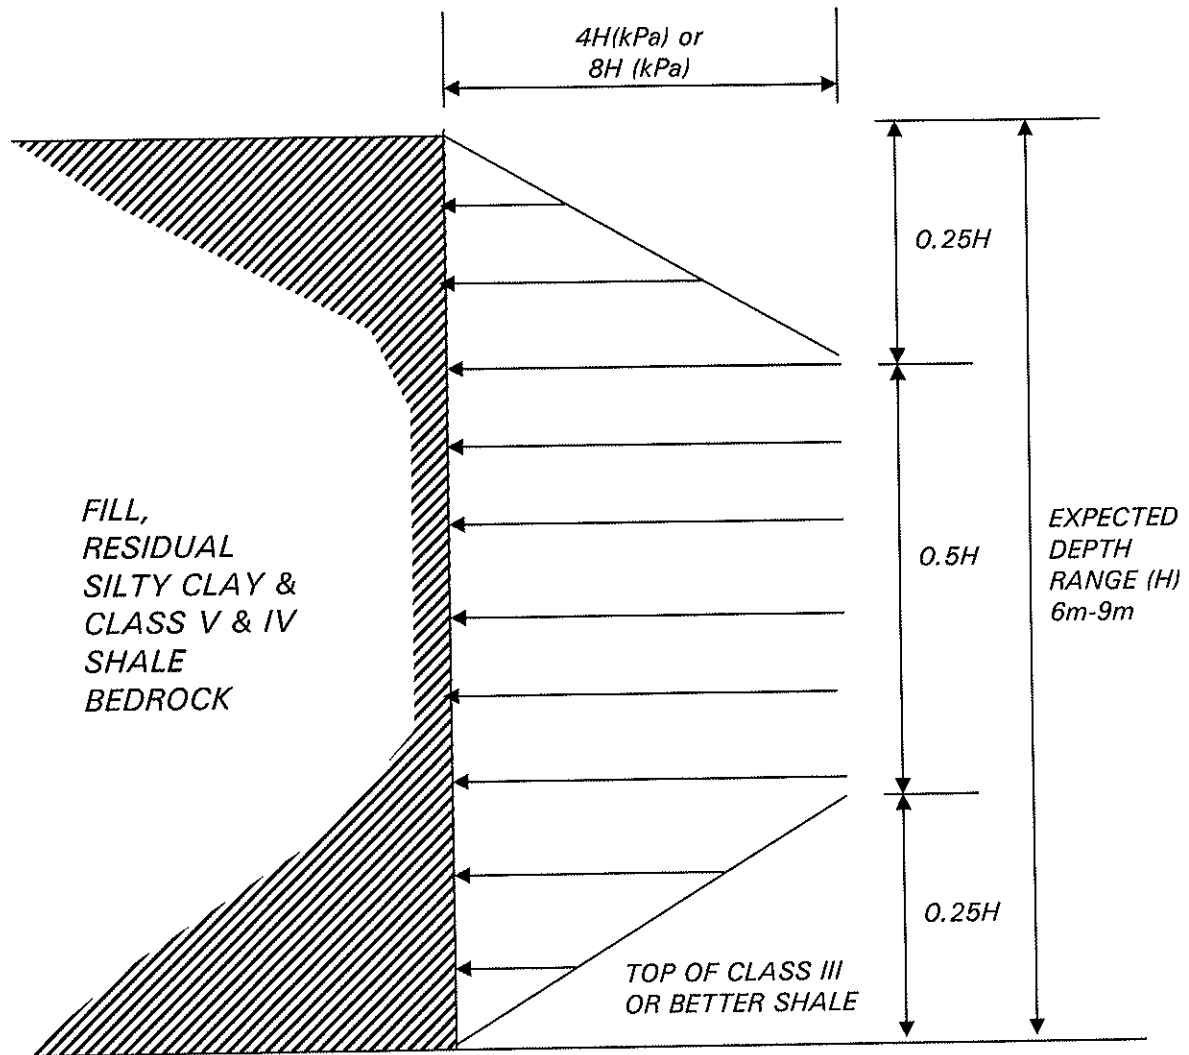
Report No. 23513W Figure No. 4

1. USE $4H$ WHERE THERE ARE NO MOVEMENT SENSITIVE STRUCTURES WITHIN $2H$ FROM THE LINE OF BASEMENT WALLS.
2. USE $8H$ WHERE THERE ARE MOVEMENT SENSITIVE STRUCTURES WITHIN $2H$ FROM THE LINE OF BASEMENT WALLS.
3. SURCHARGE AND GROUNDWATER PRESSURES MUST BE ADDED TO THE ABOVE IF APPLICABLE.
4. REFER TO TEXT OF REPORT

**RECOMMENDED PRELIMINARY DESIGN PRESSURES FOR
ANCHORED OR PROPPED RETAINING WALLS**

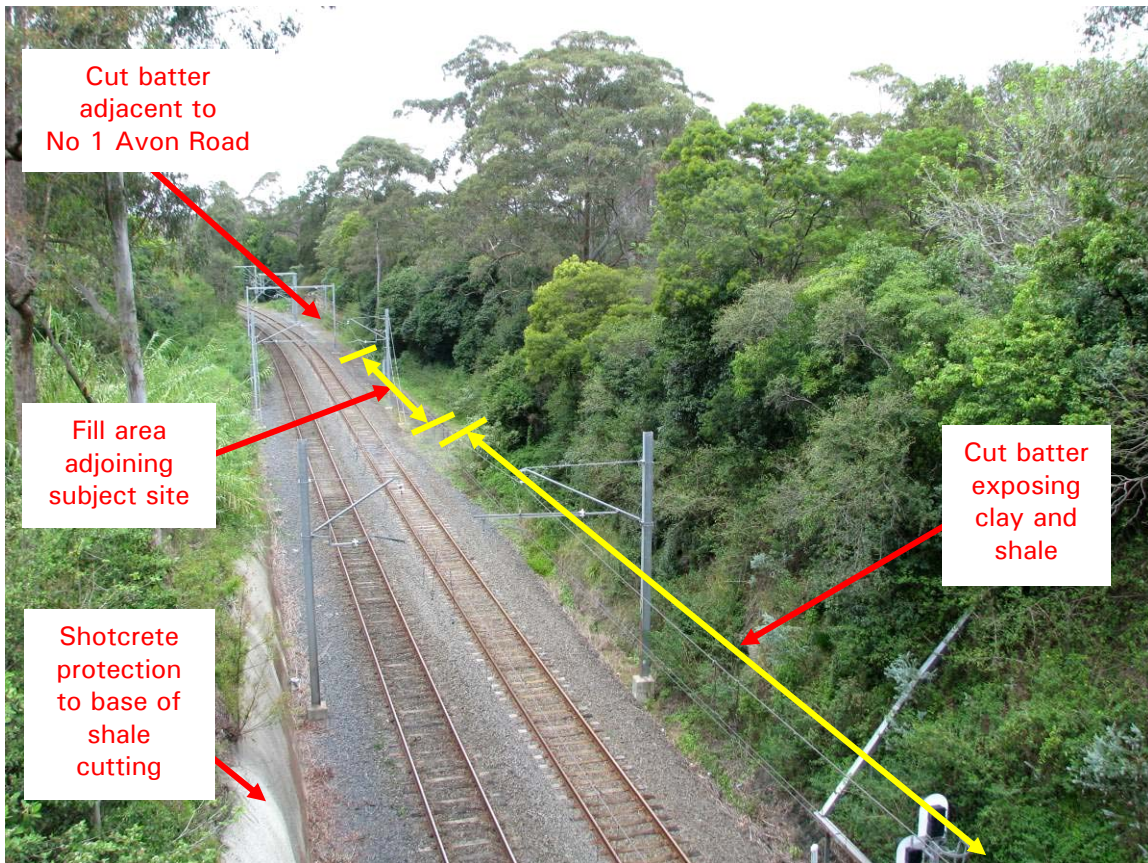
PHOTOGRAPH 1: View to south-east from Beechworth Road bridge along North Shore Railway line.

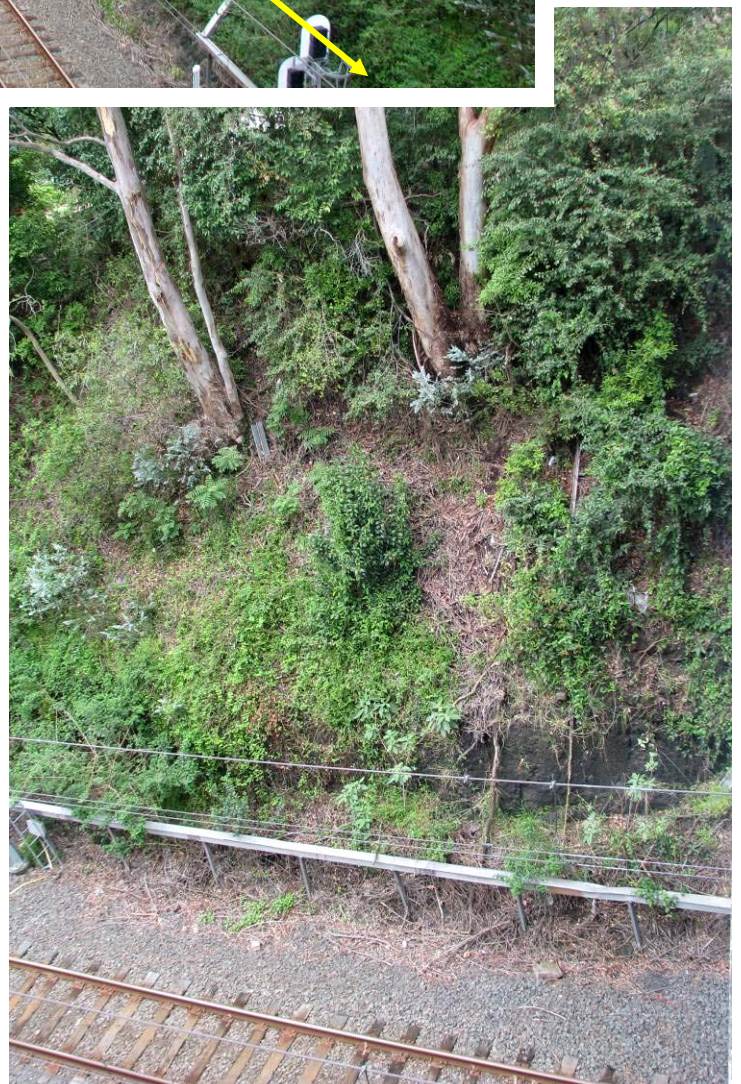
PHOTOGRAPH 2: View of cut batter on south-eastern side of Beechworth Road bridge, showing shale exposed at base of cutting.

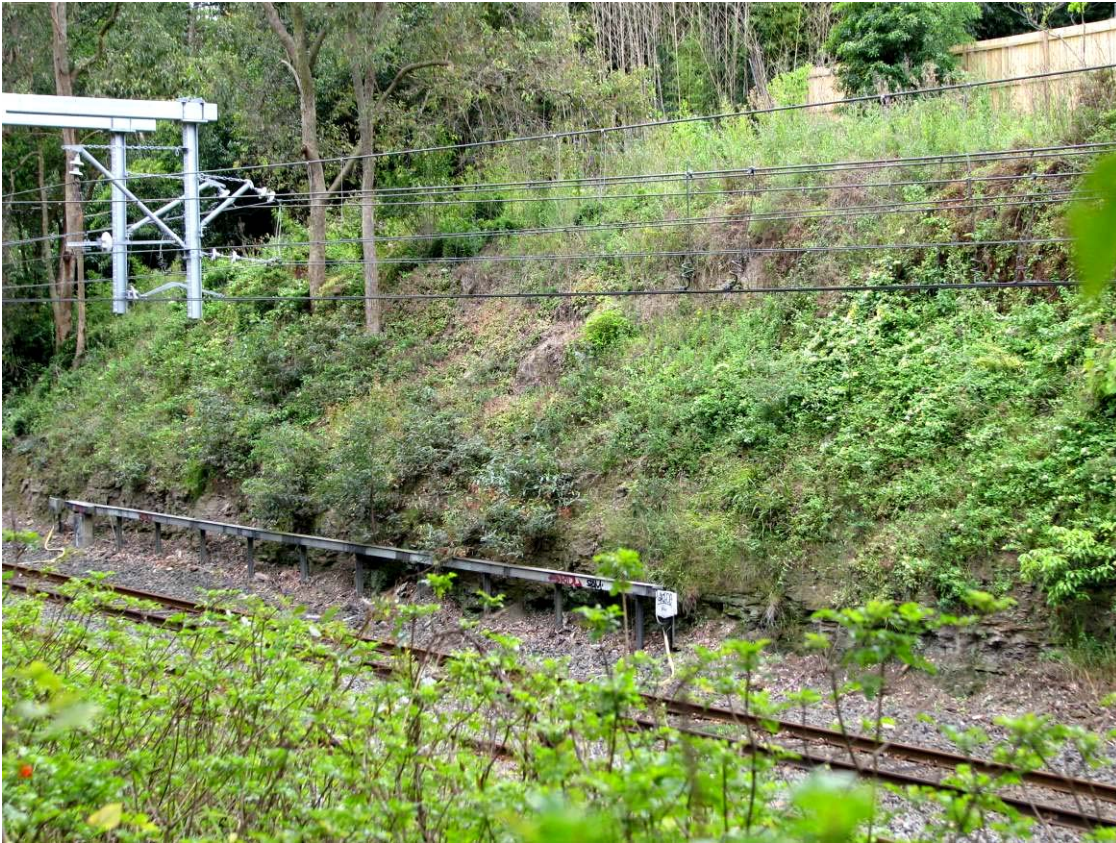
Shale bedrock was also exposed in the railway cutting adjacent to No 1 Avon Road, although the depth of cut was substantially less, being estimated at about 4m to 6m as seen in Photograph 3. The shale appeared to be of poorer quality, being more weathered and fragmented, and is similar to the upper shales at the Beechworth Road cut. The approximate extent of the two cuts is shown in Photograph 1. Between the two cuts, a fill embankment is present and could be observed from the site boundary with the rail corridor. The fill batter appeared to be of about 4m to 5m in overall height and was estimated to be at about 25° to 30° to the horizontal overall. However, the batter profile appeared to be locally steeper nearer the crest. The toe of the fill batter was set back about 3m to 5m (estimated) from the boundary fence marked by rail uprights.

PHOTOGRAPH 3: View of shale exposed in North Shore Railway line cutting on north-eastern side, adjacent to No 1 Avon Road.

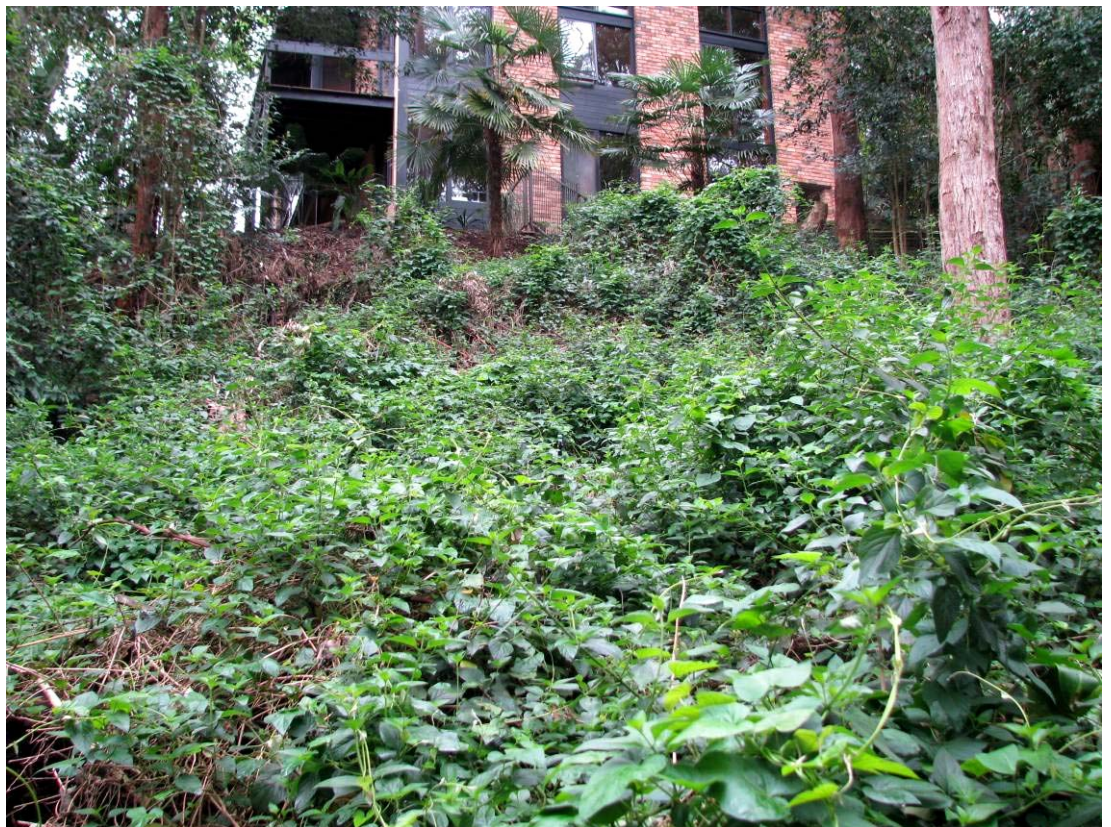
PHOTOGRAPH 4: Possible fill batter adjoining No 10A Beechworth Road.

The existing fill batter at the rail line is also considered to have a relatively low probability of failure based on its performance since construction in the 1890s. In addition, such embankments have generally remained stable along the North Shore Railway Line, with the exception noted above. Therefore, we anticipate that the annual probability of failure of this fill embankment would be about or less than 10^{-4} pa. At this stage, we have conservatively assessed a higher probability of instability of the apparent fill batter associated with No 10A. However, we note this batter is relatively minor and will not directly affect any of the proposed development.

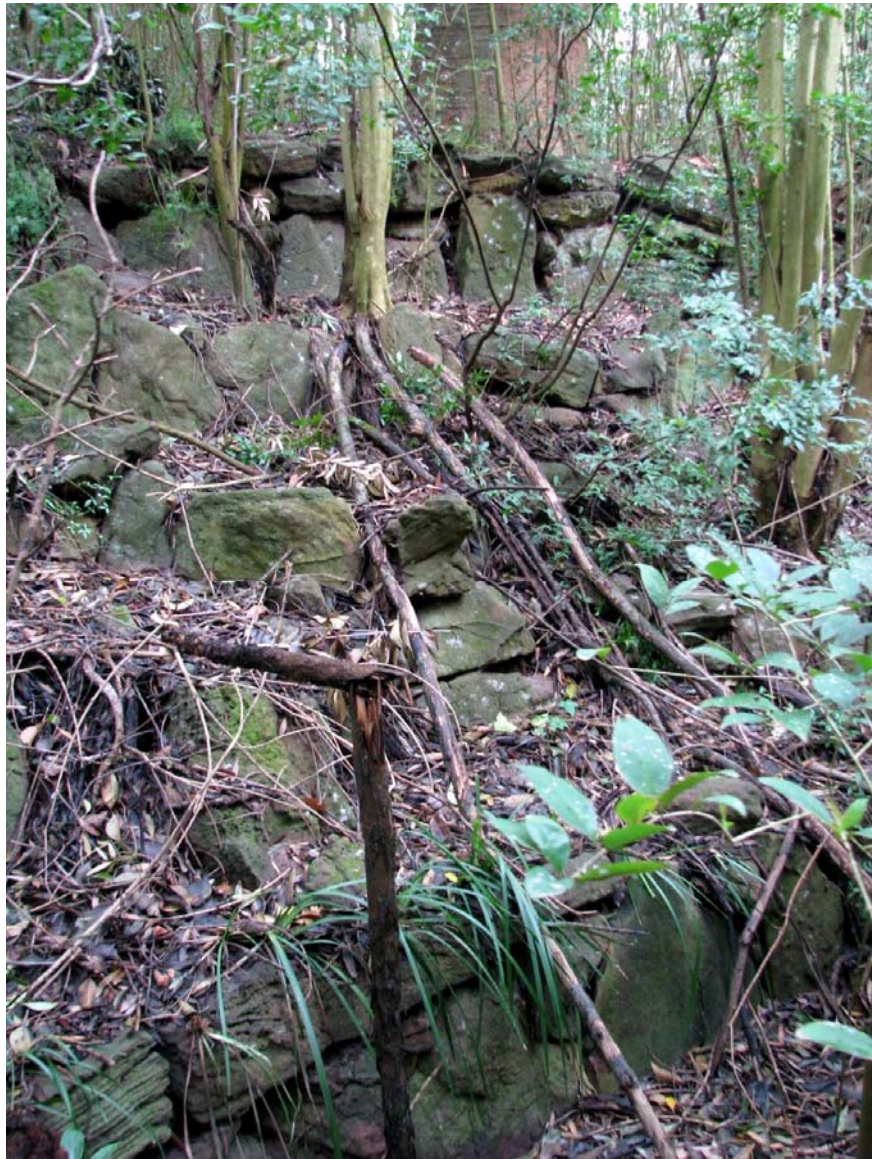
PHOTOGRAPH 5: view of terraced garden walls at north-eastern corner of the disused tennis court on No 1 Avon Road.

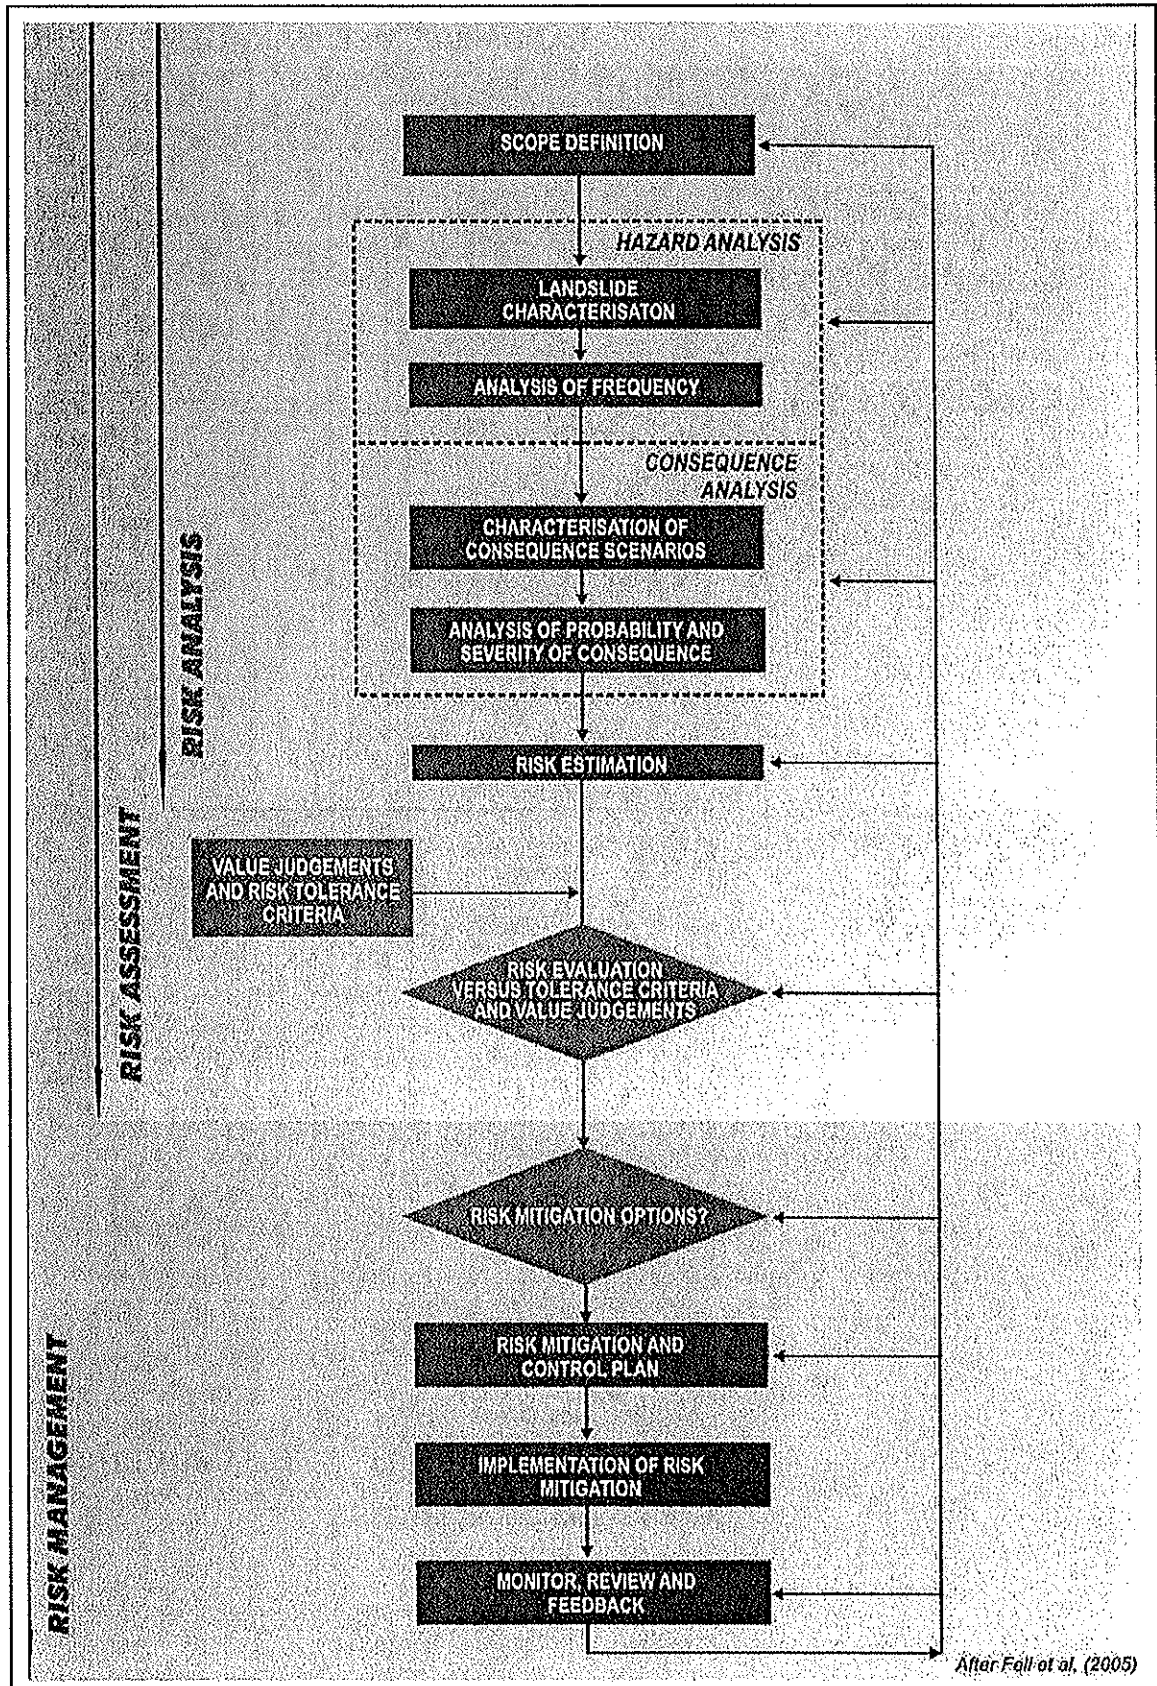
FIGURE A1: Flowchart for Landslide Risk Management.

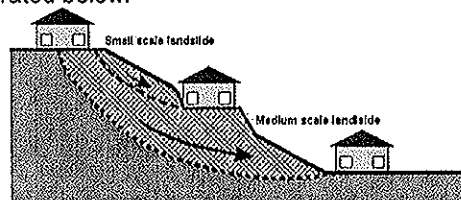
Figure 1

Rotational or circular slip failures (Figure 1) - can occur on moderate to very steep soil and weathered rock slopes (Table 1). The sliding surface of the moving mass tends to be deep seated. Tension cracks may open at the top of the slope and bulging may occur at the toe. The ground may move in discrete "steps" separated by long periods without movement. More rapid movement may occur after heavy rain.

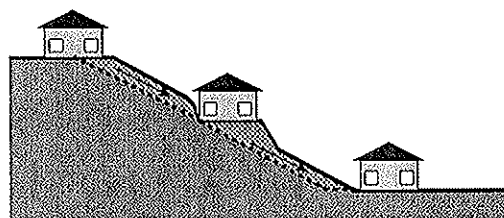
Figure 2

Translational slip failures (Figure 2) - tend to occur on moderate to very steep slopes (Table 1) where soil, or weak rock, overlies stronger strata. The sliding mass is often relatively shallow. It can move, or deform slowly (creep) over long periods of time. Extensive linear cracks and hummocks sometimes form along the contours. The sliding mass may accelerate after heavy rain.

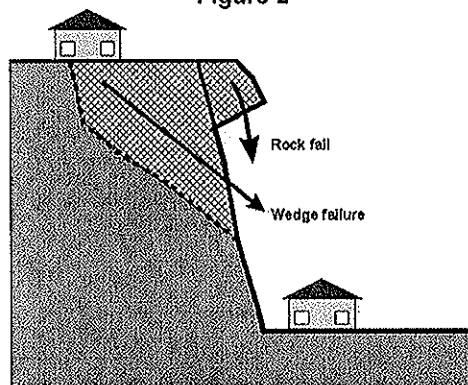
Figure 3

Wedge failures (Figure 3) - normally only occur on extreme slopes, or cliffs (Table 1), where discontinuities in the rock are inclined steeply downwards out of the face.

Rock falls (Figure 3) - tend to occur from cliffs and overhangs (Table 1).

Cliffs may remain, apparently unchanged, for hundreds of years. Collections of boulders at the foot of a cliff may indicate that rock falls are ongoing. Wedge failures and rock falls do not "creep". Familiarity with a particular local situation can instill a false sense of security since failure, when it occurs, is usually sudden and catastrophic.

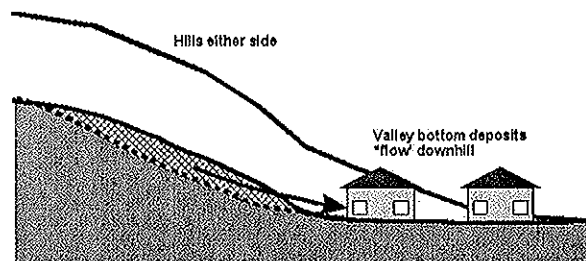
Figure 4

Debris flows and mud slides (Figure 4) - may occur in the foothills of ranges, where erosion has formed valleys which slope down to the plains below. The valley bottoms are often lined with loose eroded material (debris) which can "flow" if it becomes saturated during and after heavy rain. Debris flows are likely to occur with little warning; they travel a long way and often involve large volumes of soil. The consequences can be devastating.

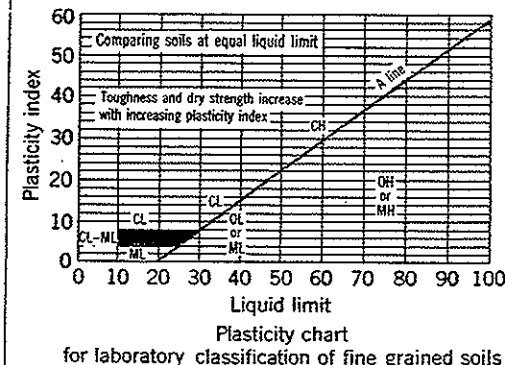
Plasticity chart for laboratory classification of fine grained soils

Use grain size curve in identifying the fractions as given under field identification
