### **OAKLANDS ETHANOL SITE**

# PRELIMINARY GEOTECHNICAL INVESTIGATION

### FOR SWAN HILL ETHANOL PTY LTD

GTS Report Number 06/4325 December 2006

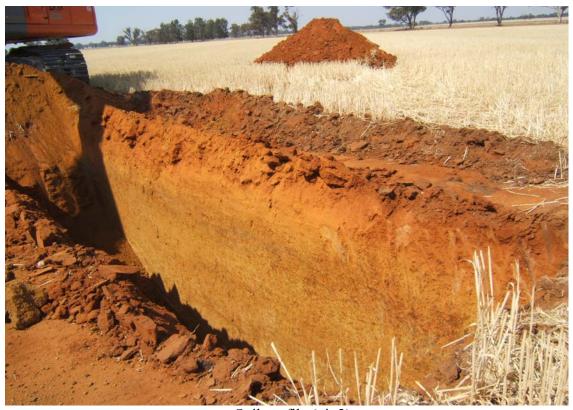
Soil profile (pit 2)

The property has experience unprecedented drought conditions in recent years, and subsequently the site was incredibly dry. The site is typical of grain growing land, and a slight fall to the rear of the property with a good coverage of dry grasses. The land is relevantly clear with a few large trees present. Several photos of the area were taken during the investigation, some of which highlight the aforementioned topographical features (Page A3-A4), namely

- Soil profile of pit 2
- General landscape (facing south- east)
- The excavation of pit 2
- Brooks grain silos (facing east)

The soil profile observed in the wall of each test pit was found to be relatively consistent, namely

• 0-200mm Sandy silty top soil, grey/ brown

• 200-600mm Clayey Sand, brown/ orange, low plasticity

• 600-3500mm Sandy clay, pale brown/yellow, low/ medium plasticity

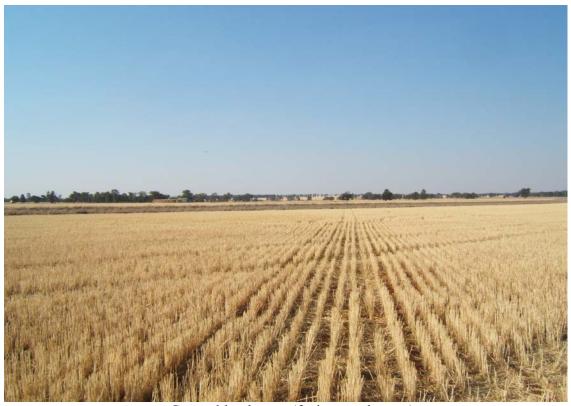
General landscape (facing south- east)

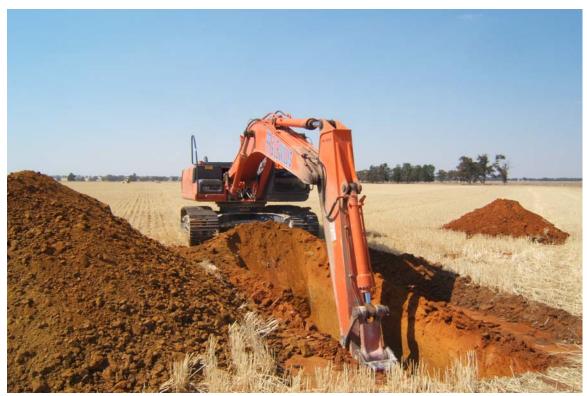
Excavator (pit 2)

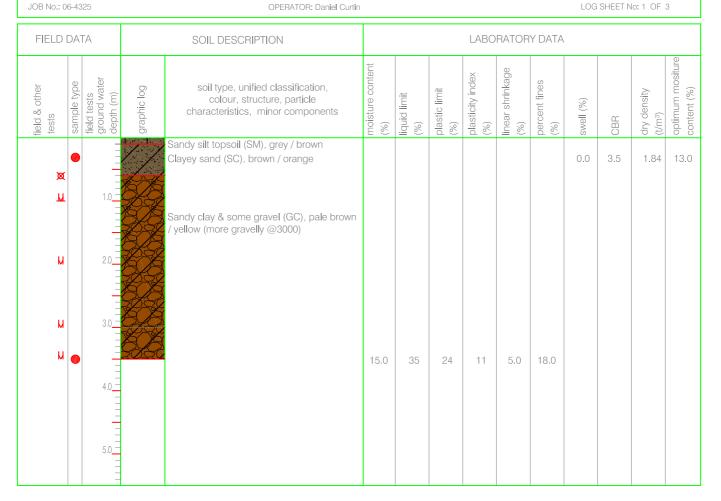
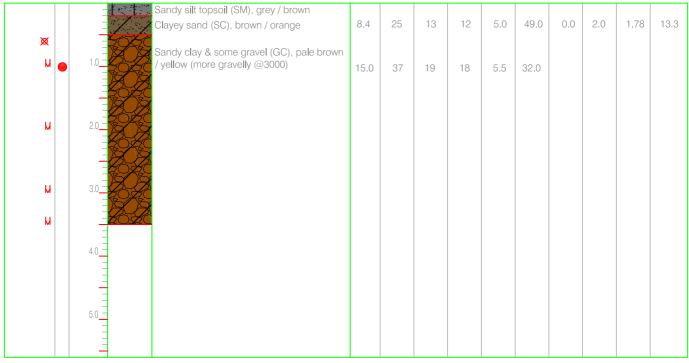
#### TEST PITS No: 1 & 2

METHOD: Test Pits- 20T Exacavator OPERATOR: Daniel Curtin

LOG SHEET No: 1 OF 3

During the excavation of all 6 test pits no ground water was encountered. Soil profile logs can be seen in pages A5-A7.

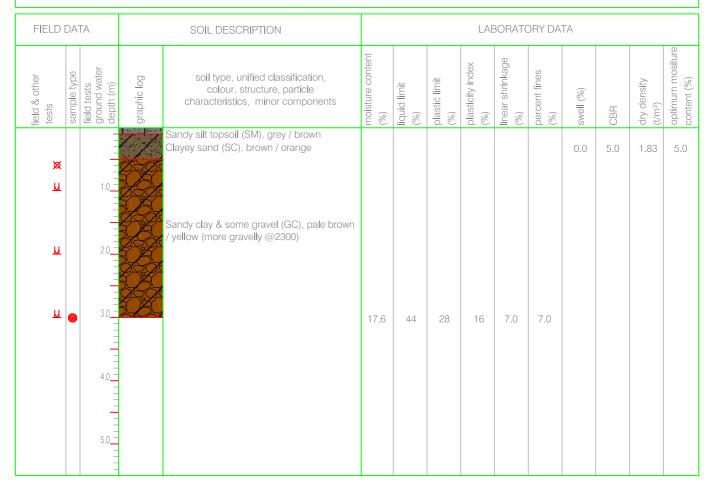
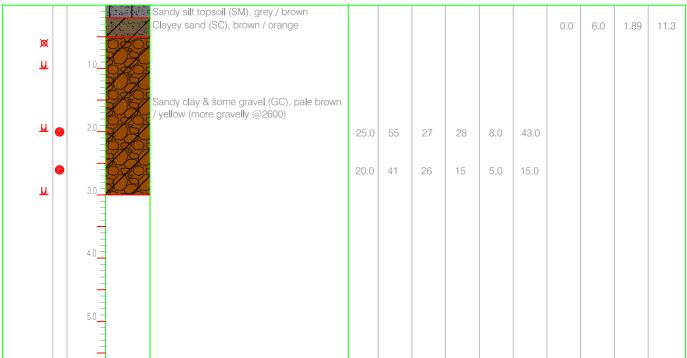
### TEST PITS No: 3 & 4

METHOD: Test Pits- 20T Exacavator OPERATOR: Daniel Curtin

LOG SHEET No: 2 OF 3

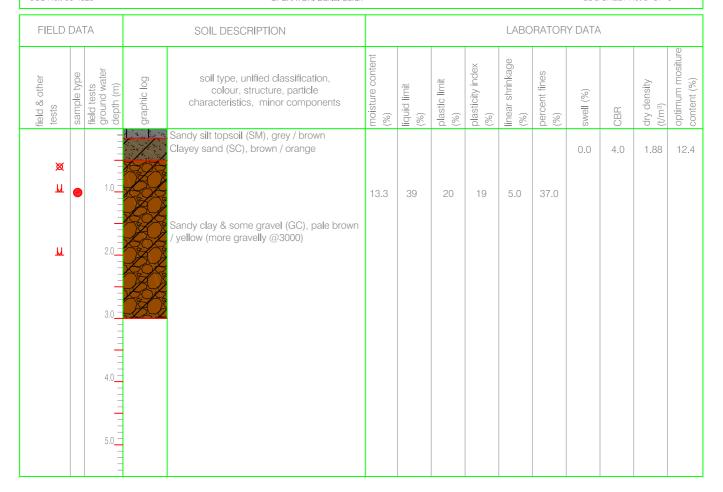
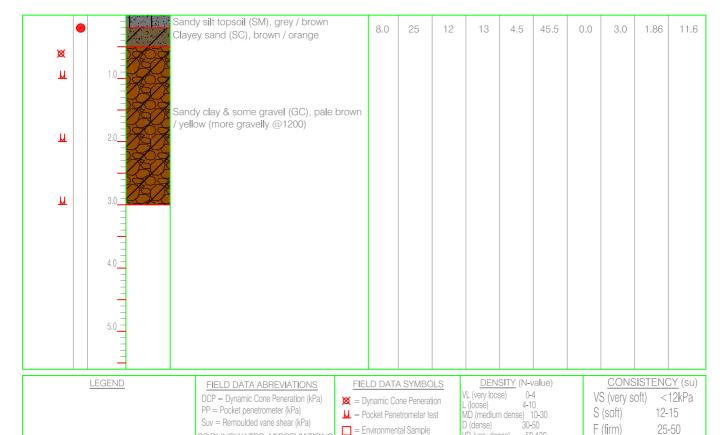
#### TEST PITS No: 5 & 6

METHOD: Test Pits- 20T Exacavator OPERATOR: Daniel Curtin

LOG SHEET No: 3 OF 3
