**STAGE 1 ENVIRONMENTAL SITE ASSESSMENT:  
CITY ONE SITE, GEORGE AND YORK STREETS, SYDNEY NSW  
PREPARED FOR THAKRAL HOLDINGS LIMITED**

REPORT ID: CES100908-THL-01-F

**Date:** 8 October 2010

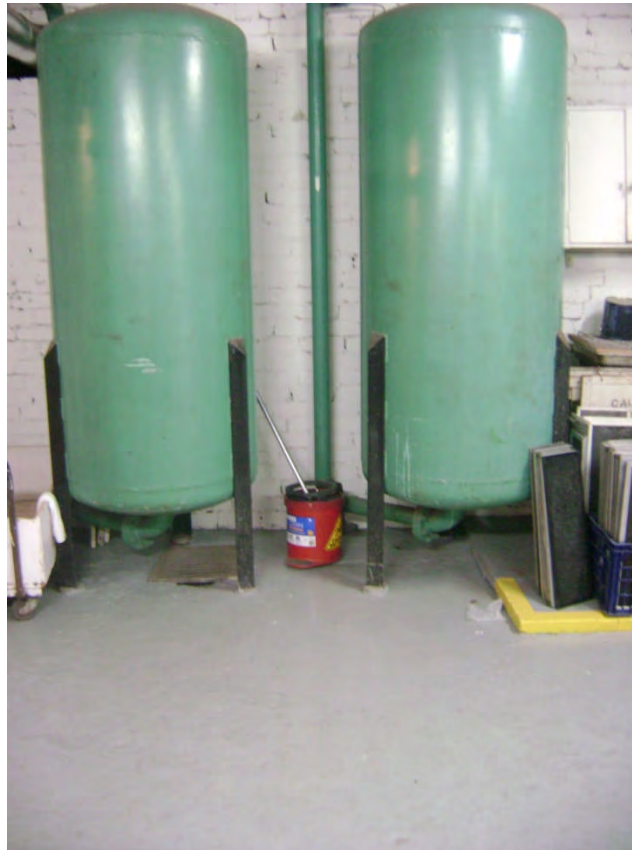
**Photograph 1 – Pressure Tanks**

A total of 6 above ground (two pressure, two boiler and one cooler) tanks and associated services were observed on the basement levels of the Menzies Hotel. Examples of these are provided in Photographs 1 through 6 in Appendix D. During the time of the inspection no visible leaks or evidence of staining was observed. CES was informed by Anura Yapa JP (Chief Engineer of The Menzies Sydney), that all tanks and motors were serviced regularly with maintenance conducted monthly. CES believe that these tanks have not contributed to contamination at the site and thus present a low risk to human health and the environment. It is anticipated that during the demolition of the Menzies hotel, these tanks and associated motors will be decommissioned. CES recommend great care be taken in dismantling all unit as to avoid any spills of water/oil mix and all contaminated equipment be disposed of by an appropriate waste disposal/recycling facility. No underground tanks were identified during the Stage 1 investigation.

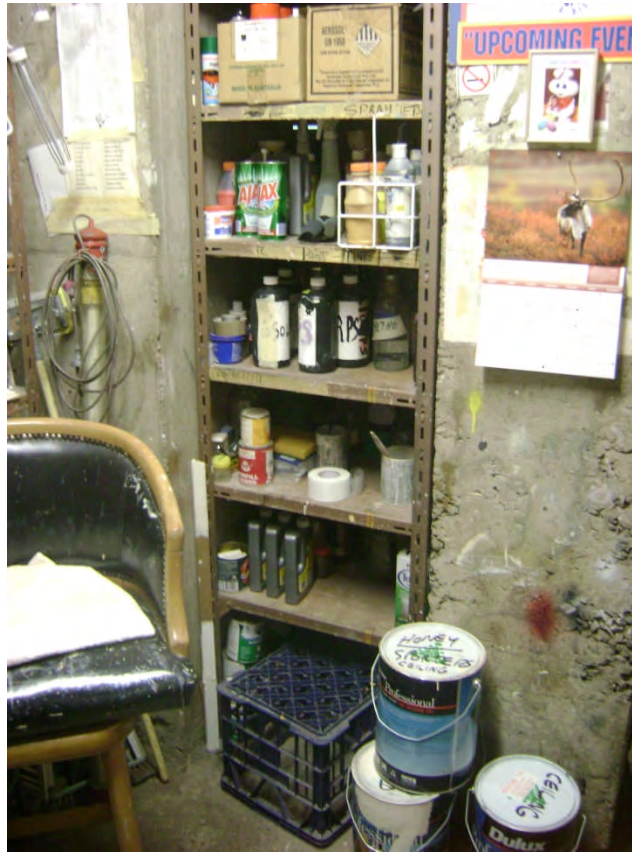
**Photograph 7 – Paint Storeroom**

A paint storage room was observed on the basement level of the Menzies Hotel. At the time of the inspection the room contained various paints, oils and cleaning chemicals (see photograph 7). The floor had evidence of minor paint staining (see photograph 8). CES believe that due to the small amount of chemicals stored in this room and the minor nature of the staining, the storage of paints, oils and cleaning chemicals has not contributed to contamination and thus present a low risk to human health and the environment.

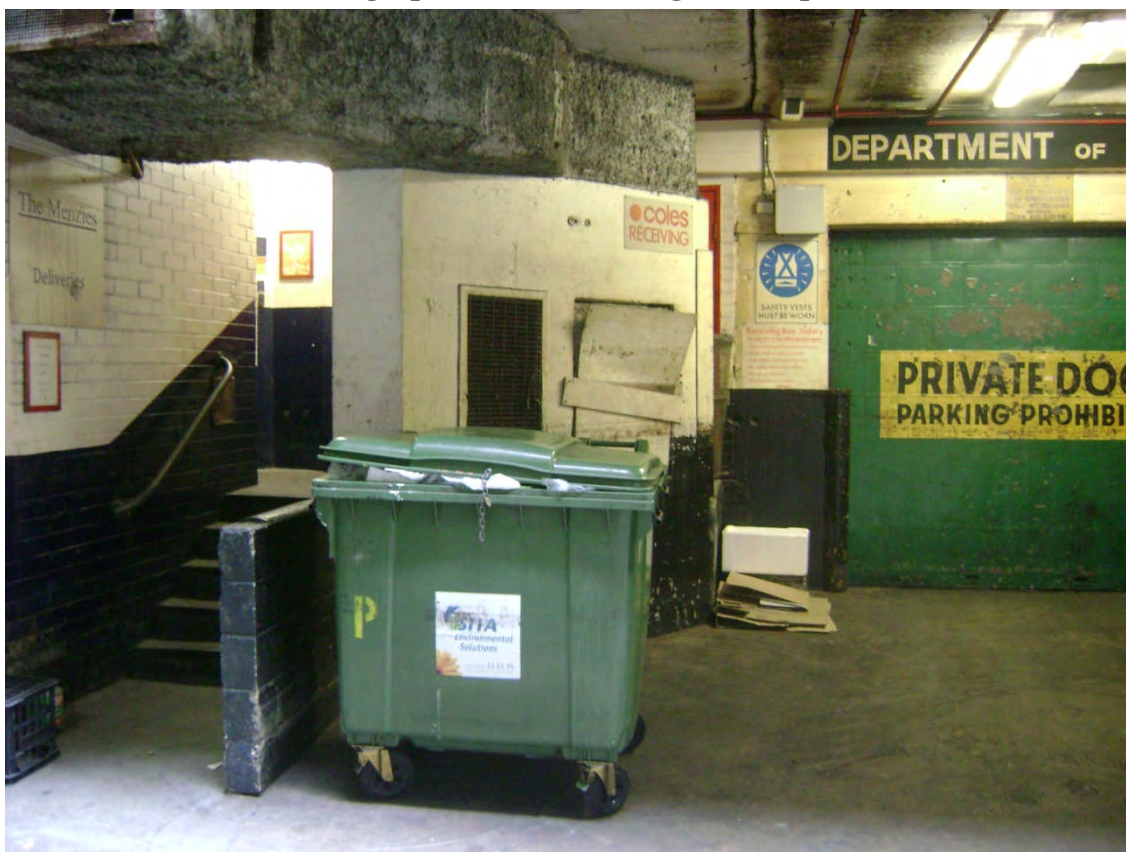
**Photograph 9 – Waste Storage (Example)**

The only waste that was observed to be generated at this facility was general waste. An example of the storage conditions can be seen in Photograph 9. All waste receptacles were stored in an acceptable manner and were not contributing to site contamination.

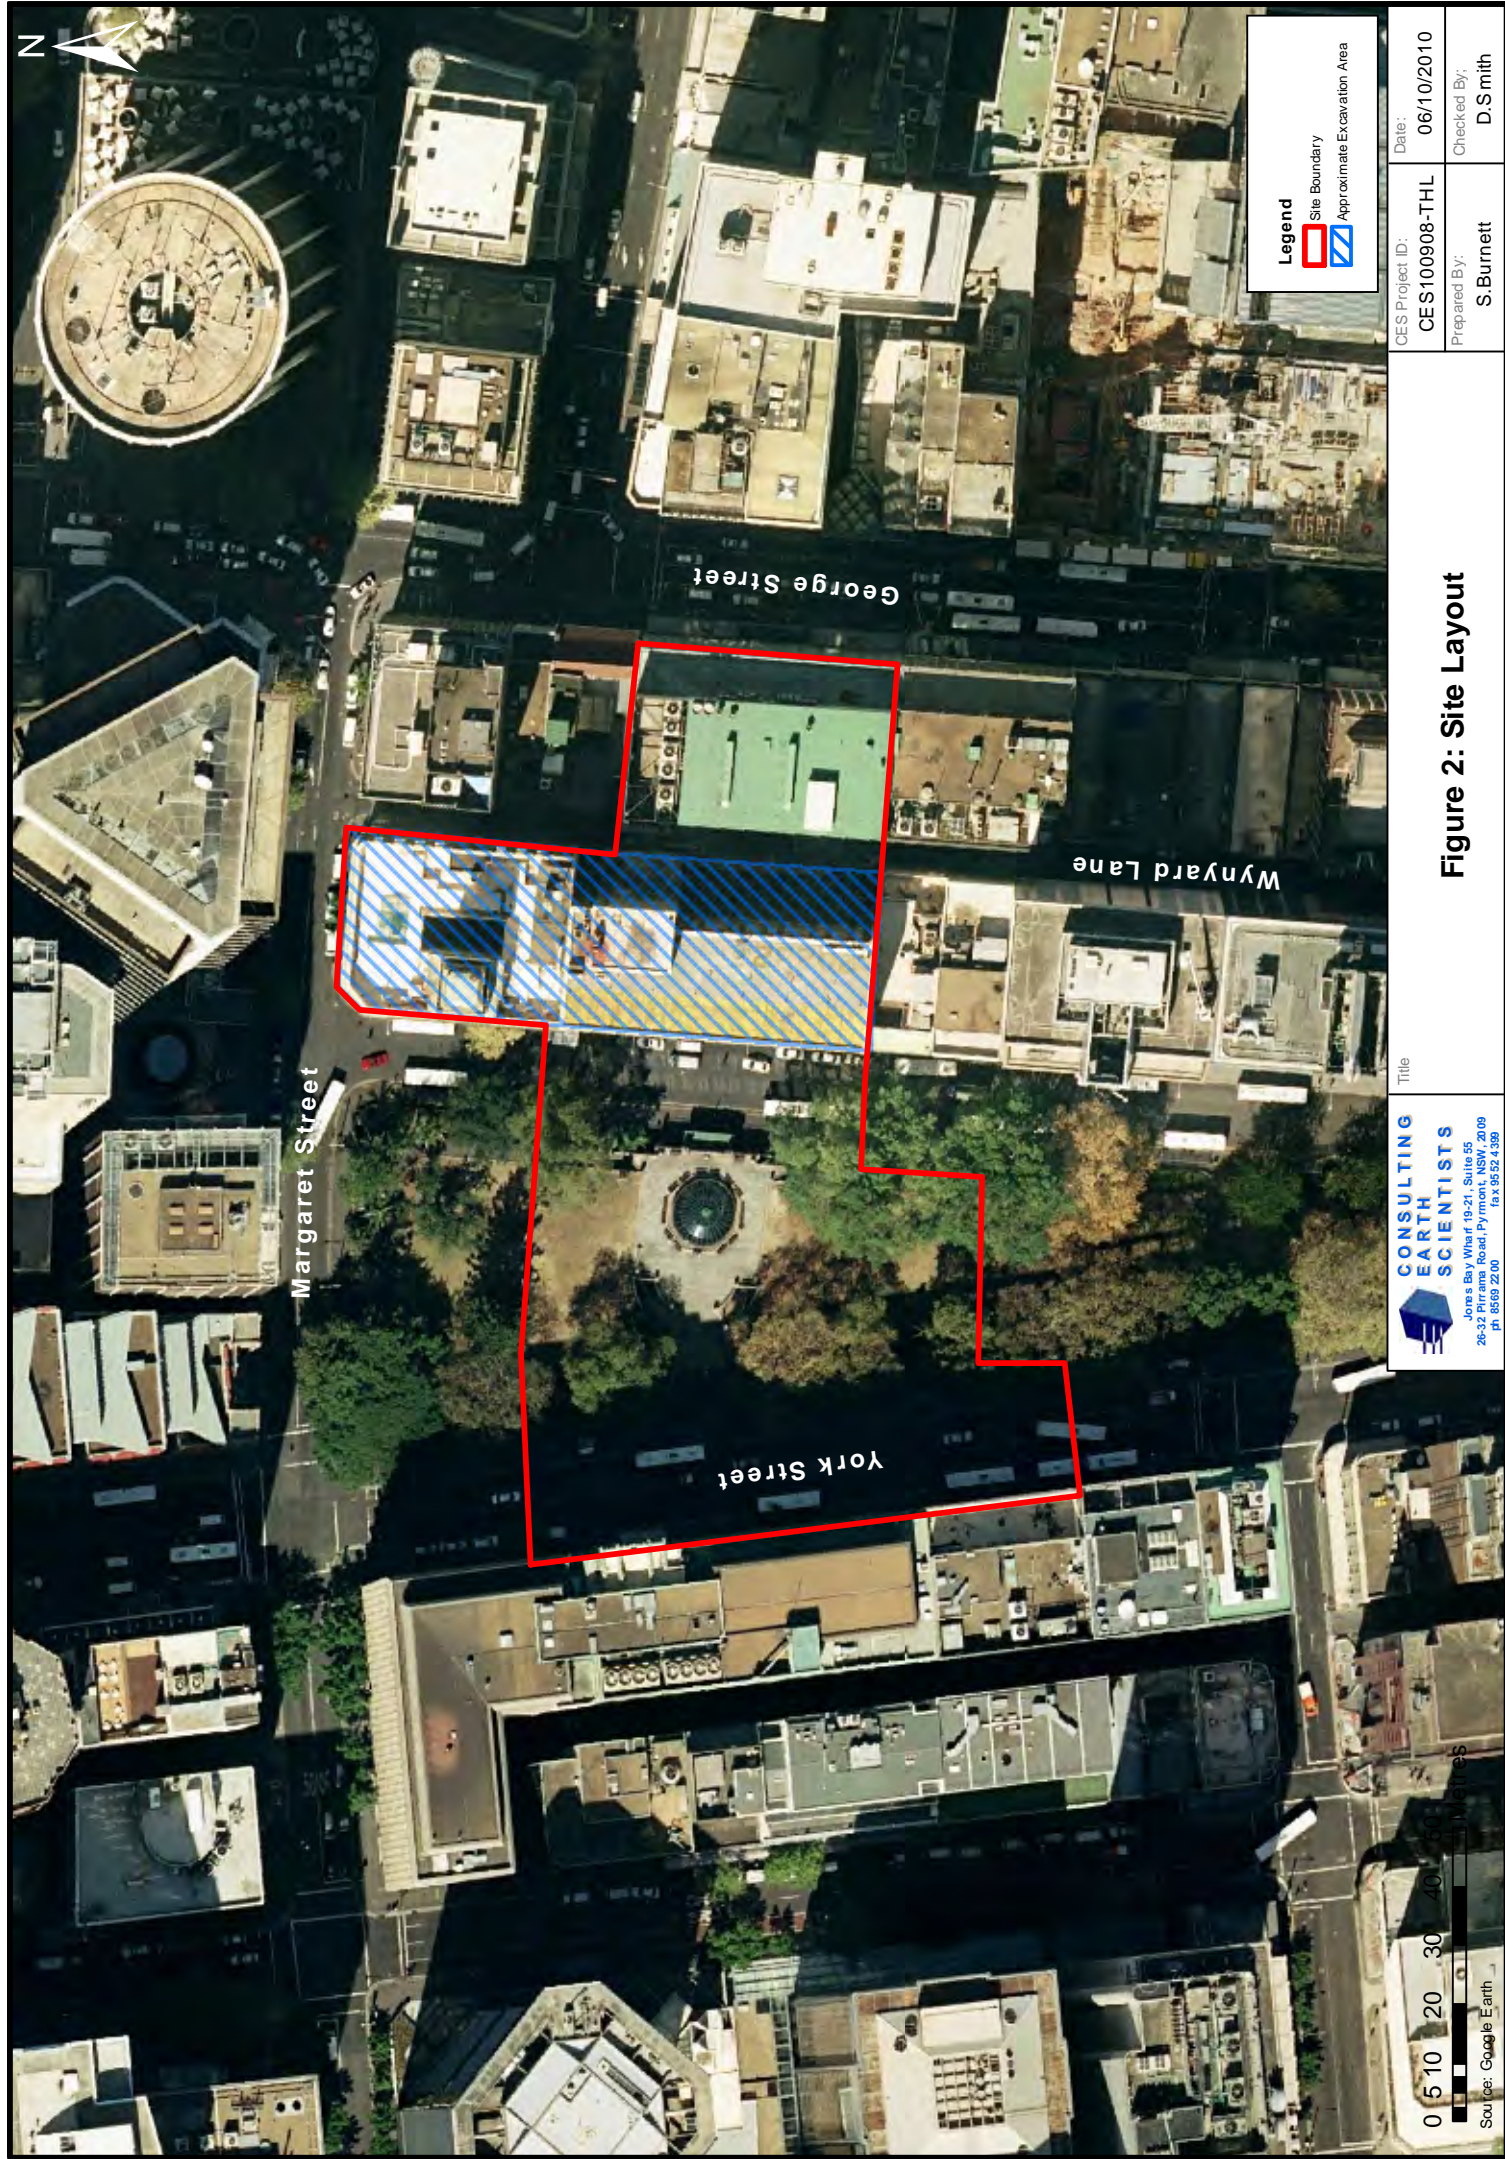
**Figure 2: Site Layout**

The site is located between George and York streets, Sydney NSW, 2000. The site location is shown on Figure 1 and the site layout is presented on Figure 2. The site is legally described as Lot 10 in Deposited Plan 595978, Lot 1 in Deposited Plan 853331, Lot 2 in Deposited Plan 853331, Lot 4 in Deposited Plan 853331, Lot 5 in Deposited Plan 853331, Lot 6 in Deposited Plan 853331 and Rail Plan 1024-41-781 and is part of the Local Government Area (LGA) of Sydney City Council with a size of approximately 11.1 hectares.
