***APPENDIX A***  
***Drawings 1 – 5***  
***Notes Relating to this Report***

***APPENDIX B***  
***Aerial Photographic Plates***

**Table C1 – Observations of Sandstone outcrops**

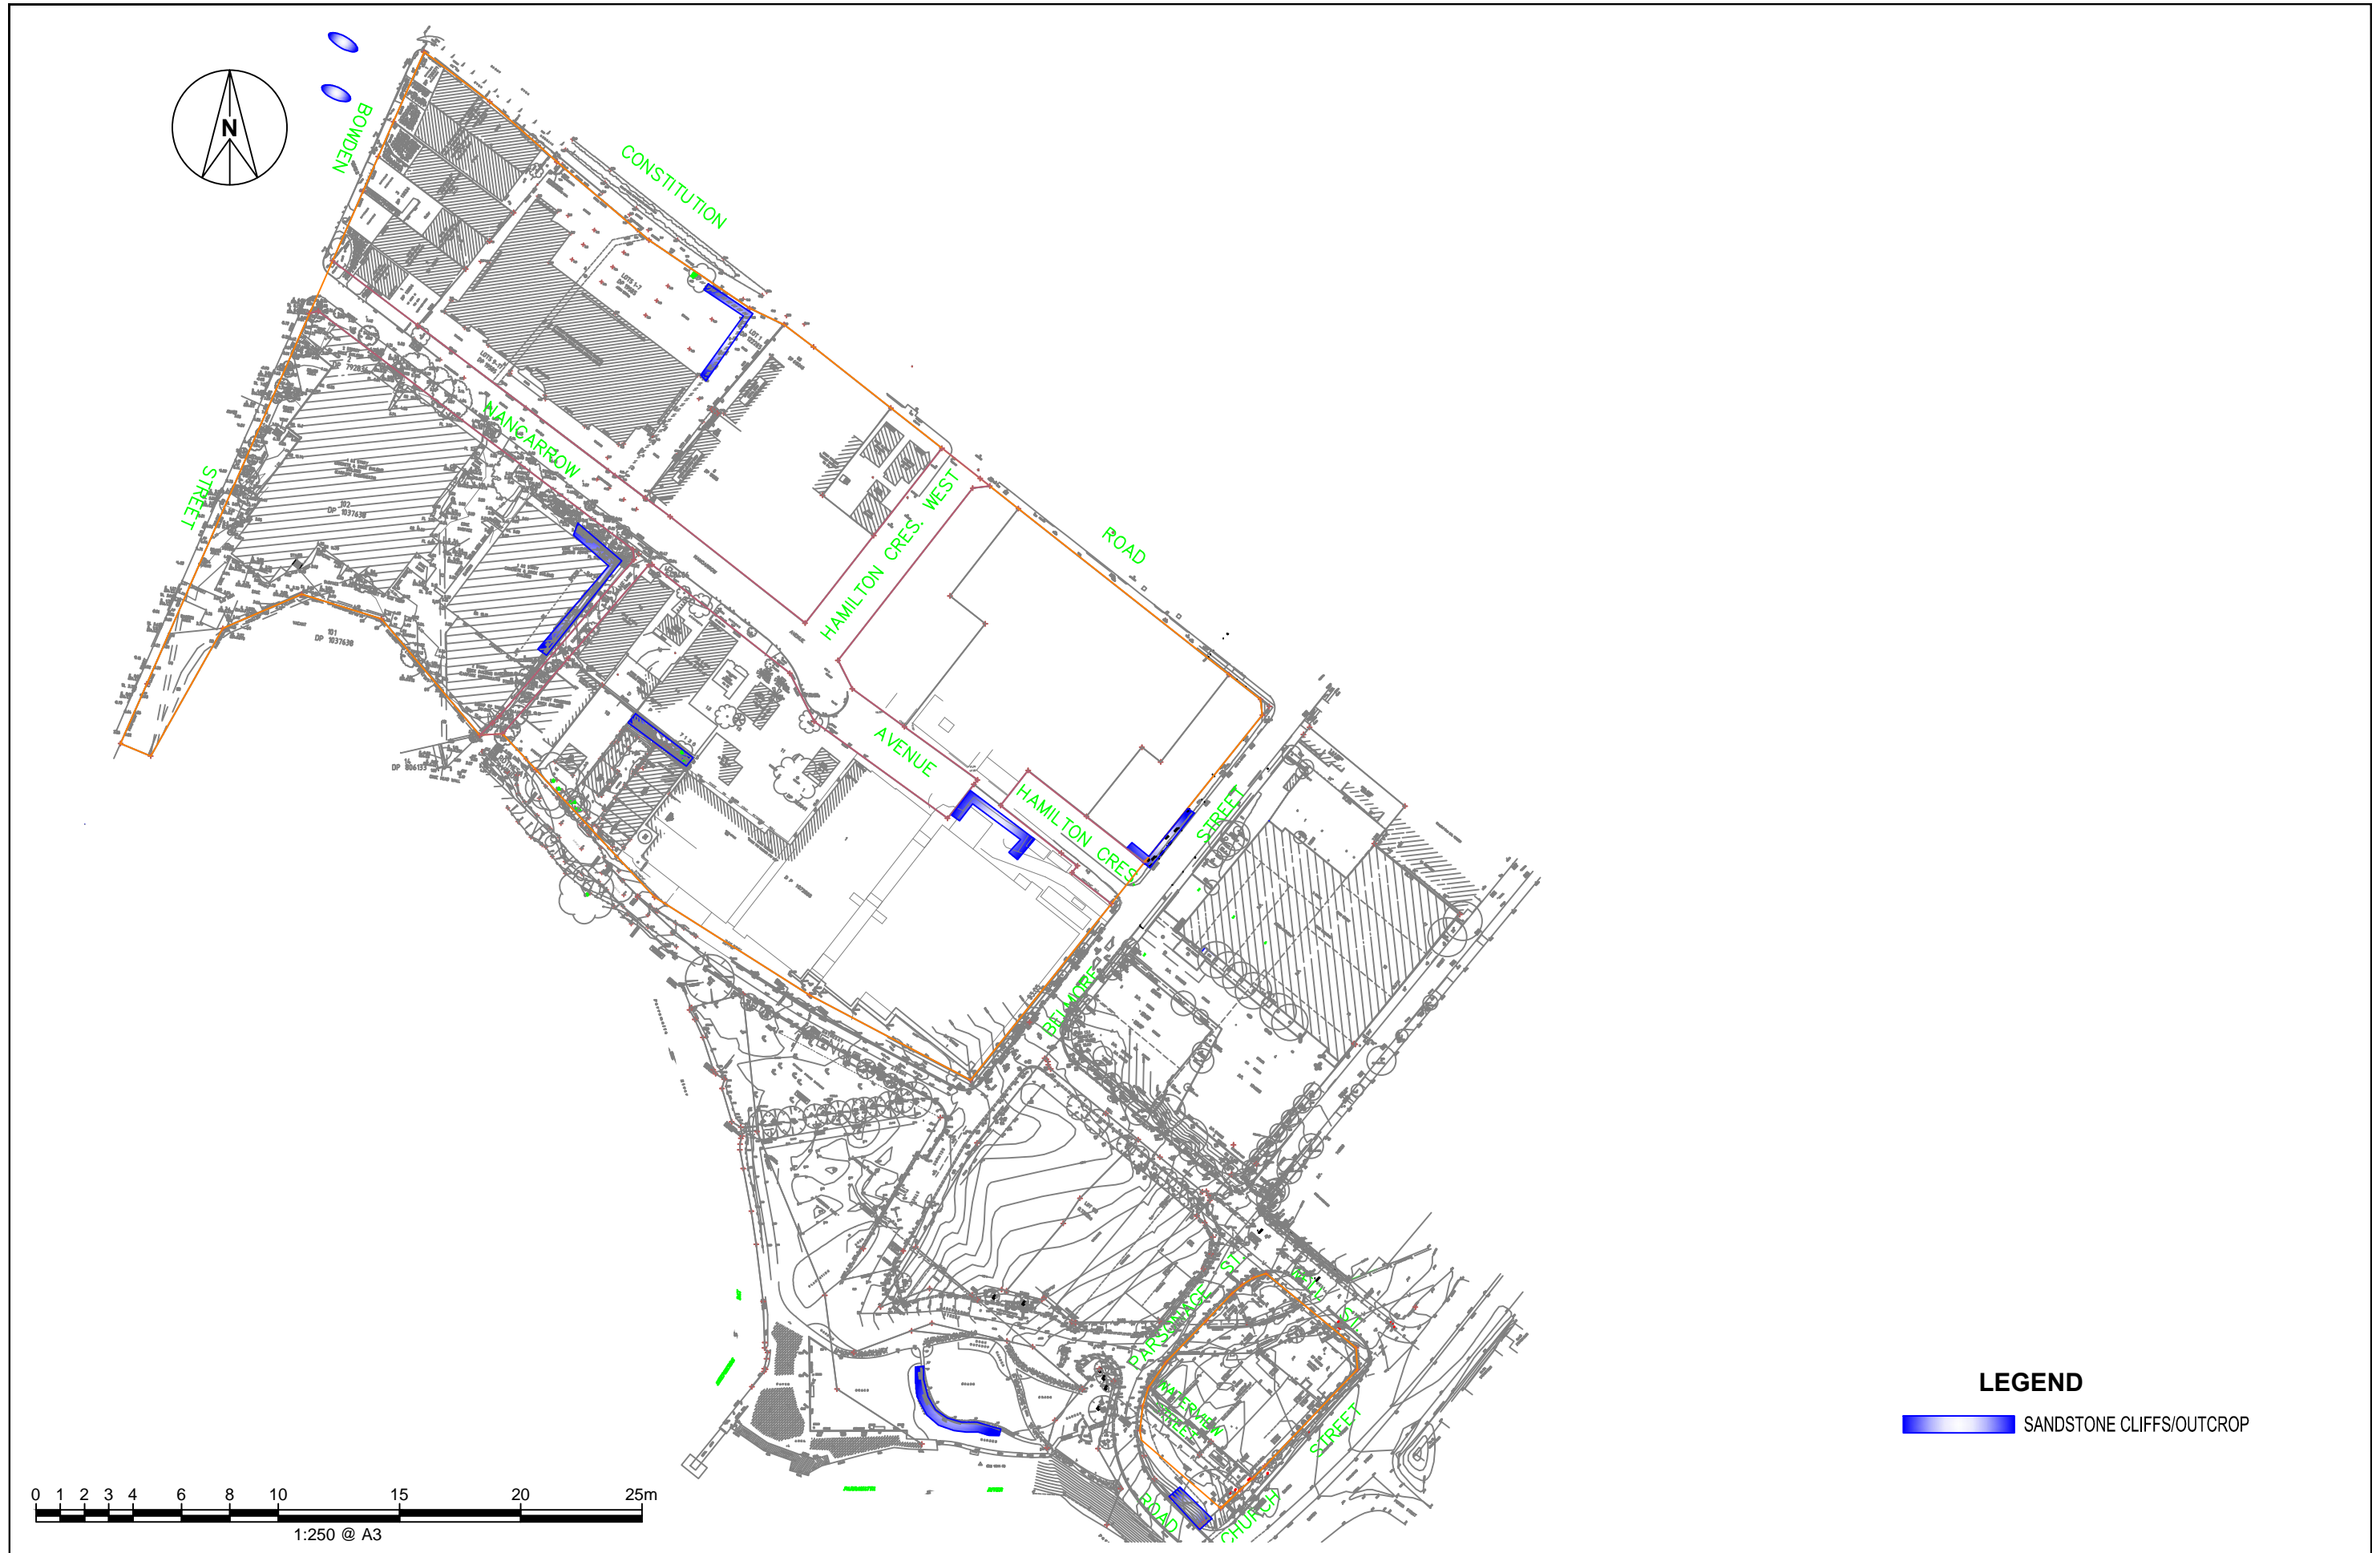
33	C5	Near-vertical sandstone cliff at north-eastern end of property up to approximately 6 m to 7 m high, becoming steeply sloping towards the base of the cut. Largely obscured by vegetation (refer Photos A and B of Plate C5). The height of the cut apparently drops off towards the north, and is not visible in the neighbouring property (Property 34). The southern extent of the sandstone cliff was unclear due to the presence of existing buildings, and the heavily vegetated slope. No seepage was visible, however seepage is likely to have been obscured by vegetation.

Property	Photographic Plate <sup>1</sup>	Comments
40	C6	Sandstone outcropping below the site at Belmore Road, up to 2 m height, and extending up to 30 m from the intersection with Hamilton Road. In parts, heavily obscured by vegetation, and with vegetation and rock weathering increasing towards the north of the site. Possibly transitioning into the Mittagong Formation in parts of the exposure (see Photo C of Plate C6). No seepage visible.
41	C7	Sandstone outcrops visible in Anderson Park (see Photo A of Plate C7), and in Loop Road below Lot 41 (see Photo B of Plate C7). Limited access to the rock face at Loop Road due to poor vehicle visibility in the area and no adjacent footpath. No seepage was visible.
Other	C8	Sandstone outcrops were also visible north-west of the Constitution Road site, on the far side of Bowden Street from Property 2. These cuts were up to 1.5 m high.
