**TARGETED CONTAMINATION  
ASSESSMENT  
SYDNEY ADVENTIST HOSPITAL  
WAHROONGA NSW**

Report Date: 8 December 2010  
Project Ref: ENAURHOD040483AB

**RE: Targeted Contamination Assessment  
SAN Hospital, Wahroonga**

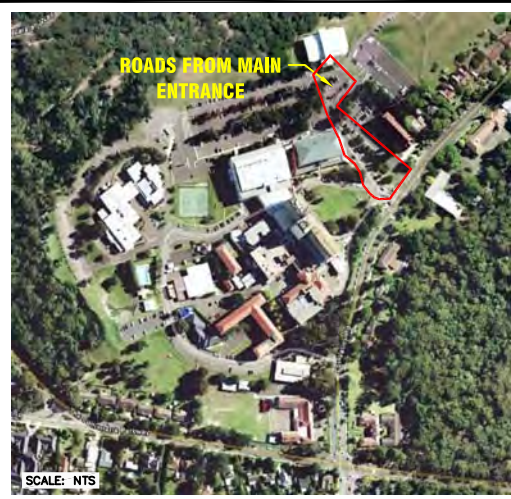
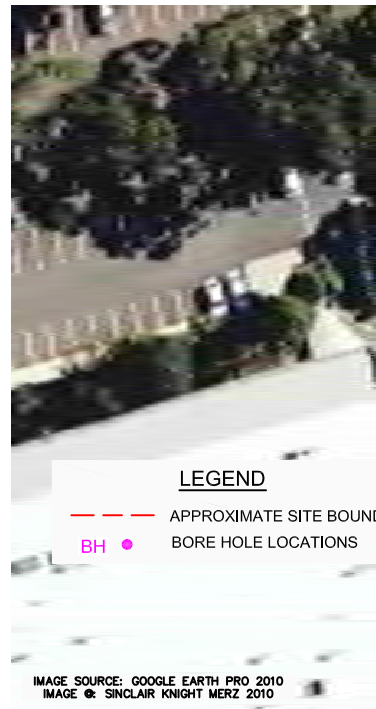
Drawing Title:	ROADS FROM MAIN ENTRANCE
Drawn	MV
Project - Drawing No.	ENAHURHOD04083AB-D01
Date	07.12.10
Figure No.	4
Rev.	A

This area consisted of the existing roads allowing access into the hospital, the Fox Valley Community Centre and the adjacent church, as well as garden beds, nature strips and car park areas. The ground surface included asphalt, garden mulch and grassed areas. The vegetation appeared to be in good health and did not show evidence of die back. Evidence of contamination (odours, significant oil staining, asbestos containing materials) was not identified during the site walkover.
