**NORTH NOWRA LINK ROAD**  
**Aboriginal Archaeological Assessment – Stage 2**

Prepared for Shoalhaven City Council

July 2010

Ref. 7004

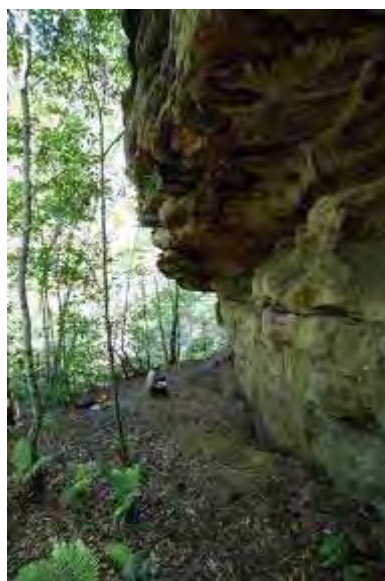
Plate 1: Shelter.

**Site Description:** Large sandstone shelter approximately five metres above Bomaderry Creek [Plate 1 and Figure 4]. The shelter is 16.5 metres long x 4 metres deep x 6-7 metres tall and is located in closed-forest of turpentine and coach-wood trees. Bomaderry Creek Reserve walking track runs through the shelter which is approximately 250 metres downstream from the northern metal bridge over Bomaderry Creek. The shelter deposit is dark brown sand with dark charcoal stained patches on the upstream entrance to the shelter. There is faint charcoal art in the northern half of the shelter consisting of 12 faint diagonal/parallel charcoal lines [Plate 2]. There are two possible quartz artefacts, one core and one flake piece located in the southern half of the shelter towards the walking track [Plate 3]. This shelter was difficult to record due to the large amount of mosquitoes along the creek line.

**Potential Impact Rating:** Low. The site is not located close to the proposed routes for the North Nowra link road alignment.

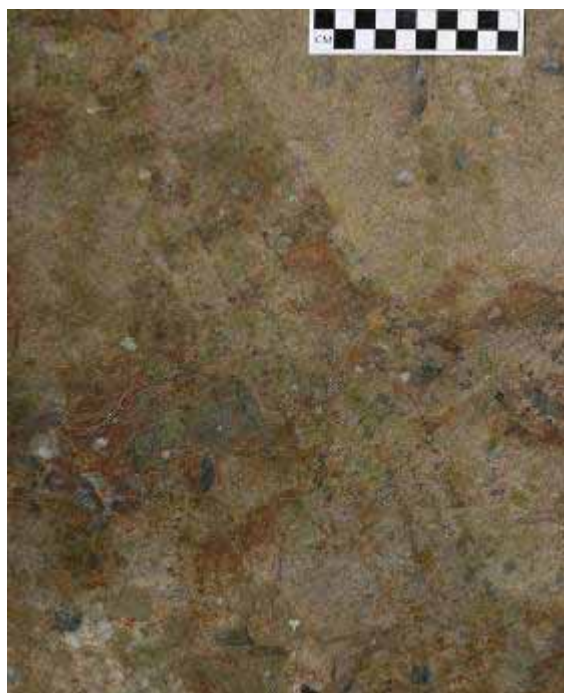
Plate 2: Indeterminate Charcoal Art.

**Natural Impacts/Weathering:** There is a heavy staining of mineral salt over the back wall of the shelter which possibly obscures other art and threatens the existing motif. The deposit has a drainage channel flowing from the north to the south part of shelter after heavy rain.

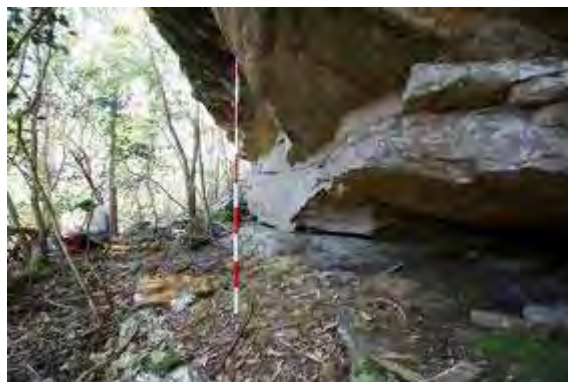
Plate 4: Shelter.

**Site Description:** Sandstone shelter located approximately 20-30 metres above Bomaderry Creek [Plate 4 and Figure 5]. The shelter is 25 metres long x 4.2 metres deep x 3.7 metres tall. The shelter has a rocky floor from past roof falls, particularly in the north-west section. The north-west section has a quartz flake, core and very fine grained red material flake piece. The north-east section has a dark, volcanic fine-grained flake piece and one quartz flake [Plate 5]. The deposit is dark, charcoal stained and only visible towards the back wall of the shelter.

**Potential Impact Rating:** Low. The site is not located close to the proposed routes for the North Nowra link road alignment.

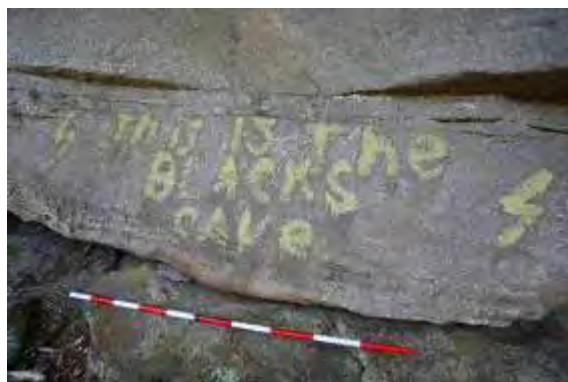
Plate 6: Graffiti.

**Human Impacts:** In the north-west side of the shelter there is yellow/green spray paint graffiti that says, 'This is the Blacks Cave' [Plate 6]. Other recent human impacts to the shelter include magazines, decaying mattress and foam rubbish.

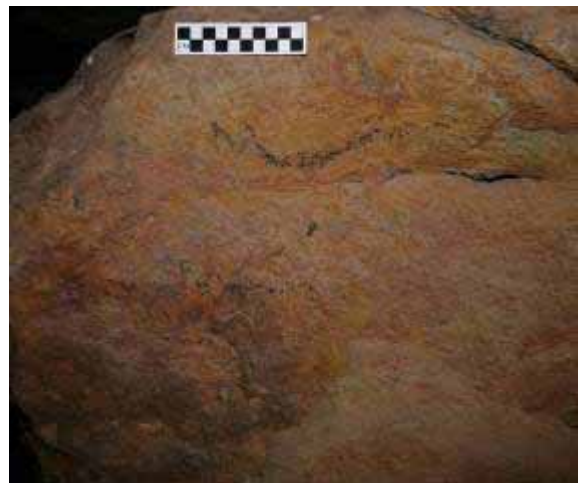
**Plate 11: Two x partial dingo charcoal motifs.**

**Site Description:** Long sandstone shelter in Bomaderry Creek gorge with art and artefacts [Plate 10 and Figure 7]. The shelter is 20 metres from Bomaderry Creek and is 43 metres long x 7.7 metres deep x 6 metres high. More than 10 artefacts were located in the shelter drip line at 16.5 metres from the south end. The main material is a deep red fine grained siliceous material of which flakes, flake pieces and cores were observed. Two of the cores have pot lid scars from heat treatment. Also at this location a river pebble was observed towards the shelter back wall with one side slightly flattened and polished looking. The pebble is 85mm long x 66mm wide x 56mm tall and has a reddish stain on the flattened area. There are more artefacts approximately 32 metres from the southern end of the shelter towards the north including at least five quartz cores. Four faint charcoal drawings were located in the southern end of the shelter. Two partial dingo motifs are located directly behind the southern artefact and polished river pebble area [Plate 11]. They are on a back wall panel that faces towards the south of the shelter. Two other indeterminate figures including one possible bird figure are located 4.5 metres north from the two dingo motifs [Plate 12]. These two motifs are on a back wall panel that faces towards the north of the shelter.

**Natural Impacts/Weathering:** Erosion of the deposit at the shelter drip-line is exposing artefacts. The art is faded from water seepage through the shelter back wall and associated mineral salt staining.

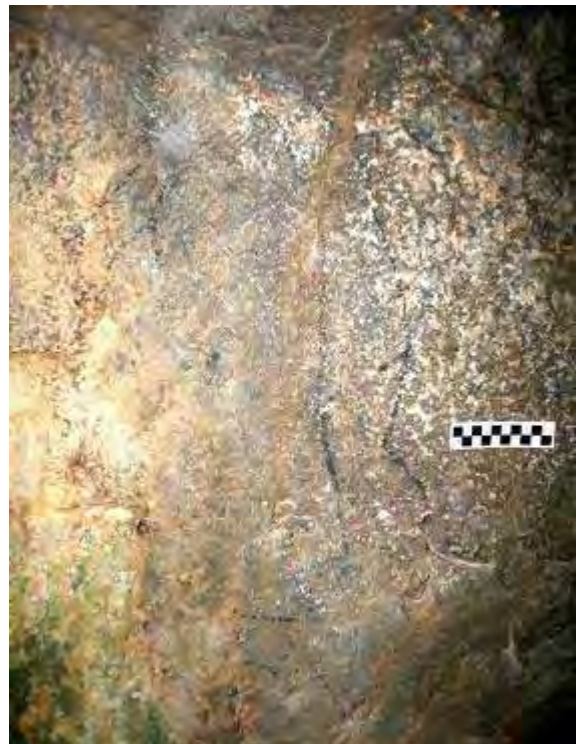
**Plate 12: Other indeterminate charcoal figure.**

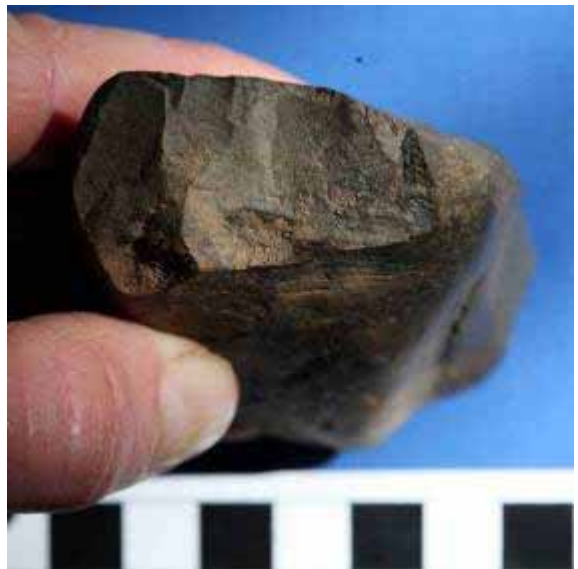
Plate 19: Grey fine-grained core.

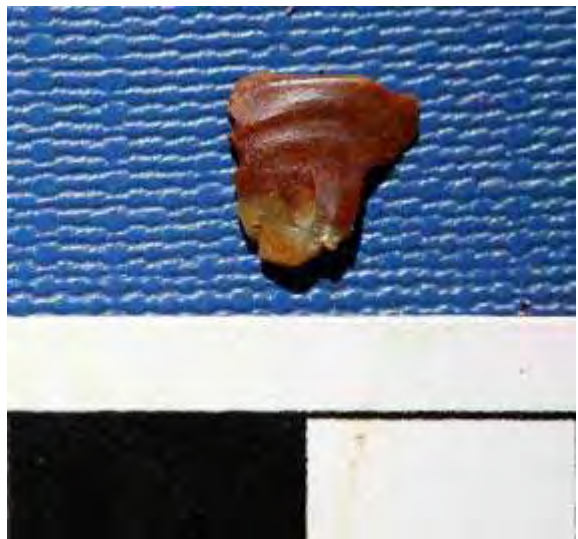
Plate 20: Possible erillure scar flake.

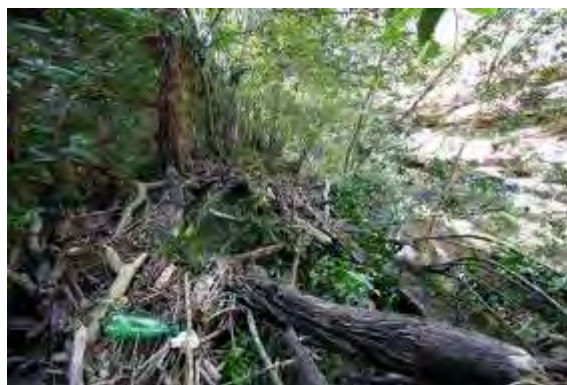
Plate 26: Large piles of drift wood close to the shelter entrance.

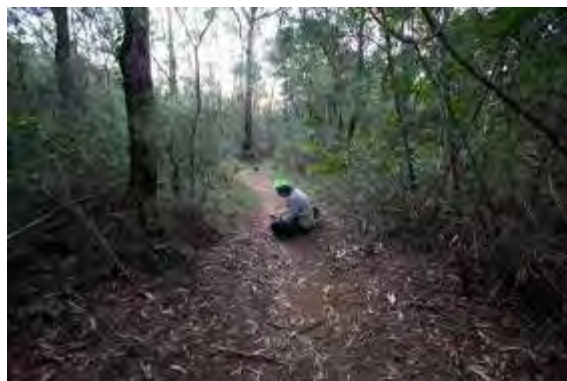
Plate 42: Open site.

**Site Description:** This site is located on the foot track in Bomaderry Creek Reserve adjacent to the North Nowra Sale Yards [Plate 42]. The Sale Yards are approximately 200 metres east of the site. Bomaderry Creek is approximately 300 metres to the west. One red, fine grained siliceous core was located on the south edge of the foot track exposure. The core has at least two flake scars [Plate 43 and Plate 44]. No other artefacts were observed at the site.

**Potential Impact Rating:** Very high. The site is located on the West Cambewarra option for the North Nowra link road alignment.

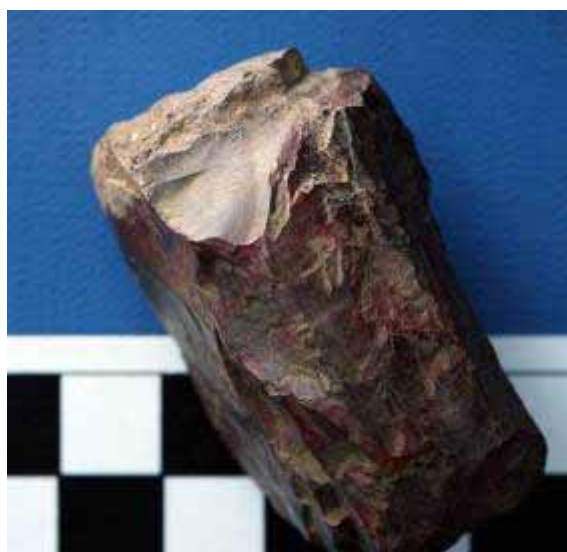
Plate 43: Flake scar on core.

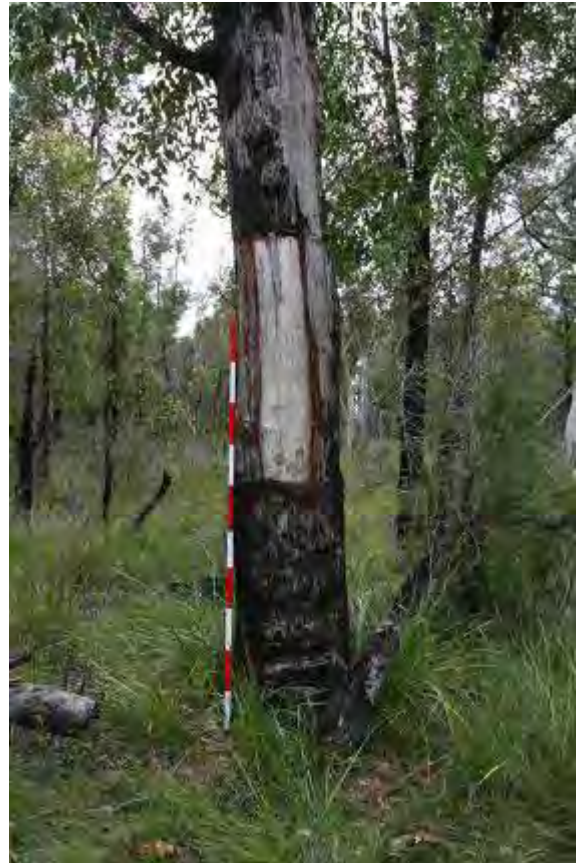
**Site Description:** Recently completed scar tree in Bomaderry Creek Reserve, approximately 5 metres south of the Illaroo Road-West Bunberra Street option for the North Nowra Road Alignment [Plate 45 and Figure 19]. The tree was recorded so that it would not be confused with a genuine Aboriginal scarred tree at a later date. (Although it is possible that the scar is the result of recent cultural activity from the local Aboriginal community.)

The tree is approximately 300 metres east of the gate on Falcon Crescent on the east side of a minor drainage area. The scar is 1.2 metres from the ground and is 1.25 metres tall x 30 centimetres wide x 4.5 centimetres deep. The scar has metal axe marks along it [Plate 46 and Plate 47]. The tree is a Stringy Bark, *Eucalyptus* sp. and has burnt recently. It is likely that the scar was completed in the last decade. There is rubbish on site including broken glass. There are axe marks in another small stringy bark tree 10 metre to the east of the scar tree, and also the remains of two small sawn trees.

**Natural Impacts/Weathering:** Recent bush fire has burnt the tree.

**Plate 45: Scar tree.**

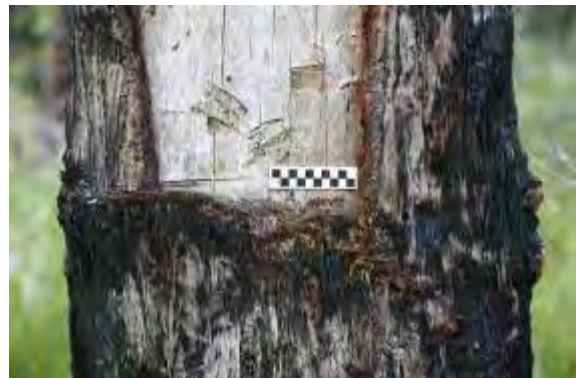
**Plate 46: Scar – lower end.**

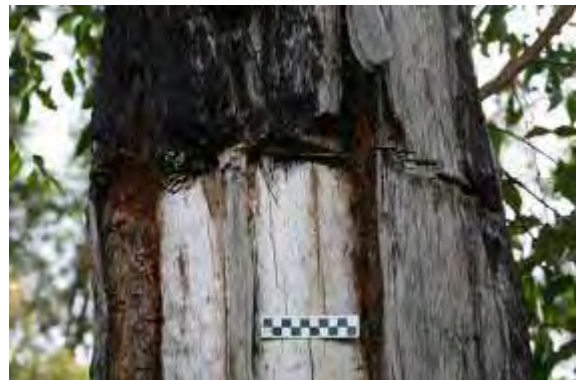
**Plate 47: Scar – upper end.**

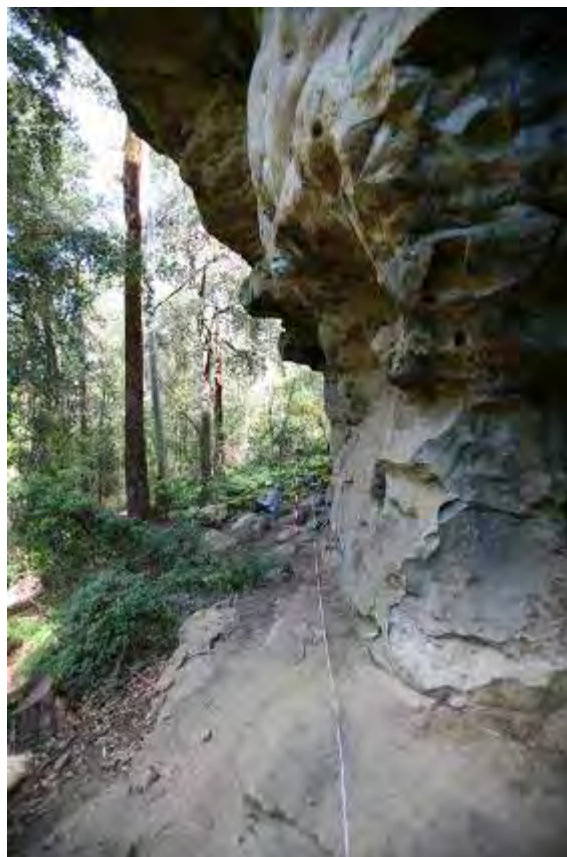
**Site Description:** Sandstone shelter located approximately 300 metres east of the end point of Warren Avenue, North Nowra [Plate 48 and Figure 20]. The shelter is 21 metres long x 6 metres deep x 10-15 metres high. One charcoal stained, red fine grained siliceous flake was located in north-east part of the shelter towards the drip line [Plate 49]. The shelter deposit is charcoal stained fine sand apart from the northeast area where pale sand from fresh exfoliation of the shelter back wall is occurring. Outside the north-east part of the shelter is a sawn stump of turpentine.

**Plate 48: Shelter.**

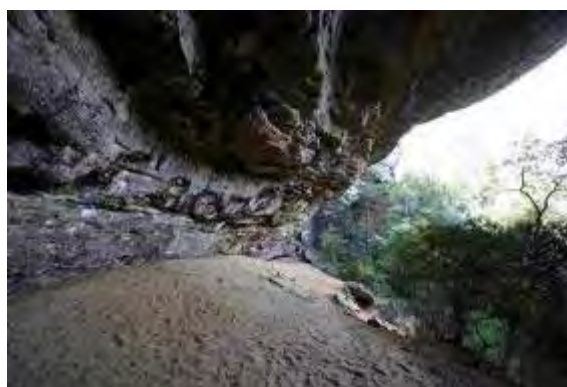
**Site Description:** Very large row of sandstone shelters on a bend along the western side of lower Bomaderry Creek [Plate 50, Plate 52, Plate 54 and Figure 21]. The row of shelters is 115 metres long x up to 30 metres deep x 20-25 metres high approximately at the drip line. The site was recorded as two shelters, Shelter A and Shelter B. Shelter A is the southern most shelter and is 50.9 metres long [Plate 50]. The northern corner of this shelter has a partly collapsed roof and between roof fall and back wall there is a flat area four to five metres wide, with charcoal stained deposit. One red fine-grained proximal flake was located in this area [Plate 51]. Much of the shelter floor is steeply sloped apart from an area five–six metres wide towards the back wall. Shelter B is partly separated from Shelter A by six metres due to the past roof collapse. Shelter B is 65 metres long x 15-20 metres deep x 20-25 metres tall [Plate 52 and Plate 54]. The deposit is less pale than in shelter A and has more orange staining from ironstone leaching. Around 30 metres from the center of this shelter there is a partly collapsed roof fall. To the south of the roof fall, at 29 metres from the start of the shelter towards the north there is a one faint indeterminate charcoal drawing on the shelter back wall, consisting of three vertical charcoal lines [Plate 53]. Two quartz cores were located at 45-50 metres in the shelter drip-line and one part of a possible broken grinding palette was recorded at 55 metres in the shelter drip-line [Plate 55].

Plate 50: Shelter A.

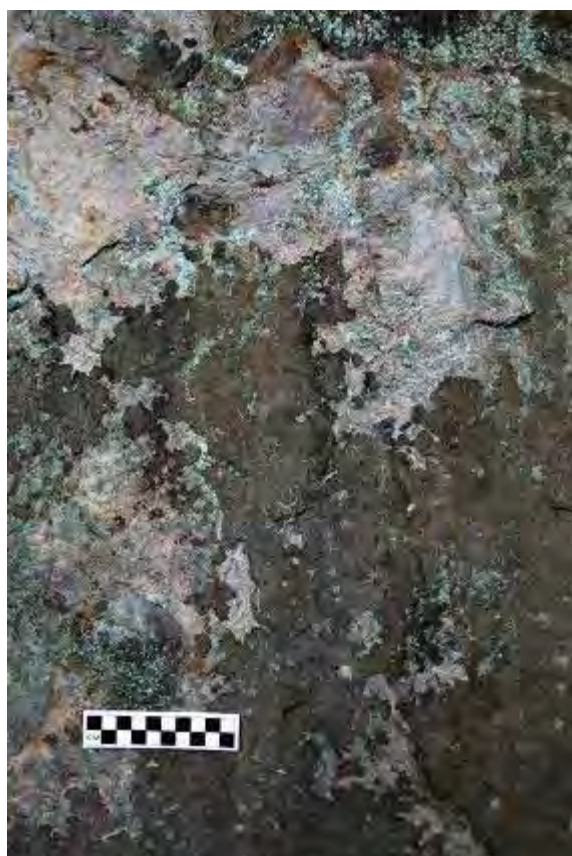
form. Mineral salt stain and lichen growth has occurred on the back wall of the shelter and obscures the art in Shelter B.

Plate 53: Charcoal art from shelter B, section 1.

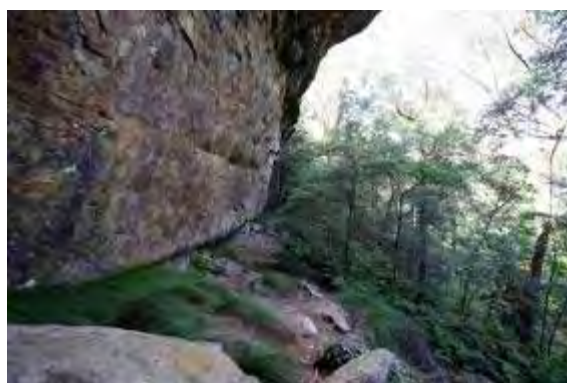
Plate 54: Shelter B, section 2.

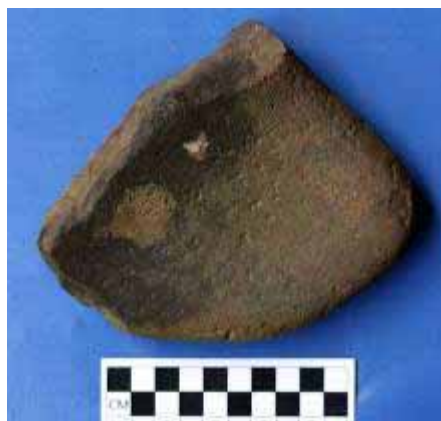
Plate 55: Grinding palette, shelter B, section 2.

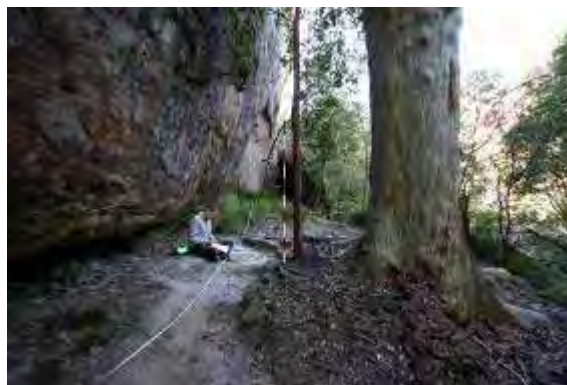
**Human Impacts:** The Bomaderry Creek walking trail runs through the shelter and has caused minor erosion of the deposit [Plate 58].

Plate 58: Shelter.

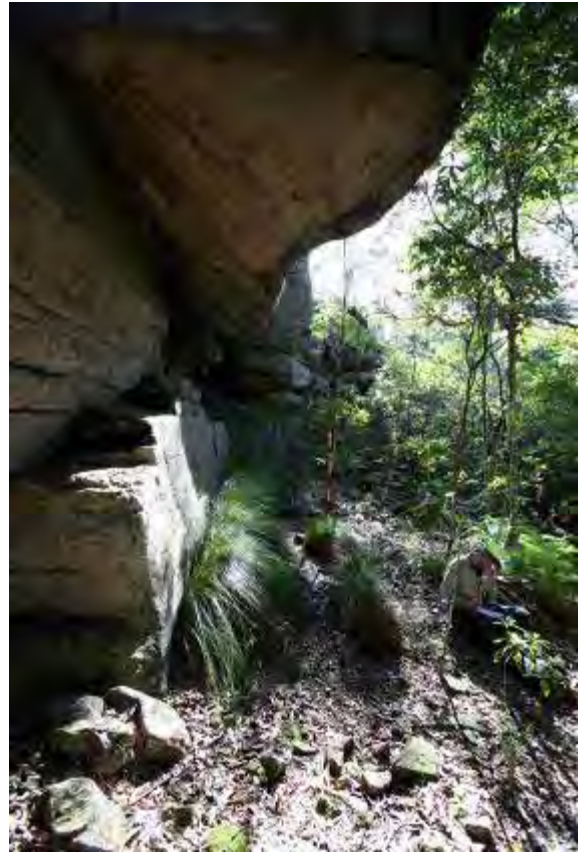
**Site Description:** Sandstone shelter on the western side of Bomaderry Creek gorge [Plate 64 and Figure 25]. The shelter is 12 metres long x 3.2 metres deep x 4.5 metres high. The shelter is located approximately 30 metres west of site 021, the 'Sheltered Cave'. Two red fine-grained proximal flakes, one with pot-lid scar on the ventral surface, were located at this site [Plate 65]. The deposit has 70% native grass cover. An upper hole or cavity in the shelter back wall is located in the north/west part of the shelter.

Plate 64: Shelter.

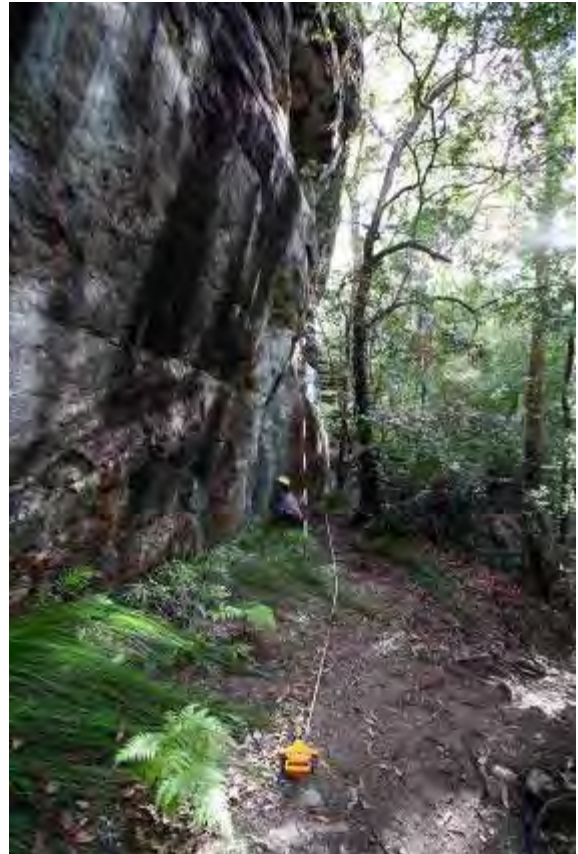
**Site Description:** Sandstone shelter on the western side of Bomaderry Creek gorge [Plate 66 and Figure 26]. The shelter is formed by a leaning cliff-line and is 31 metres long x 2 metres deep x 6-7 metres high approximately. One red fine-grained flake piece and one red fine-grained core were observed eroding from the edge of the Bomaderry Creek walking trail towards the north of the shelter. The deposit mostly has a cover of native grasses and bracken. Two charcoal drawings were observed in the northwest of the shelter back wall. They are located on the southern side of a fault in the back wall of the shelter in which small animals have been burrowing. Motif one consists of a charcoal oval with no infill, 1.3 metres from the shelter floor [Plate 67]. Motif two consists of seven parallel/diagonal charcoal lines 1.07 metres from the shelter floor. [Plate 68]

Plate 66: Shelter.

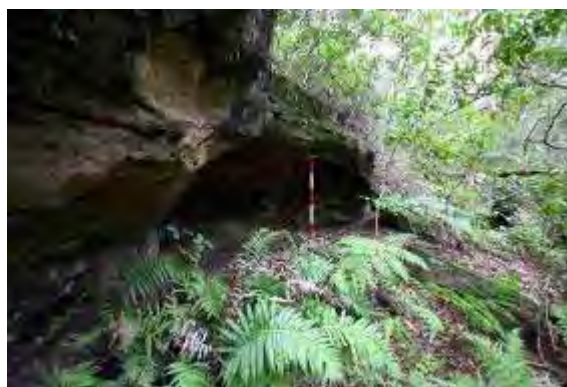
**Site Description:** Small sandstone shelter on the western side of Bomaderry Creek gorge. The shelter is 6.7 metres long x 2.10 metres deep x 1.3 metres high (Plate 69 and Figure 27). One grey silcrete flake with a step termination was located in the drip line towards the centre of the shelter (Plate 70). The shelter is approximately six metres west of the Bomaderry Creek Reserve walking trail and 10-12 metres from Bomaderry Creek.

**Plate 69: Shelter.**

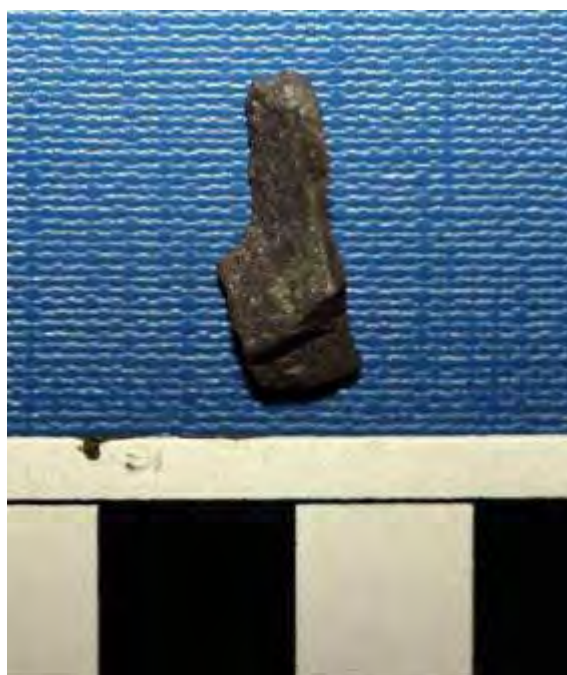
**Plate 70: Artefact.**

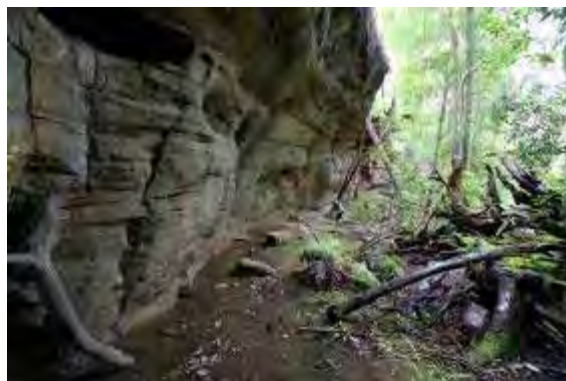
**Site Description:** Long sandstone shelter on the western side of Bomaderry Creek gorge [Plate 71 and Figure 28]. The shelter is 44 metres long x 4 metres deep x 5 metres high. At the northern end of the site Bomaderry Creek flows within two metres of the shelter. The drip line has eroded into the deposit approximately 35-40 centimetres. Six red fine-grained flakes and flake pieces were observed along the shelter drip-line [Plate 72]. The deposit is scattered with fresh water mussel shells that could be the result of flood deposition.

**Plate 71: Shelter.**

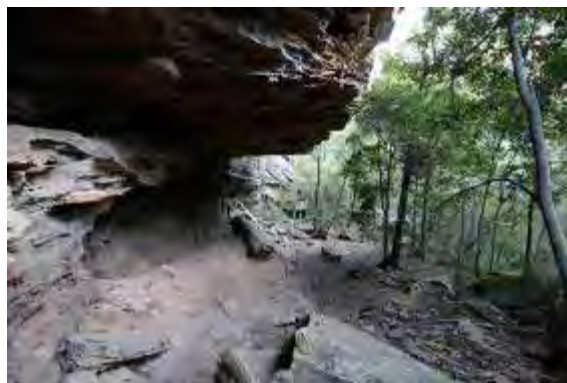
**Site Description:** Sandstone shelter on the eastern side of Bomaderry Creek gorge, directly below the Illaroo Road-West Bunberra Street option for the North Nowra Road Alignment [Plate 73 and Figure 29]. The shelter is 18.4 metres long x 9.4 metres deep x approximately 20 metres high at the drip-line. The shelter is at the down stream (southern) side of the Rock Fall Canyon in Bomaderry Creek Reserve. The walking trail through the reserve runs through the shelter. The deposit slopes from the back wall to the front and has a small scattering of shell fragments towards the drip-line [Plate 74]. One red fine-grained flake piece was located at the central part of the drip-line [Plate 74]. An aluminum seat has been erected in the centre of the deposit.

**Plate 73: Shelter.**

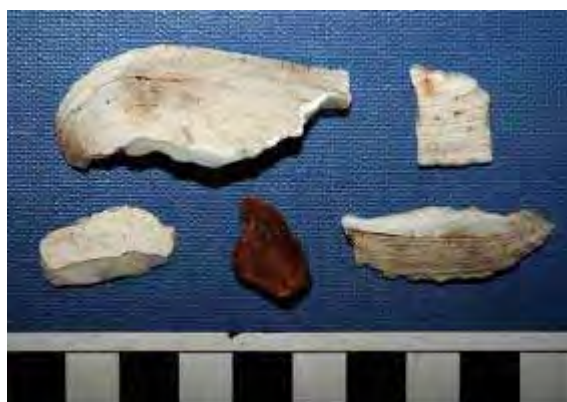
**Plate 74: Shell Fragments and Artefact.**

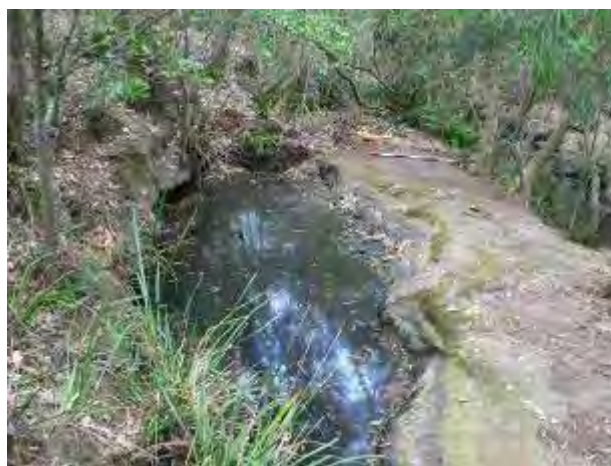
**Plate 78:** View south across the rock outcrop, showing the artificial pool in the centre of the photo and the grinding grooves next to the range pole.

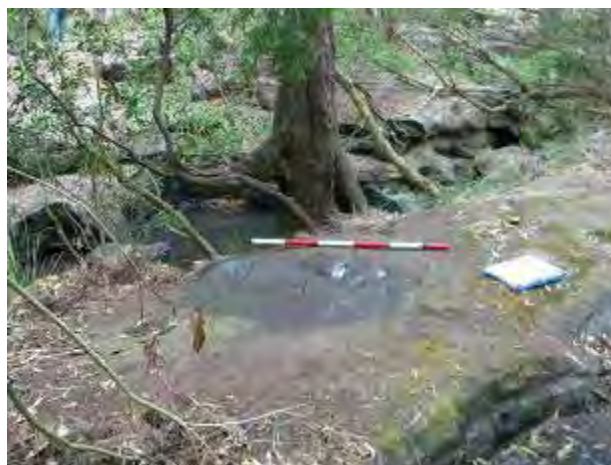
**Plate 79:** View northwest across grinding grooves, with Bomaderry Creek in the background.

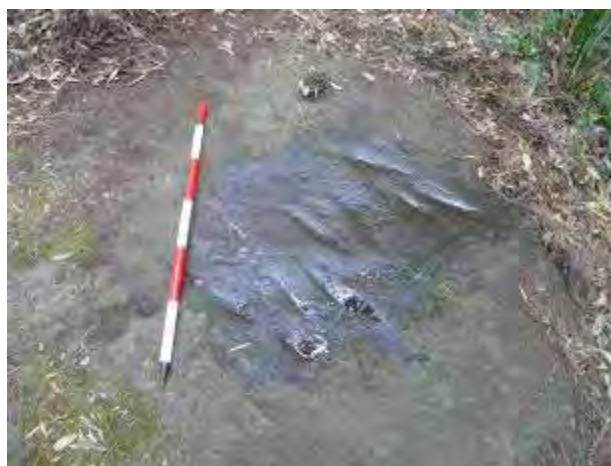
**Plate 80:** Grinding grooves, site BCRP 028.
