# Appendix B

Test Pit and Borehole Logs

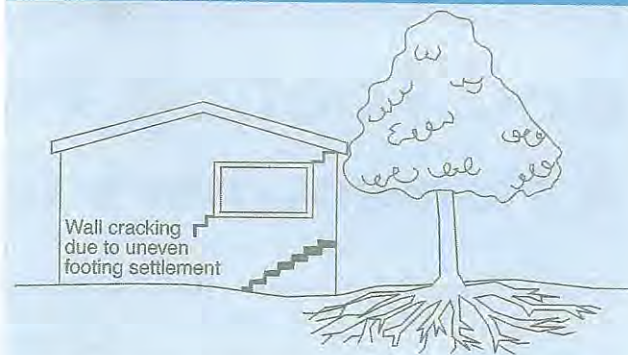
### Trees can cause shrinkage and damage

As the weather pattern changes and the soil begins to dry out, the external footings will be first affected, beginning with the locations where the sun's effect is strongest. This has the effect of lowering the external footings. The doming is accentuated and cracking reduces or disappears where it occurred because of dishing, but other cracks open up. The roof lines may become convex.
