PRELIMINARY GEOTECHNICAL INVESTIGATION REPORT:
LOT A BURLEY ROAD, HORSLEY PARK EMPLOYMENT PRECINCT, NSW

PREPARED FOR JACFIN PTY LTD.
CES DOCUMENT REFERENCE: CES100606-JBA-AF

Date: 25 November 2010

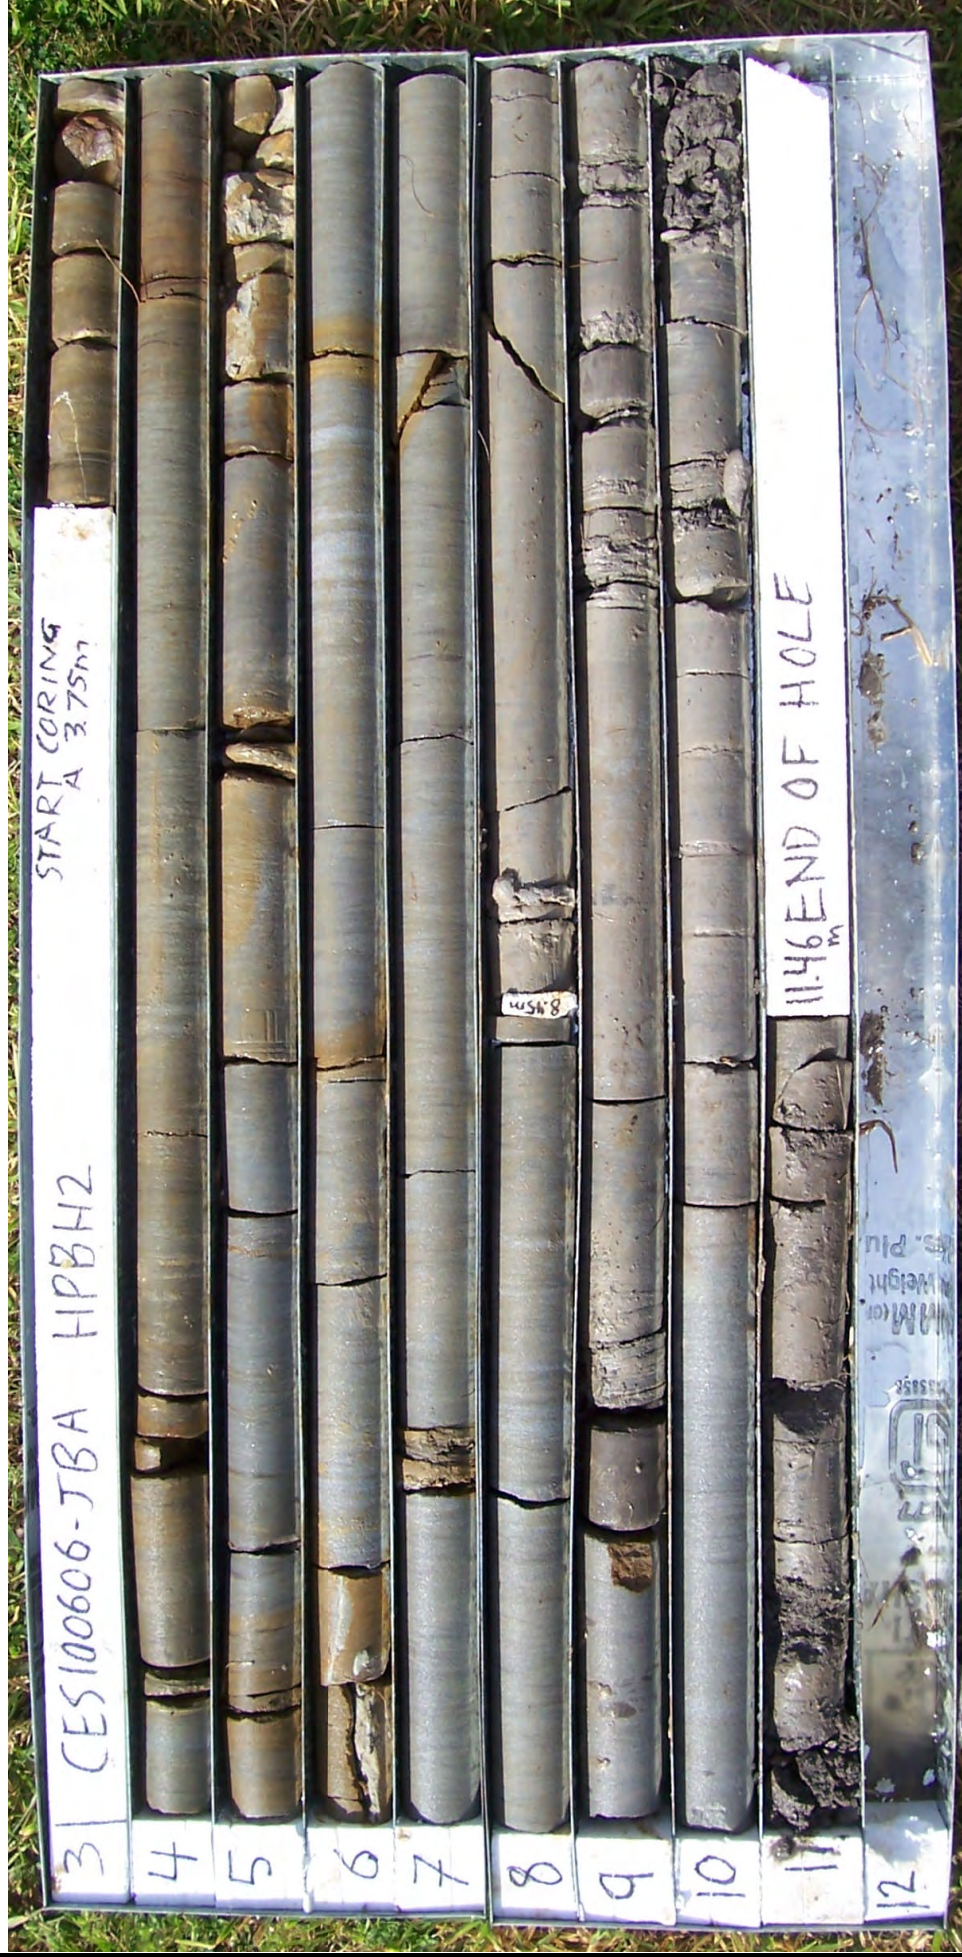
Date:	22/07/2010	Title:	BH2 Horsley Park 3.75m to 11.46m
Prepared by:	M. Pickett		
Checked by:	D. Lowe	CES Project ID:	CES100606-JBA
Scale:	NTS		
Size:	A4	Client:	Jacfin Pty Ltd

Drilling Information					LITHOLOGY							Natural Defects								
Depth (mBGL)	R.L. (m)	Method (Support)	% Coreloss	Water	Symbol	Rock Description ROCK TYPE: grain characteristics, colour structure, minor components	Weathering	Estimated Strength MPa						Is (50) MPa	RQD %	Spacing (mm)				Description
								EL 0.03	VL 0.1	L 0.3	M 1	H 3	VH 10			EH	20	60	200	
0																				0
67																				
1																				1
66																				
2																				2
65																				
3																				3
64																				
4																				4
63																				
5																				5
62																				
6																				6
61																				
7																				7
60																				
8																				8
59																				
9																				9
58																				
10																				10

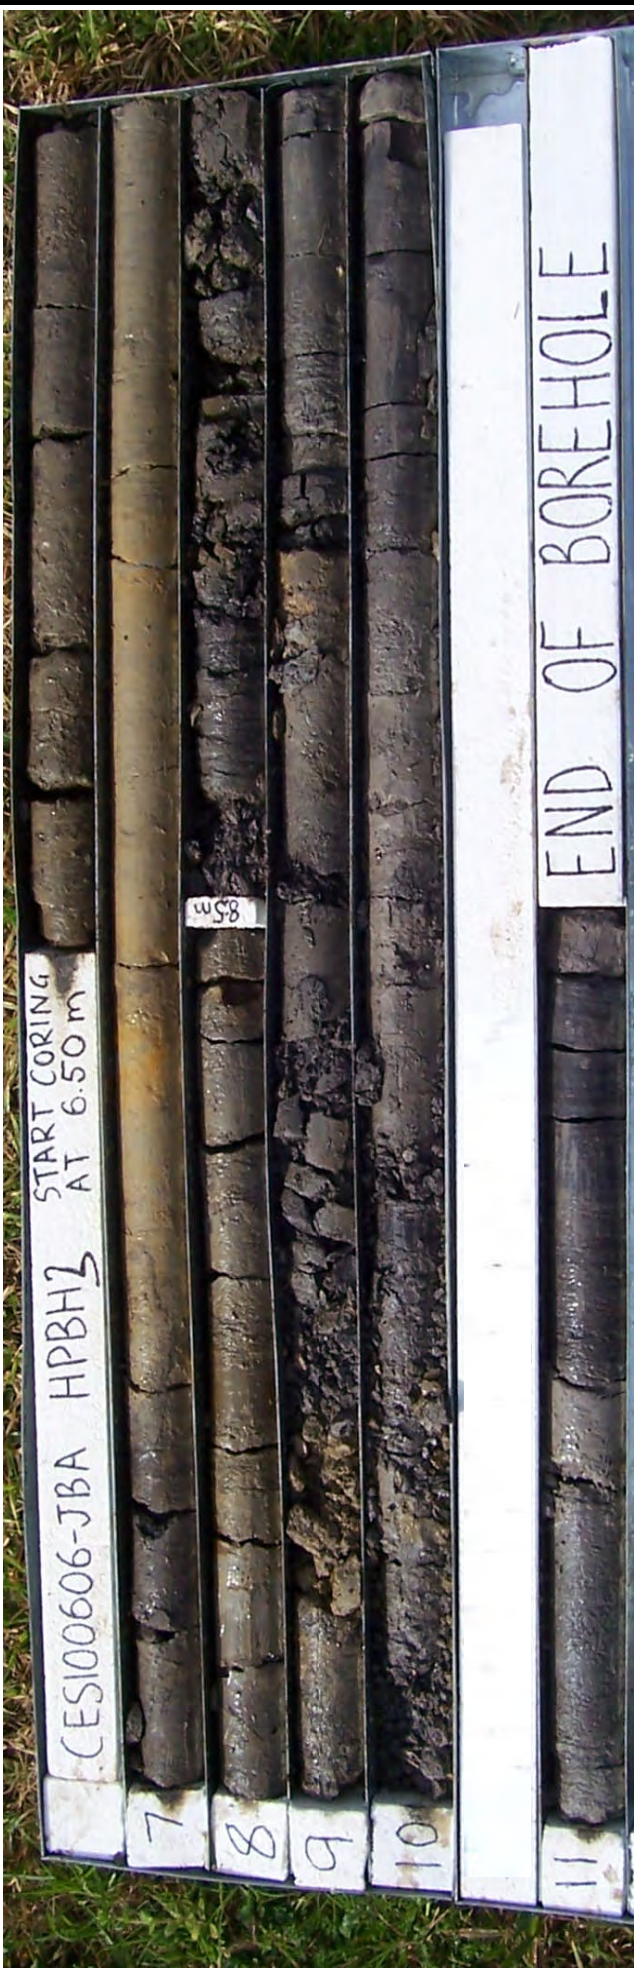
Date:	22/07/2010	Title:	BH3 Horsley Park 6.50m to 11.50m
Prepared by:	M. Pickett		
Checked by:	D. Lowe	CES Project ID:	CES100606-JBA
Scale:	NTS		
Size:	A4	Client:	Jacfin Pty Ltd

Drilling Information					LITHOLOGY							Natural Defects					
Depth (mBGL)	R.L. (m)	Method (Support)	% Coreloss	Water	Symbol	Rock Description	Weathering	Estimated Strength MPa						Is (50) MPa	RQD %	Spacing (mm)	Description
						ROCK TYPE: grain characteristics, colour structure, minor components		EL	VL	L	M	H	VH	EH			
								0.03	0.1	0.3	1	3	10			20	60
																200	600
																2000

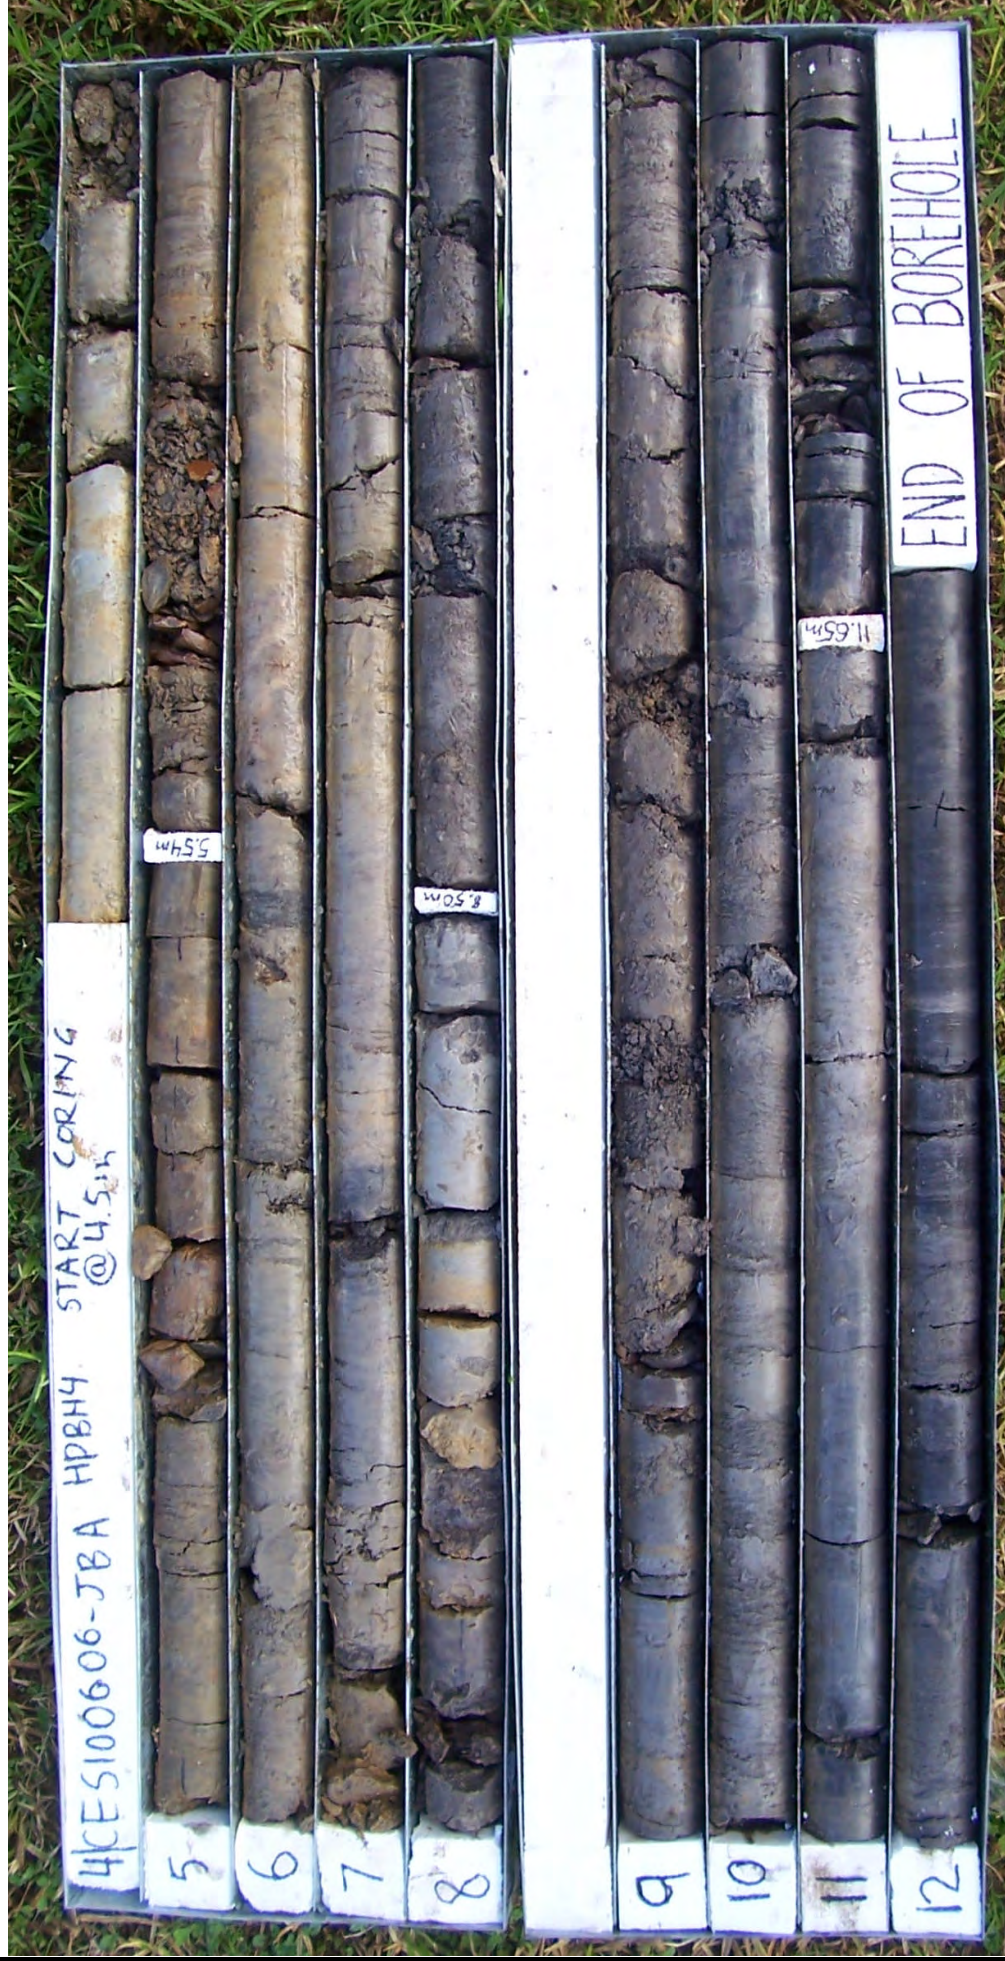
Date:	22/07/2010	Title:	BH4 Horsley Park 4.50m to 12.70m
Prepared by:	M. Pickett		
Checked by:	D. Lowe	CES Project ID:	CES100606-JBA
Scale:	NTS		
Size:	A4	Client:	Jacfin Pty Ltd

Drilling Information					LITHOLOGY										Natural Defects				
Depth (mBGL)	R.L. (m)	Method (Support)	% Coreloss	Water	Symbol	Rock Description ROCK TYPE: grain characteristics, colour structure, minor components	Weathering	Estimated Strength MPa						Is (50) MPa	RQD %	Spacing (mm)	Description		
								EL 0.03	VL 0.1	L 0.3	M 1	H 3	VH 10					EH

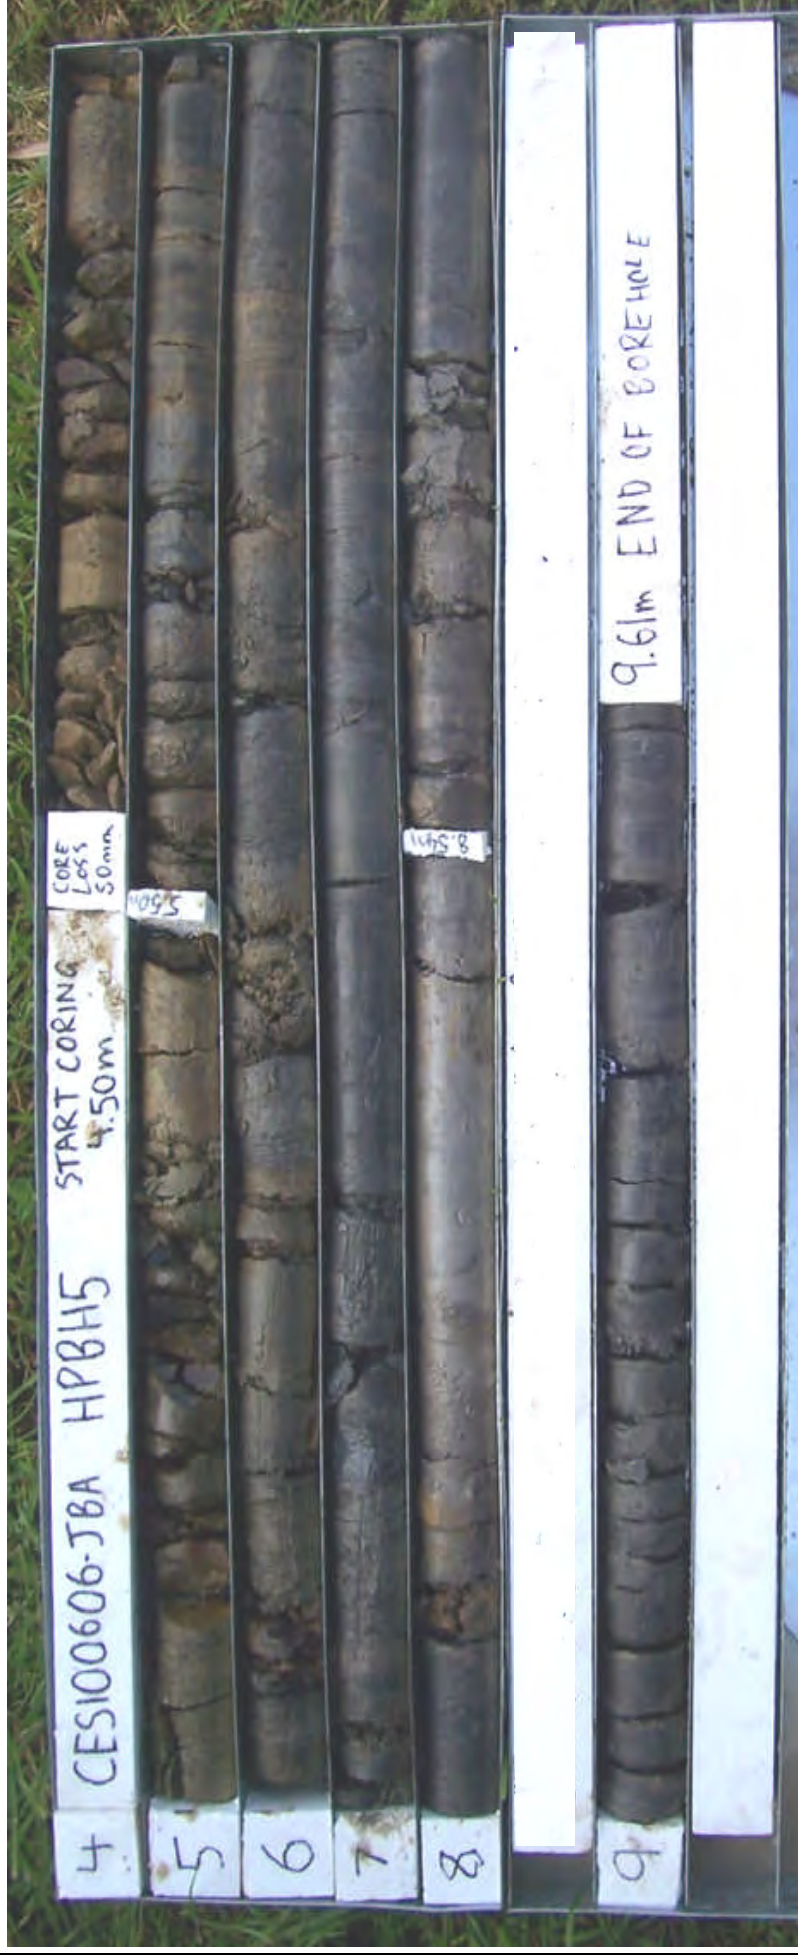
Date:	22/07/2010	Title:	BH5 Horsley Park 4.50m to 9.61m
Prepared by:	M. Pickett		
Checked by:	D. Lowe	CES Project ID:	CES100606-JBA
Scale:	NTS		
Size:	A4	Client:	Jacfin Pty Ltd

Drilling Information					LITHOLOGY								Natural Defects							
Depth (mBGL)	R.L. (m)	Method (Support)	% Coreloss	Water	Symbol	Rock Description ROCK TYPE: grain characteristics, colour structure, minor components	Weathering	Estimated Strength MPa						Is (50) MPa	RQD %	Spacing (mm)				Description
								EL 0.03	VL 0.1	L 0.3	M 1	H 3	VH 10			EH	20	60	200	
0																			0	
88																				
1																			1	
87																				
2																			2	
86																				
3																			3	
85																				
4																			4	
84																				
5						SHALE: pale brown/ pale grey, distinctly bedded at 0-5 degrees	HW											4.5 to 5.75m HIGHLY FRACTURED CORE, DRILLING INDUCED	5	
83																				
6							MW											BT, 0 deg, Pl, So, VN, BROWN CLAY	6	
82																				
7						SHALE: pale grey, distinctly bedded at 0-5 degrees	SW											JT, 40 deg, Pl, So, Co, GREY CLAY	7

81							Fr													
8																			8	
80																				
9																		SM, 10 deg, Pl, BROWN CLAY, 20 mm.		
79																		9 to 9.4m HIGHLY FRACTURED CORE, DRILLING INDUCED	9	
10						End of borehole.													10	
Drill Company: Macquarie Drilling Operator Name: Glen Garsive Refer to Standard Sheets for details of abbreviations																				
Machine Type: Hydropower
