Preliminary Site Investigation

Landcom via
Hughes Trueman

Airds Bradbury Renewal Project
Airds, NSW

March 2009
JBS 40719-12908
JBS Environmental Pty Ltd

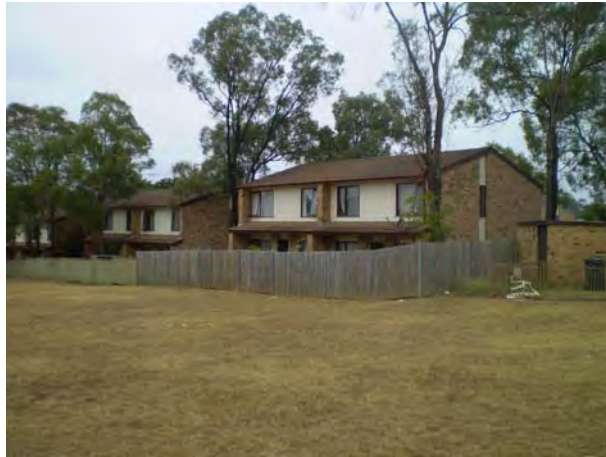
Photo 1. Rear of Cardew Precinct properties, as they back onto Baden Powell Reserve.

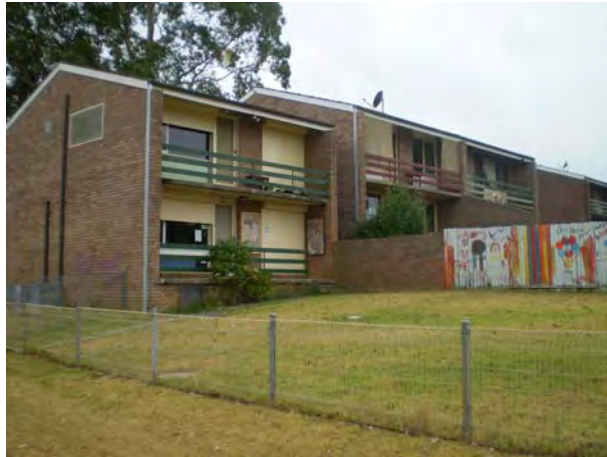
During the site inspection, demolition works had been completed on a number of the town houses, and were continuing on other townhouses within the Precinct. The properties where demolition had been completed were covered with building rubble, with no aboveground structures remaining.

Photo 2. Properties in Creigan Precinct.

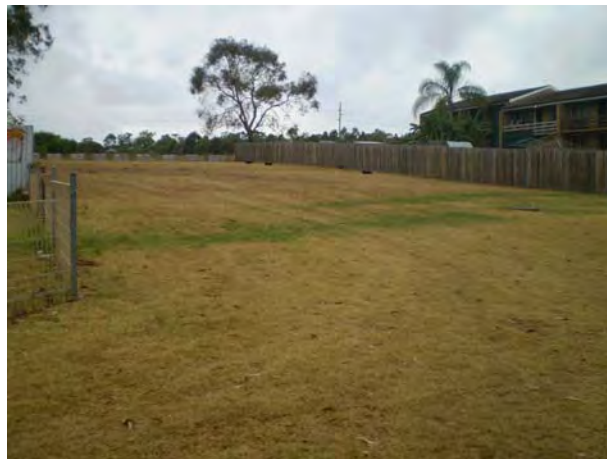
Photo 3. Grassed open space area in Creigan Precinct.

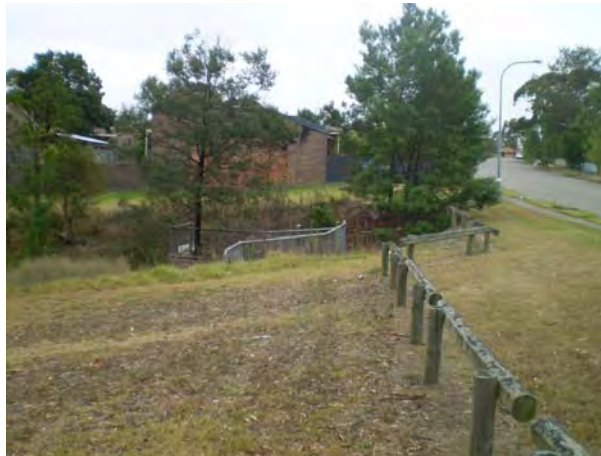
Photo 4. Hagan Reserve and storm water drain running down the south end.

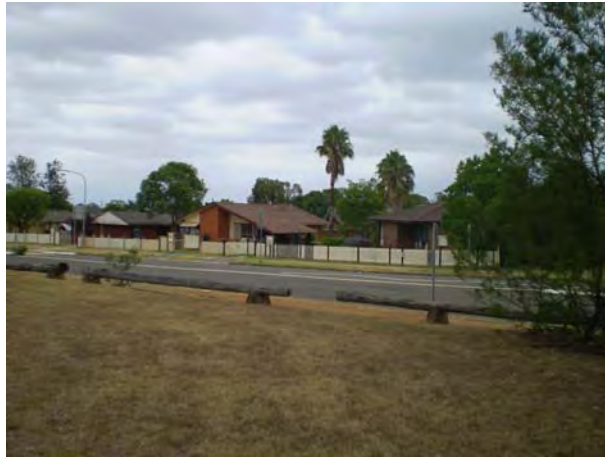
The residences are comprised of well maintained one storey brick and weatherboard homes with tile roofing. The fences consist of 2m timber picket fencing along the rear and sides of properties with 1m picket fencing at the front. The exterior of the houses and visible areas of the yards appear to be generally neat and tidy. There are no significant areas of bare soil or stressed vegetation. The Precinct is generally flat.

Photo 5. Properties in Deans Precinct across the Kevin Wheatley Memorial Reserve and Deans Rd.

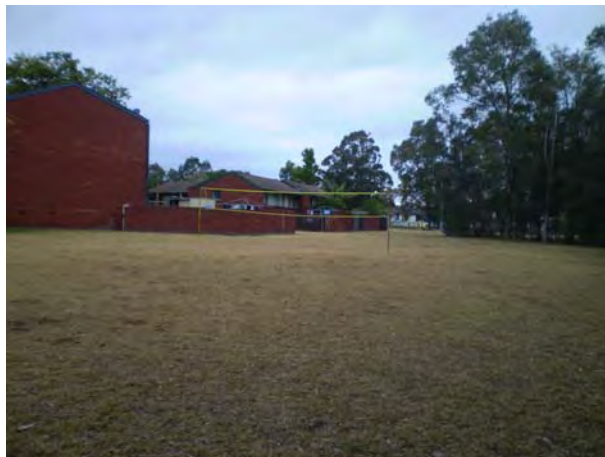
The residences are comprised of two storey brick and weatherboard town houses with tile roofing. The fences consist of 2m timber picket fencing along the rear and sides of properties with 1m metal fencing at the front. The exterior of the houses and visible areas of the yards appear to be reasonably tidy, with only a small amount of general rubbish identified. There are no significant areas of bare soil or stressed vegetation.

Photo 6. Properties in Elmslea Precinct backing on to a large open space.

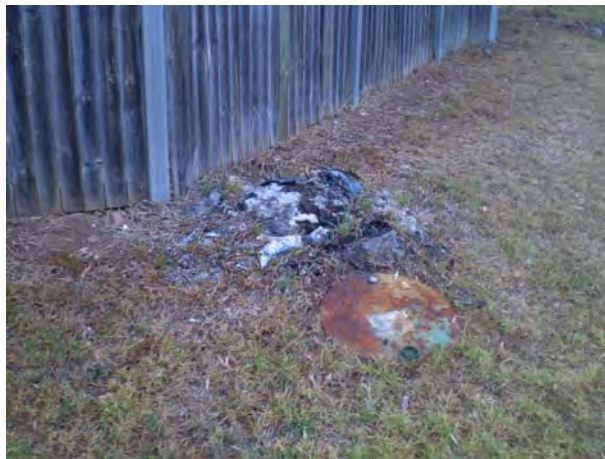
Some minor localised general household rubbish and ash is present behind the residences along the Bypass Corridor. The precinct is generally flat with a gentle slope west towards the Bypass Corridor.

Photo 8. Ash and burnt rubbish behind properties in the Kingston Precinct.

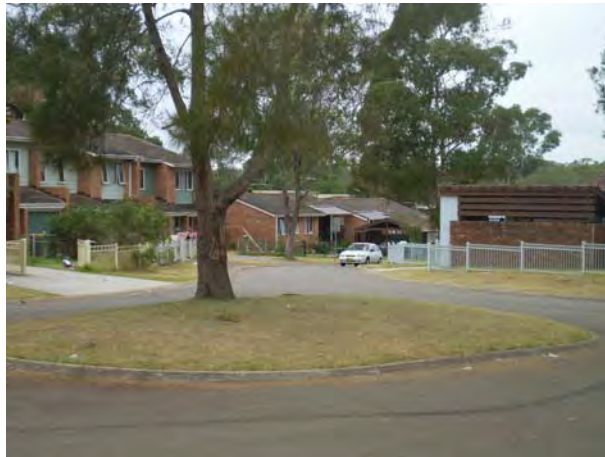
The residences are comprised of one and two storey brick and weatherboard town houses and stand alone homes with tile roofing. The fences consist of 2m timber picket fencing along the rear and sides of properties with 1m metal fencing at the front. The exterior of the houses and visible areas of the yards appear to be generally neat and tidy. There are no significant areas of bare soil or stressed vegetation.

Photo 10. Properties in Mamre Precinct

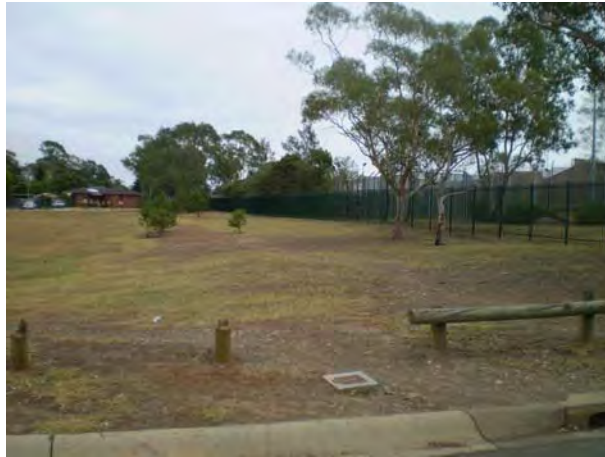
Merino Park is bound by Merino Precinct and private residential properties to the east, west and south, and the Reiby Juvenile Justice Centre to the north. The Park is a flat grassed area which appears to have been cut and filled historically.

A single suspected asbestos containing material (ACM) fragment was identified on the ground surface in the northern end of Merino Park (see **Figure 3**).

Photo 11. Merino Park and the south side of The Reiby Juvenile Justice Centre

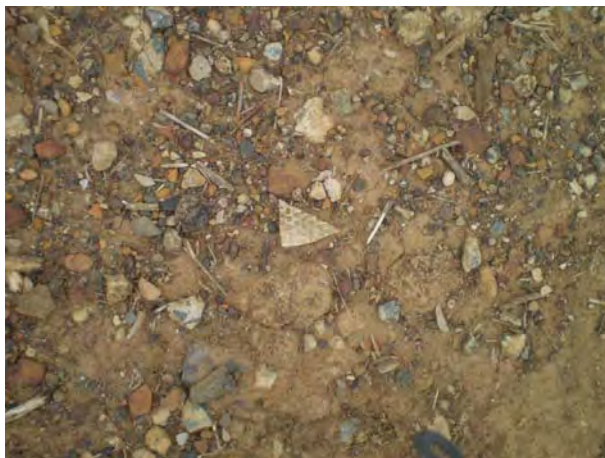
Photo 12. An ACM fragment identified in the northern portion of Merino Park

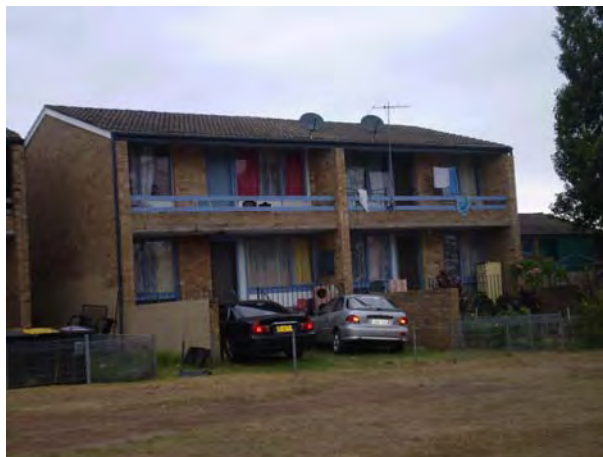
The residences are comprised of one and two storey attached and freestanding brick and weatherboard homes with tile roofing. The fences consist of 2m timber picket fencing along the rear and sides of properties with 1m metal fencing at the front. The exterior of the houses and visible areas of the yards appear to be generally neat and tidy. General household rubbish was identified at the rear of the properties. There are no significant areas of bare soil or stressed vegetation.

Photo 13. Properties and open space in Prell Precinct

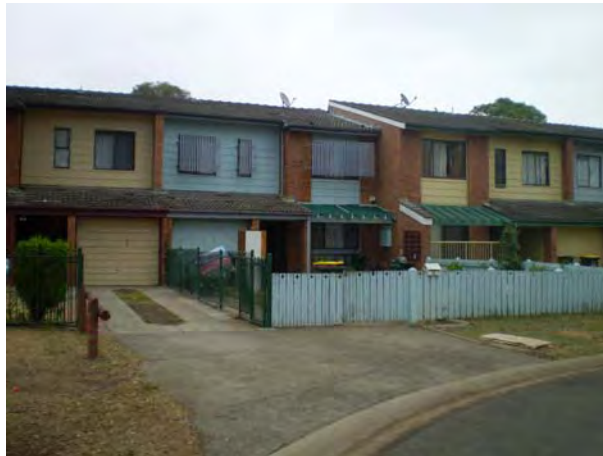
The residences are comprised of two storey brick and weatherboard homes with tile roofing. The fences consist of 2m timber picket fencing along the rear and sides of properties with 1m picket fencing at the front. The exterior of the houses and visible areas of the yards appear to be generally neat and tidy. There are no significant areas of bare soil or stressed vegetation.

Photo 14. Properties in Rawdon Precinct

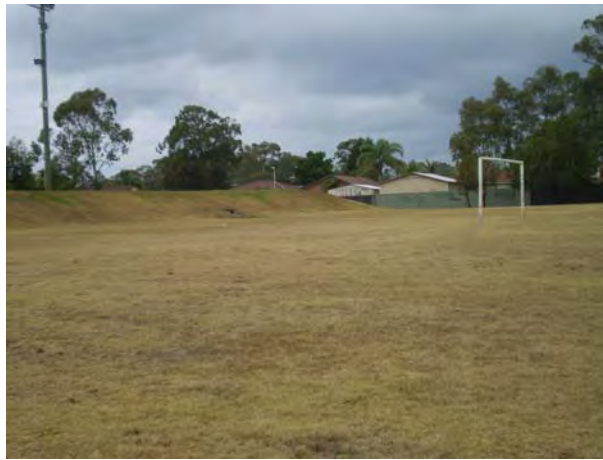
Kevin Wheatley Reserve/KL Jervis Field comprise four grassed terraced playing fields, stepping up approximately 1m from north to south between each field. The playing surfaces appear to have been cut and filled to create flat playing fields. A gravelled car parking area is located in the eastern portion adjacent to the Tharawal Aboriginal

Photo 15. The south eastern corner of the Kevin Wheatley Memorial Reserve.

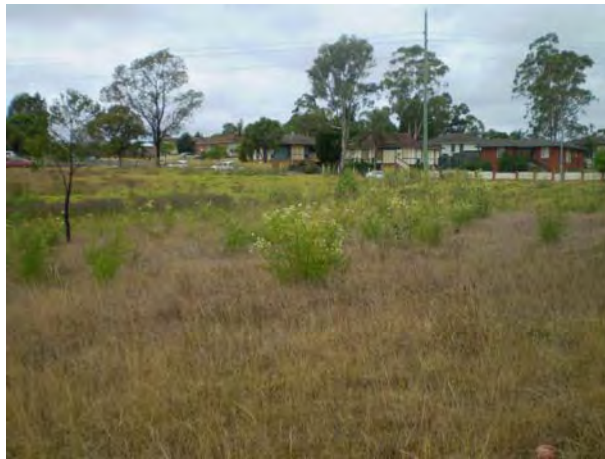
The northern section of the Corridor lies adjacent to a bus terminal and a substation on the western side. This section of the Corridor comprises partially cleared bushland, with evidence of tipping of general household rubbish.

Photo 17. Smiths Creek Bypass Corridor north of Briar Road.

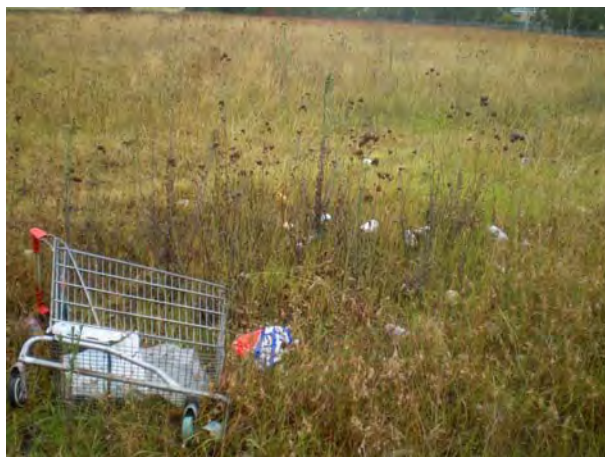
Photo 18. General rubbish in the central portion of the Smiths Creek Bypass Corridor.

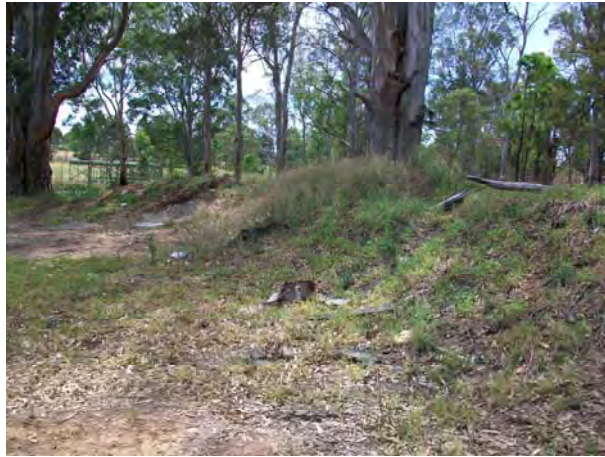
A soil stockpile was identified in the western portion of the Corridor, along the northern end of Creigan Rd. The stockpile appeared to be placed to prevent surface water runoff from the Corridor onto the road, or to prevent vehicular access to the Corridor. The stockpile was approximately 1 m high 2 m wide and 30 m long, and appeared to comprise gravelly silty clay. Minor amounts of roadbase, sandstone and ironstone gravels were identified on the surface of the stockpile. The stockpile was covered in grass which prevented a detailed visual inspection. No suspected ACM was identified on visible areas of the surface of the stockpile, or at the footing of the stockpile.

Photo 19. Stockpiled material adjacent to Creigan Rd.

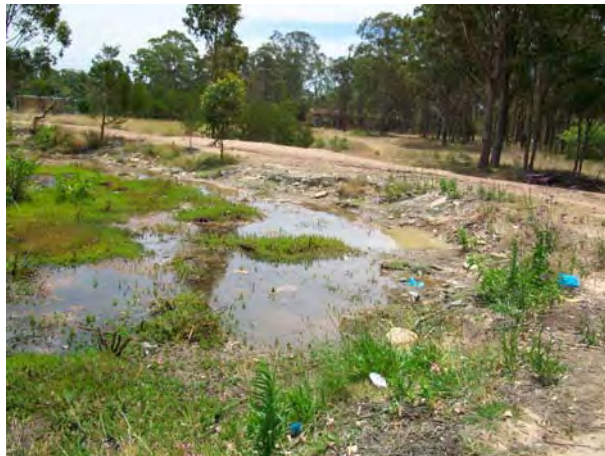
The area lies adjacent to the Smiths Creek Bypass Corridor and comprises open grassed areas with a gentle slope to the west towards the Corridor. A dam with visibly healthy water plants is located to the west of the Sports Centre. The dam banks appear to be comprised of gravelly silty sand fill material on the western and northern sides. A number of pipes are located in the northern and southern portions of the dam, providing inflows presumably from local surface drainage, and an outlet for any overflowing water.

Photo 20. Dam to the west of the Indoor Sports Centre.

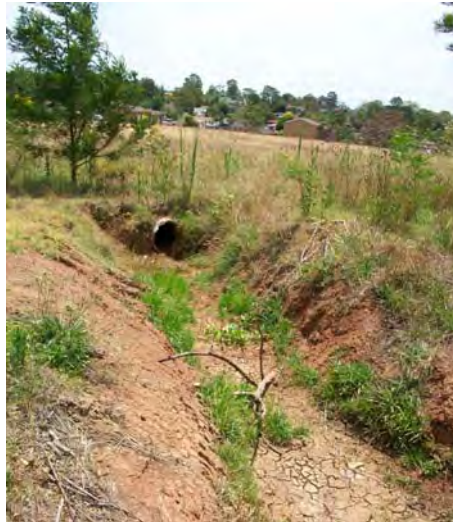
Photo 21. Overflow pipe from the dam.

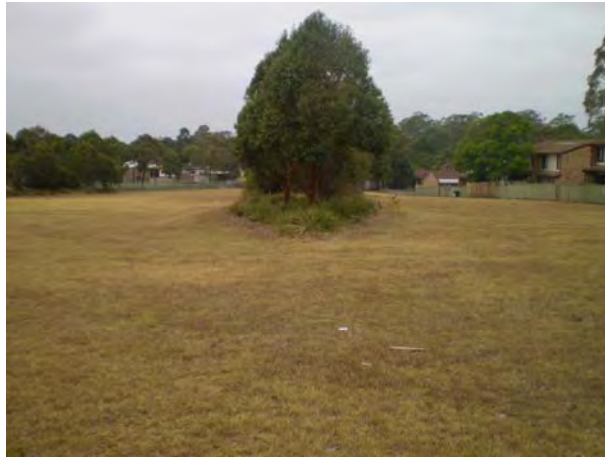
A single fragment of suspected ACM was identified on the surface in the western corner of the reserve. There are no significant areas of bare soil or stressed vegetation.

Photo 23. The Baden Powell Reserve

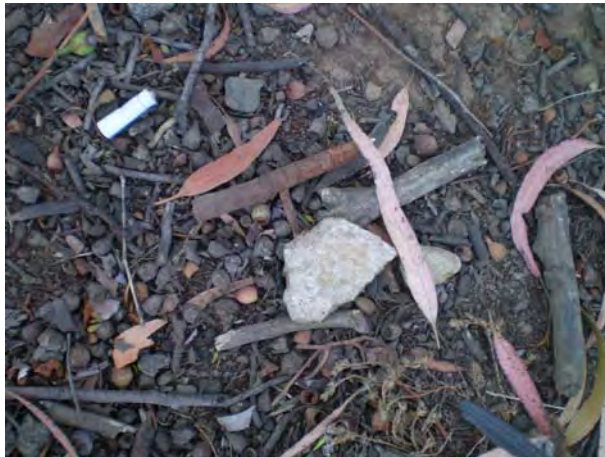
Photo 24. ACM identified in the western corner of the Baden Powell Reserve

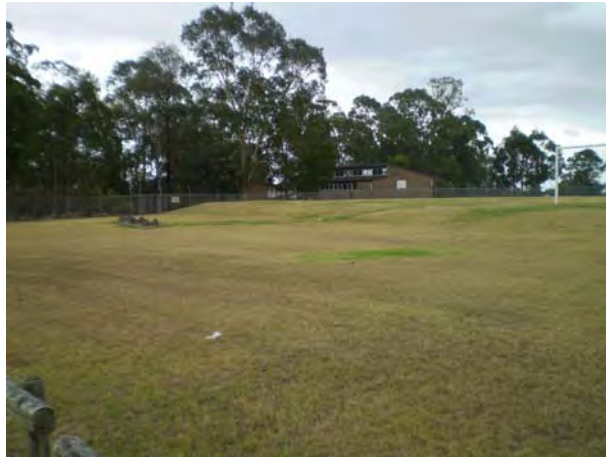
The Park is generally flat with a steep 1m rise to the playing field area, which appears to be fill material imported to create a flat playing surface.

Photo 25. Riley Park

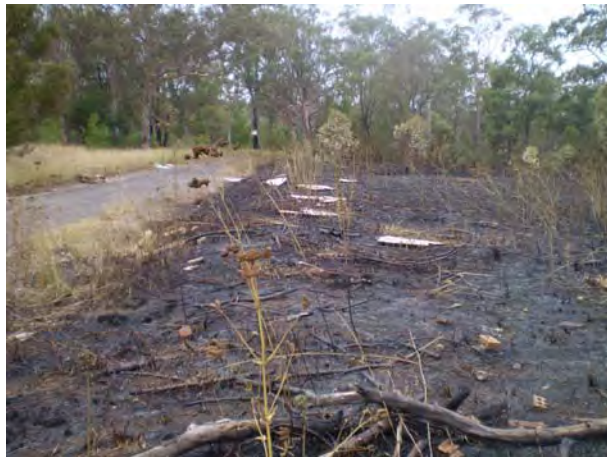
Minor amounts of general household rubbish were identified in several locations along the Reserve. General rubbish, ashes and burnt grass were identified at the eastern end of Woolwash Rd. A second (apparently older) burnt area was identified in the northern portion adjacent to Peppin Cr.

Photo 26. Rubbish, ashes and burnt grass at the end of Woolwash Road in the Georges River Parkway Reserve.

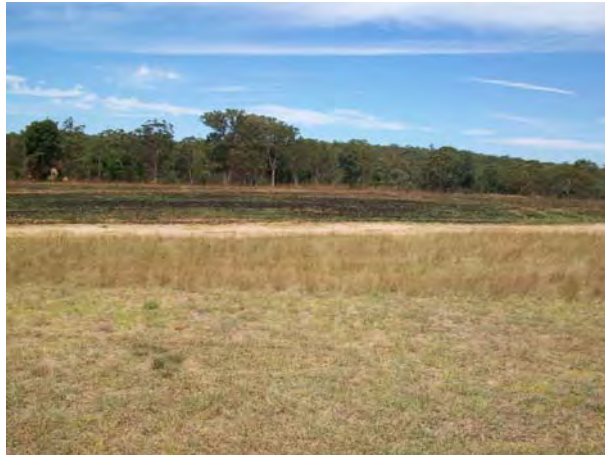
Photo 27. Burnt area adjacent to Peppin Cr in the northern portion of the Georges River Parkway Reserve.

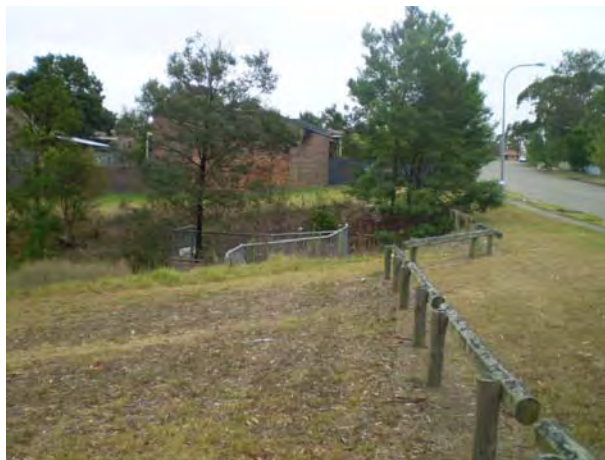
There were no significant amounts of rubbish or dumped material in the Reserve. There was no evidence of stressed vegetation.

Photo 28. Stormwater Drain in Hagan Reserve.

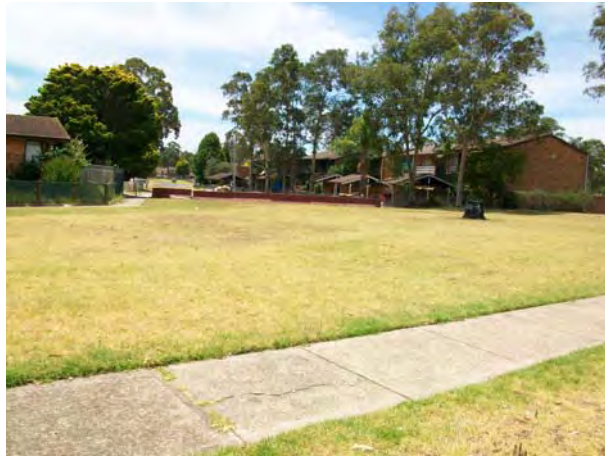
A cleared grassed area with occasional trees is located along the northern site boundary. The area is relatively flat with some small rolling hills. Properties in the Elmslea and Tiverton Precincts back onto the area. A volleyball net is constructed in the western portion adjacent to Riverside Dr. The area was generally clear of household rubbish and dumped materials.

Photo 29. Grassed area along northern site boundary.
