Preliminary Geotechnical Investigation and Dam Embankment Investigation Airds and Bradbury Redevelopment Project St Johns Road, Greengate Road and Georges River Road, Airds, NSW

Ref: JG09245A

April 2009

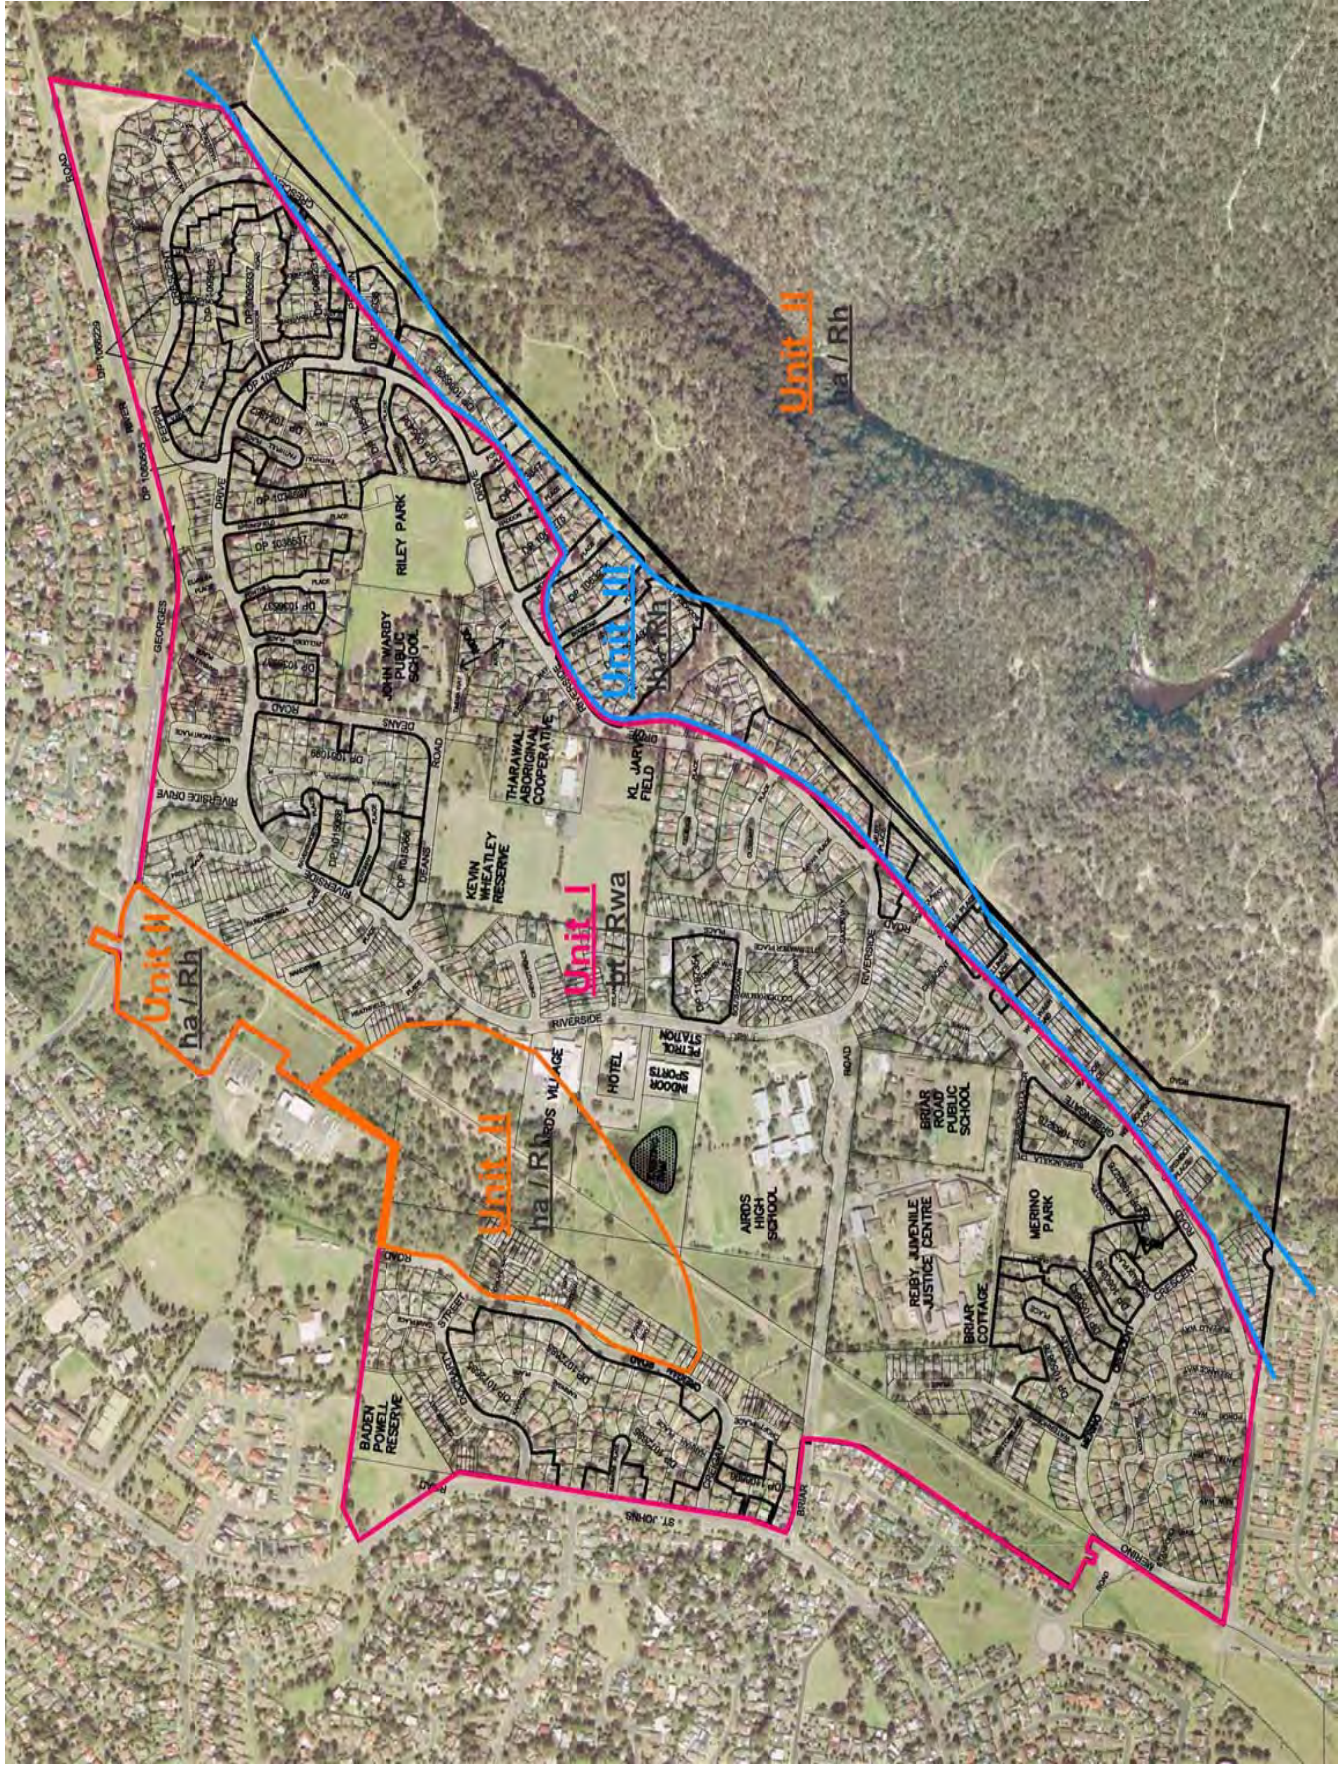
JBS Environmental Pty Ltd	Project No:	JG09245A	Drawing No: 2
Airds/Bradbury Redevelopment			
Soil Landscape and Geological Units

- Unit II - Hawkesbury Soil Landscape group (Ha) of colluvial origin at the lower slopes along the eastern perimeter of the site and the proposed road reserve to the north west of the school and community areas. Typical soil consists of earthy sand, yellow earths and some yellow podzolic soil on the inside of sandstone benches and along joints and fractures.

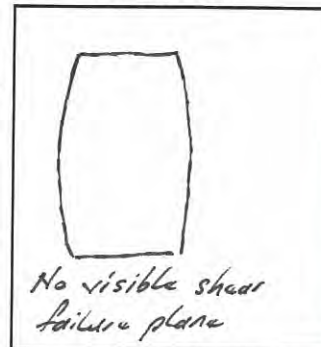
Failure Mode

SAMPLE INFORMATION				
Specimen No :		1	2	3
Moisture Content Before (%)		10.3		
Dry Density Before (t/m ³)		1.95		
Moisture Content After	Top (%)	19.7		
	Centre (%)	21.9		
	Bottom (%)	21.5		
Sample Size (mm)		50 x 99

- ☒ Consolidated ☐ Drained ☒ With pore pressure measurement
☐ Unconsolidated ☒ Undrained ☐ Without pore pressure measurement
☒ Sample stage tested ☐ Separate sample for each stage
