VOLUME 2 APPENDICES J - P

WAGGA WAGGA BASE HOSPITAL

BASELINE ARCHAEOLOGICAL ASSESSMENT

WWBH MASTERPLAN DEVELOPMENT
HELICOPTER NOISE ASSESSMENT

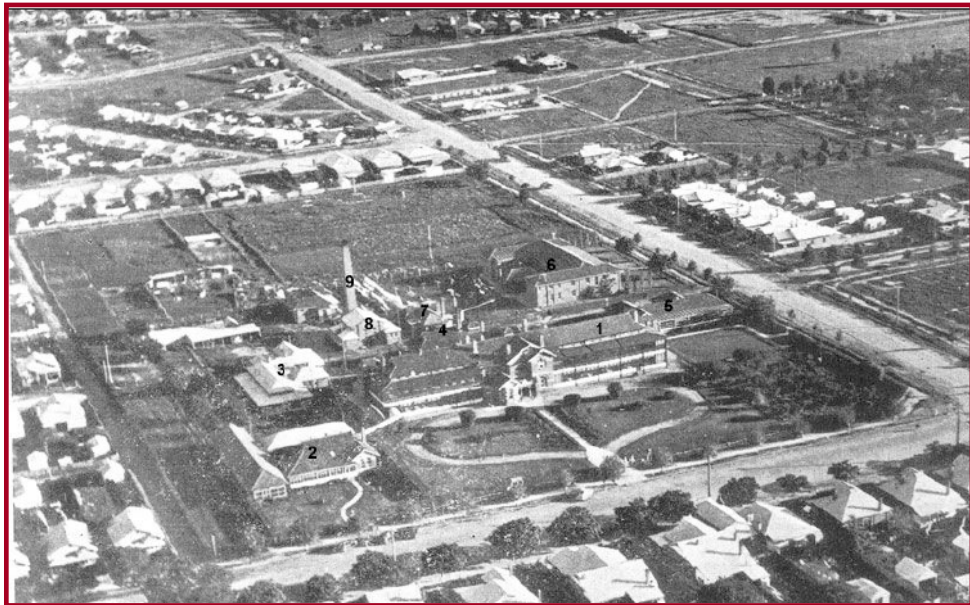
Aerial Photograph of Wagga Wagga Base Hospital, 1943

By 1943 the hospital had grown into a complex of buildings, services, and landscapes including a kitchen garden to the south of the site (Figure 8).

Gardening and landscaping, seen in changing garden beds, trees, hedges and pathways were a part of the hospital from its commencement on the study site. The patterns of gardening seen in Figures 7, 8 and 9 demonstrate changes over time within the hospital layout. These changes also indicate how the landscaping and gardens reflected the continual growth of the hospital where over time there was less need for gardens, more for buildings, and post war, for car parking.

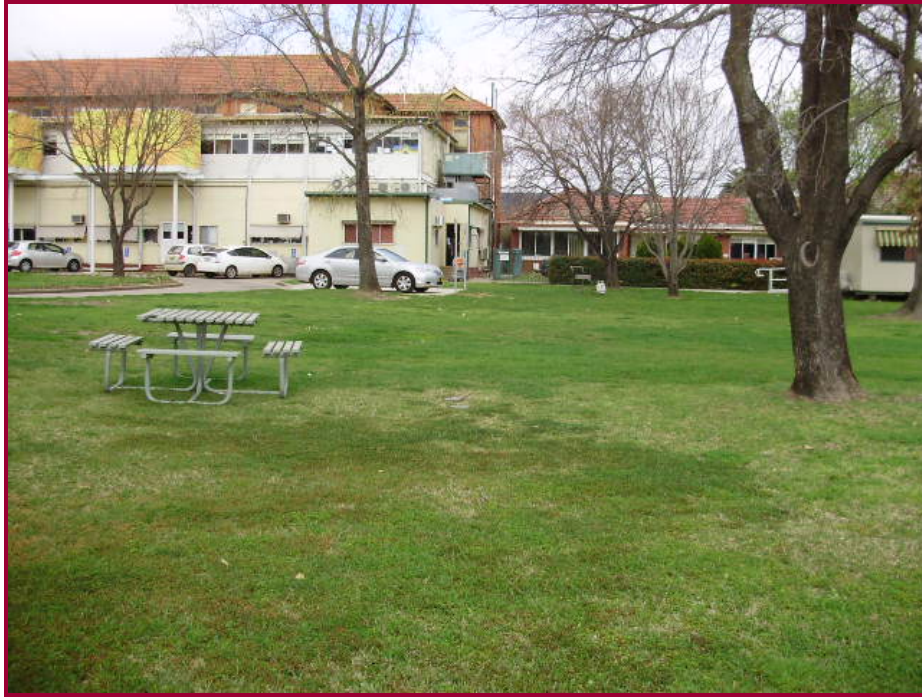
Figure 3. View facing South across the Edward Street lawn, showing lack of original vegetation and homogenized nature of the landscape.

- Across the entire site, the majority of original vegetation has been removed. The process of vegetation clearing (especially removal of tree roots) and resultant construction activities has significantly disturbed original topsoils. Aboriginal objects within the affected soils would have been upturned; and
- Previous land uses would have disturbed remnant original topsoils to a depth of approximately 150 mm. The stratigraphic integrity of any of the Aboriginal objects located within this 'disturbance zone' would have been compromised.

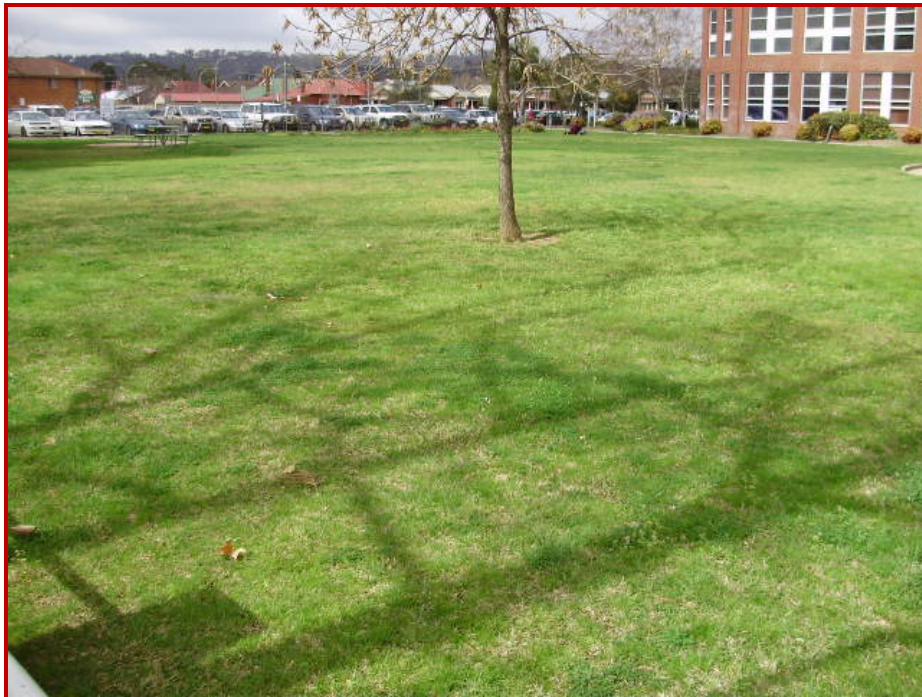
Figure 4: Approximate location of the former Rawson House facing Edward Street.

The one area of exception is Rawson House, the archaeological remains of which may have been retained largely intact (Figure 4). This structure appears not to have been recorded in any detail and information about it and its use do not seem to have been retained in public records. This information may be retained in the archaeological record.

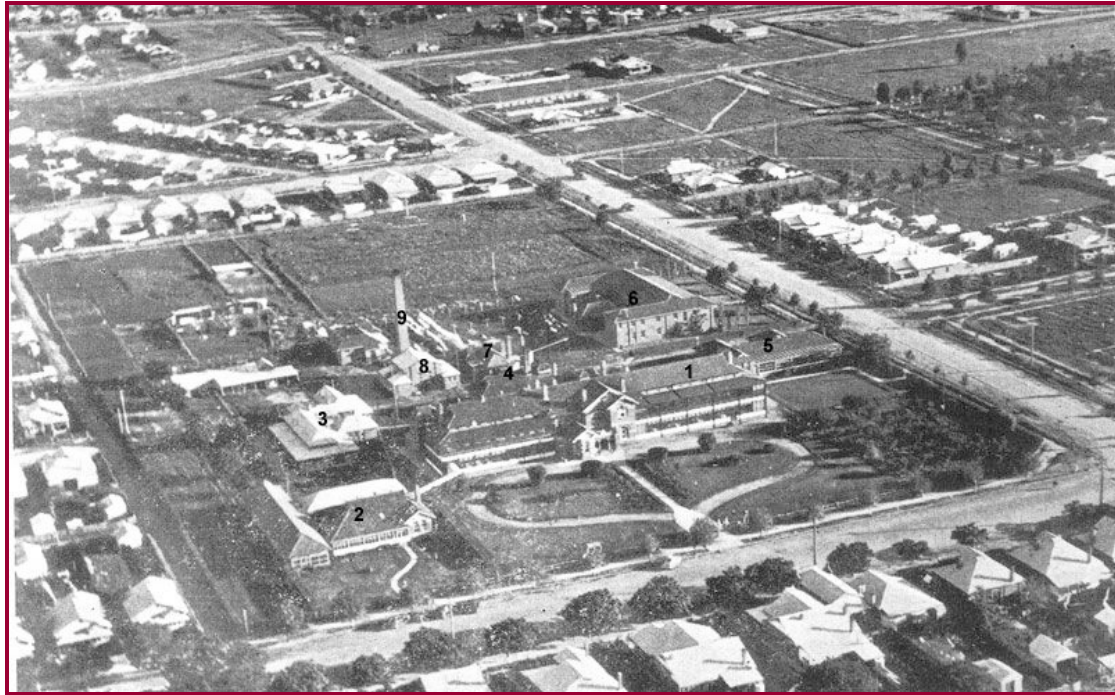
Figure 8: Aerial photograph of Wagga Wagga Hospital, 1943.

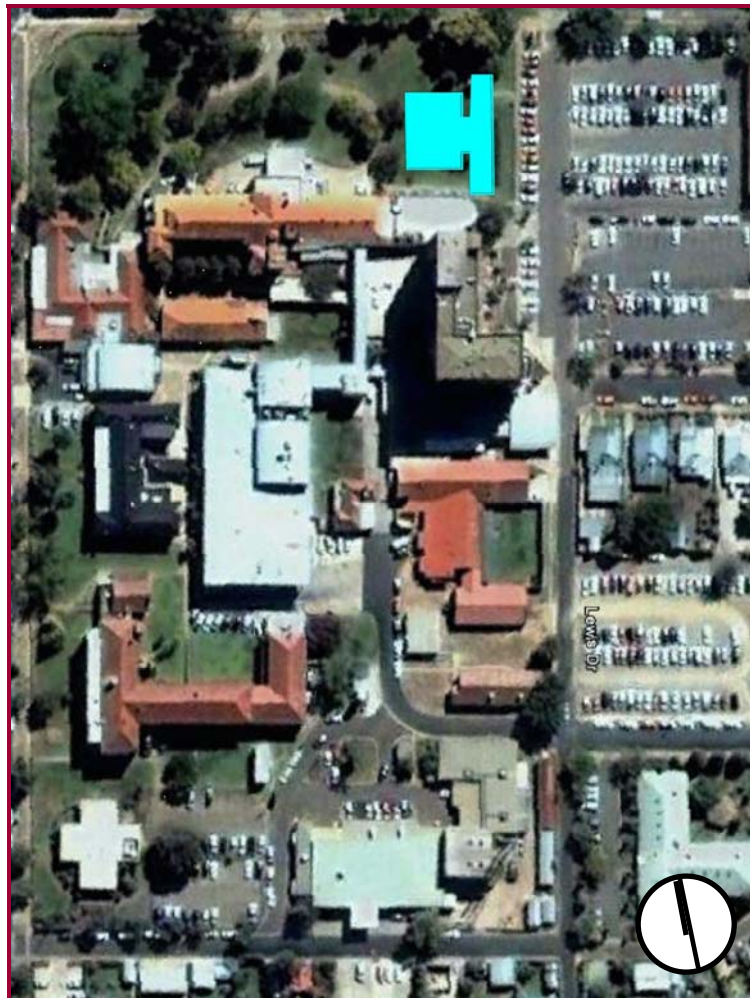
Figure 10: Image in Blue indicates the location of the former Rawson House (light blue) within the Wagga Wagga Base Hospital site.

Figure 10 below indicates the location of the Rawson House archaeological remains (light blue) relative to current structures and features at the site.

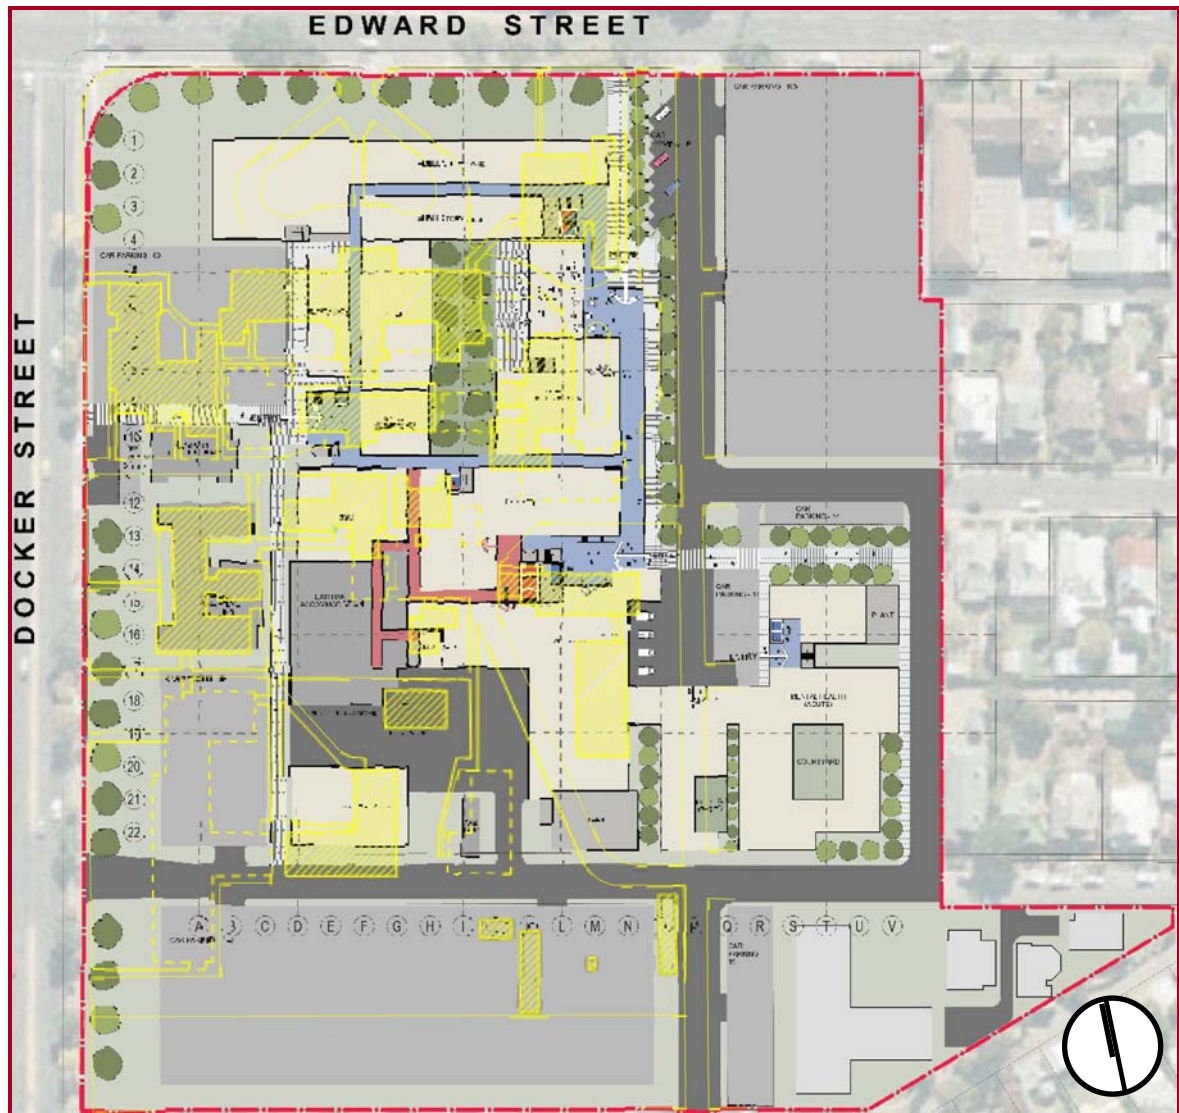
Figure 11: Overlay of the 1956 Wagga Wagga Base Hospital (yellow) over proposed development plan.

Overlays of the 1956 plan of the Wagga Wagga Base Hospital with the footprint of the proposed new works (Figures 11 and 12), indicate that nearly all current buildings and historical archaeological resources will be impacted by the proposed new works. This includes the remains of Rawson House which would be disturbed to make way for the proposed new Ambulatory Care and Health Information buildings.

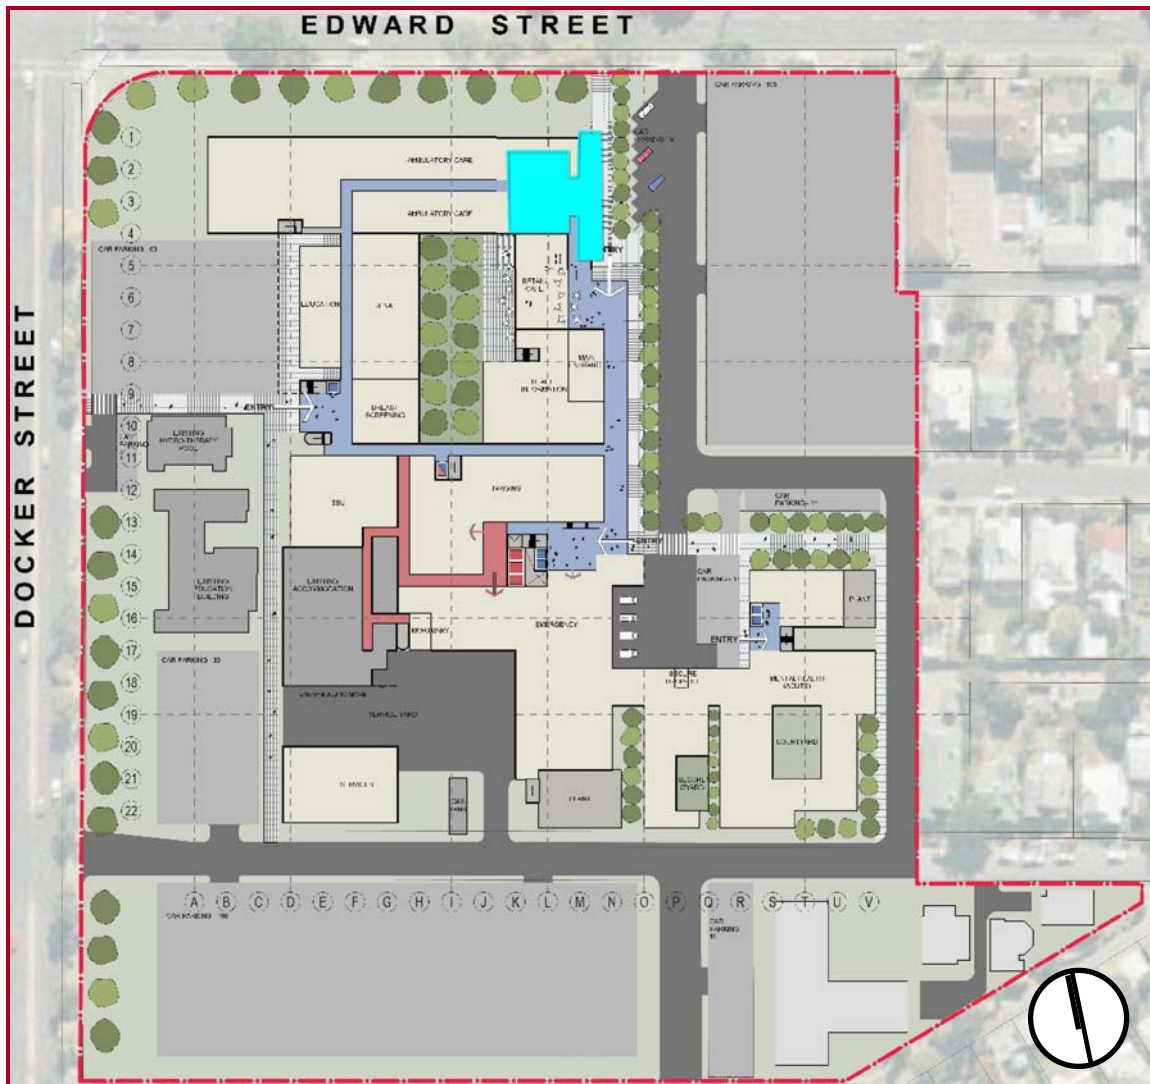
Figure 12: Location of Rawson House site (light blue) in relation to proposed development plans.

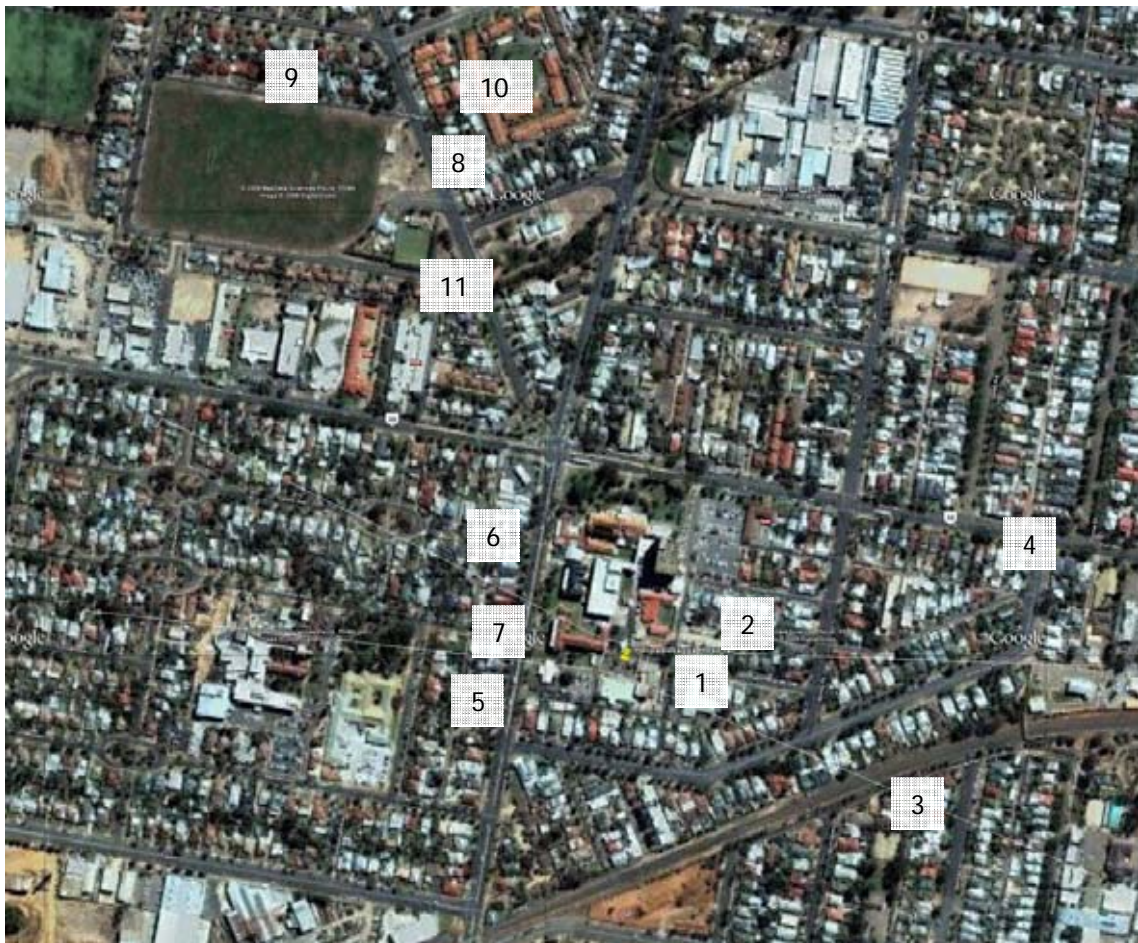
Figure 2-3 Location of Sensitive Receivers

Location	Closest Helipad
1. Yathong Street	Proposed
2. Yabtree Street	Proposed
3. Norman Street	Proposed
4. Cnr Brookong Avenue and Sturt Highway	Proposed
5. Hardy Avenue	Proposed
6. Gormly Avenue	Proposed
7. Dwyer Avenue	Proposed
8. Bolton Street	Existing
9. North Parade	Existing
10. Turana Lane	Existing
11. Cnr South Pde and Shaw Street	Existing

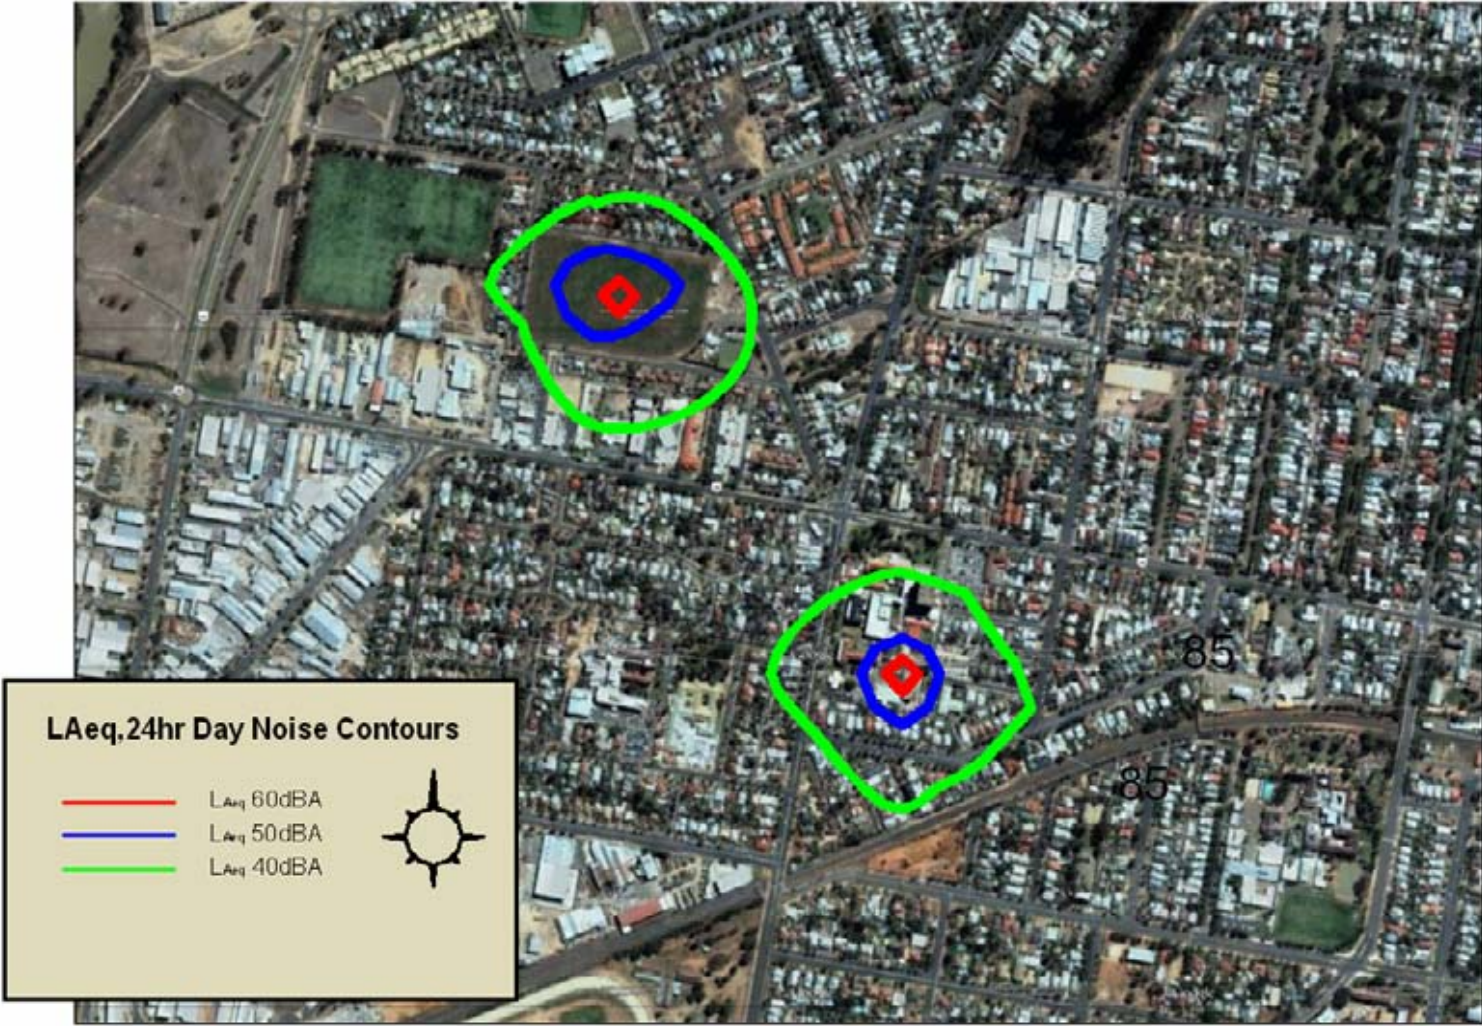
Figure 4-1 LAeq 24hour Noise Contours

Heliport	Number of Houses Inside	Number of Houses Inside	Number of Houses Inside
	$L_{Aeq,24\text{hr}}$ 40 Contour	$L_{Aeq,24\text{hr}}$ 50 Contour	$L_{Aeq,24\text{hr}}$ 60 Contour
Existing	7	0	0
New	40	0	0
