ENVIRONMENTAL SITE ASSESSMENT

**78 – 90 OLD CANTERBURY ROAD
LEWISHAM, NSW**

Report No. E1074.1 AF

7th October, 2009

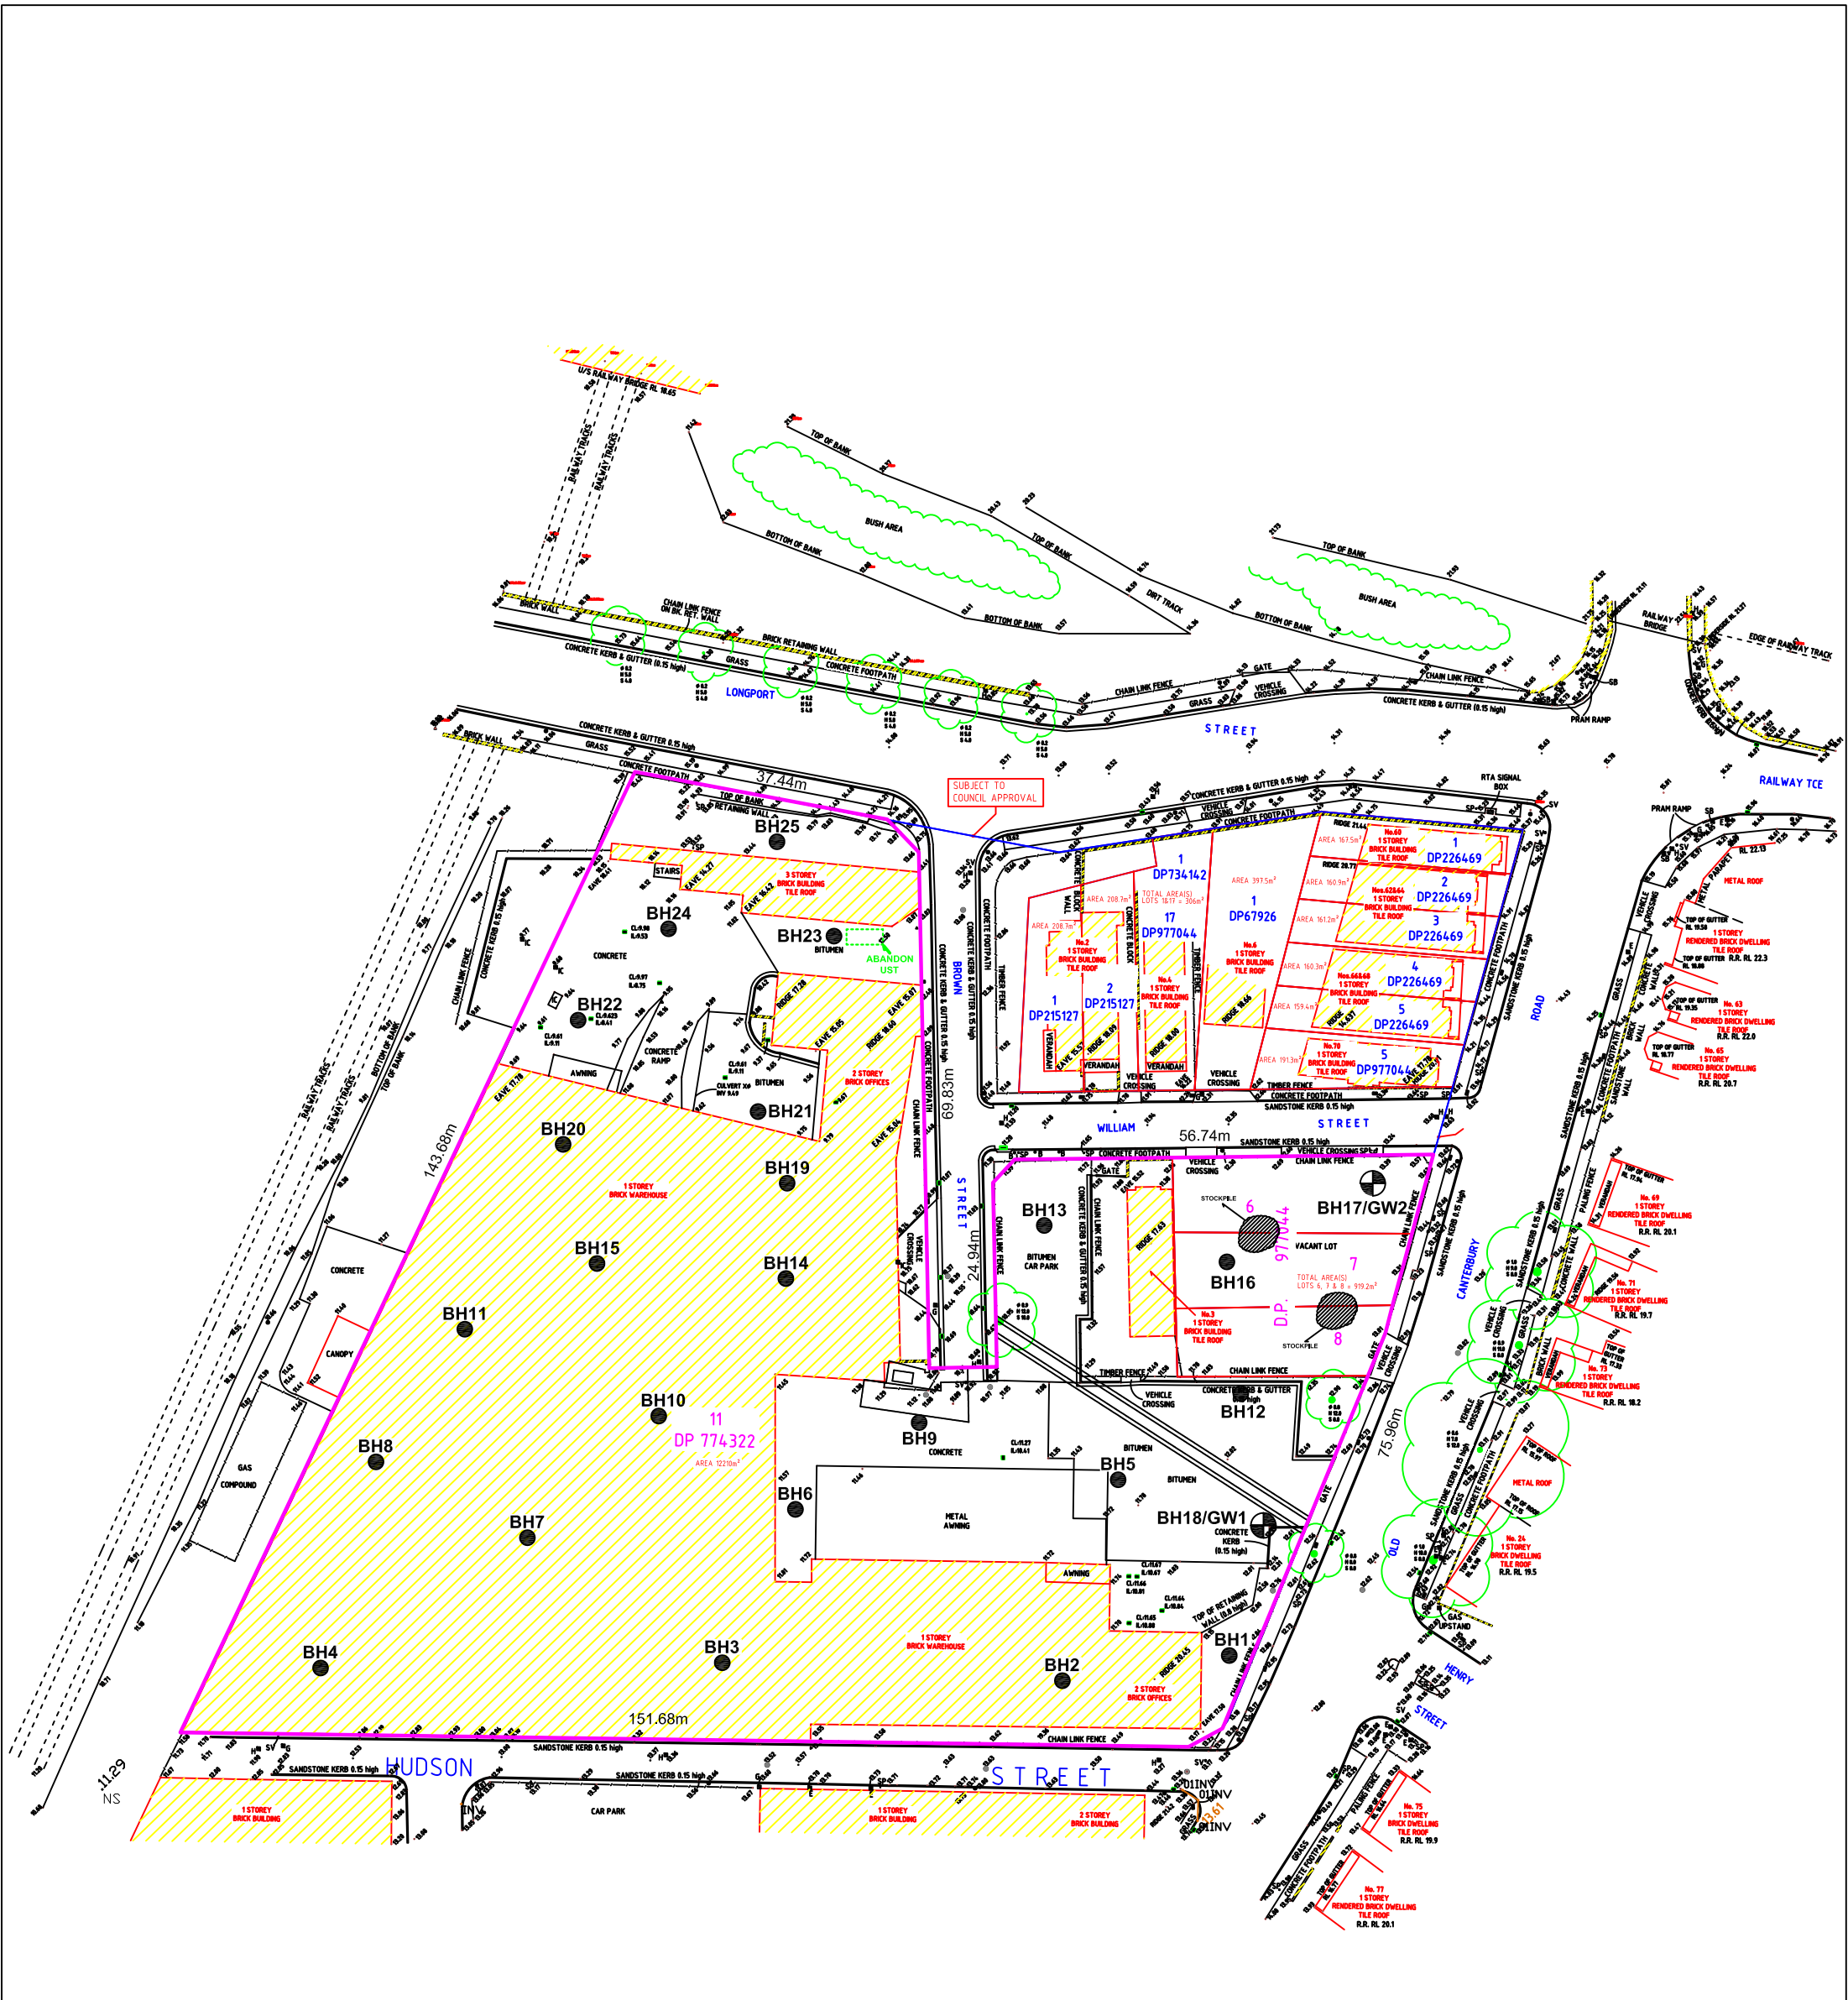
- Borehole Locations
- Borehole / Monitoring Well Locations
- Approx. Site Boundaries

P O Box 215, ST PETERS 2044 Ph (02) 9516 0722 Fax (02) 9516 0741	Drawn:	V.J	Lewisham Estate Pty Ltd Environmental Site Assessment 72-78 Old Canterbury Road, Lewisham, NSW. Sampling Location Plan	Figure:
	Approved:	E.G		2
	Date:	07-10-09		Project: E1074.1
	Approx Scale:	N.T.S
