MIXED RETAIL AND RESIDENTIAL DEVELOPMENT

**78 -90 OLD CANTERBURY ROAD,
LEWISHAM. NSW**

PRELIMINARY GEOTECHNICAL ASSESSMENT

**Environmental Investigations
Report No. E1195.1 GA**

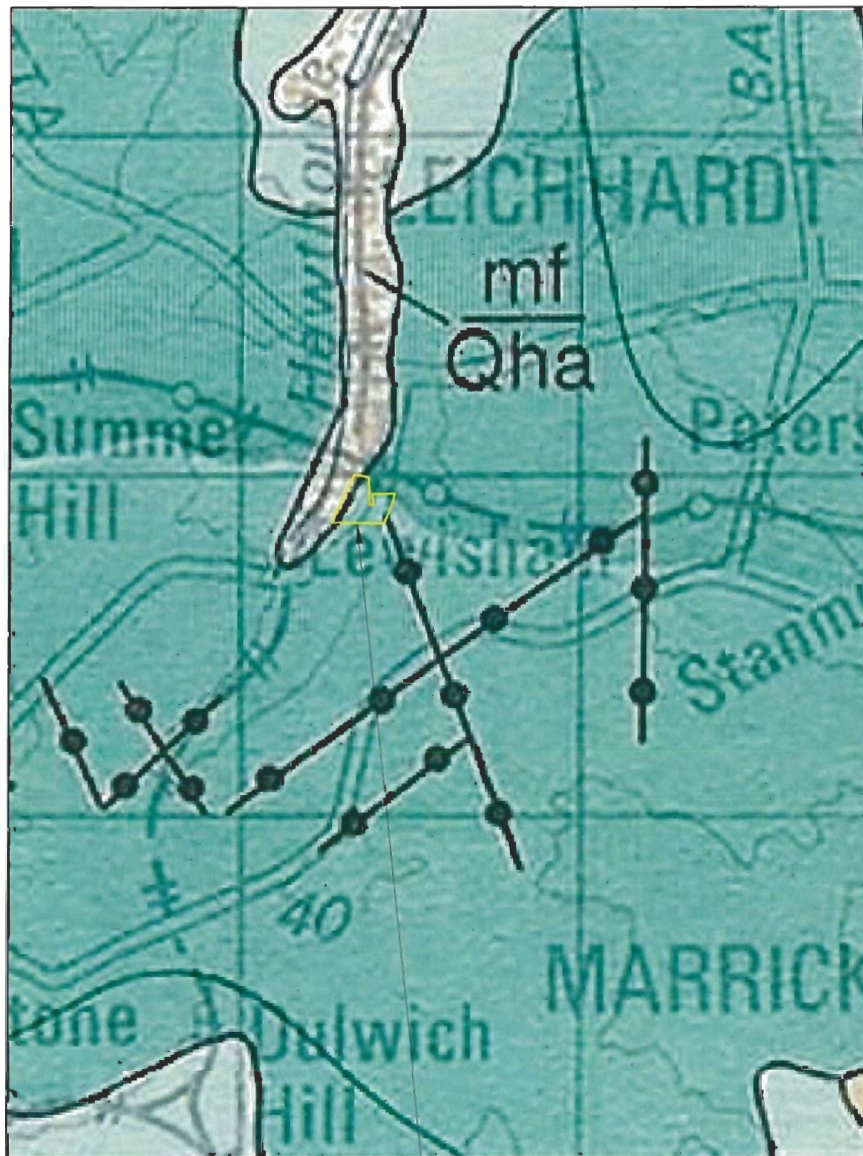
Figure 2 – Regional Geology

The 1:100,000 Penrith Geological Map indicates the site is underlain by Ashfield Shale, with Quaternary alluvium to the west, as shown in the attached Figure 2. The alluvium is likely associated with a drainage depression or previous creek. The shale bedrock typically weathers to form residual clay soils of medium to high plasticity.

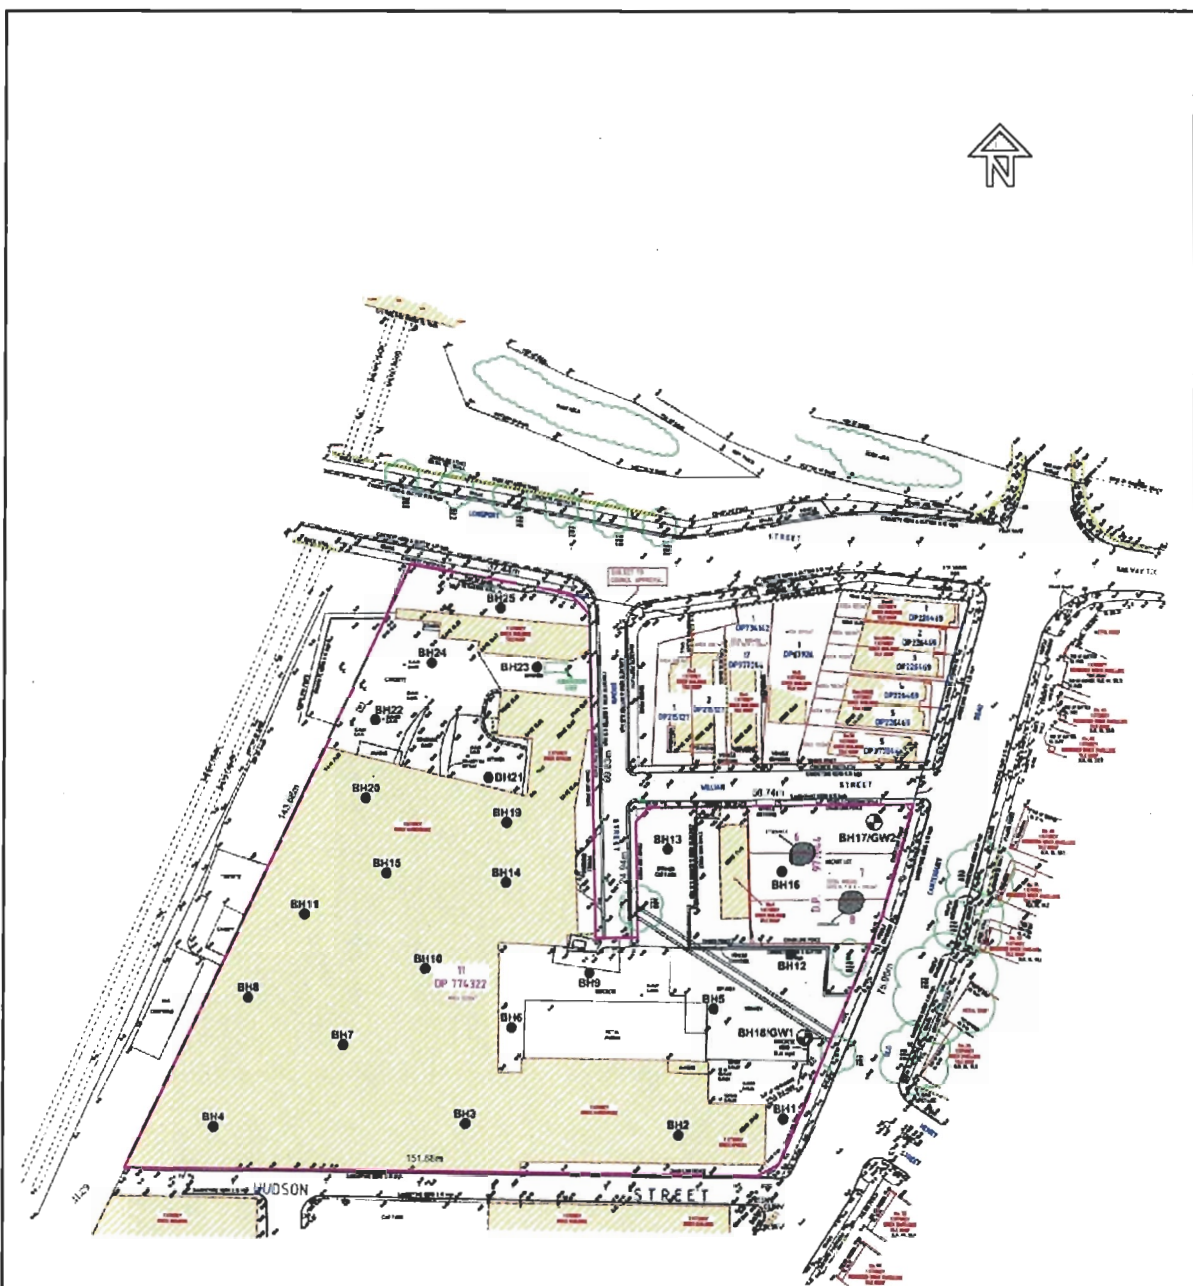
Figure 3 – Test Locations

- Borehole Locations
- ⊙ Borehole / Monitoring Well Locations
- Approx. Site Boundaries

The subsurface investigation carried out by Environmental Investigations indicated a generalized subsurface profile comprising:

- Filling materials of grey / brown to grey and yellow, red and orange gravel, silt, sand with rootlets, moderate plasticity, ranging in thickness between 0.35m and 1.6m below ground level; overlying
- Natural light grey silty sand/sandy clay, fine to medium grain/medium plasticity; overlying
- Natural orange/red/grey highly weathered sandstone, medium grained (encountered in 17 of the 25 boreholes drilled). The depth to the top of sandstone in the 17 boreholes ranged from 0.2m to 3.1m (average 1.2m) and these holes encountered refusal of the tungsten carbide tipped auger at depths ranging from 0.5m to 3.25m (average 1.5m). TC refusal is assessed to be on Class 4 or possibly Class 3 Sandstone¹.
