**PRELIMINARY SITE INVESTIGATION
74-78 BELMORE STREET, RYDE,
NEW SOUTH WALES**

**ACHIEVE AUSTRALIA
C/- NBRS AND PARTNERS**

**PROJECT NO. 17900/8471B
REPORT NO. 11/0026**

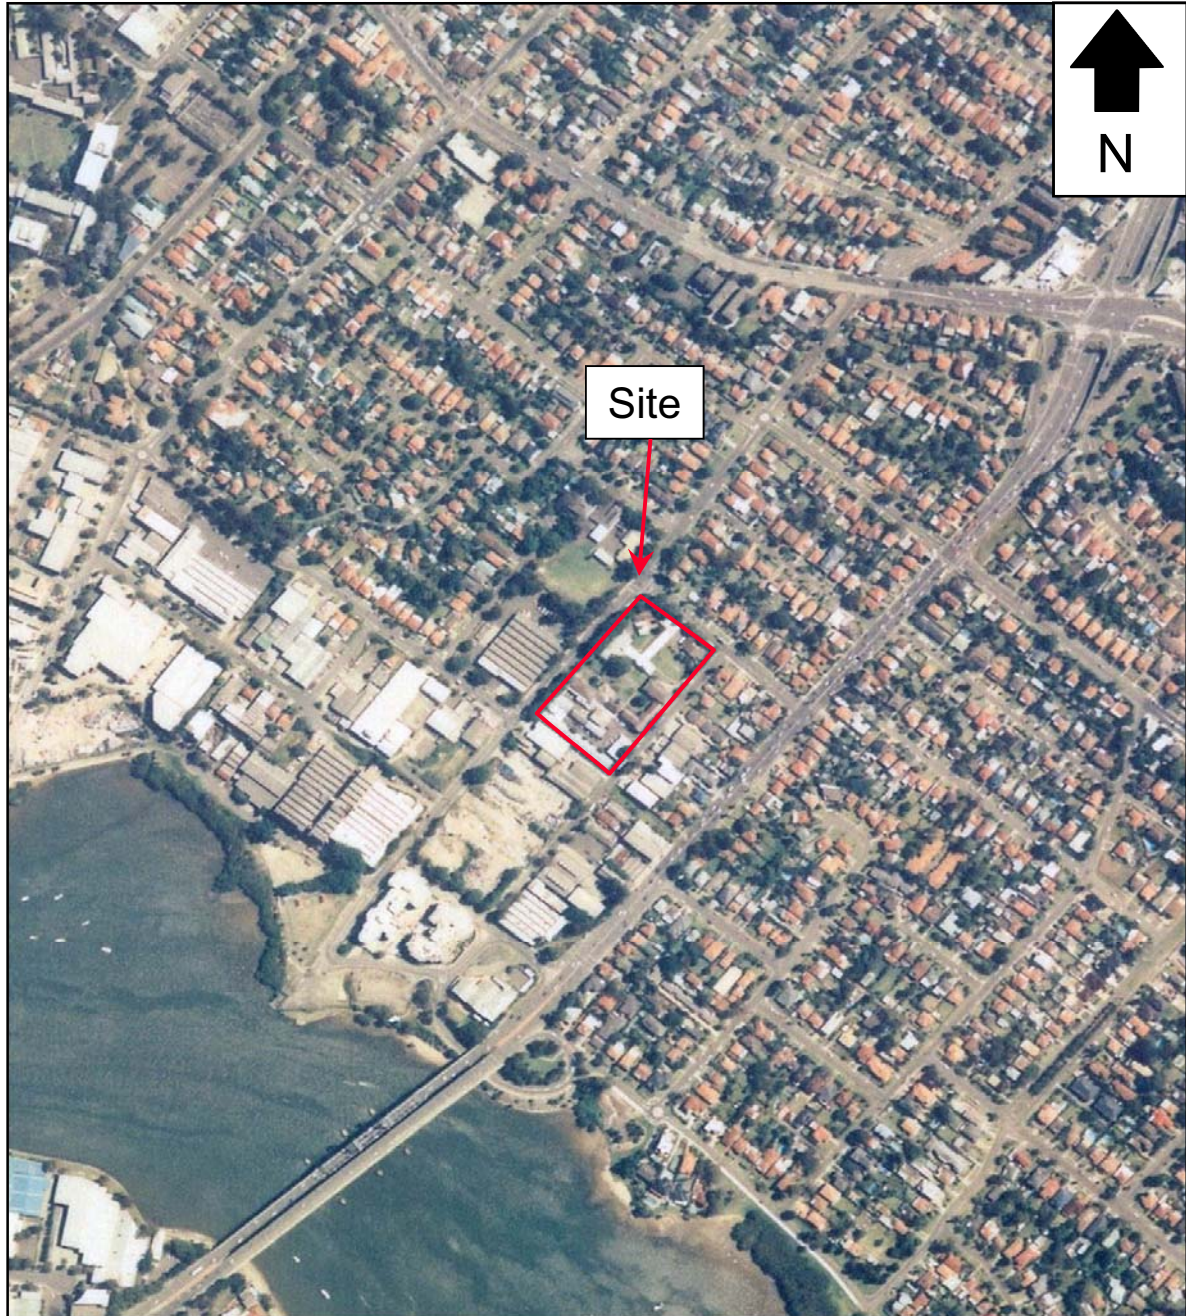
2005 Aerial Photograph Showing the Site and its Surrounds

2005	Site features are unchanged from those shown in the 1994 aerial photograph.	Surrounding land uses also remain unchanged.

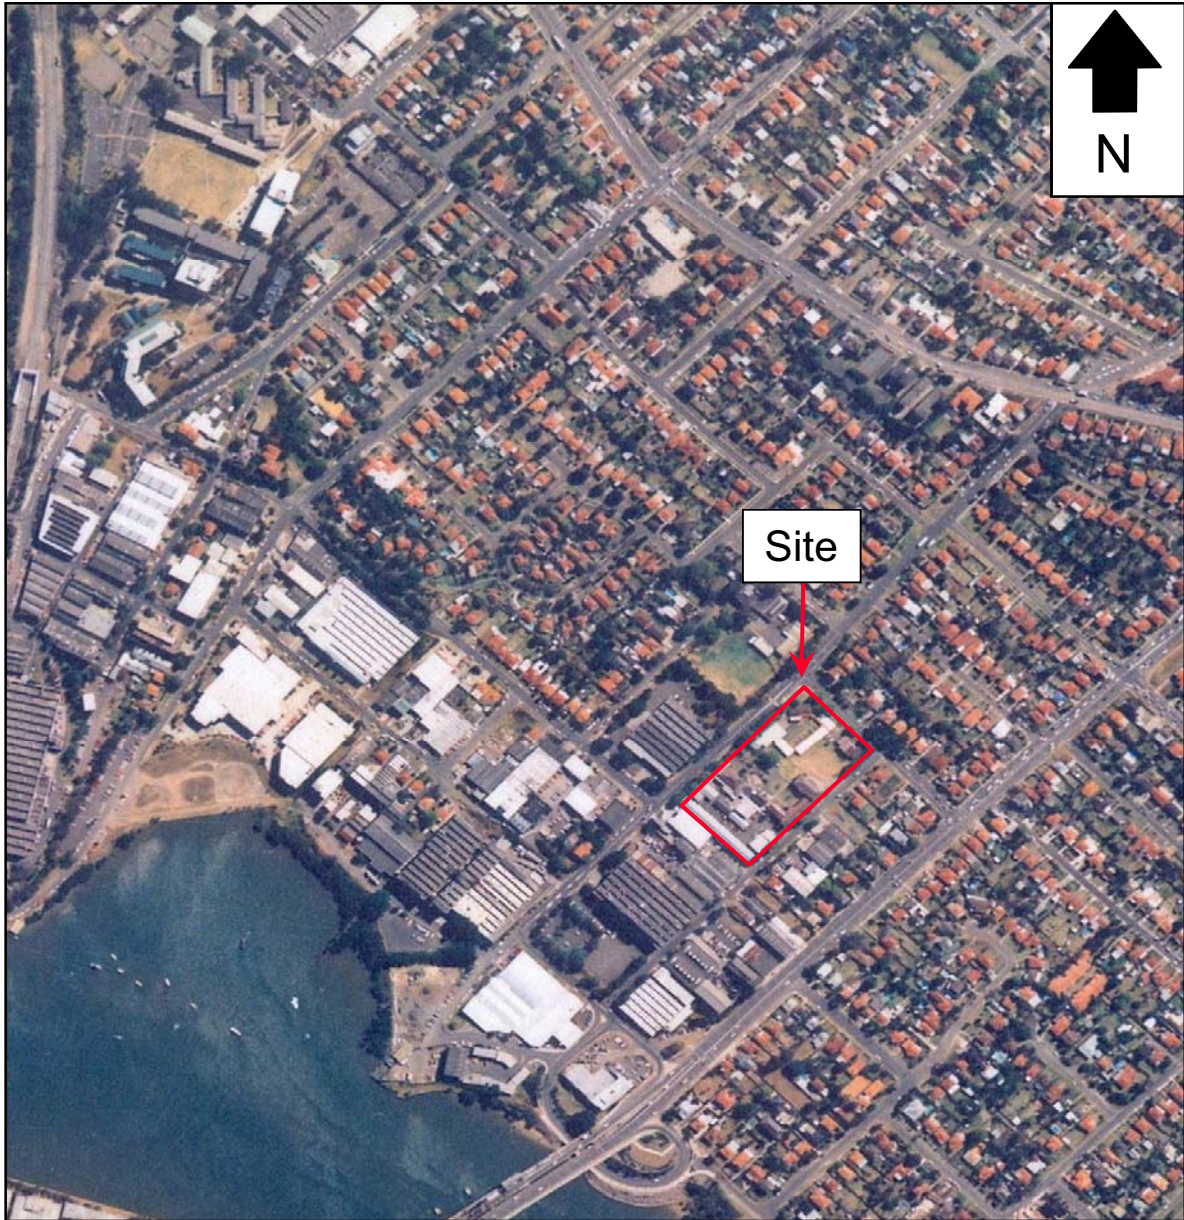
1994 Aerial Photograph Showing the Site and its Surrounds

Year	Site Features	Surrounding Land Use
1986	Site features are essentially unchanged from those shown in the 1970 aerial photograph, however, an additional building has been constructed in the north-eastern corner of the site. The grass cover in the vacant area in the north of the site is also more extensive than in the 1970 aerial photograph.	Surrounding land uses remain largely unchanged from those shown in the 1961 aerial photograph, however a new commercial/industrial buildings have been constructed on the land to the south-west of the site. Several small commercial/industrial buildings also appear to have been constructed on the land to the south-east of the site.
1994	Site features are largely unchanged from those shown in the 1986 aerial photograph. However, three new rectangular buildings have been constructed in the northern corner of the site.	Surrounding land uses also remain unchanged from the 1986 aerial photograph.

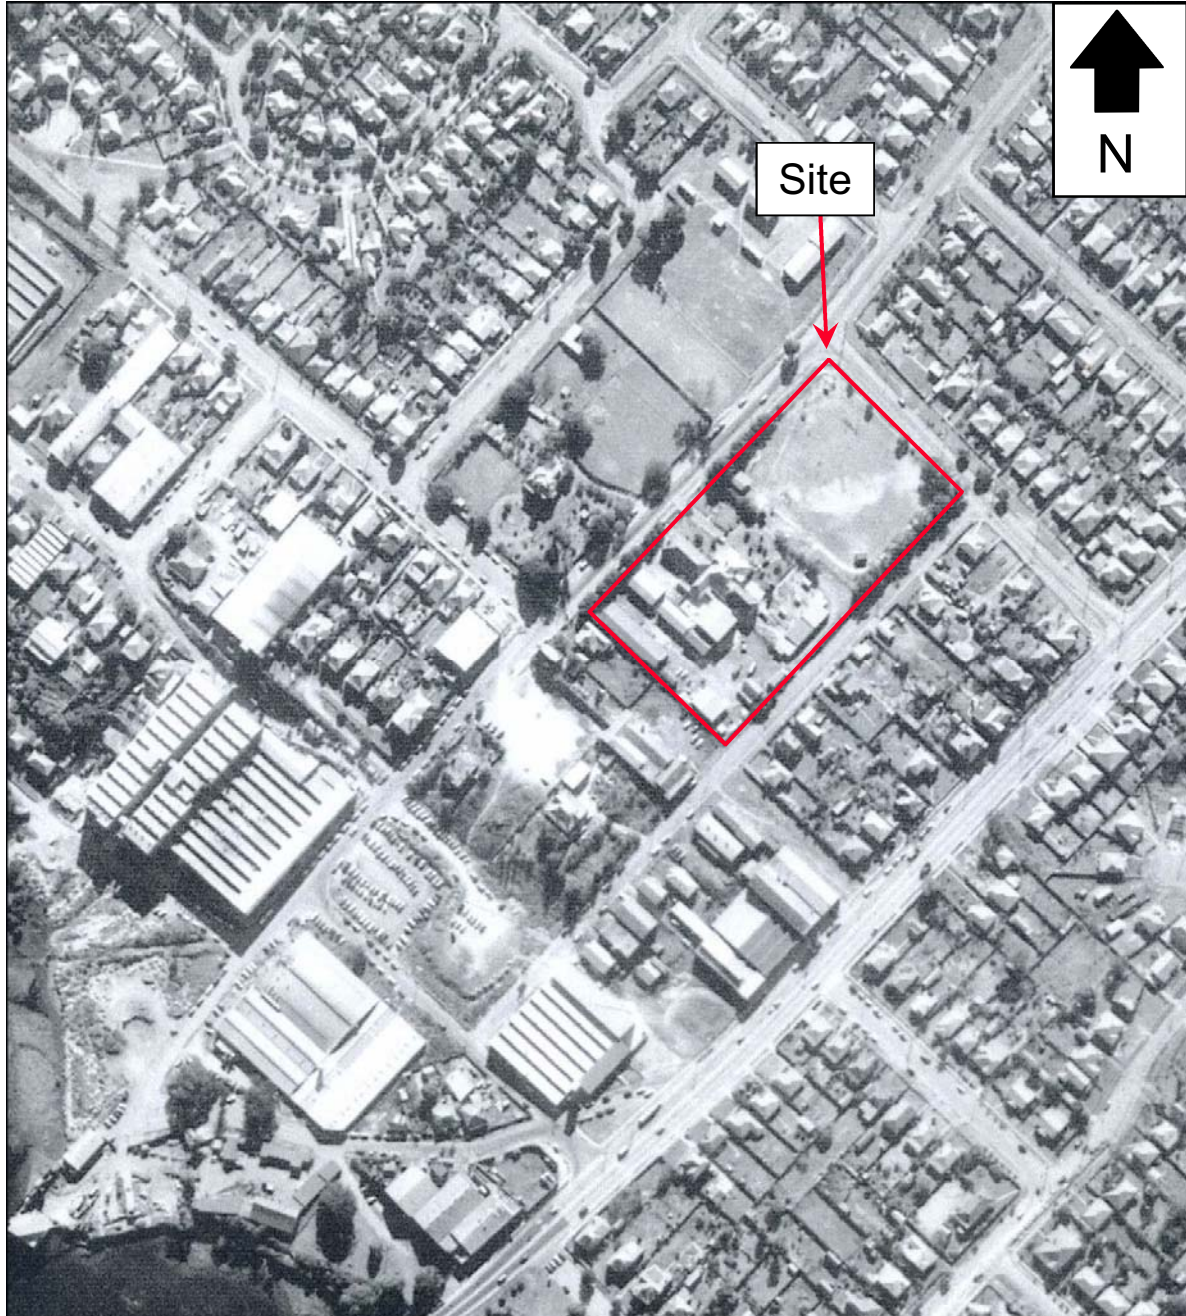
1961 Aerial Photograph Showing the Site and its Surrounds

1961	The southern portion of the site has undergone significant redevelopment, which has included the construction of numerous additional small buildings. The land surrounding the buildings appears to comprise sealed access roads/paths and car parking areas. Minor grass and garden areas are also visible. The northern portion of the site remains a vacant grassed area.	Surrounding land uses remain essentially unchanged, although the density of the surrounding residential develops has increased. The land to the south of the site also appears to have been developed for commercial/industrial purposes.
1970	The 1970 aerial photograph shows that a new elongate rectangular building has been constructed along the southern site boundary. Two additional buildings have also been constructed in the north of the site adjacent to Belmont Street. The remaining site features are essentially unchanged, however, the grass cover in the northern portion of the site appears to have become sparse with areas of bare earth showing.	Surrounding land uses remain largely unchanged from those shown in the 1961 aerial photograph, however new commercial/industrial buildings have been constructed on the land to the south. The previously existing residential buildings to the north-west of the site across Belmont Street have also been removed leaving a vacant and grassed area.

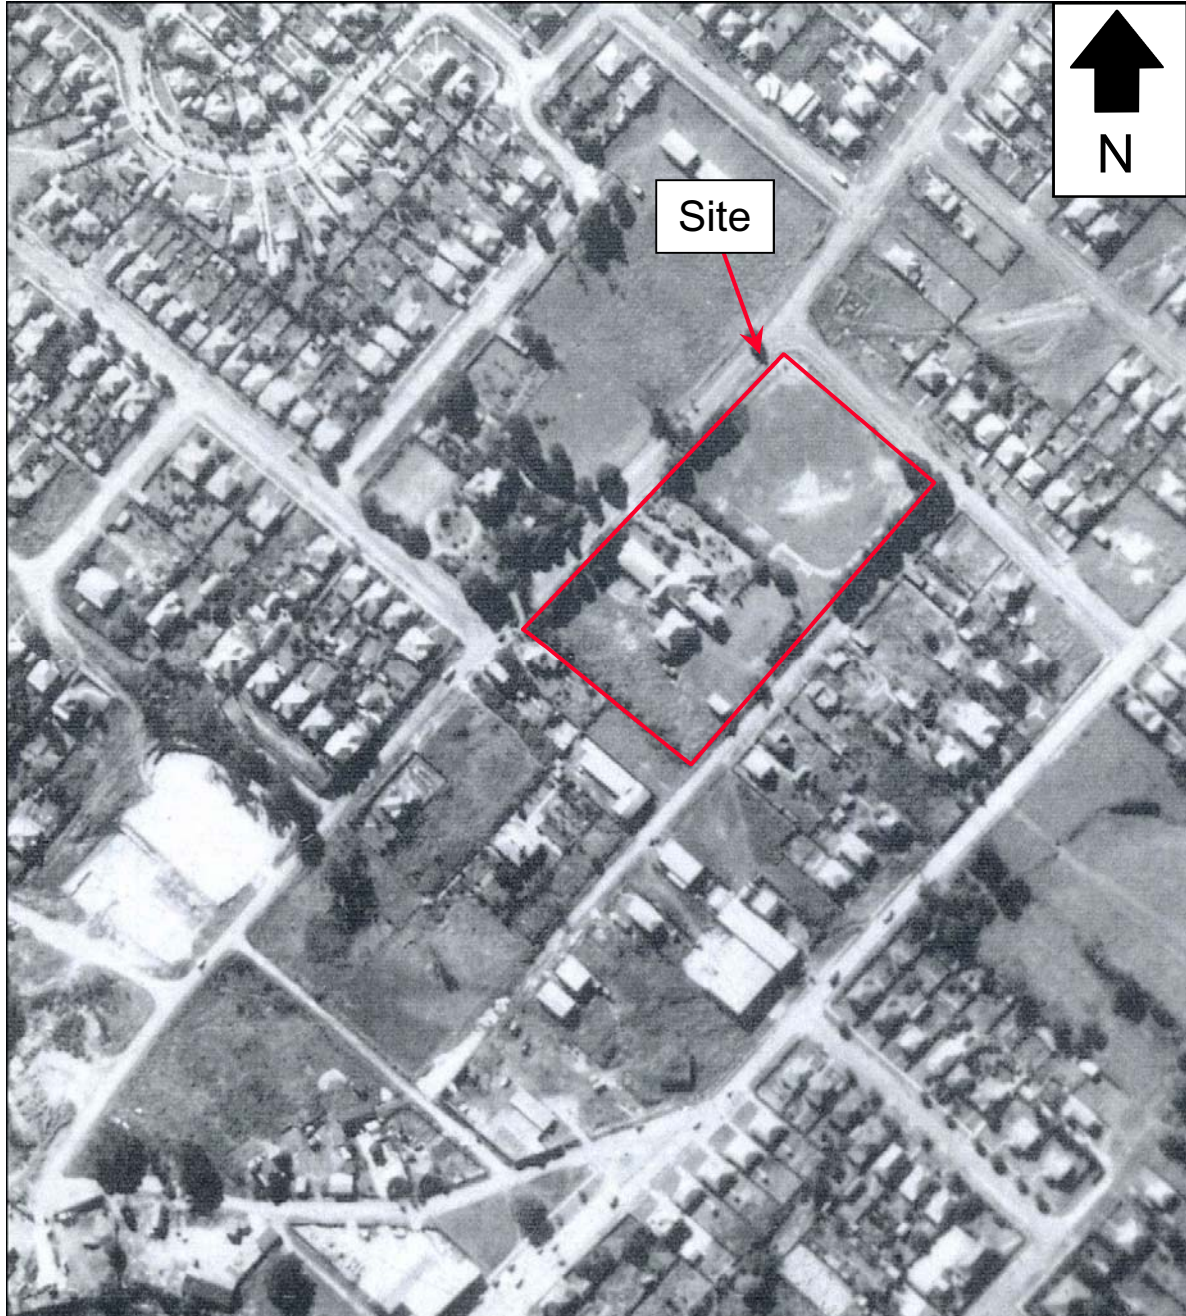
1951 Aerial Photograph Showing the Site and its Surrounds

Year	Site Features	Surrounding Land Use
1930	The quality of the aerial photograph is poor and site features are not easily distinguished. However, it can be ascertained that the northern portion of the site comprises a vacant grassed area. One main building that appears to be residential in nature is located in the central-southern portion of the site. Two smaller buildings or sheds are also located in the southern portion of the site. The land surrounding the buildings appears to be grassed.	Residential developments and areas of grassland surround the site.
1951	The site features remain essentially unchanged from those shown in the 1930 aerial photograph, however, several additional buildings have been constructed in the central-southern portion of the site. Small areas of sealed land also appear to be located to the north of the buildings.	Surrounding land uses also remain essentially unchanged.
