## 8 Surface Water and Hydrology

### 8.1 Introduction

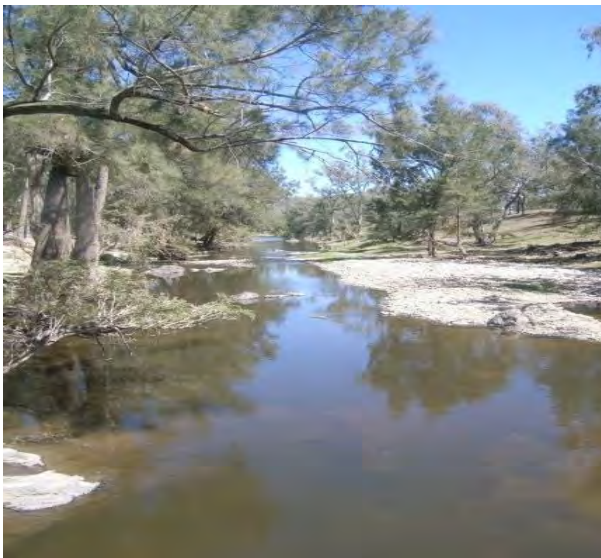
**Plate 8-1 View of Mole River North of Proposed Alignment**

**Plates 8-1 and 8-2** show selective surface water features observed within or in close proximity to alignment west during field investigations. Photograph locations are presented in **Figure 8-2**.

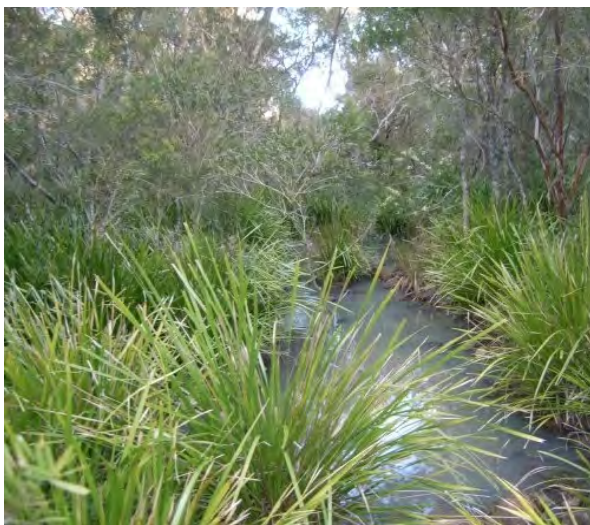
**Plate 8-3 Teatree Creek**

**Plates 8-3 – 8-4** show surface water features observed in proximity to alignment east during field investigations. Photograph locations are shown on **Figure 8-2**.
