Aboriginal and Historic Heritage Assessment

Far North NSW (Dumaresq to Lismore 330kV Transmission Line) Project

June 2011

Report Prepared by
OzArk Environmental & Heritage Management Pty Ltd
for URS
on behalf of
TransGrid

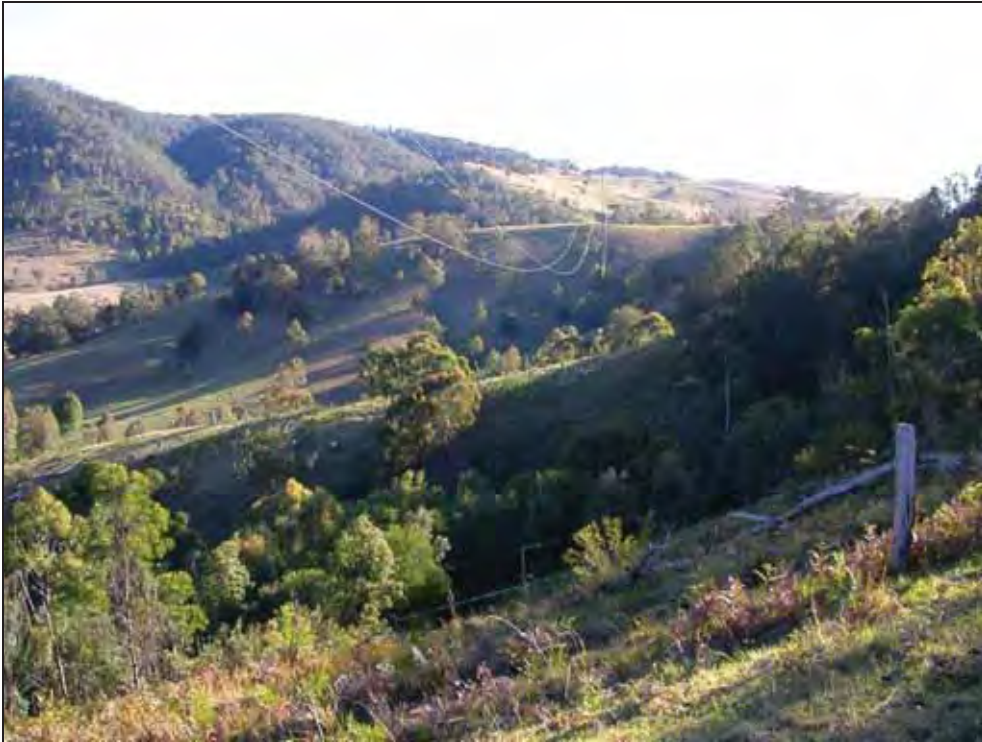
Plate 2-2: Landscape near the Clarence River. Note the easement cutting through regenerating woodland in the distance.

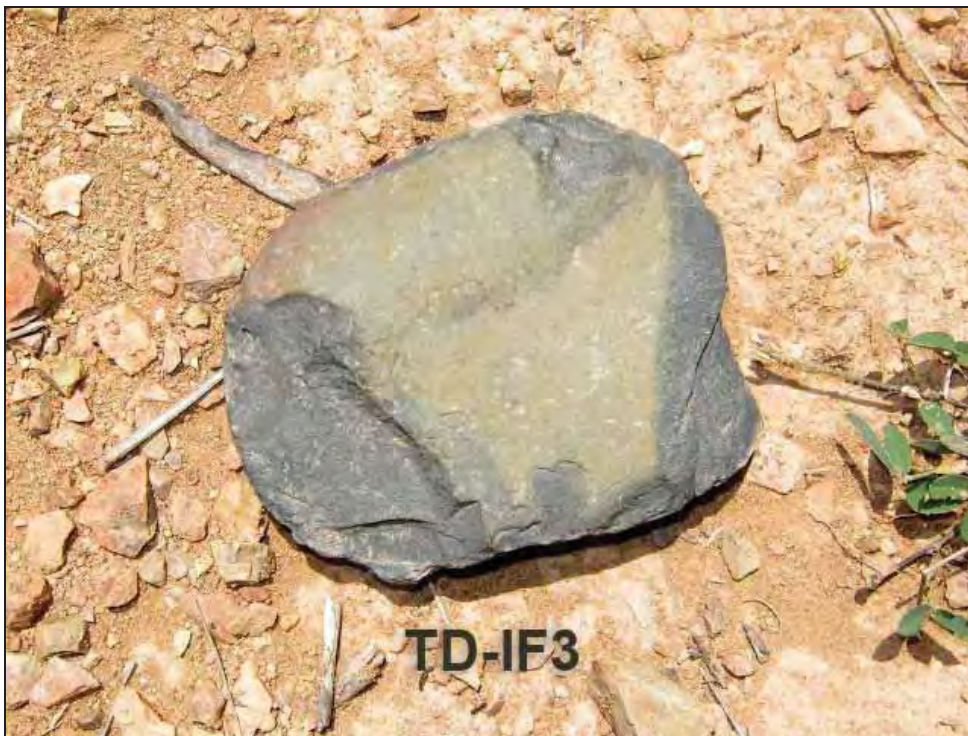
Plate 4–25: **TD-IF1**: a possible granite hammerstone.

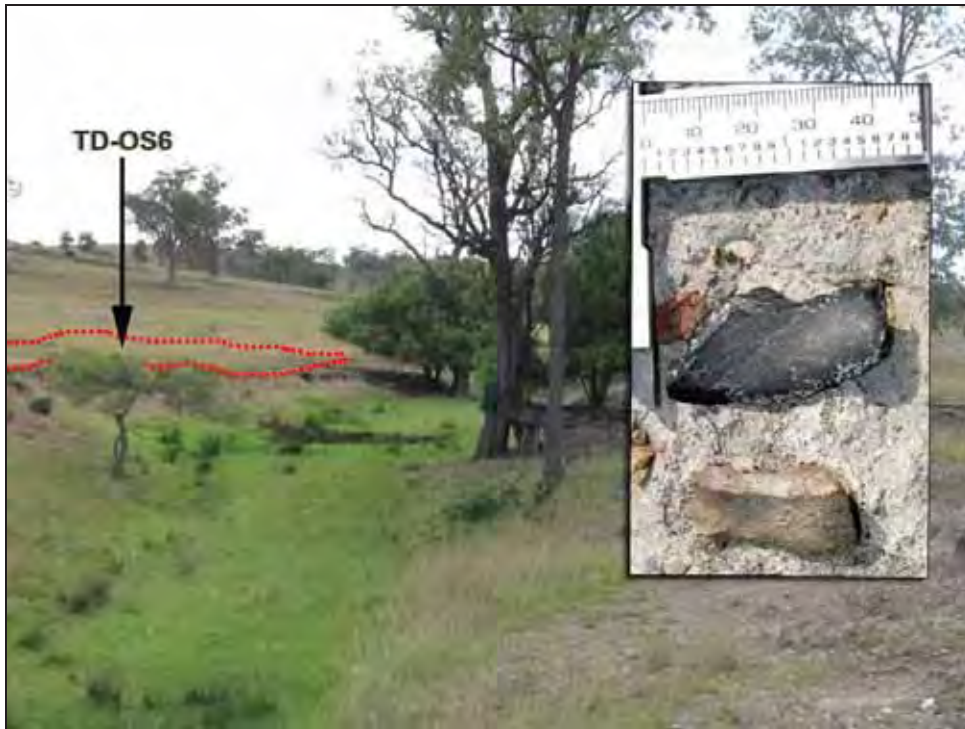
Plate 4-38: **TD-OS5 with PAD**. Artefacts. All fine-grained basalt. Top left: broken blade, Top right: flake, Bottom: Scraper (left = ventral, right = dorsal).

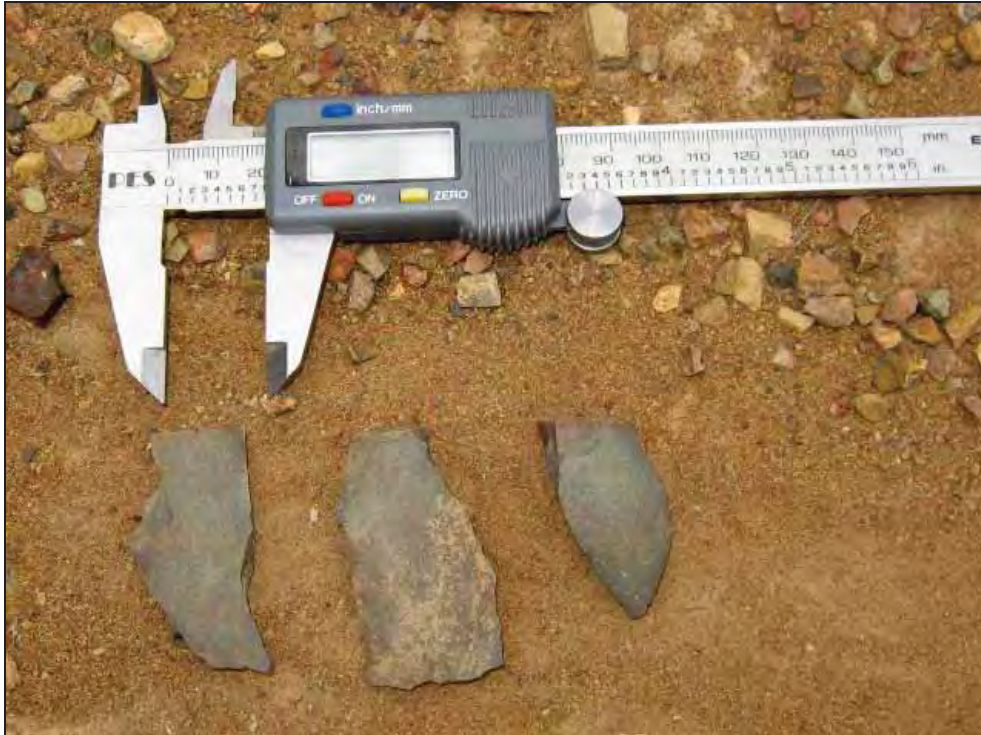
Plate 4-40: **TD-OS7**. Artefacts. Top: Grey quartzite axe (same artefact despite colour shift), Bottom left: Possible greywacke flake, Bottom right: fine-grained basalt flake.

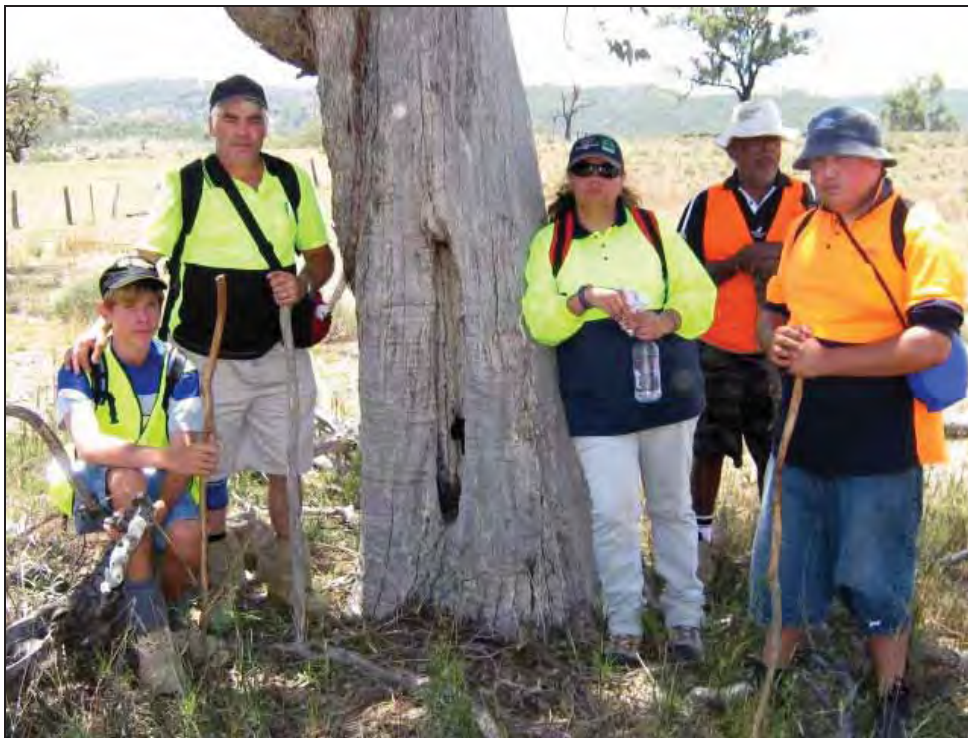
Plate 4–53: **TD-ST1**: Possible Aboriginal Modified (scarred) Tree.

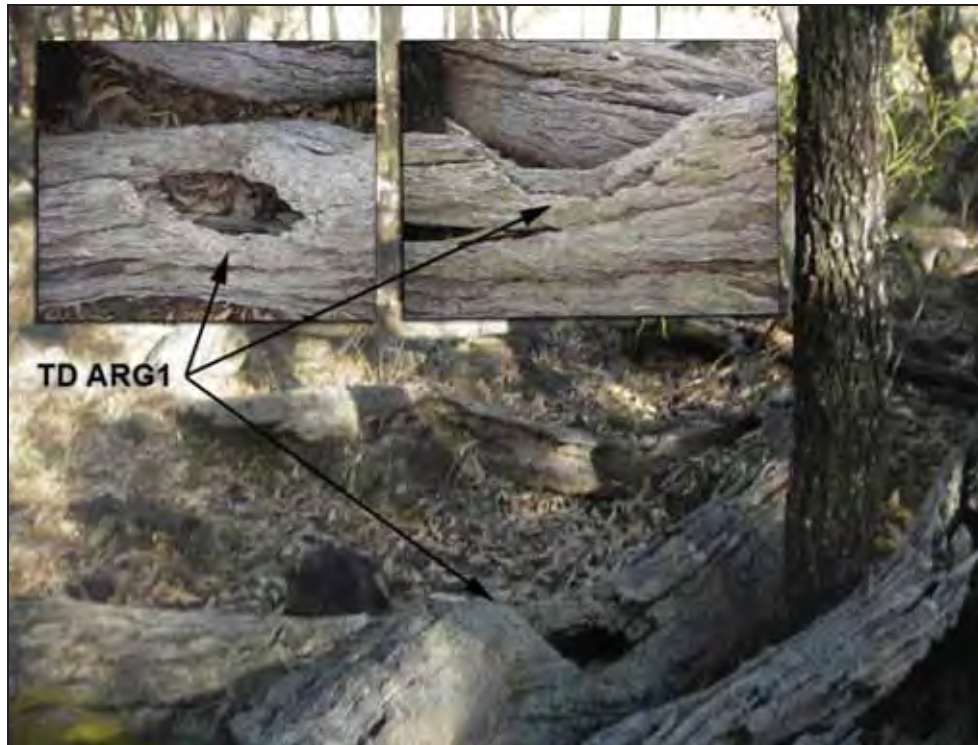
Plate 4–58: **TD-ST6**: Detail of the scar.

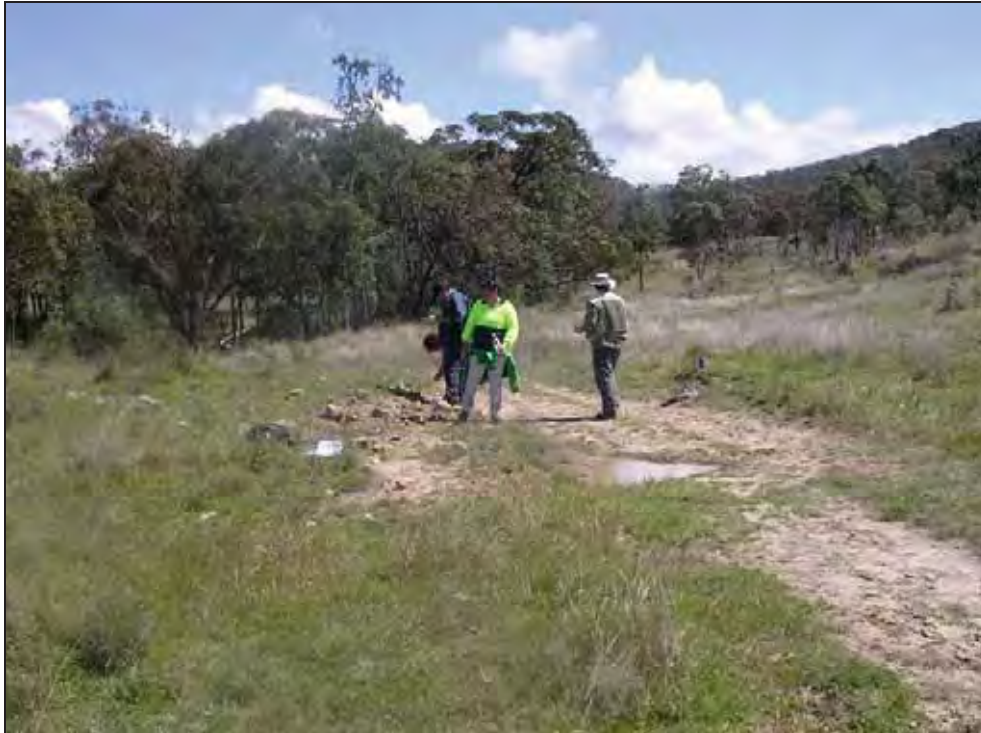
Plate 4–82: Selection of artefacts from **TD-OS18** including a quartzite flake and milk quartz flakes from the western bank of the gully (top row) and quartzite and quartz flakes from the eastern side of the gully (bottom).

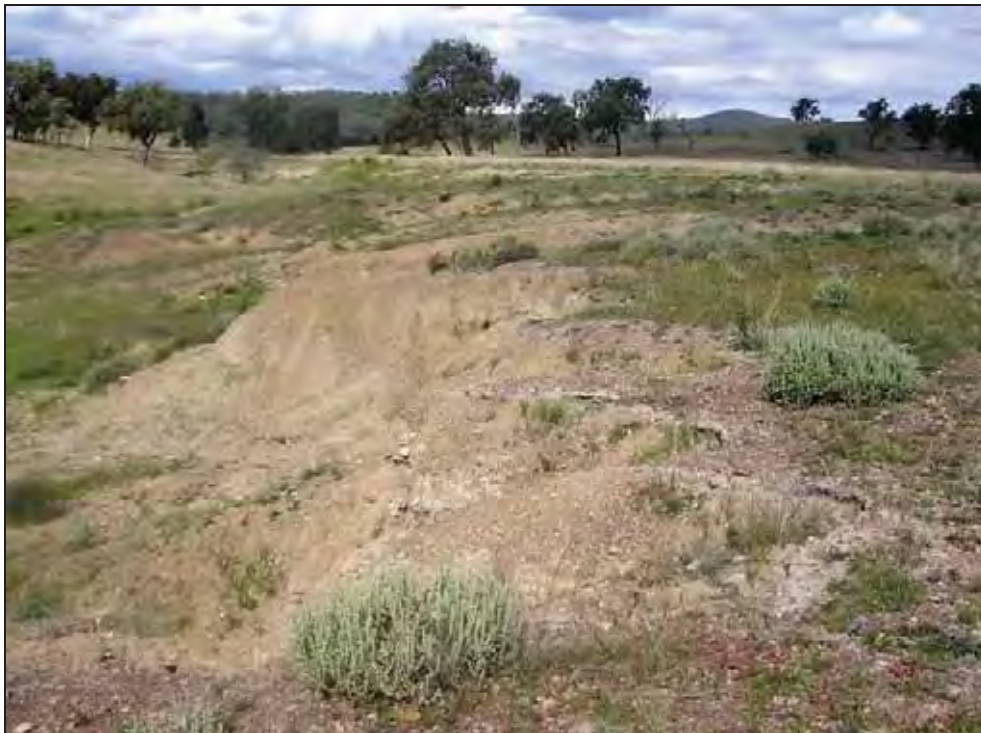
Plate 4–85: View of **TD-OS20 with PAD** from the north. The location of the spring can be seen by the darker vegetation. Artefacts were located on both the near and far bank over the entire area where the figures stand.

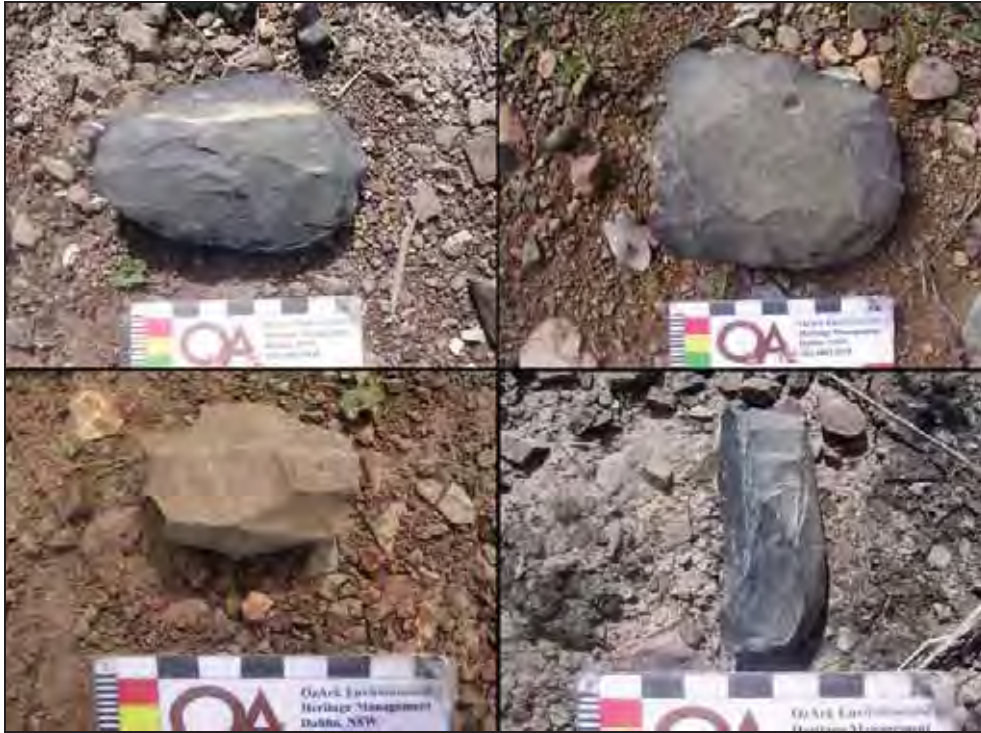
Plate 4–86: **TD-OS20 with PAD** showing the severe erosion that is impacting the site that is located right along the southern bank (shown here to right). Artefacts were recorded from the top break of slope to a distance of 30m away from the creek.

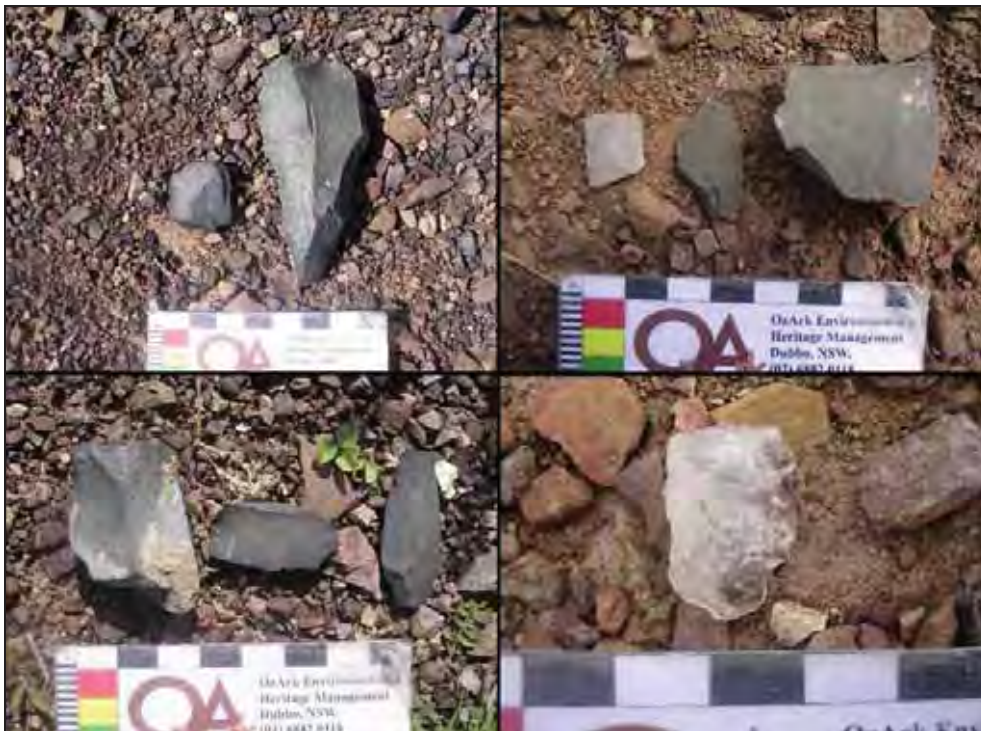
Plate 4-87: A selection of artefacts from **TD-OS20 with PAD**. These include basalt axe blanks (top row), quartzite core (bottom left) and a basalt bladelet core (bottom right).

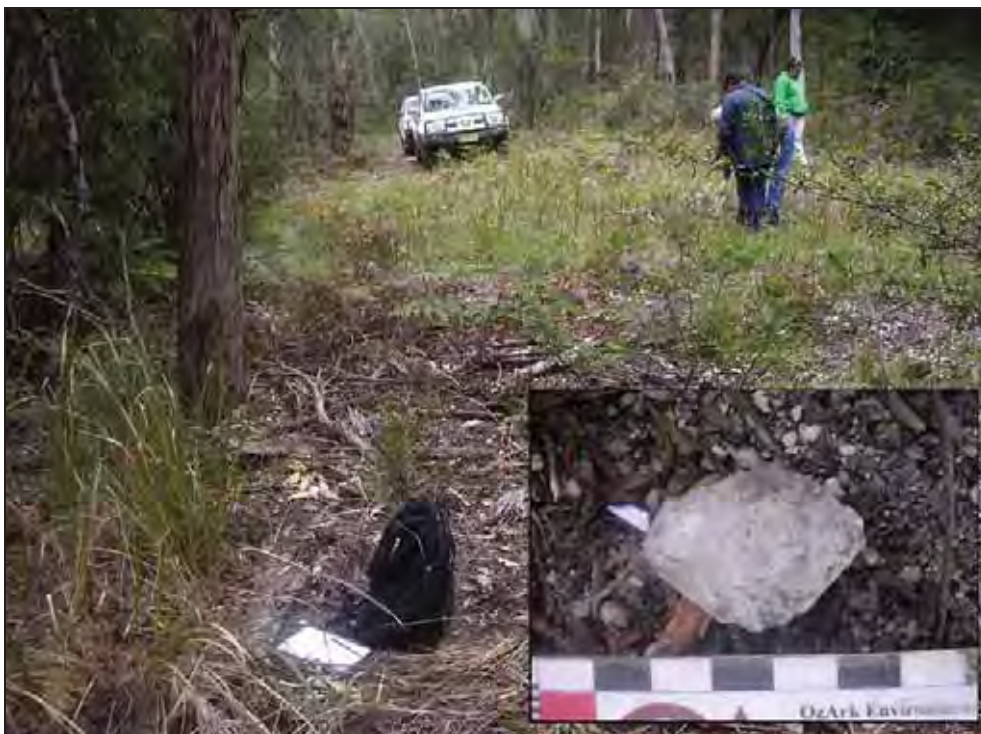
Plate 4-91: The location of **TD-IF12** is indicated by the back pack. Insert: TD-IF12; a basalt flake.
