**PREPARED FOR  
CODLEA PTY LTD**

**STAGE 1 PRELIMINARY  
CONTAMINATED LAND ASSESSMENT**

LOT 1 on DP 871039  
STAGE 2 BAYSIDE BRUNSWICK ESTATE

*Ref: BT 19034-CL2*

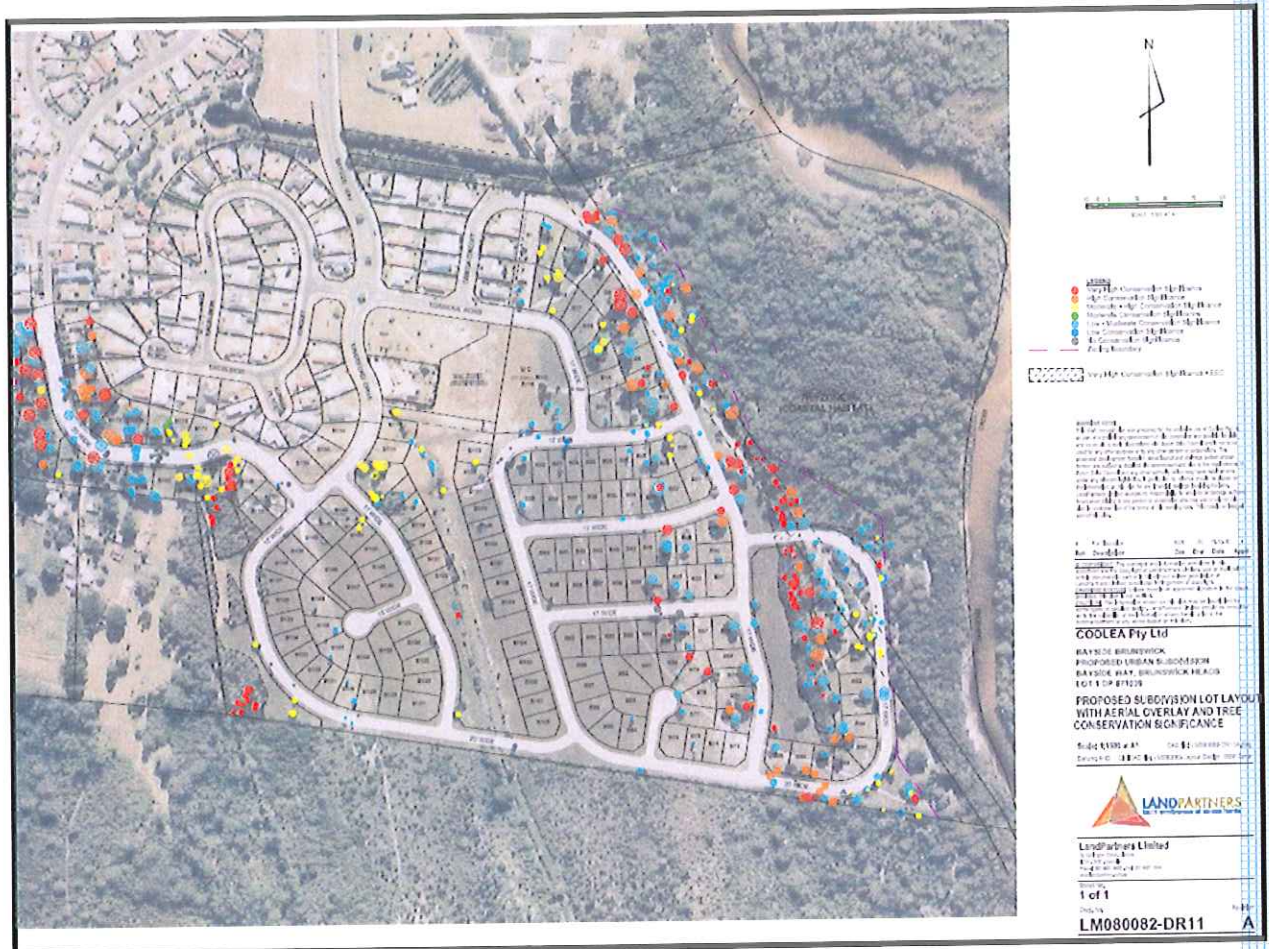
Figure 2: Final Proposed Layout Plans (image courtesy of LandPartners)

Border-Tech has received a consultant brief and final proposed layout plans dated 13/10/10 indicating the type of development proposed for the site (see Figure 2). From this information it is understood that the project involves the subdivision of a 31.33ha parcel of land to create a residential housing estate consisting of a total of 178 allotments of various sizes. Of the 31ha, approximately 23ha is to be developed into a mixture of single dwelling, dual occupancy and medium density lots. The remaining land will include areas of public parkland and an 8.2ha environmental reserve adjacent to Simpsons Creek.

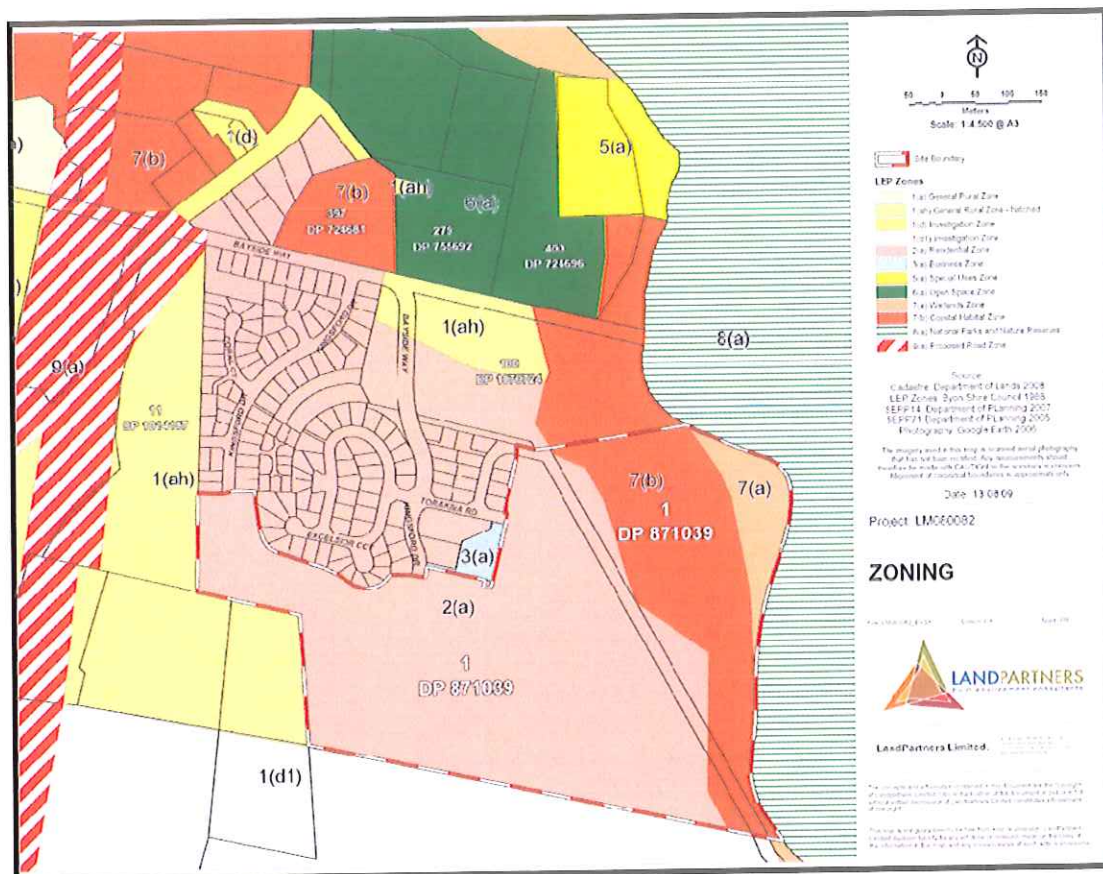
*Figure 3: Zoning Map – Byron LEP 1998 (image courtesy of LandPartners)*

Under the Byron Local Environmental Plan 1988 (Byron LEP 1988), last updated 16 March 2006, the site currently falls under the following three zonings as illustrated in Figure 2:

- Part 2(a) Residential Zone: incorporates the proposed building footprint.
- Part 7(b) Coastal Habitat Zone: existing remnant vegetation along the eastern side of the site adjoining Simpsons Creek.
- Part 7(a) Wetlands Zone: located in the north east corner of the site

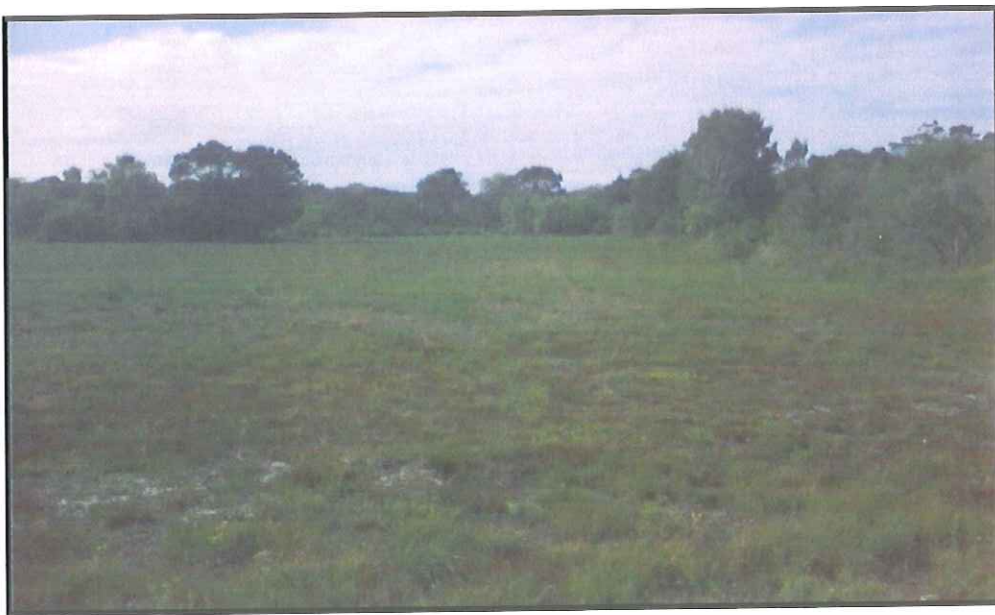
*Figure 4: Subject Site Showing Slashed Heath in South-Western Corner*

The entire heath community to the west of the environment protection zone, (zoned - 2(a) residential) appeared to be periodically slashed.

With the exception of a raised mound at the termination of Kingsford Drive (presumably stripped topsoil from Stage 1 of Bayside Brunswick Estate), no areas of fill or disused building pads were evident.

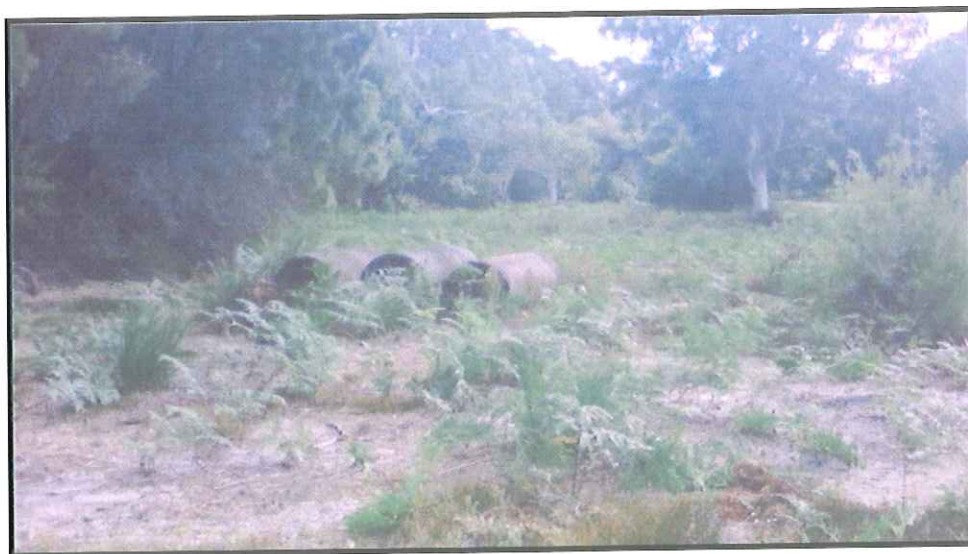
**Figure 5: Illegally Dumped Concrete Pipes**

The site showed no evidence of the above with the exception of a relatively small amount of scattered waste/rubbish dumped illegally on the site. Types of waste found include:

- Concrete pipes
- Corrugated iron
- Carpet
- Black plastic and black plastic pots
- Chicken wire
- PET drink containers

All of the illegally dumped waste identified was found to be inert, the bulk of which was found on the more heavily vegetated eastern side of the site. Given the large size of the site and its proximity to residential areas, the volume of rubbish uncovered is not considered to be unusual.

With the exception of illegally dumped waste, no potentially contaminating activities were uncovered as part of the field investigation. All of the waste identified was considered to be inert and not capable of causing significant soil contamination. None of the waste showed visual signs of containing or leaking hazardous chemicals.

- All illegally dumped rubbish be removed from the site and placed in an approved landfill facility.
- Should potentially contaminating or hazardous material be uncovered, at any time during construction works, these materials are to be isolated and classified prior to removal to landfill under the supervision of a qualified contaminated materials consultant.
- Any hazardous materials are to be documented, with a report made available to the relevant consent authority.

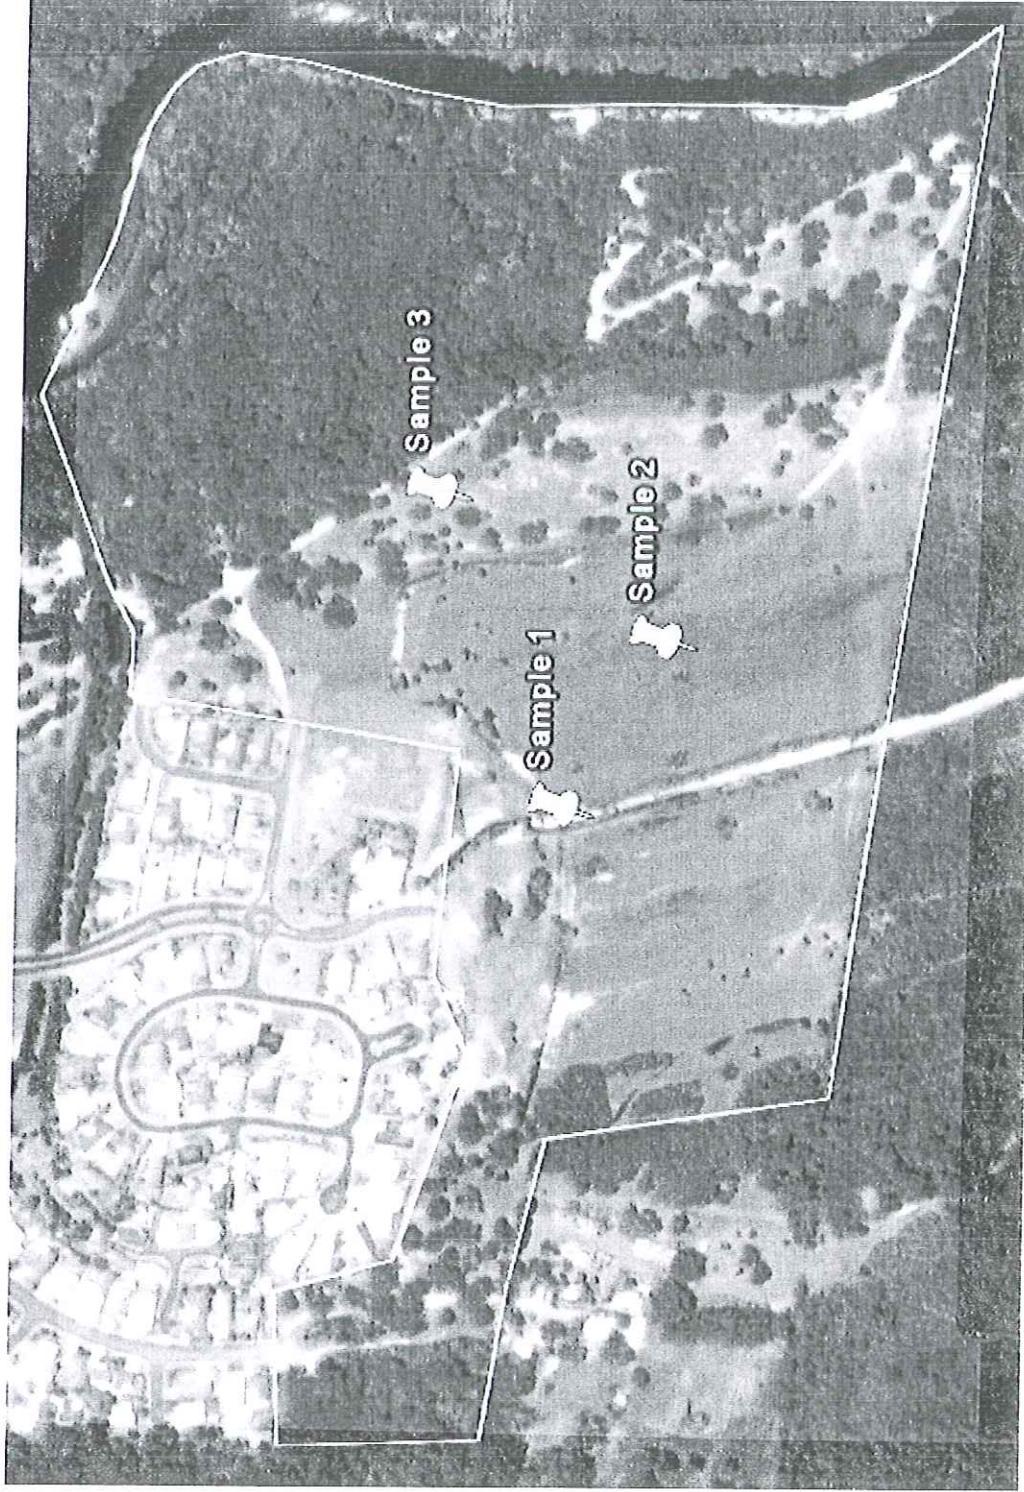
Fieldwork was undertaken on 11 August 2009 and involved sampling at the three (3) locations displayed on the attached site plan (*see Appendix 1*). Sample locations were derived using a judgemental sampling regime to include areas on the site where human activities have occurred, in particular the central (north – south) drain, and beneath illegally dumped rubbish. A further sample was recovered from the centre of the slashed paddock where the soil was deemed not to have been directly affected by human disturbance.

**Sample 1 (E18883)** – Located in the wall of the central (north-south) drain

**Sample 2 (E18884)** – Located in the centre of the slashed paddock

**Sample 3 (E18885)** – Located directly beneath concrete pipes and other rubbish

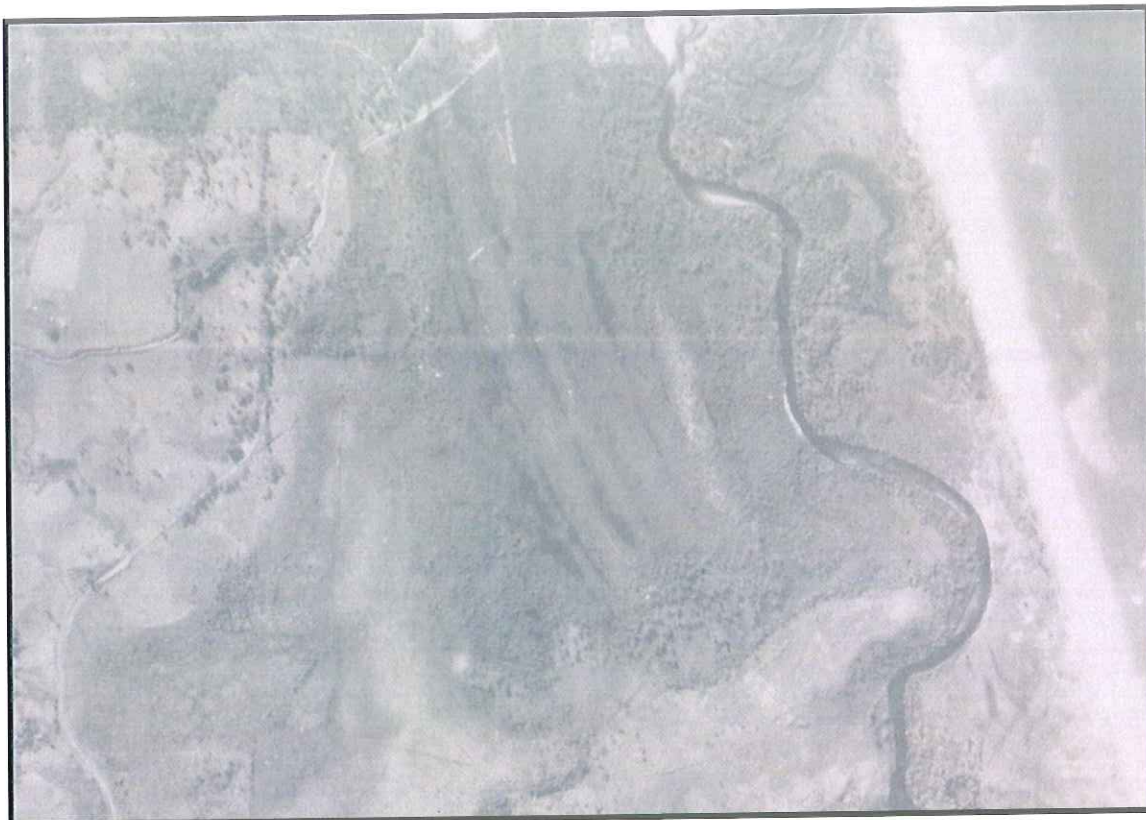
***Figure 6: Aerial Photograph 1947 (Ref: Byron Bay. Run 2. 27/5/47)***

Year	Description
1947 Figure 5 Appendix 2	The site appears to be in its natural state with no visible signs of use. A natural vegetation change is evident with taller forest on sand ridges on eastern side of site giving way to lower (heath) vegetation on flatter low-lying areas.
1966 Figure 6 Appendix 2	Drain to the south of site appears recently constructed (or improved), evident by un-vegetated spoilage on either side of drain. Natural vegetation appears largely intact. No structures visible on the site, cleared/mowed rectangular area joined by north south running track. The reason for the cleared/mowed area is unknown however it does not appear large enough for an airstrip.
1979 Figure 7 Appendix 2	Image only covers northern section of the site. Vegetation appears intact and no new structures evident. A service road has been constructed down the eastern side of the site.
1987 Figure 8 Appendix 2	Clearing in the approximate location of Stage 1 (Bayside Brunswick Estate) is evident. No evidence of land clearing or any structures on the subject site. The cleared/mowed rectangular area observed in the 1966 image is no longer visible. The main north south drain has been constructed.

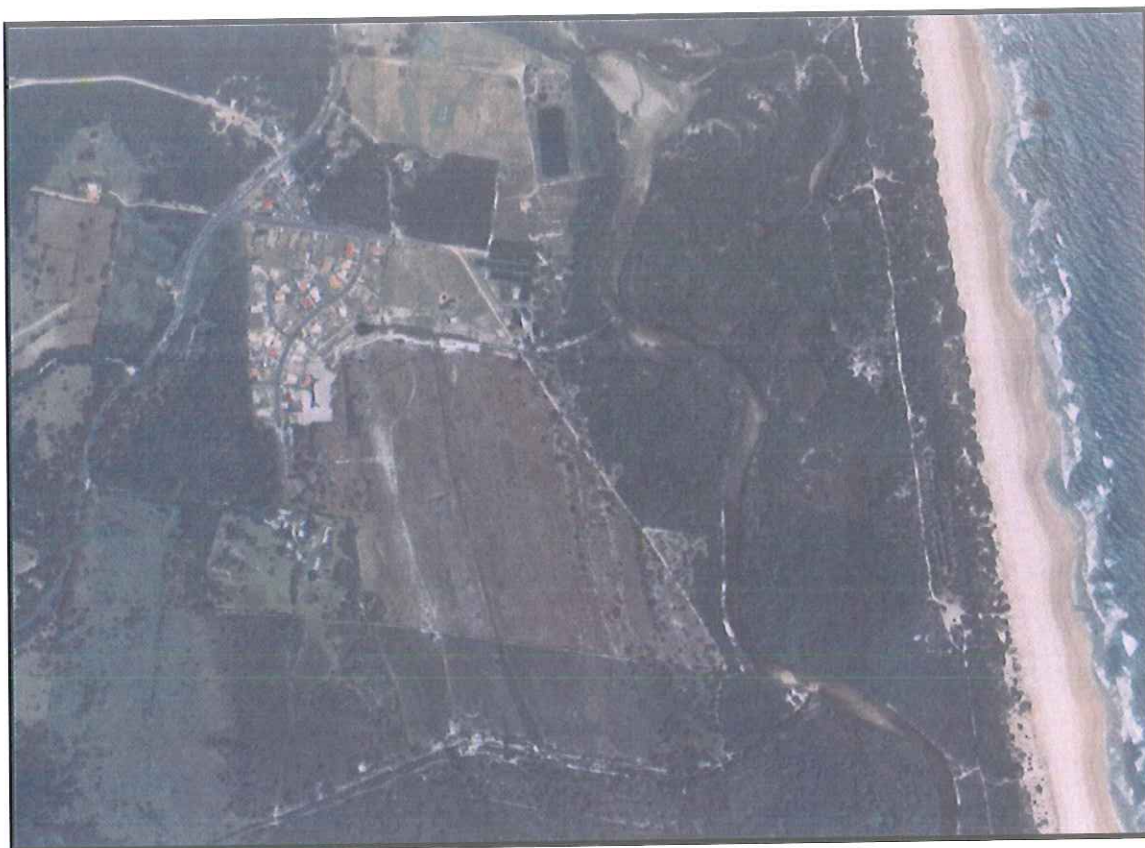
*Figure 10: Aerial Photograph 1993 (Ref: Unknown)*

1993 Figure 9 Appendix 2	Stage 1 of Bayside Brunswick Estate has been partially developed. Clearing/slashing of the heath and dry sclerophyll forest has occurred to the western side of the service road.
2006 Figure 10 Appendix 2 (Source: Google Earth)	Stage 1 of Bayside Brunswick Estate has been fully developed. An additional drainage channel (running roughly east-west) has been constructed, which links up with the existing (north-south) drain. No further vegetation clearing appears to have occurred, however all previously cleared and low lying heathland areas are slashed to prevent regrowth.

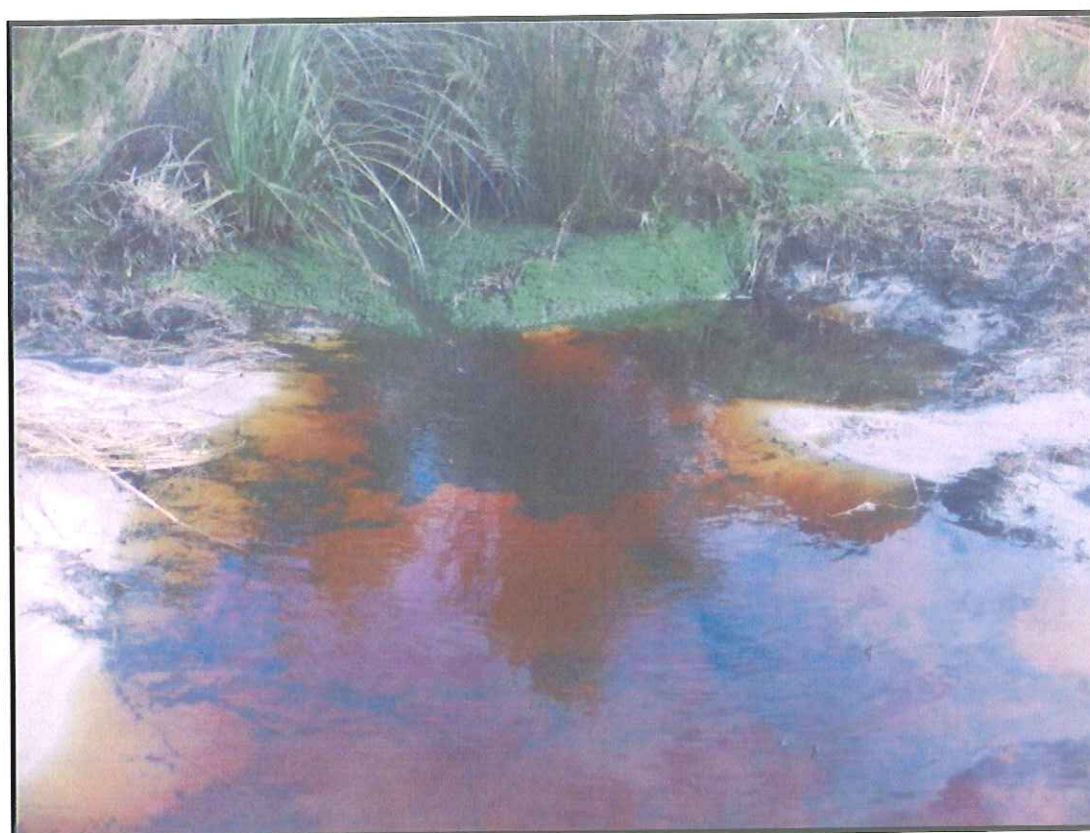
***Figure 15: Tannin Stained Water Flowing into the Central Drain***

The appearance of the water showed no signs of excess algal growth or oil slicks of any kind. A brown tannin stain was present in all surface waters, a characteristic of the wallum sand heath environment.
