Ref: E20345Klet2.1 (review)

**PROJECT REVIEW**

**CRONULLA SHARKS REDEVELOPMENT,**

**461 CAPTAIN COOK DRIVE, WOOLLOOWARE**

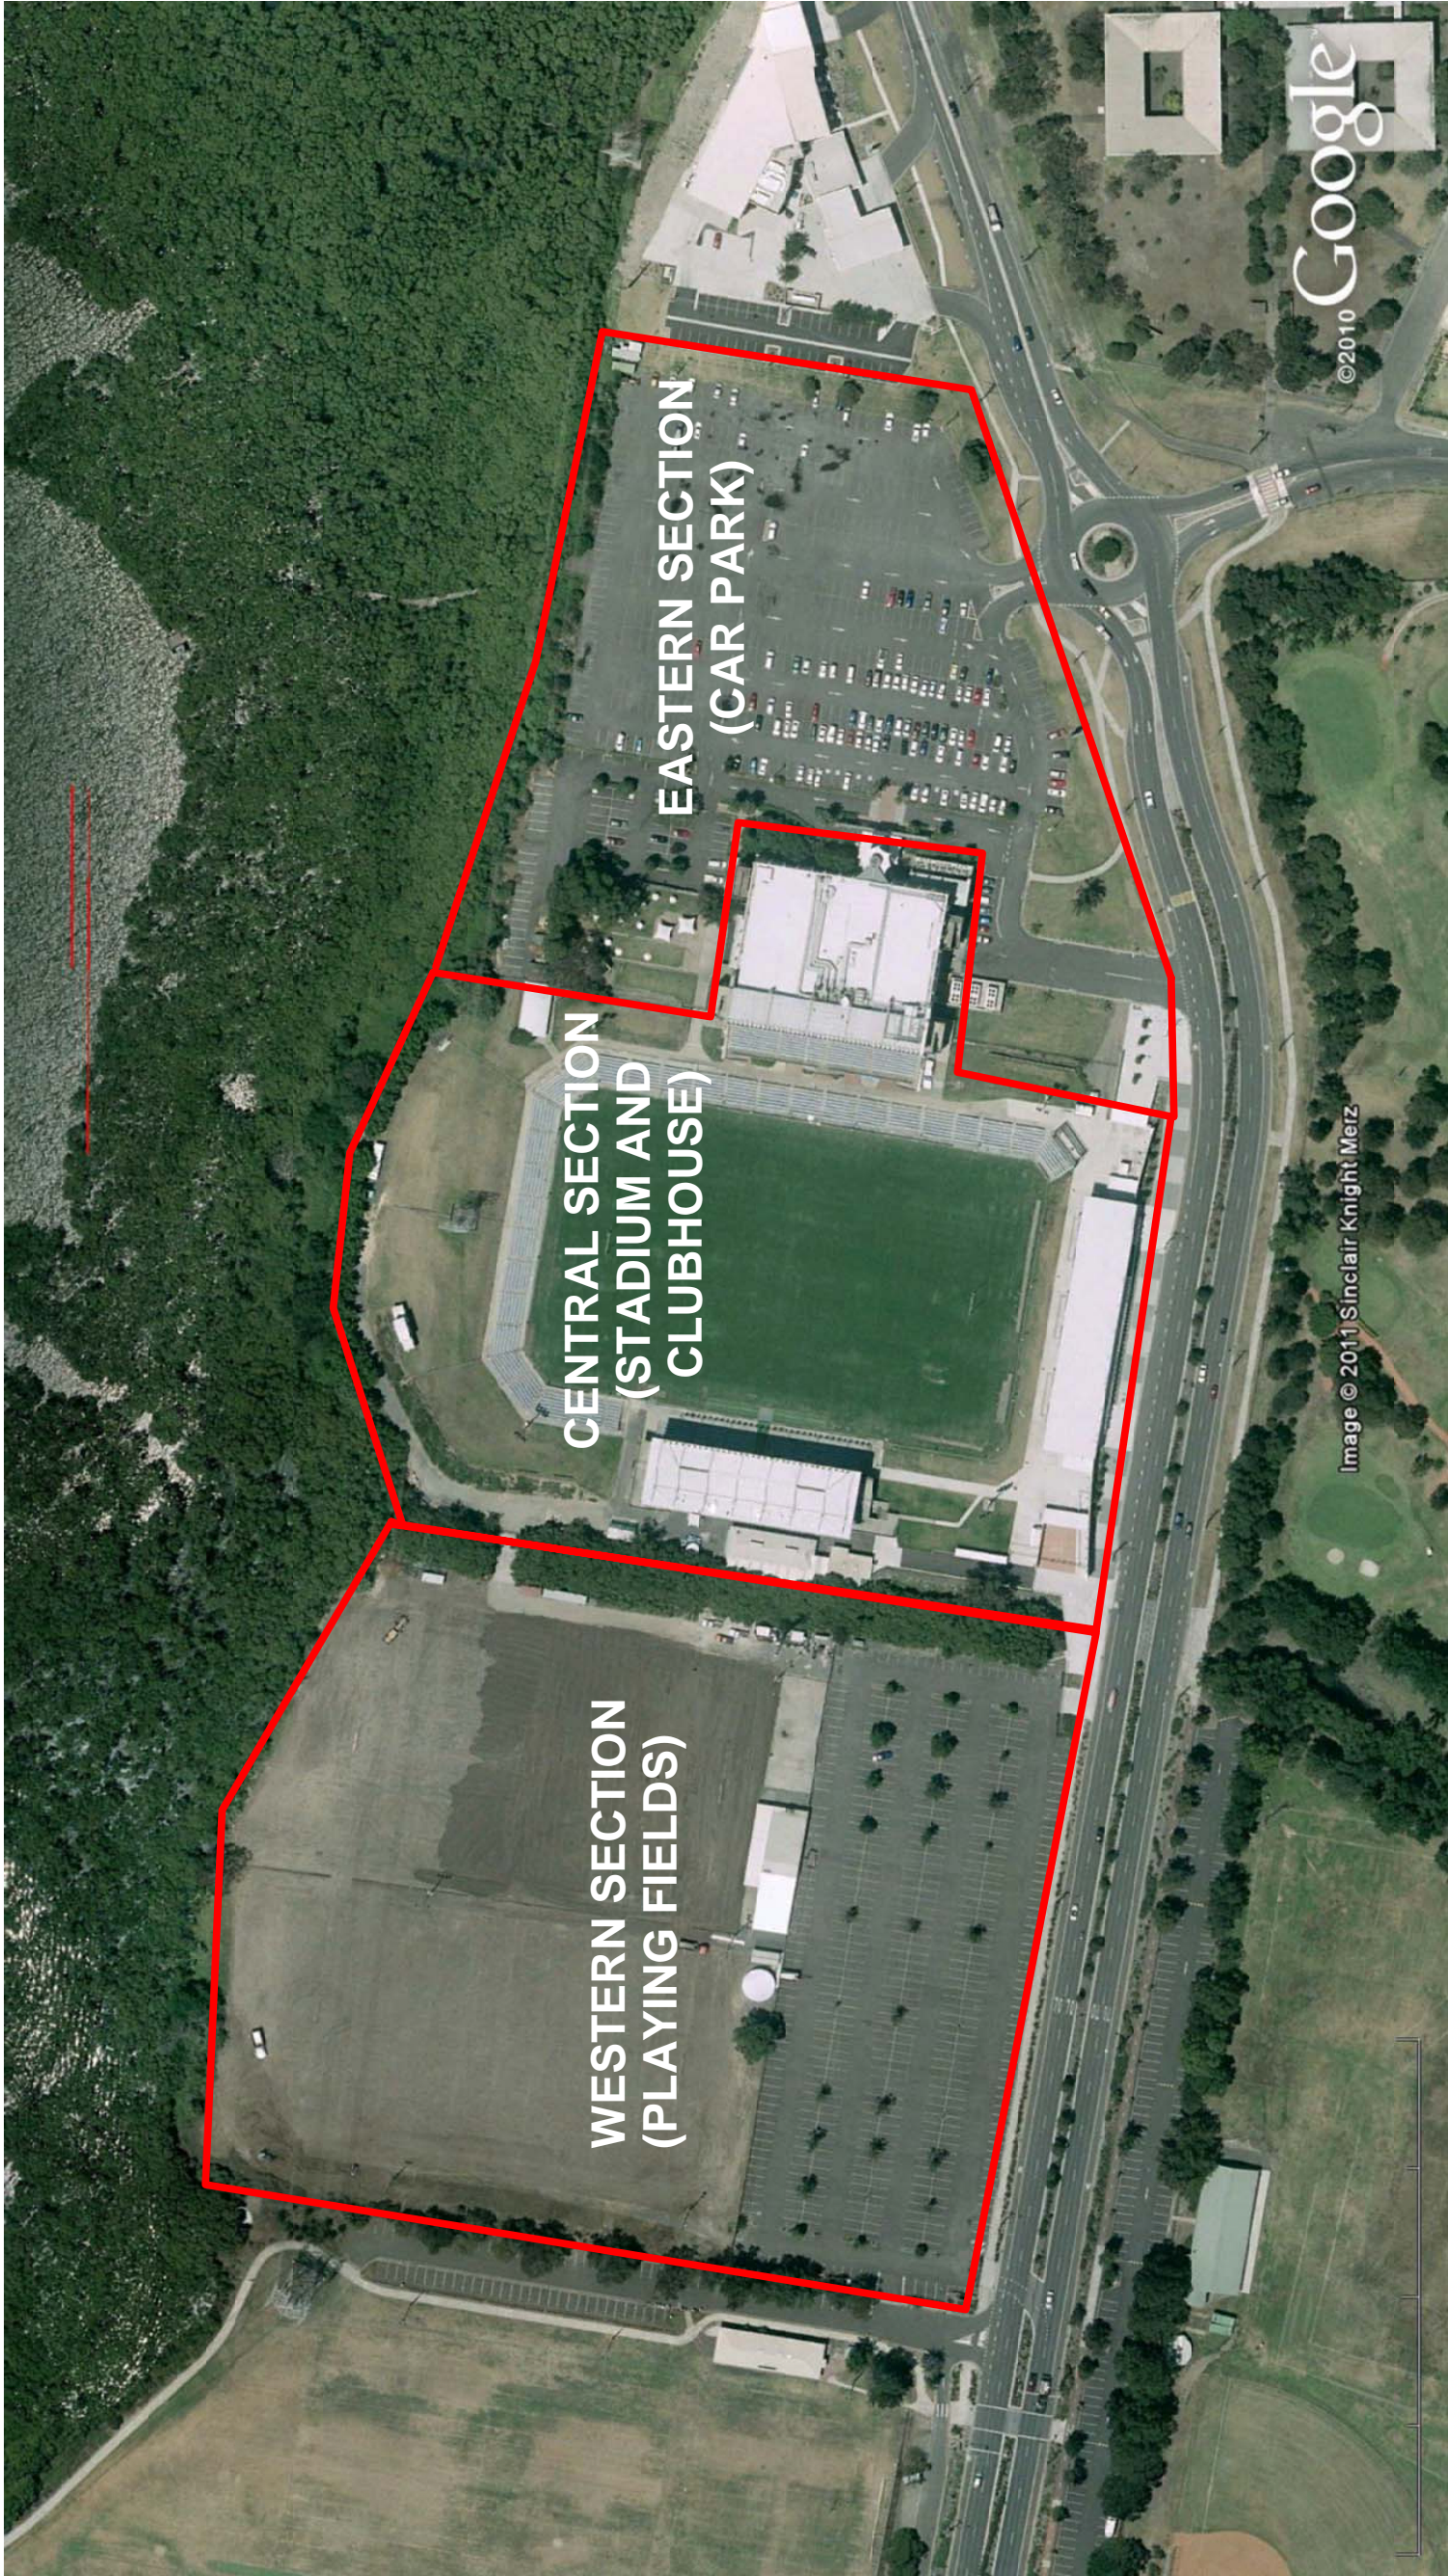
NOTES:  
Figure 2 has been recreated from Google EarthPro  
Reference should be made to the report  
text for a full understanding of this plan.

For descriptive purposes the site can be divided into three principal sections (as shown on Figure 2):

- The western section that is occupied by open, grassed playing fields and an on-grade car park (which located to the south of the playing fields);
- The central section that is occupied by the Toyota Park stadium and club house (which is located to the east of the stadium); and
- The eastern section that is occupied by an on-grade car park.
