Cronulla Sharks Redevelopment

Stormwater and Services Report - Concept Application

Report no: 11-59-R001

Date: July 2011

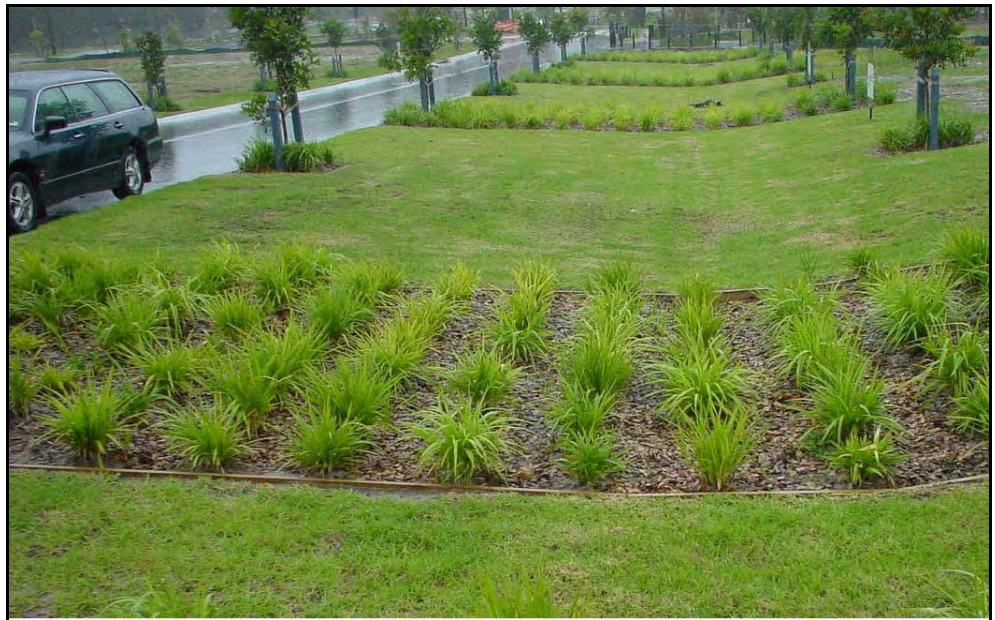
Figure 1. Swale Image

Bio-retention systems are systems that promote the filtration of stormwater through a prescribed filter medium. The type of filter medium determines the effectiveness of the pollutant removal, with material of lower hydraulic conductivity providing the most efficient pollutant removal.

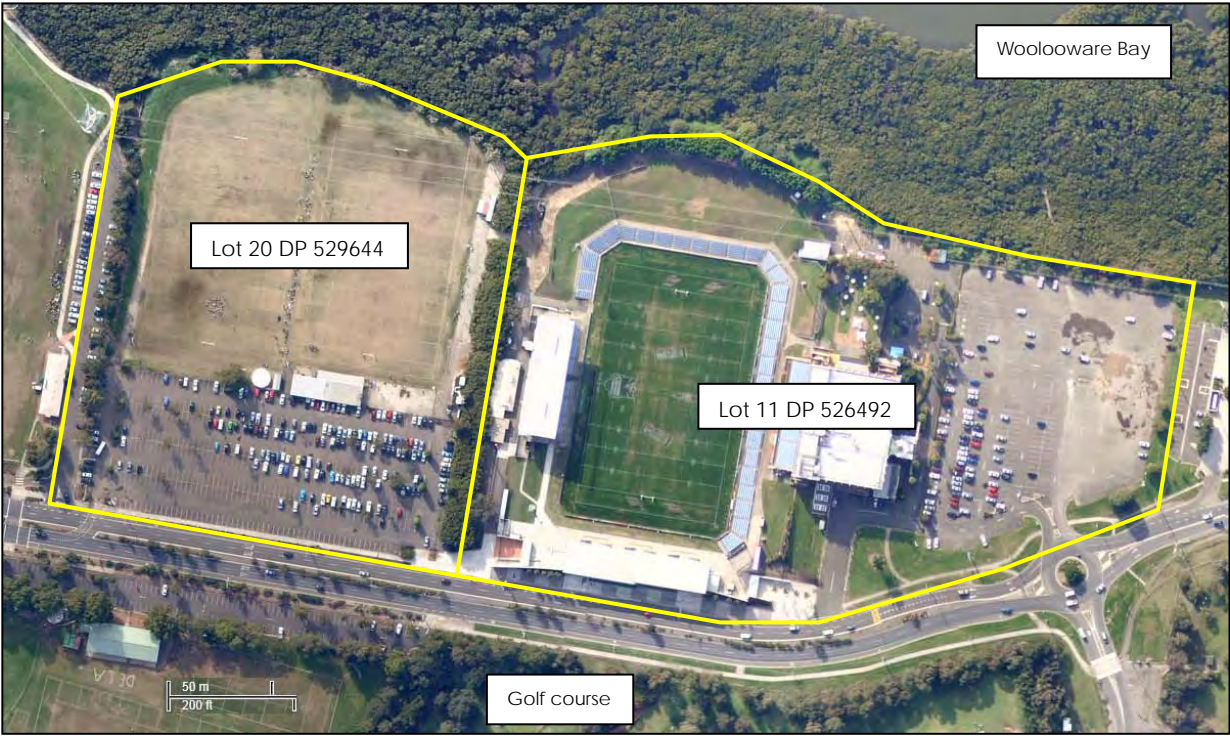
Martens & Associates Pty Ltd ABN 85 070 240 890		Environment Water Wastewater Geotechnical Civil Management	
Drawn:	JSF	SITE AERIAL (2011) Approximate site boundaries.	FIGURE 1
Approved:	ASN		
Date:	12/7/11		Job No: P1103017
Scale:	N/A

Existing site conditions are shown on the site aerial (Figure 1 of Attachment B).

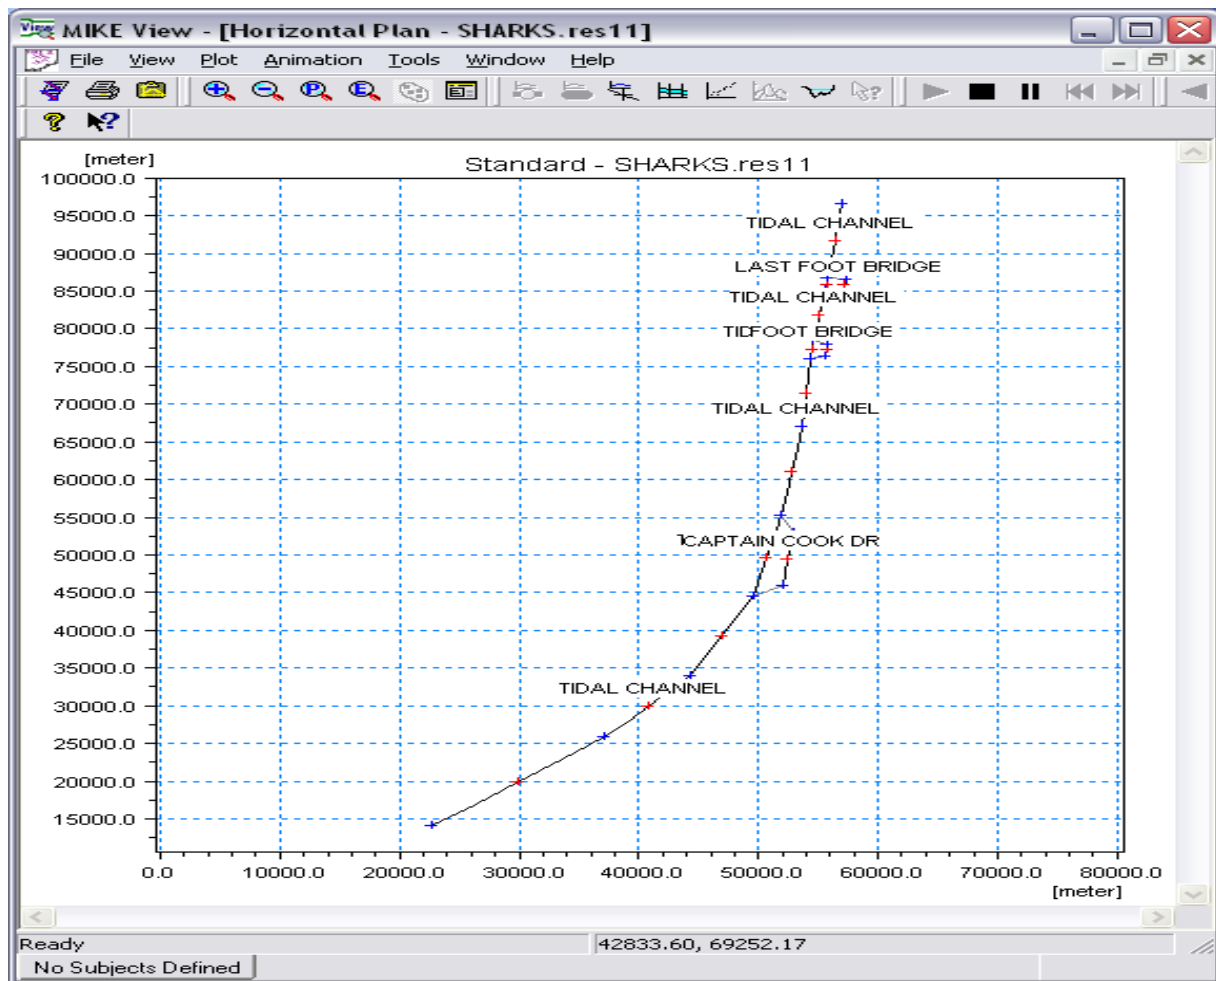
Figure 3.4 Mike-11 model layout

2 x 2.4x1.2 m box culverts are located under Captain Cook Drive. It is reasonable to expect that the culverts would be blocked during a large storm event, so their capacity was halved. The 100 year ARI flood profile along the tidal channel is shown on Figure 3.5. It should be considered as a conservative estimate of the 100 year flood levels because of the coincidence between the king tide (peak at R.L. 1.85 m AHD), and concentrated flow along the Sharks land only. Namely, significant amount of overland flow is expected to enter the playing fields to the west of the site, however this flow path was not taken into account to remain on a conservative site.

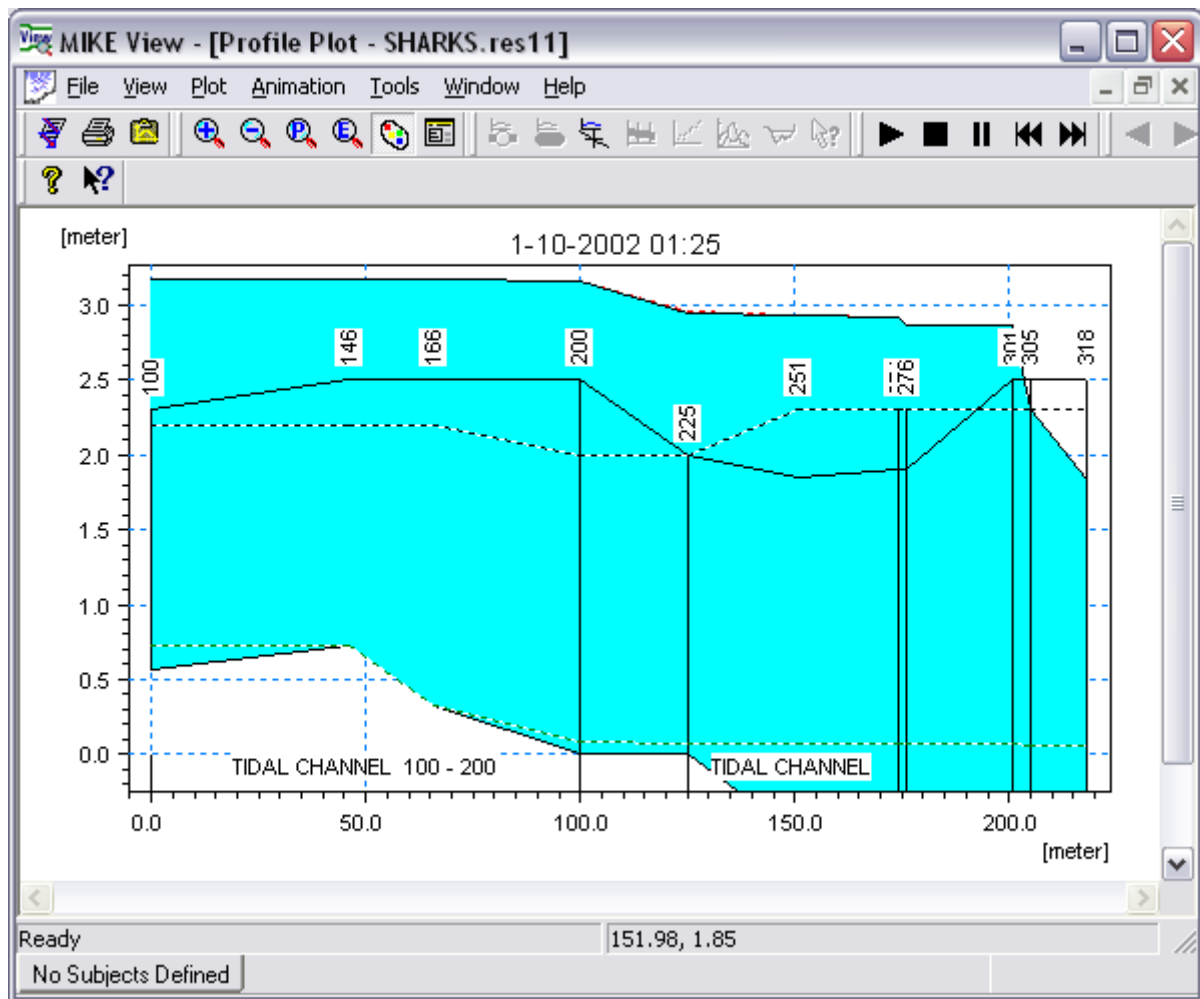
Figure 3.5 100 year flood profile along the tidal channel.
Note: Captain Cook Drive is located between cross sections 200 and 225

It can be seen from the profile that the conservative estimates of the 100 year flood levels are at or below R.L. 2.9 m AHD downstream of Captain Cook Drive, while the entrance to the level 1 basement carpark is at R.L. 3.4 m AHD, which represents 0.5 m freeboard.

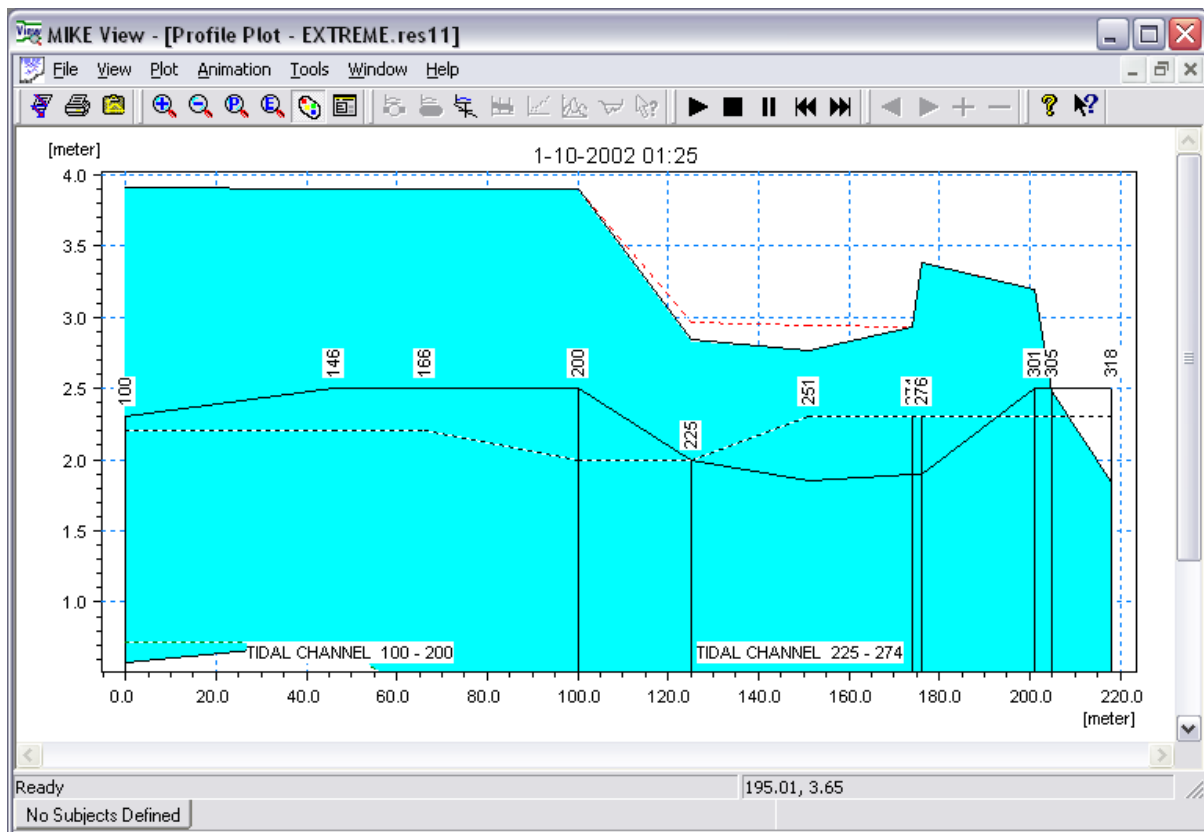
Figure 2.6 Extreme Flood Profile

The extreme flood was simulated by using a combination of a king tide with 3 times the 100 year flood hydrograph. This is a very conservative assumption and the resulting flood profile is shown on Figure 3.6. The extreme flood levels downstream of Captain Cook Drive are below 3.0 m AHD because of the supercritical flow. In order to remain on a conservative side the flood level resulting from the hydraulic jump of R.L. 3.4 m AHD could be adopted as the extreme flood water level for the proposal, which is equal to the entrance level to basement carpark.

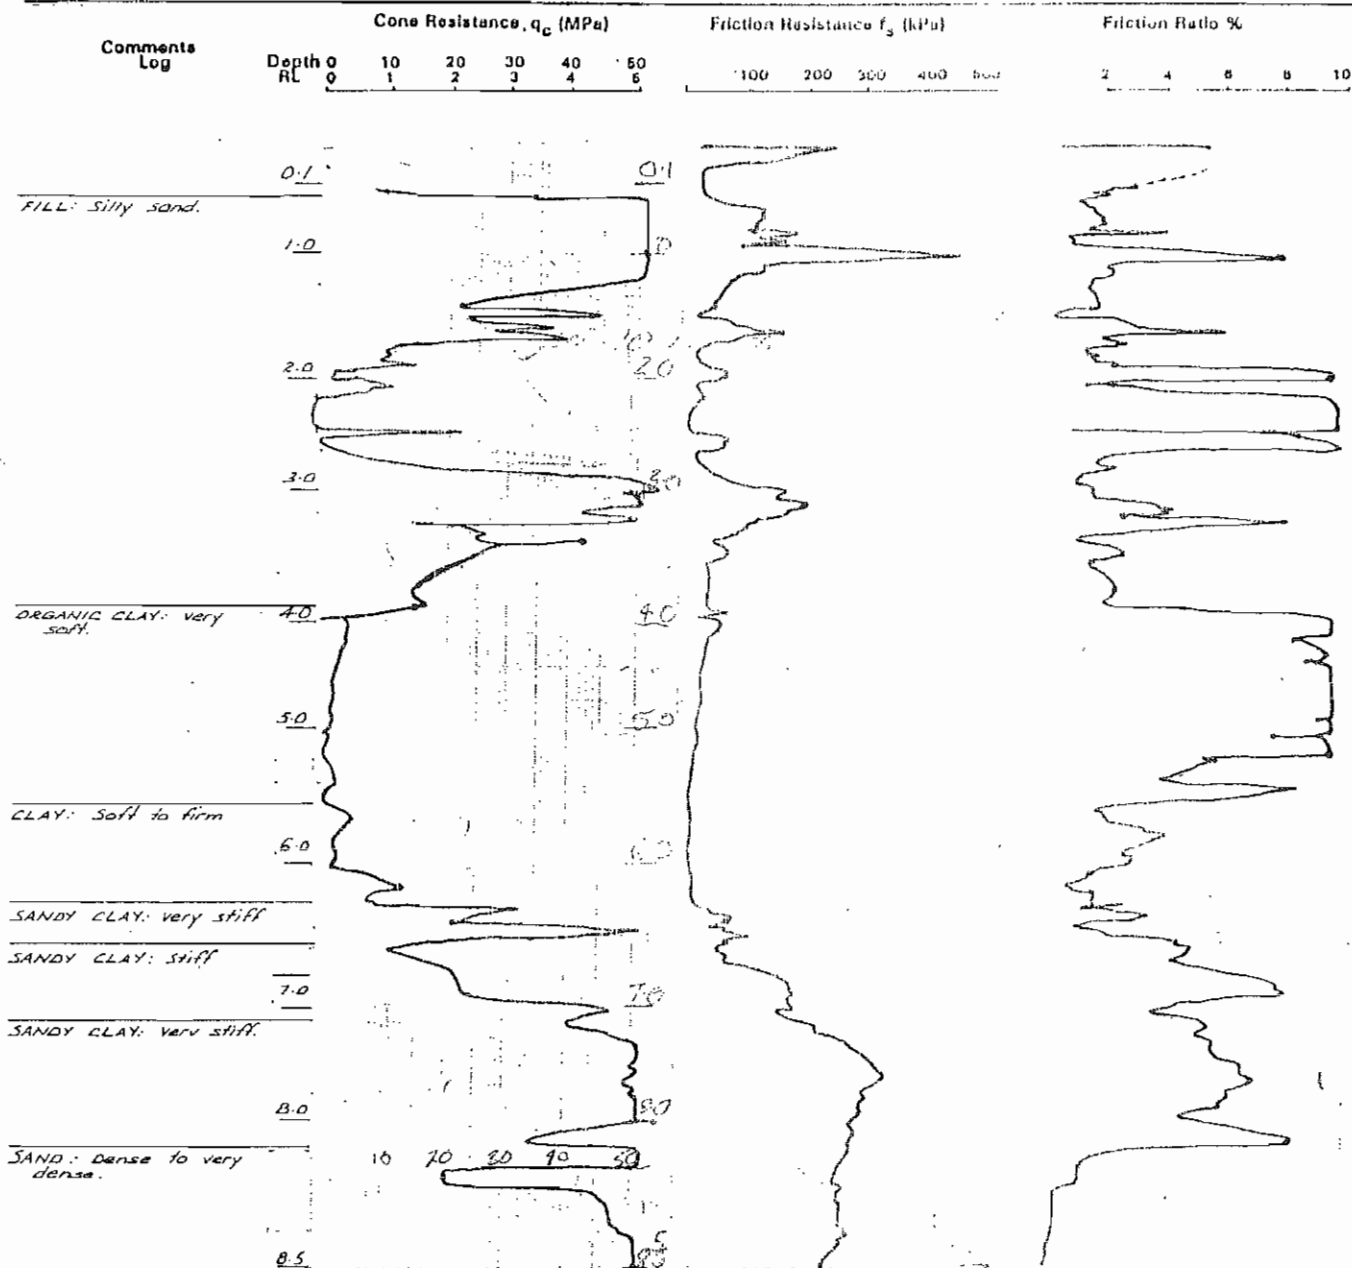
ELECTRONIC FRICTION CONE PENETROMETER TEST (TO AS. 1289 F5.1 - 1977)

Job No. <u>15009 J.T.P.</u>	Operators <u>BRYAN & STEVE</u>	Cone Type <u>MAES4</u>
Client <u>CRONULLA SHARKS</u>	Time & Date <u>11-3-90</u>	Note: Test performed with 37mm dia.
Project <u>SHARK PARK REDEVELOPMENT</u>	Last Calibration <u>9-30-89</u>	Revs. 110 friction Reducer used.
Location <u>CAPTAIN LOOK DRIVE WOODCOWABE</u>	Comment on Cone Condition <u>GOOD</u>	15 tonne thrust Penetrometer used.
		Results recorded on 3 Track Chart Recorder

Copies of the borehole logs and EFCP test results are provided in Appendix A. The approximate locations of these tests are shown on the attached Figure 1; the locations have been scaled from the plans contained in the previous reports and so the plotted locations could be in error by about 10m or so. It should also be noted that these depths were from existing ground level at the time of the fieldwork for those investigations and depths may have subsequently changed following excavations or the placement of additional fill.
