3.8 The former Ward Building, Recreation Room and Bathroom/Lavatory Block

3.9 Historical Archaeology

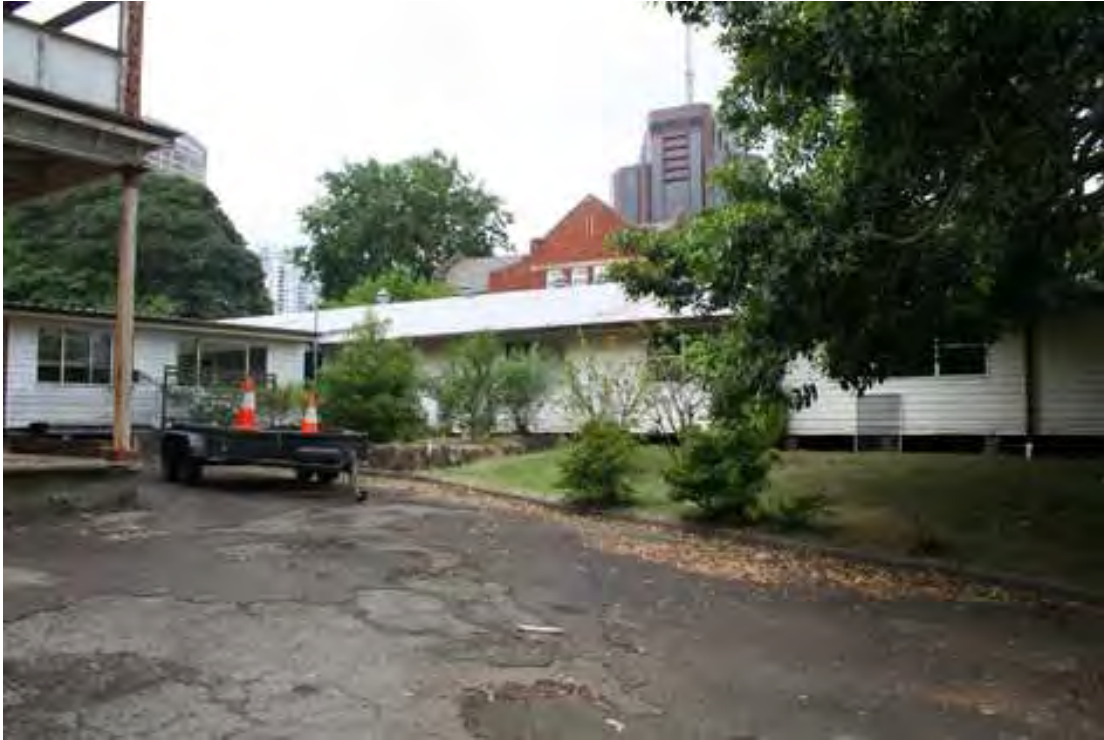
Figure 3.63 The west elevation of the Ward Building today. The original low-lying form of the building remains but the verandahs on both sides have been enclosed.
Source: Tanner Architects 2010.

This long, single storey, rectangular building is the former ward for incapacitated patients, albeit extensively refurbished and remodelled in the early 1980s to accommodate fee-paying aged patients. At this time the long open ward and flanking open verandahs to the east and west of the open ward were partitioned and enclosed by cladding in weatherboards. The existing internal finishes of the building are consistent throughout and comprise vinyl flooring, plasterboard walls and plasterboard ceilings, aluminium-framed windows, and fire-rated flush panelled doors. These linings may conceal earlier finishes and materials. The roof of the building is a shallow pitched hip clad in corrugated steel, and the ridge has a series of original steel ventilators.

Overall, the ward and its ancillary buildings have a low level of integrity of original plan form and fabric. The evocative deep, open verandahs have been removed effectively by the cladding of the outer face and removal of the inner wall to create enclosed compartmentalised ward spaces.

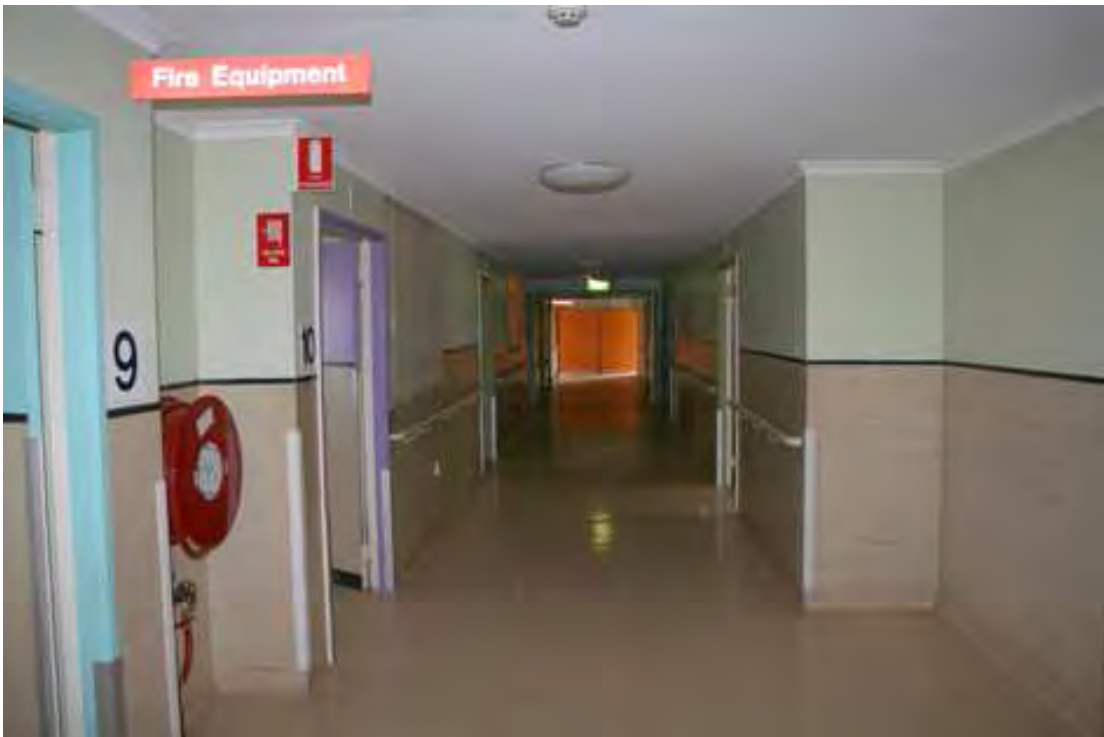
Figure 3.64 The existing corridor of the Ward Building. It was formed in the early 1980s with the partitioning of the originally open ward.
Source: Tanner Architects 2010.

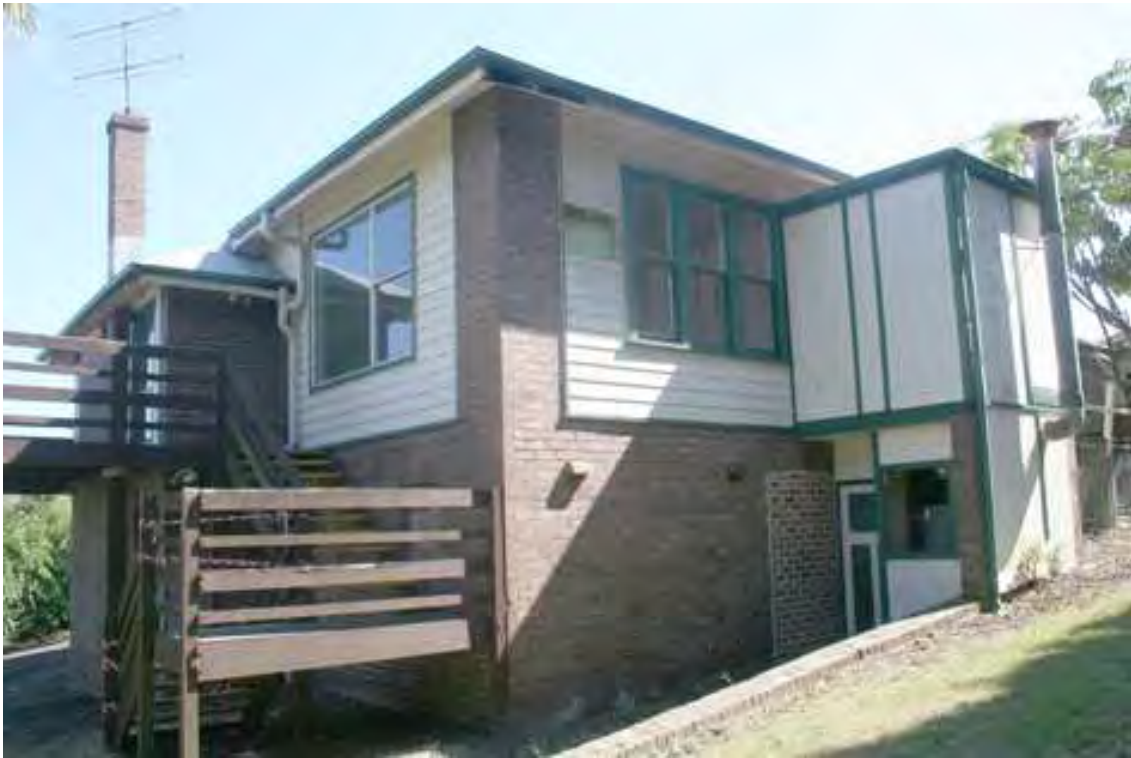
Figure 3.65 The former recreation room at the southern end of the Ward Building.
Source: Tanner Architects 2010.

The recreation room at the south end of the ward was constructed of brick with a garage underneath. This building was one large room but has been partially subdivided and refurbished in the early 1980s. The existing finishes of the building are consistent with the neighbouring wards with its vinyl flooring, plasterboard walls and plasterboard ceilings, aluminium-framed windows, and fire-rated flush doors. However, the original timber double hung windows and moulded timber architraves remain on the side (east and west) elevations only. The garage door and other openings in the basement have been bricked-in, and a timber deck has been added, this work being done in the 1980s.

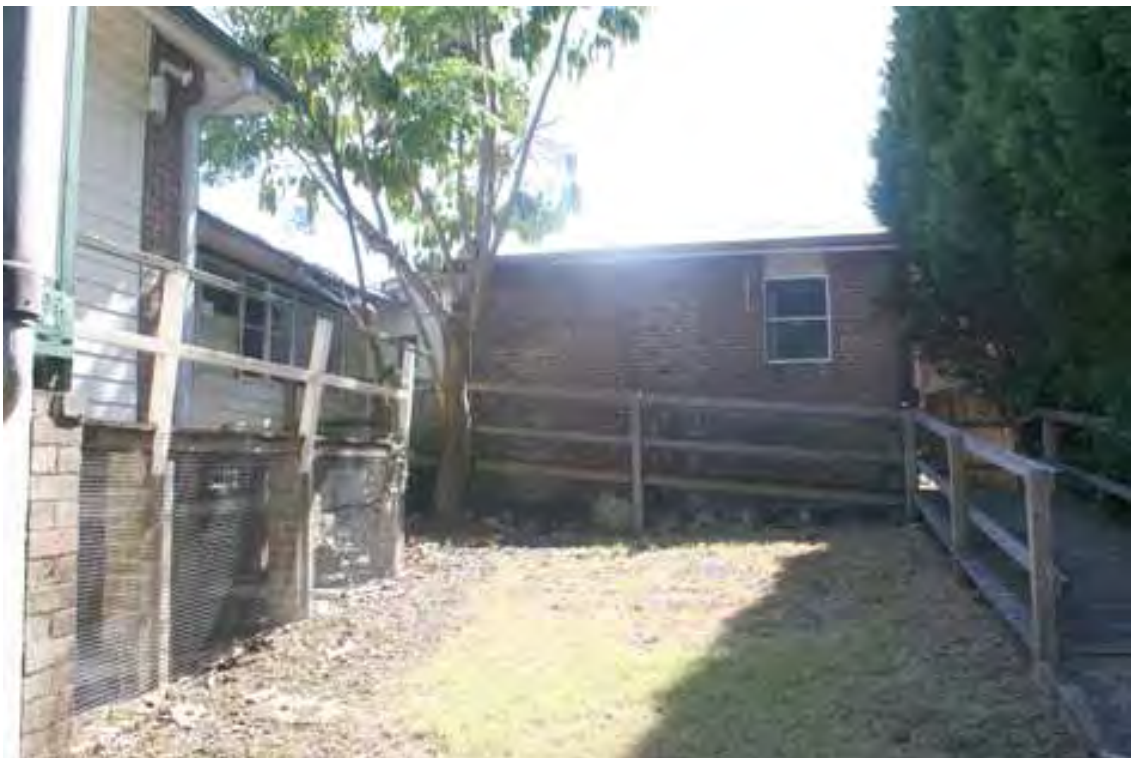
Figure 3.66 The lavatory and bathroom block on the east side of the Ward Building.
Source: Tanner Architects 2010.

Attached on the eastern side of the ward building is the bathroom/lavatory block. This is a brick building that is contemporary with the main ward. It has been totally refurbished internally, the windows replaced, and some doors and windows have been bricked-in. The connection to the wards, originally open, has been enclosed.

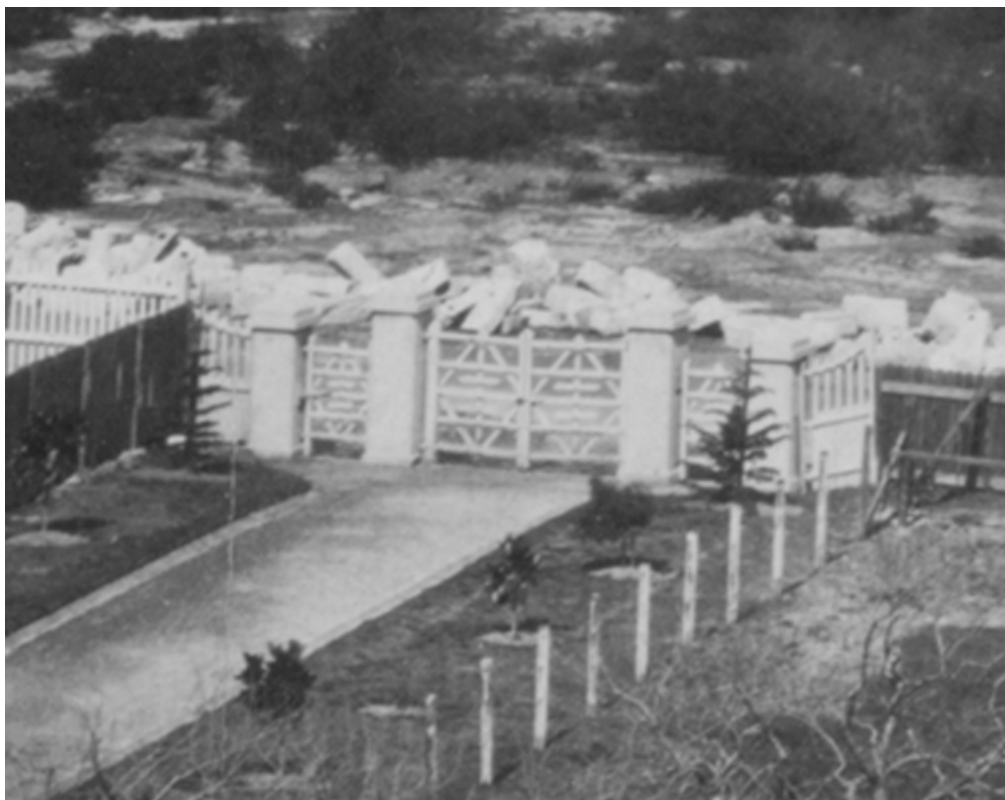
Figure 3.67 The Union Street entrance gates and driveway. Undated but possibly c1880.
Source: National Library of Australia.

3.8.1 Entrance Gates

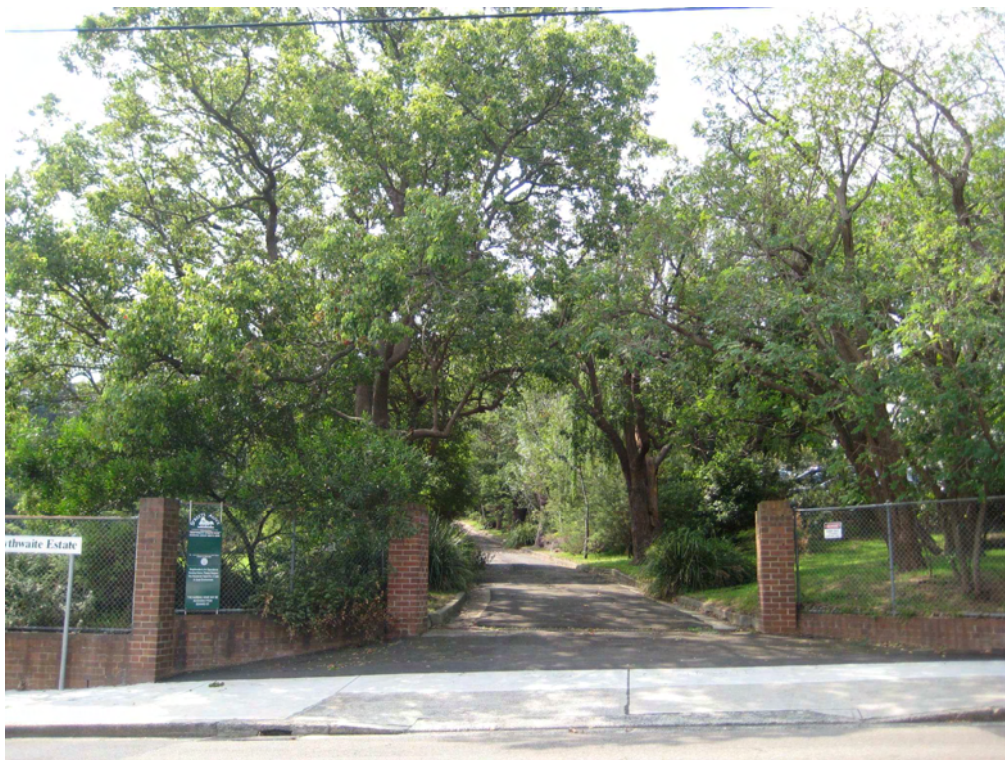
Figure 3.68 The Union Street entrance gates and driveway today.
Source: Tanner Architects 2010.

The Union Street boundary is a low brick wall with brick gateposts that dates from 1959 (Figure 3.68). In the original design there was a chain wire fence that has since been removed.²

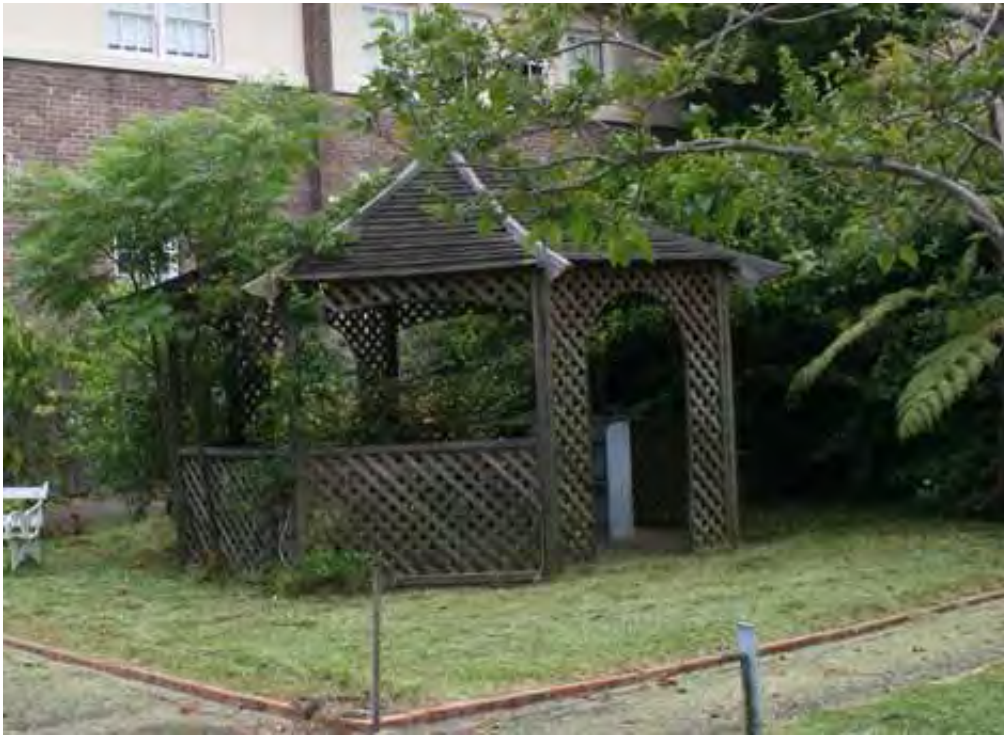
Figure 3.69 Timber-framed 'Summer House' in the west garden.
Source: Tanner Architects 2010.

Located within the formal garden at the north-west side of the house is a timber framed 'Summer House' or gazebo. It dates from the 1970s or later.

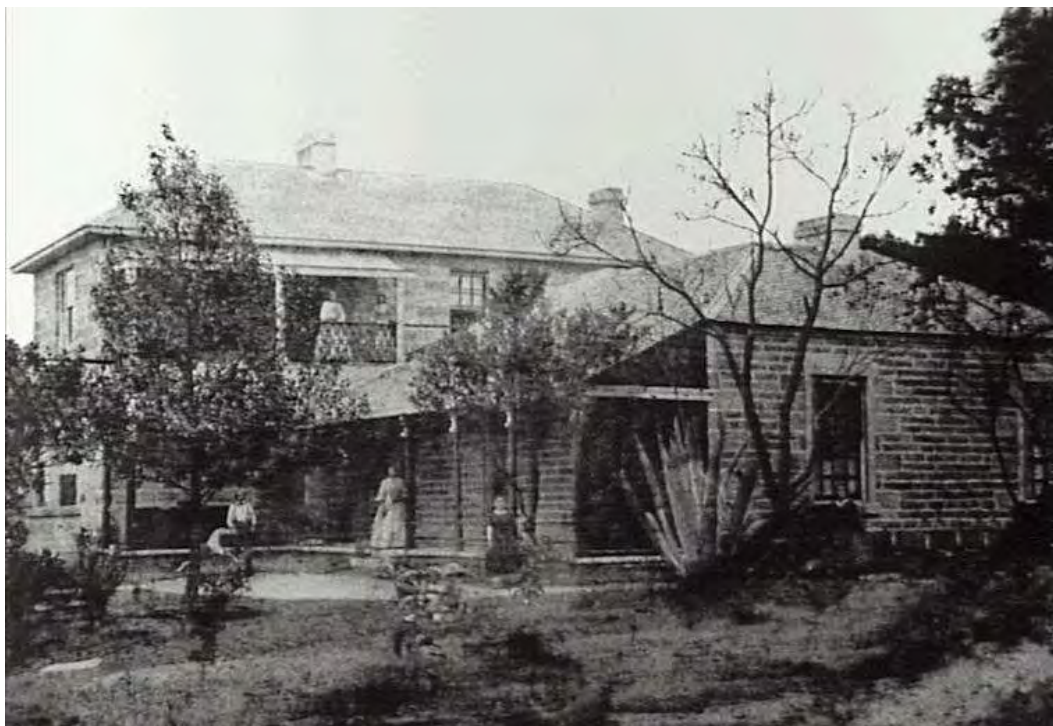
Figure 3.70 'Euroka Cottage', built by Thomas Walker in 1833, is the original single-storey house in the foreground, facing south towards Sydney Harbour. The two-storey western addition in the background was constructed in the 1850s. Note the various plantings.
Source: Stanton Library (Image 2796).

This phase involved the construction of the original single-storey stone cottage 'Euroka' and stables by Thomas Walker (see Figure 3.70 and Figure 3.71). Other outbuildings around the yard would have included a kitchen and scullery, storeroom, stables, cesspits, well, and rubbish pits associated with this phase of occupation. There is mention of a basement associated with the original house. The only standing building thought to belong to this stage is the original stables, although the house may also retain some evidence in the basement walls and west wall of the entrance hall.

The property was acquired by Edwin Sayers who resided there from 1853 to 1868. Edwin Sayers constructed a two-storey west addition to the original house and a new single-storey kitchen to the rear (north) of the original house (see Figure 3.70). The place was described in 1867 as:

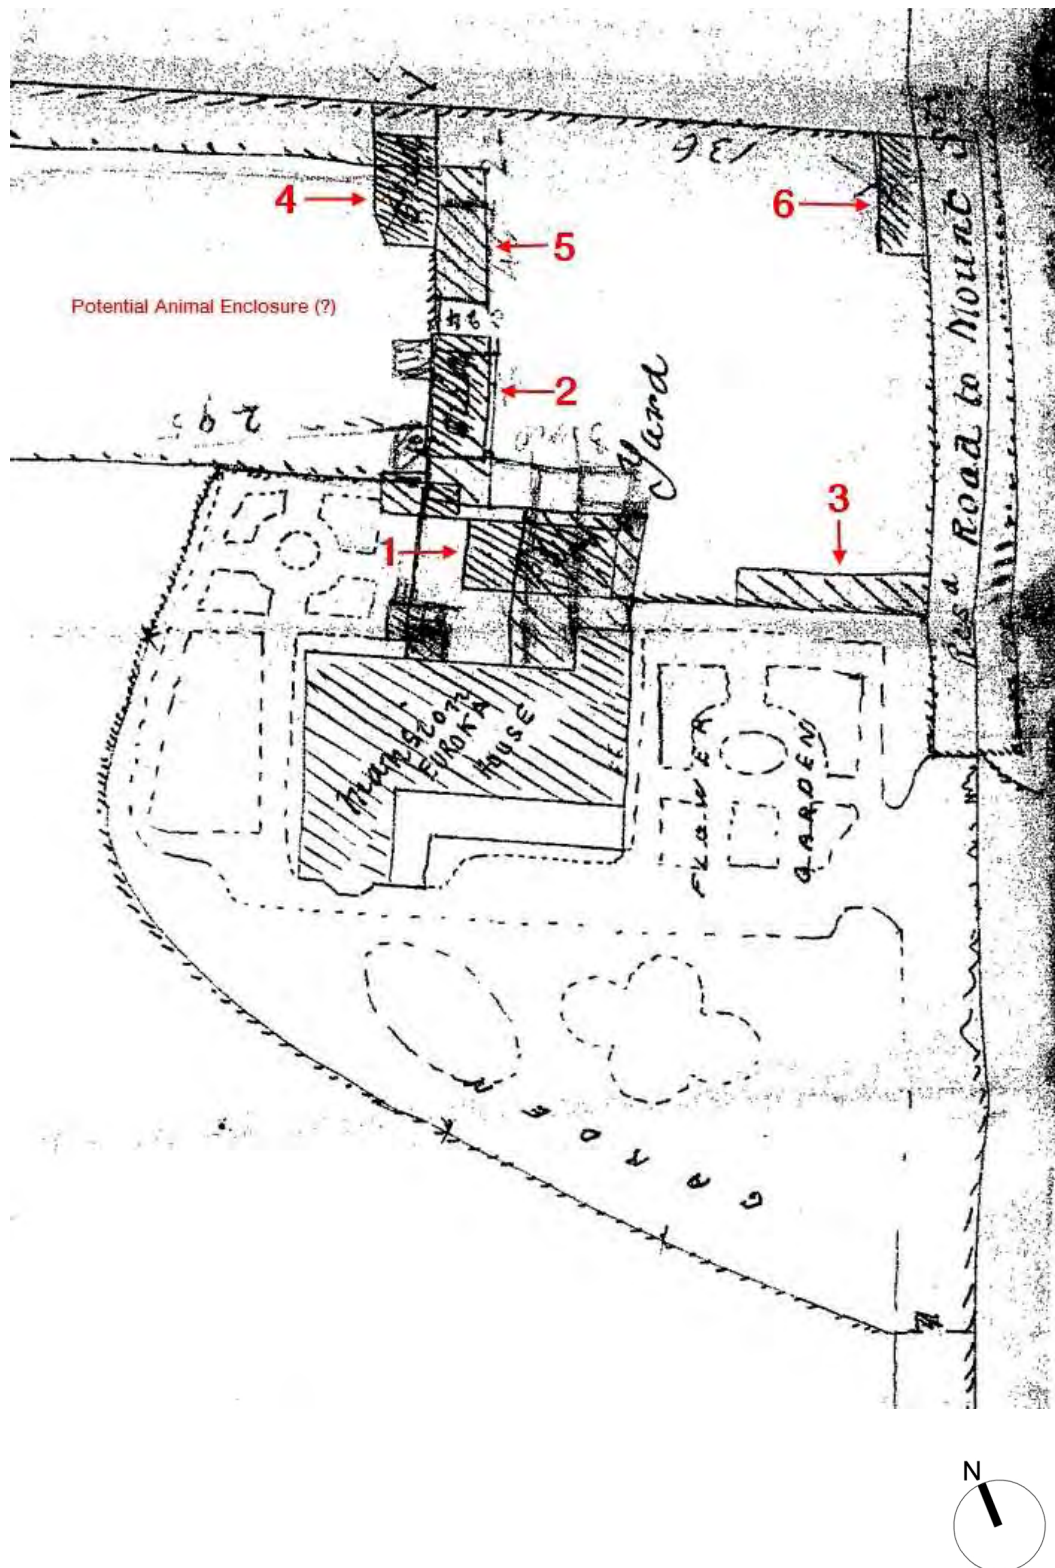
Figure 3.71 Detail of the 1867 survey of the site, showing the original single-storey house and the 1850s western addition. The outbuildings ranged around the yard. This appears to be a field book rather than an accurate plan and is therefore an indication of the outbuildings and their locations rather than a measured survey.

The 1867 survey (see Figure 3.71) indicates that there were six outbuildings around the rear yard with three more to the west of the yard fence and another small building to the rear of the two-storey wing. The vegetable garden was probably to the northwest of the two-storey wing as the flower garden was to the east of the original cottage. Some of the outbuildings are depicted in a c1875 photo—the two buildings inside the rear yard's western fence line and the corner of one along the southern fence line (see Figure 3.76). It is noted that the openings in the stables building in the c1875 photo is different to the surviving building (see Figure 3.75).

The text on the 1867 survey indicating the use of the outbuildings is illegible so identification is uncertain but the original detached kitchen (1) is most likely immediately behind the original house, with the stables (2) to the north and the coach house (3 or 6) to the east rather than immediately north of the stables. The c1875 photo suggests that the northern outbuilding (5) is a small temporary structure, possibly for storage of timber etc. Identification of the other structures is uncertain though the store (4) is probably further to the west and it appears to have been demolished by c1875.

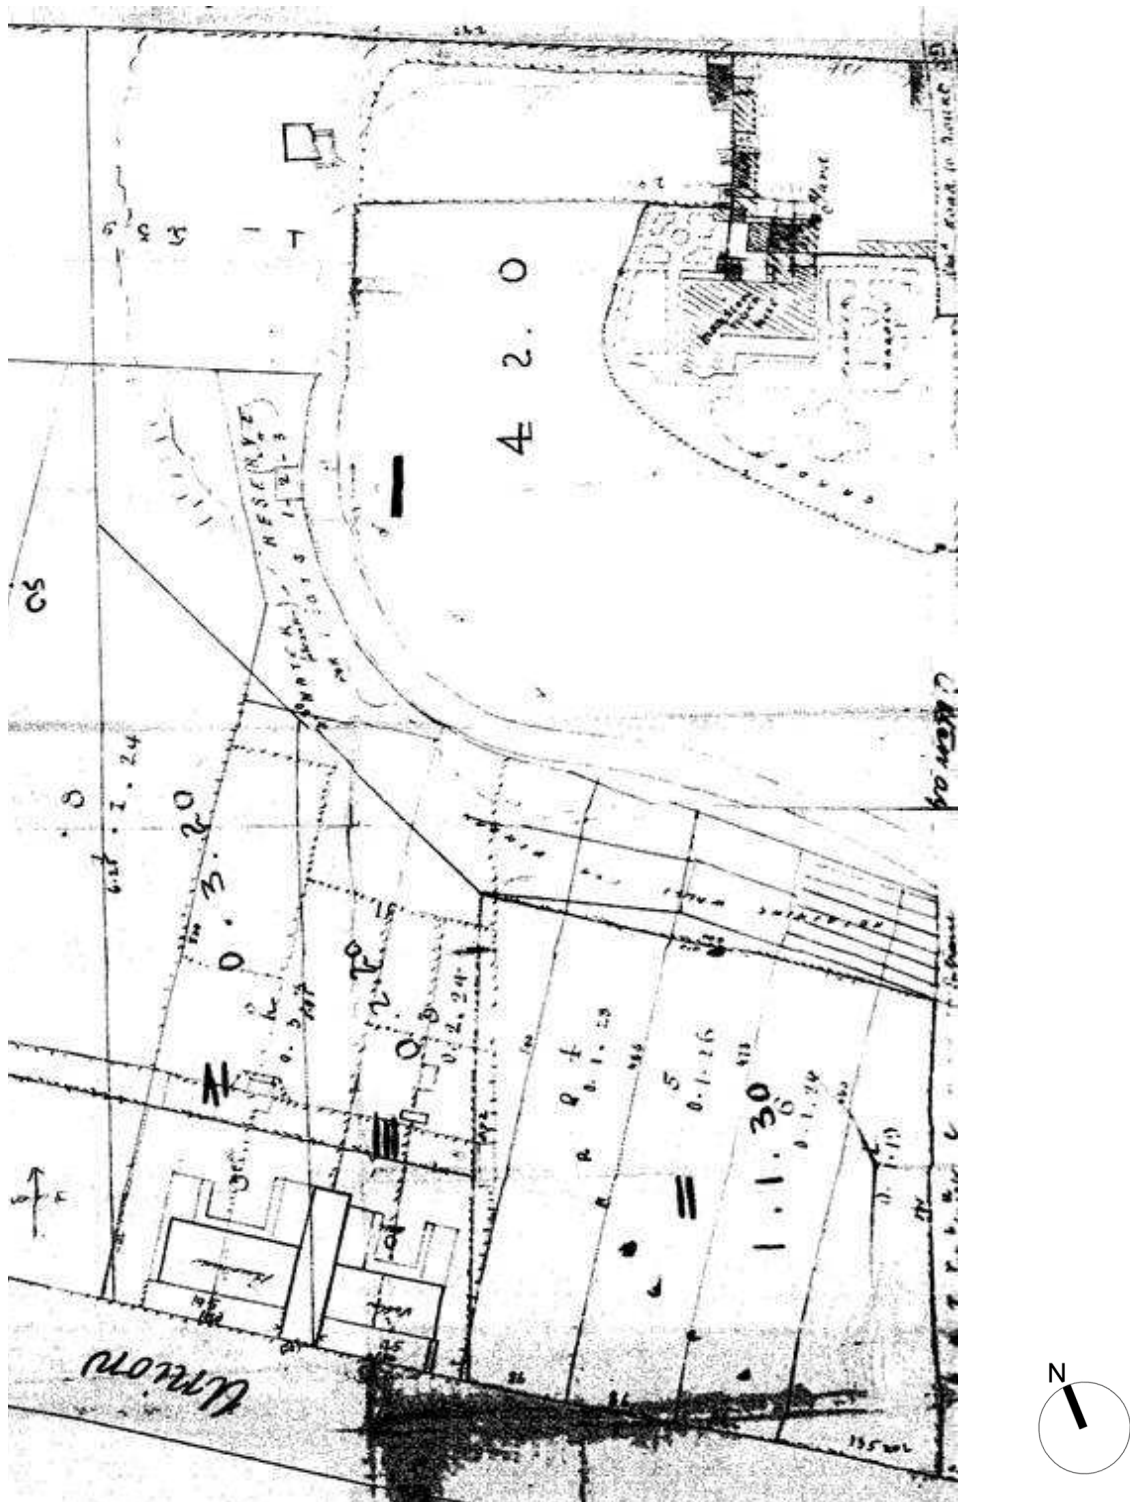
Figure 3.72 An 1867 survey of the study area, prepared for a proposed subdivision, showing the location of 'retaining walls for winery', south of the main buildings and then the land proposed for subdivision, which was originally used as an orchard. The western part of the upper terrace was identified as a 'water reserve' for Lots 1,2 and 3, which have already been sold. The retaining walls or the remains of them, appear to be shown in an 1870s photograph, which suggests that a lot of stone has been collected. This photograph also suggests that the vineyard barely survives in the terraced area and that the walls have been dismantled and the stone re-used.
Source: Mitchell Library—Sydney Suburb Subdivision Plans—North Sydney—N11/122.

The retaining walls within the vineyard area, marked on the 1867 survey, appear to have been demolished in the 1870s leaving limited evidence of the vineyard. Some of the stones may still be retained but within a disturbed context.

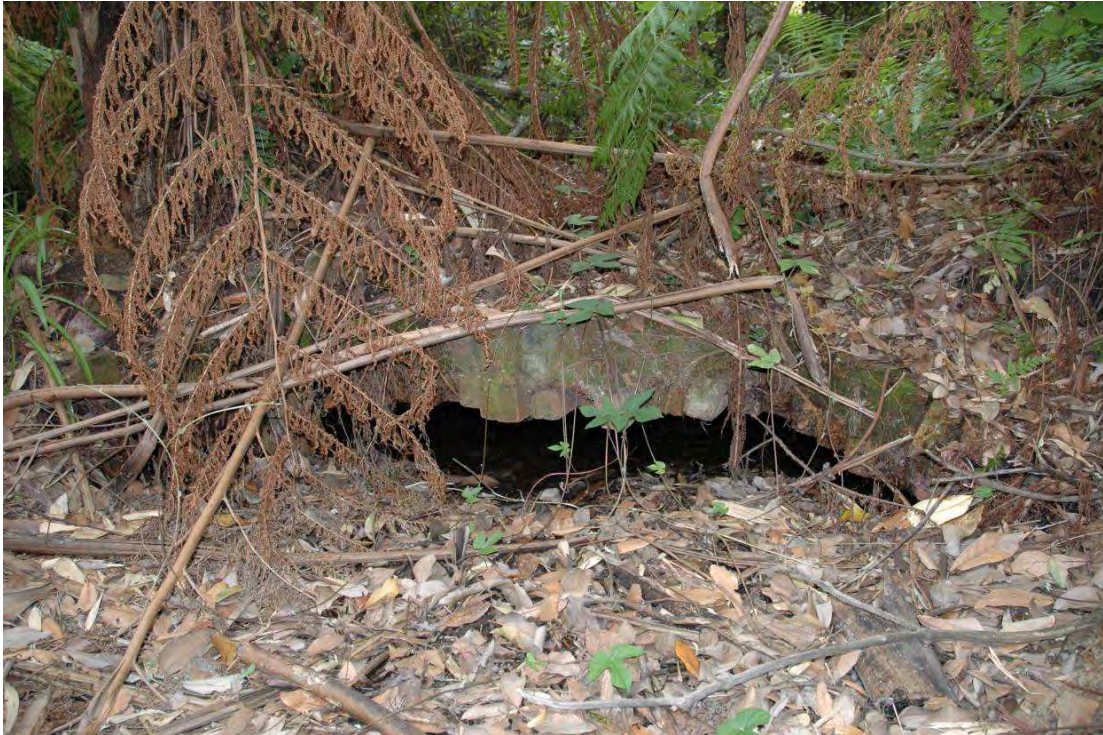
Figure 3.73 Photograph of the top of a brick arch—probably the roof of a brick cistern. The bricks are sandstock with a shallow 'cigar-shaped' frog. The bricks suggest a date of construction as no later than the 1860s. This cistern probably stored water to be used on the vineyard and orchard. Source: Mary Casey, 2010.

The arched brick roof of a structure, probably a water cistern, is located on the edge of the central terrace near the clump of giant bamboo. It is likely the cistern, probably used to collect stormwater and store it for distribution to the orchard and vineyard, and any associated underground drainage was built at the same time as the orchard and vineyard. The advertisements during this phase typically refer to the availability of a constant supply of fresh water. The orchard and vineyard area were already well established when surveyed in 1867 and are visible in some of the historic photos east of the two houses built in the subdivision. The 1867 survey suggests there were stone retaining walls associated with the vineyard along the embankment between the central and lower terraces.

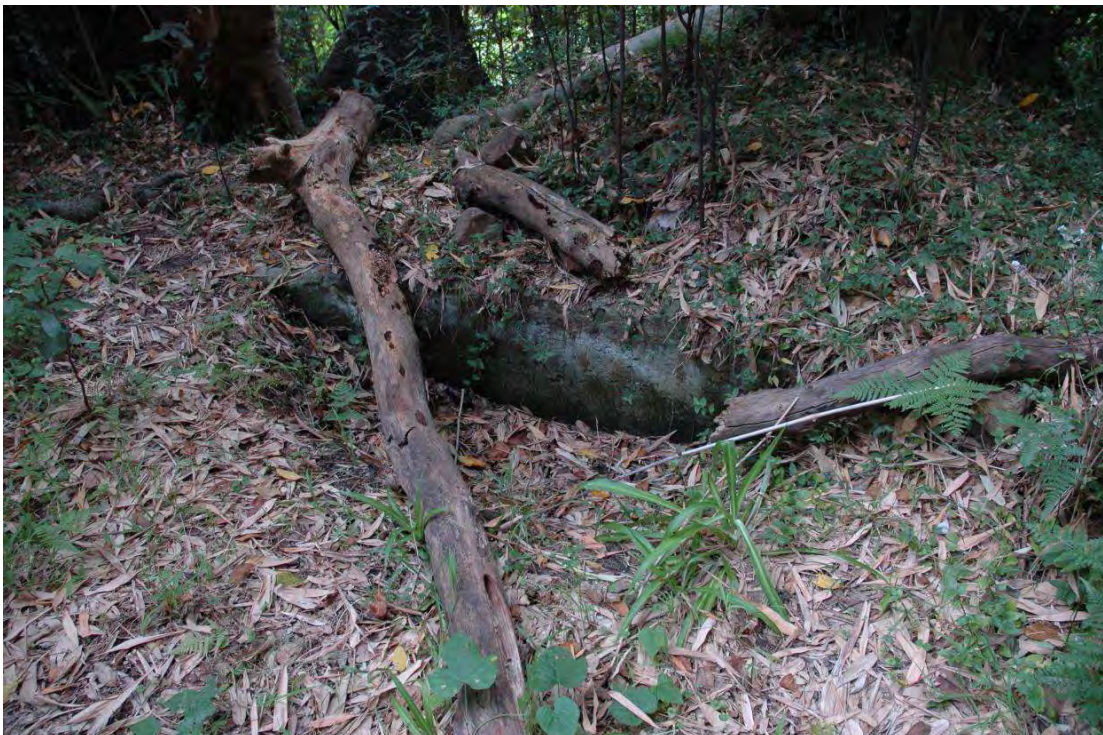
Figure 3.74 Photograph of cement-rendered structure adjacent to the clump of giant bamboo. It was probably a garden feature—phase of construction and use uncertain. Source: Mary Casey 2010.

- the gazebo shown on the 1891 plan;
- remains of brick c1860s structure, possible water cistern/reservoir and likely brick drains used to gravity feed water from the cistern/reservoir;
- remains of cement-rendered structure adjacent to stand of giant bamboo, possibly a pond;

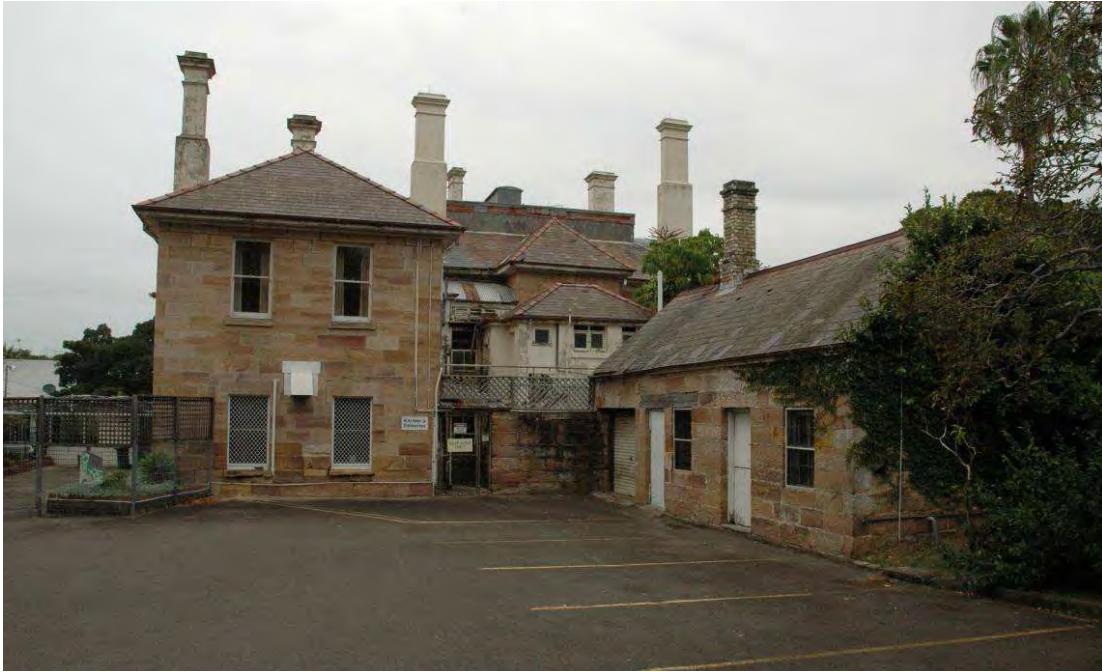
Figure 3.75 Photograph of the rear yard behind the existing buildings with the former stables building at right. Compare the openings of this building with the c1875 photograph (see Figure 3.76). There was a larger central opening in the c1875 photograph and roof was shingled, suggesting that it was re-roofed at a later date. The large timber lintel may indicate the position of the original double opening doors and rebuilding of part of the front wall of the former stable building. Source: Mary Casey 2010.

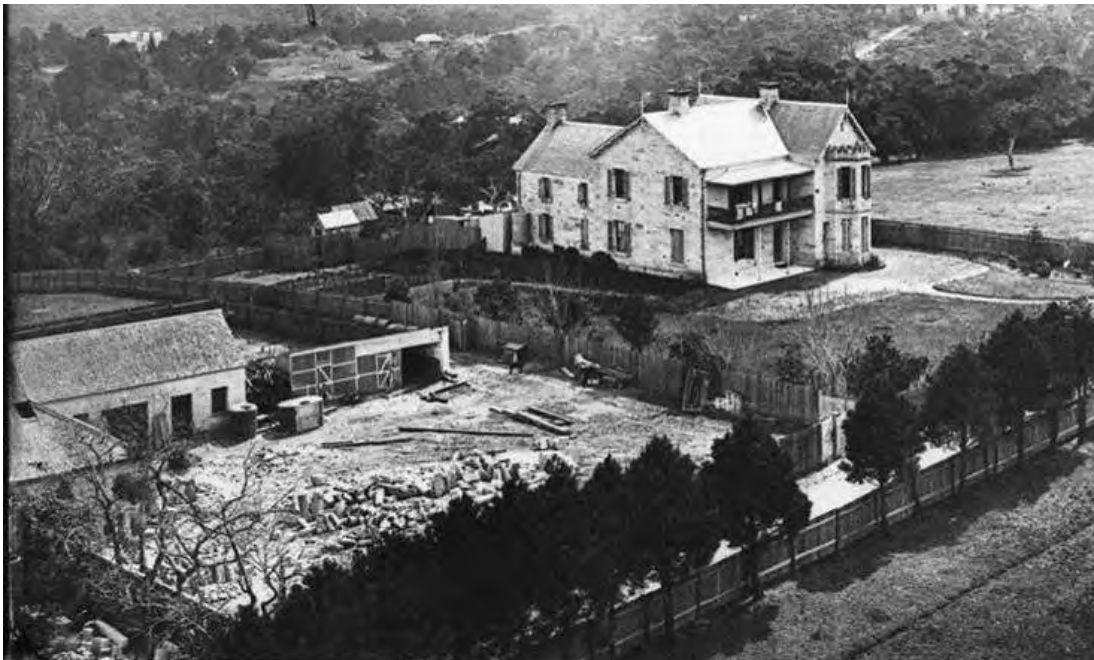
Figure 3.76 A c1875 photograph of Upton Grange in the background. The rear yard of Euroka Villa is shown in the foreground. This image shows the extant stables outbuilding with another to the north along the western side of the yard. Source: State Library of NSW—Home and Away—42273.

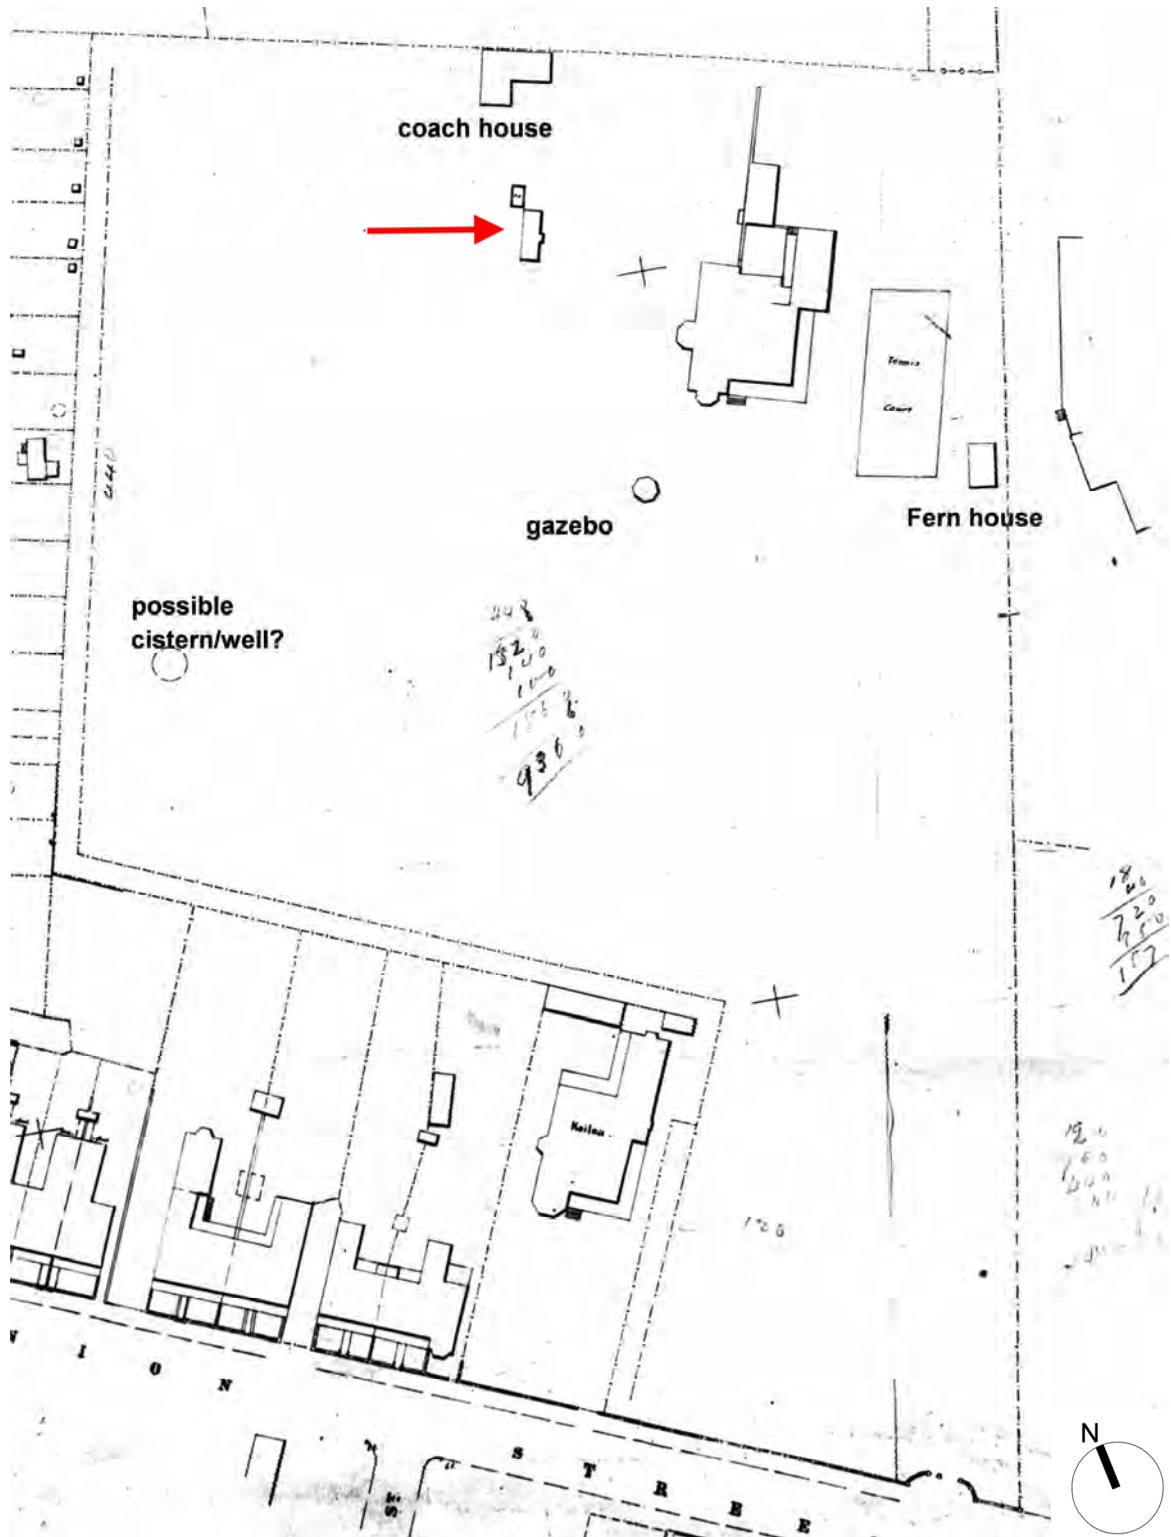
Figure 3.77 1891 survey of the area.

This image shows the footprint of the house after the major additions of 1875-1876. The Coach House was also constructed at this time as well as two other structures to its south (see red arrow) and the gazebo on the slope above the middle terrace. Another area of the orchard has been subdivided by this time reducing the property to its existing site area.

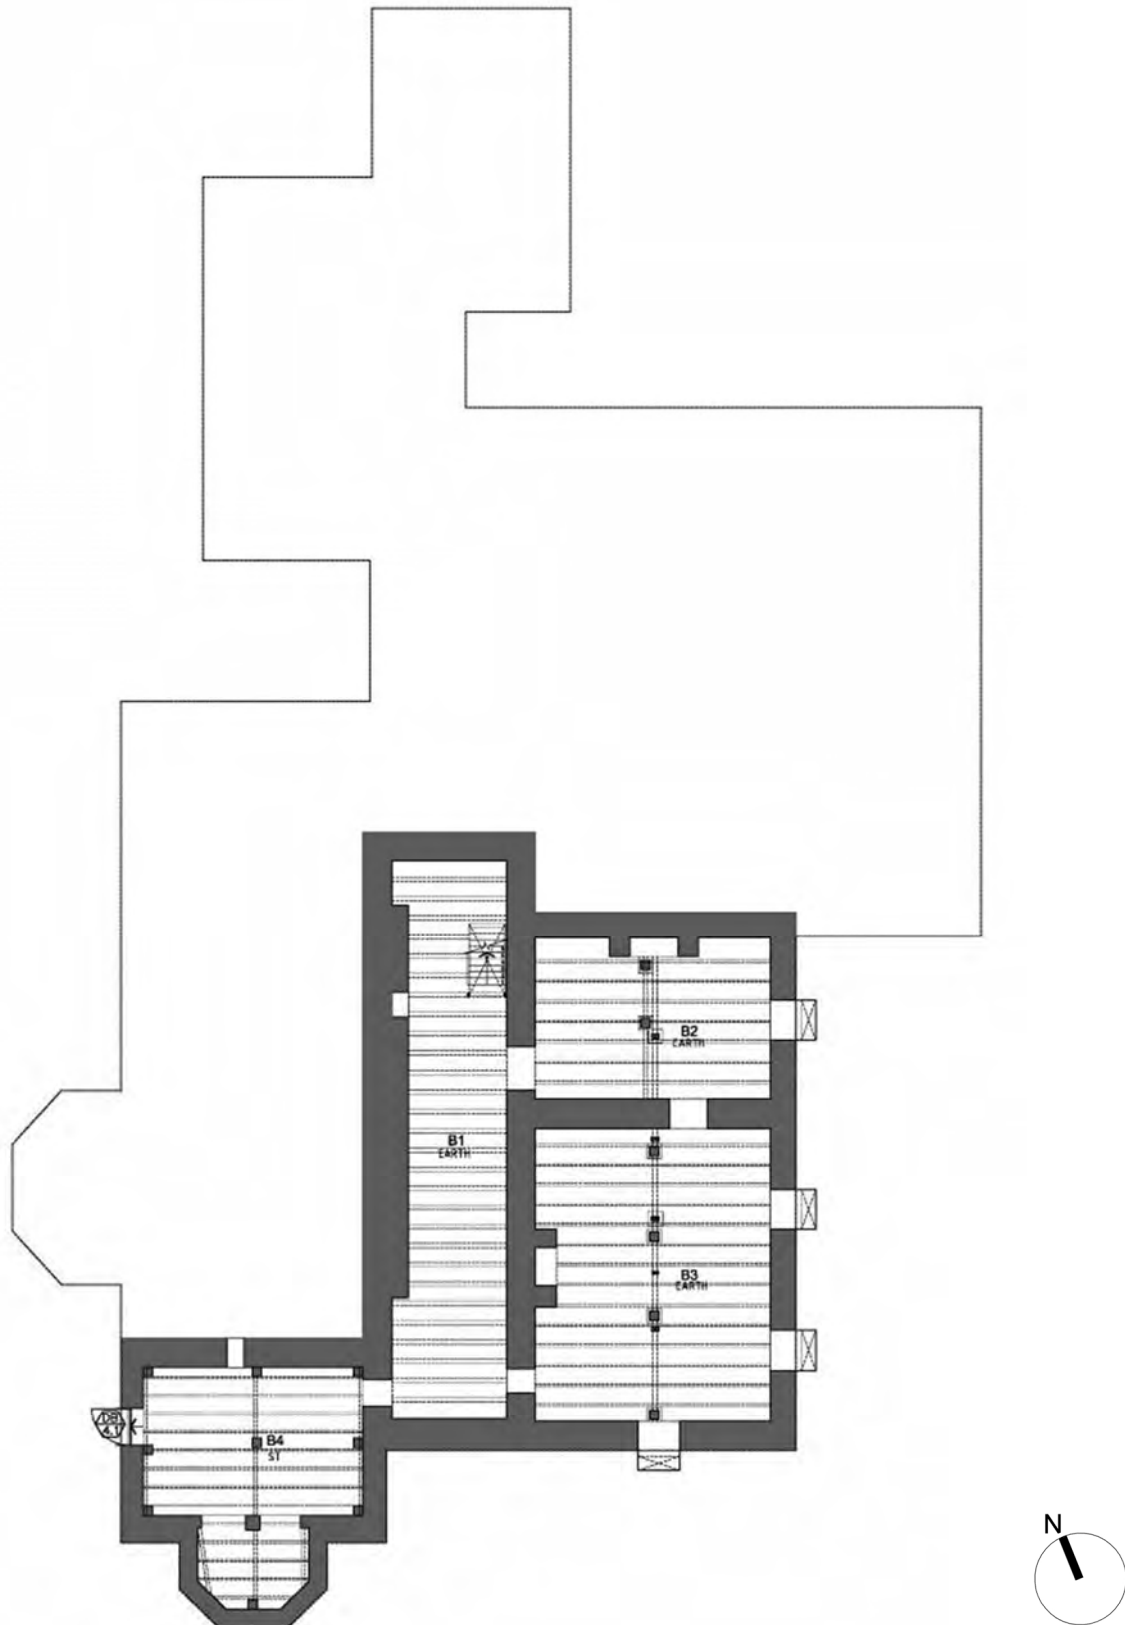
Figure 3.78 Basement plan for the house complex showing the extent of excavation for the house.
Source: Tanner Architects, 2010

By 1867 the outbuildings included: kitchen, servant's room, store room, laundry, coach-house, stable, and loft, fowl-house, and cow shed. Most of these were probably the original outbuildings but others may have been added after 1867. There are likely to have been other changes to the landscape and buildings in this area but these are not mentioned in the historical resources. The two-storey wing from this phase is still extant and there are cellars beneath the southern section (see Figure 3.78).
