3.8 The former Ward Building, Recreation Room and Bathroom/Lavatory Block

3.9 Historical Archaeology

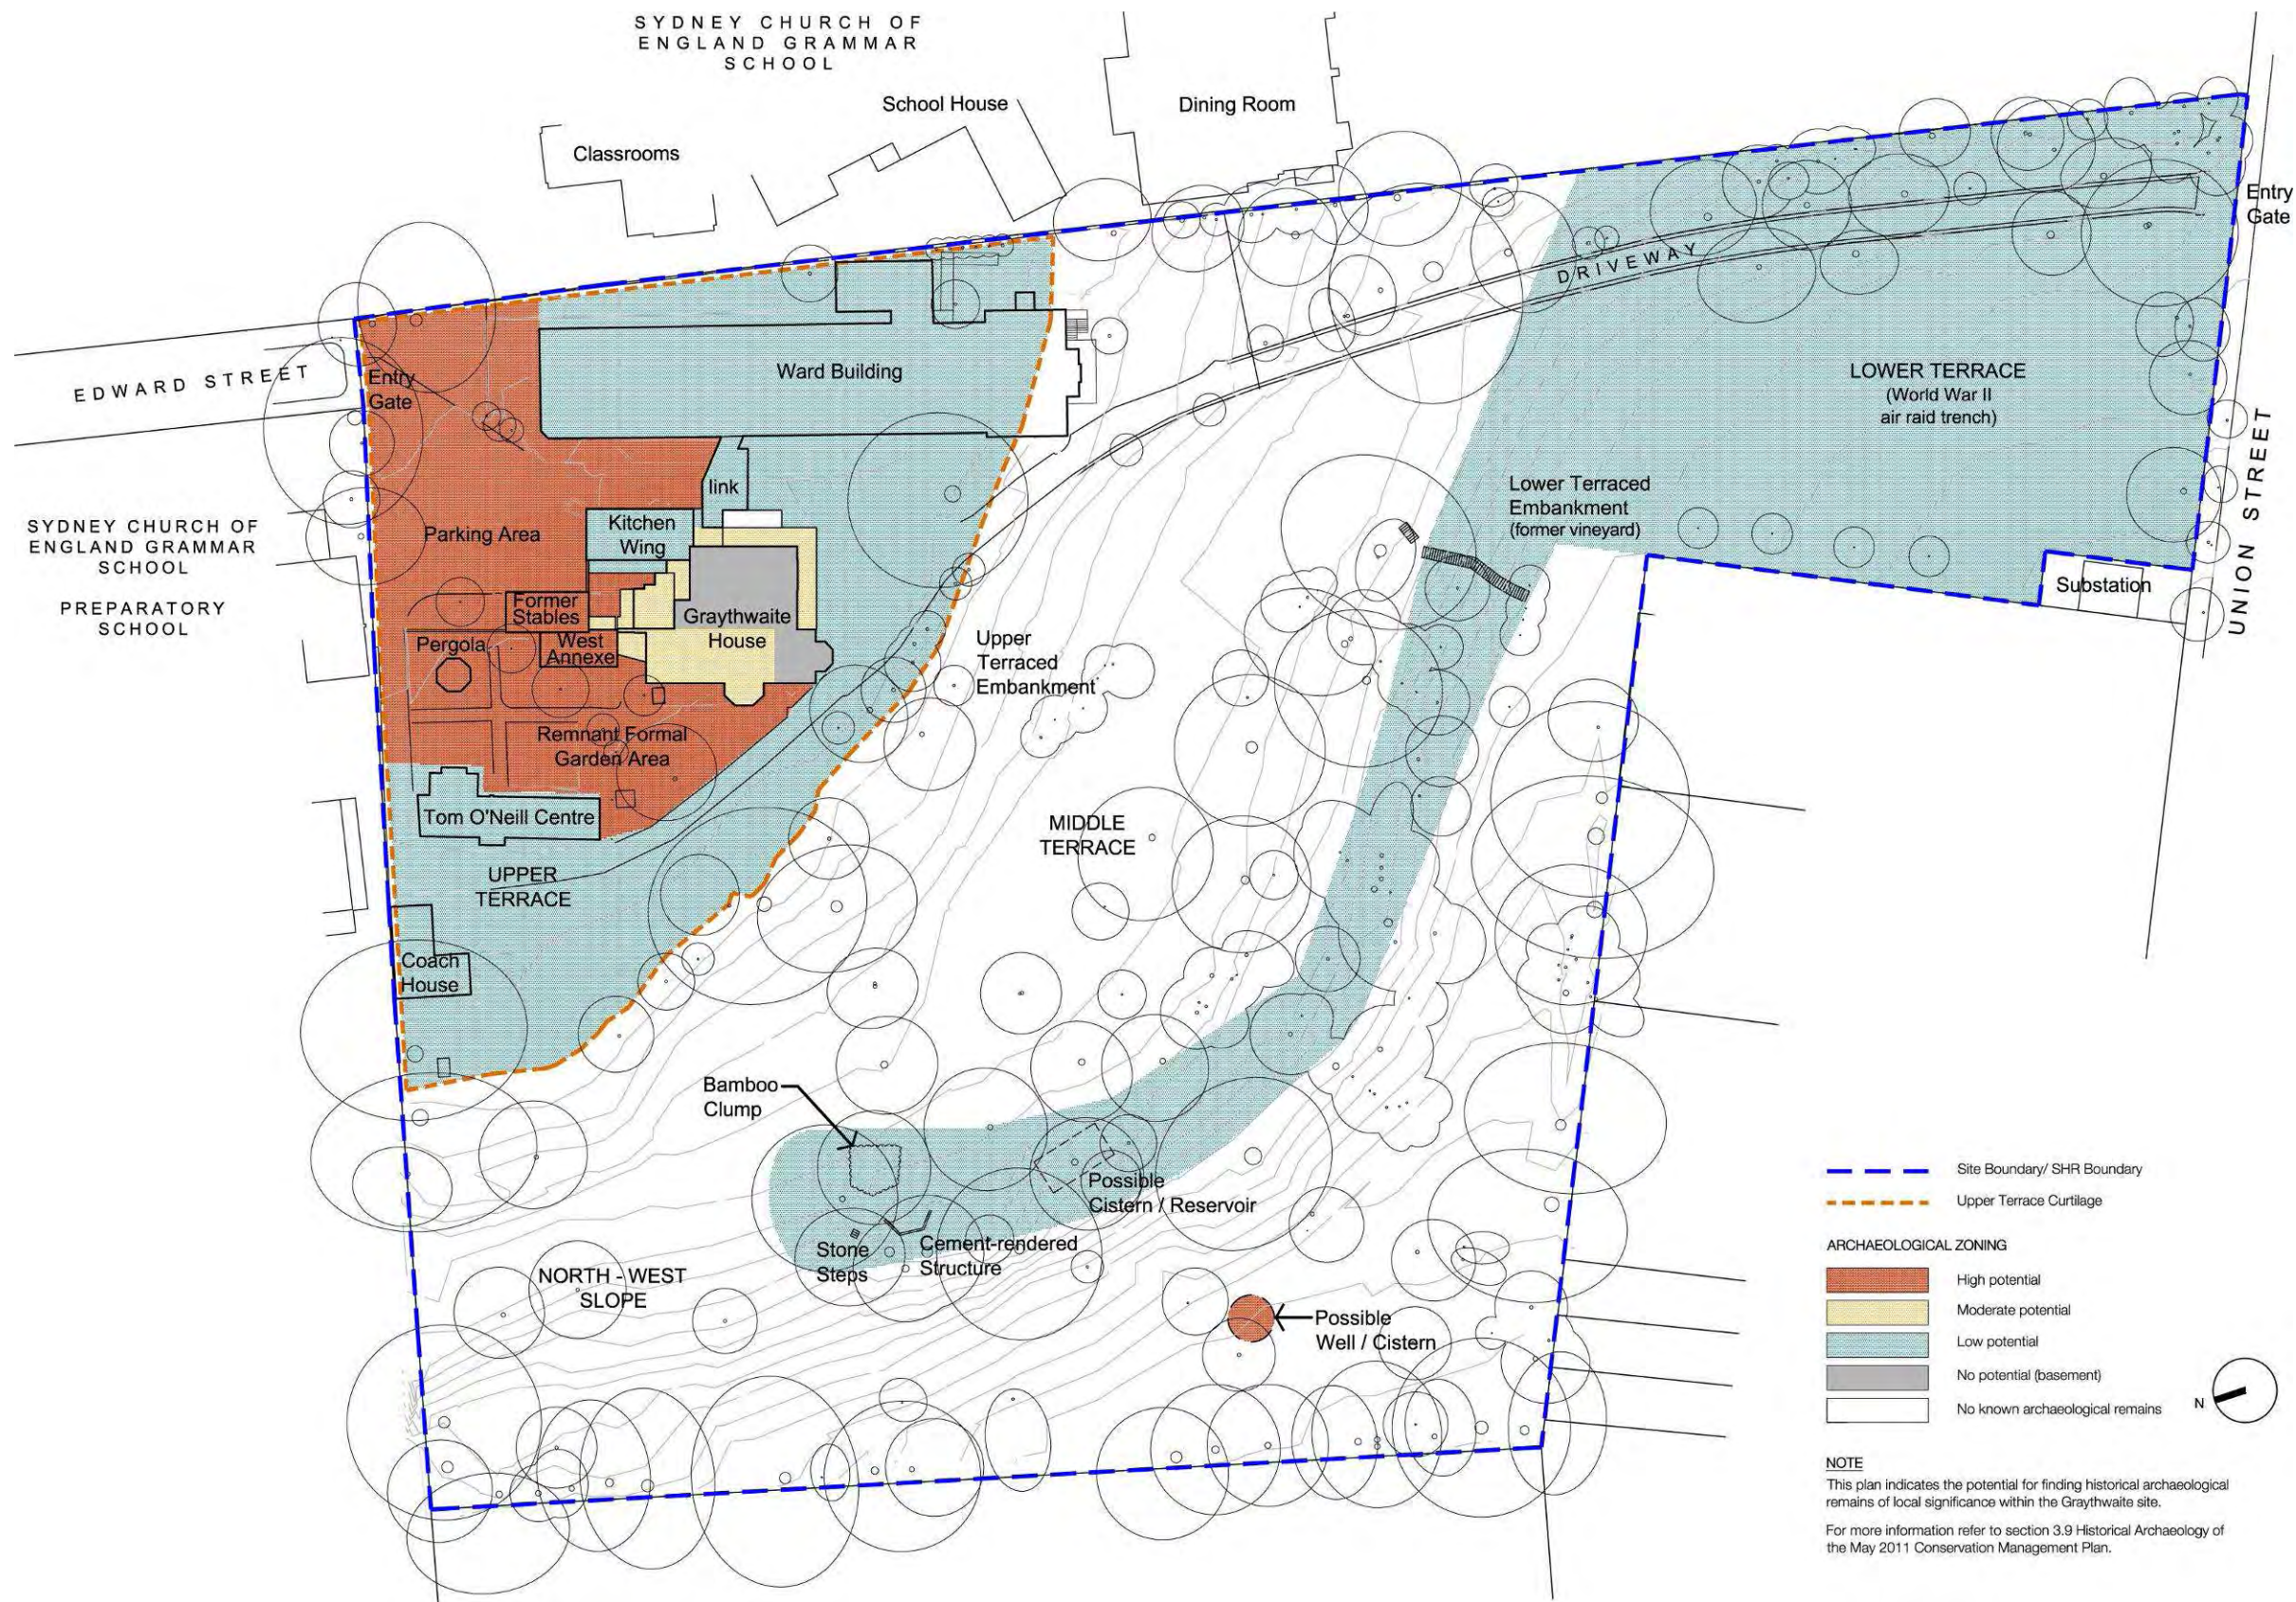
Figure 3.79 The areas of potential historical archaeological remains of heritage significance on the Graythwaite site.
Source: Tanner Architects with Casey & Lowe overlay.

Not all of the remains at the Graythwaite site would be of heritage significance. Figure 3.79 shows the areas of the site with potential to contain historical archaeological remains of local or state heritage significance—defined as ‘relics’ under the *Heritage Act 1977* (NSW). Refer to Section 4.6.6 of this CMP for a more detailed discussion on what constitutes significant archaeological remains (‘relics’).
