GRAYTHWAITE
UNION STREET, NORTH SYDNEY

CONSERVATION MANAGEMENT PLAN

prepared for
SYDNEY CHURCH OF ENGLAND GRAMMAR SCHOOL

FINAL ISSUE P4 – NOVEMBER 2010
TA JOB No. 09 0821

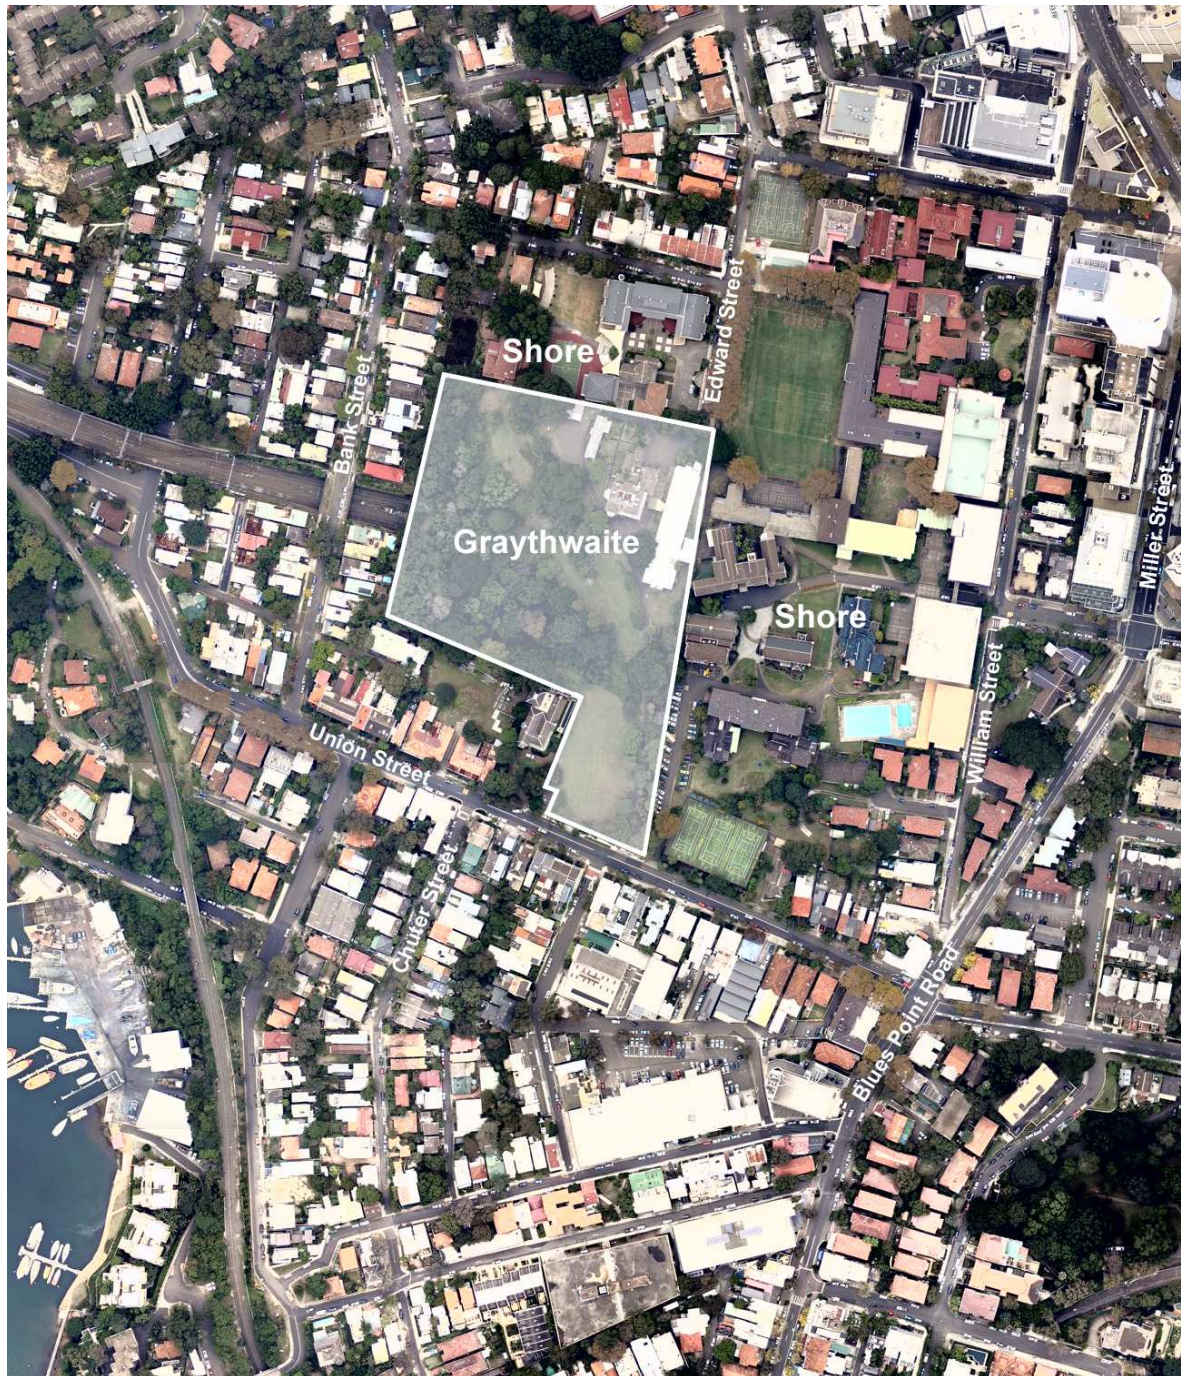
Figure 1.1 Aerial photograph of the immediate context of Graythwaite, showing the site's relationship with Shore and surrounding residential areas, not to scale.
Source: www.nearmap.com with Tanner Architects overlay 2010

Located at Union Street, North Sydney, Graythwaite comprises an expansive land holding of 2.678 hectares (Figure 1.1) within the local government area of North Sydney. The property is bounded on the east and north by Shore School, on the south by Union Street and private residential properties fronting Union Street, and on the west by private residential properties fronting Bank Street. The current street address is 20 Edward Street, although a Union Street address was used throughout the nineteenth century and greater part of the twentieth century.

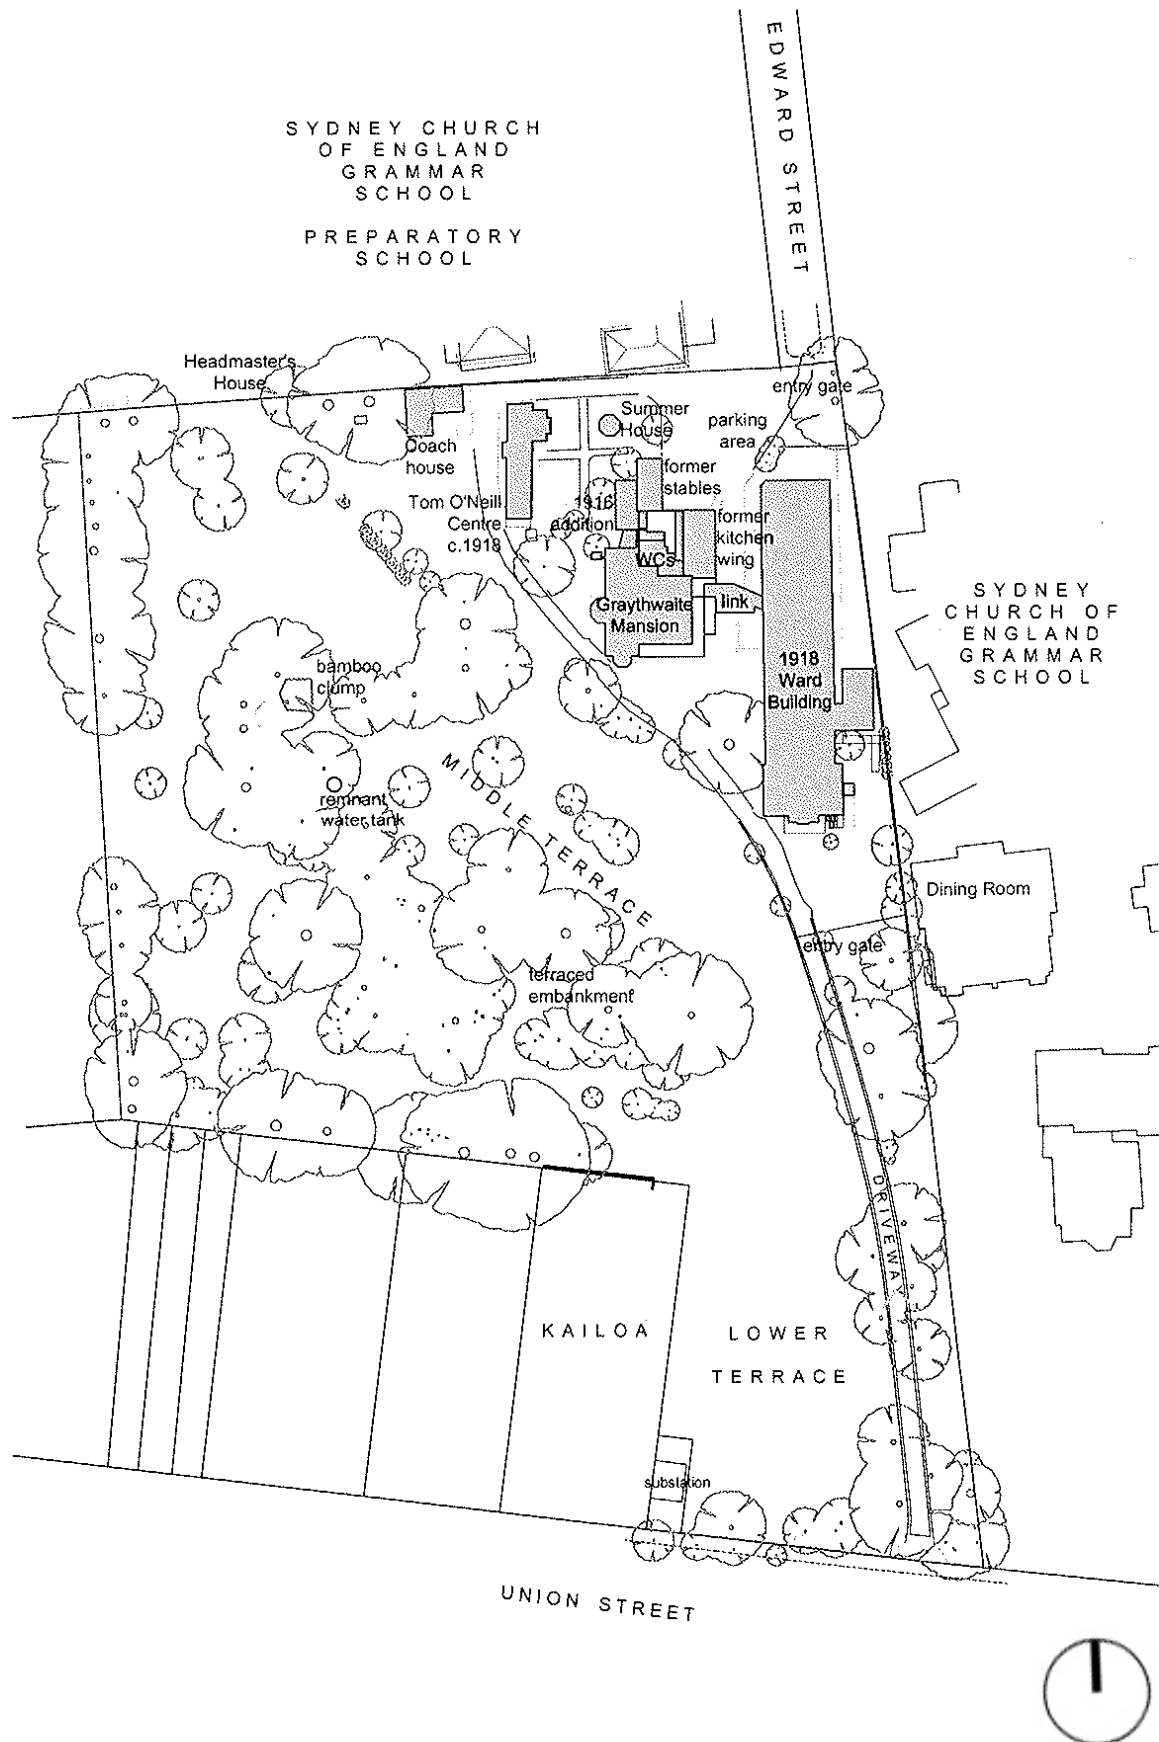
Figure 1.2 Site plan for Graythwaite, not to scale.
Source: Tanner Architects, 2010

The principal entry gate is at the south-east corner, fronting Union Street. The site slopes steeply upwards to the north-east and features a number of open grassed areas and landscaped embankments. The principal buildings on the site are located on the upper terrace to the north-east, accessed via a curved driveway from the main gate (Figure 1.2). The main buildings include the House Complex including Graythwaite House, a two-storey Kitchen Wing and single storey Stables Building at the rear (north), the Ward Building to the north-east, the Tom O'Neill Centre to the west of the House, and the Coach House abutting the north boundary.
