GRAYTHWAITE
UNION STREET, NORTH SYDNEY

CONSERVATION MANAGEMENT PLAN

prepared for
SYDNEY CHURCH OF ENGLAND GRAMMAR SCHOOL

ISSUE B – JUNE 2011
TA JOB No. 09 0821

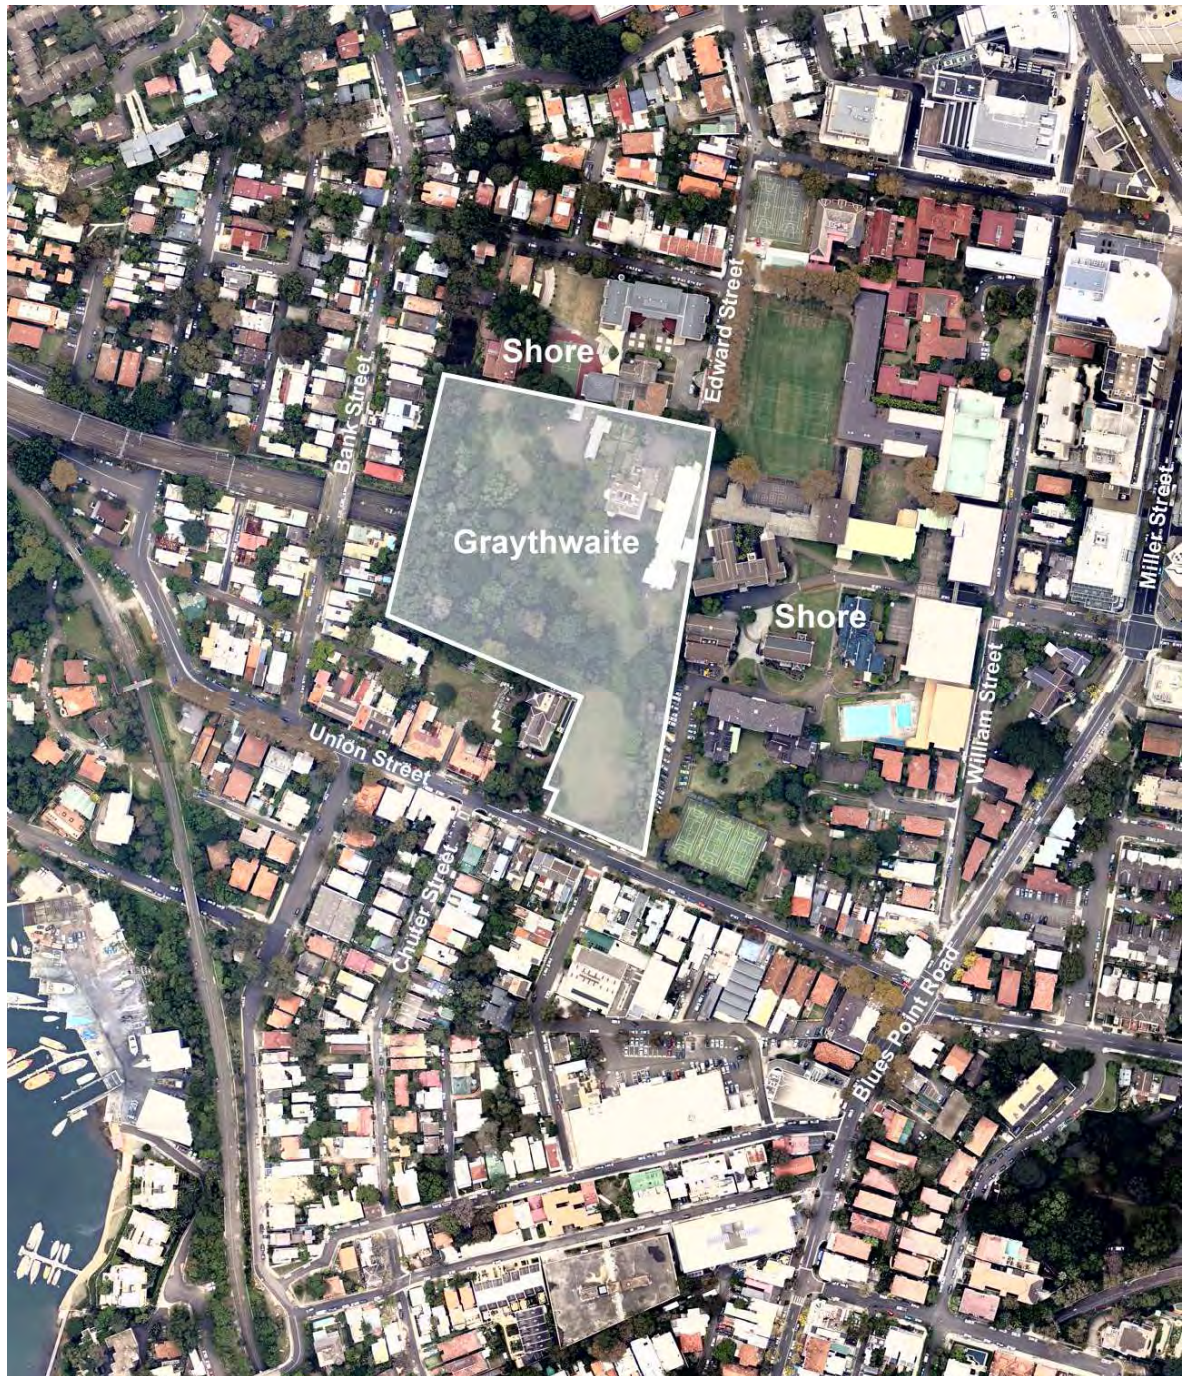
Figure 1.1 Aerial photograph of the immediate context of Graythwaite, showing the site's relationship with Shore and surrounding residential areas, not to scale.
Source: www.nearmap.com with Tanner Architects overlay 2010

Located at Union Street, North Sydney, Graythwaite comprises an expansive land holding of 2.678 hectares (Figure 1.1) within the local government area of North Sydney. The property is bounded on the east and north by Shore School, on the south by Union Street and private residential properties fronting Union Street, and on the west by private residential properties fronting Bank Street. The current street address is 20 Edward Street, although a Union Street address was used throughout the nineteenth century and greater part of the twentieth century.

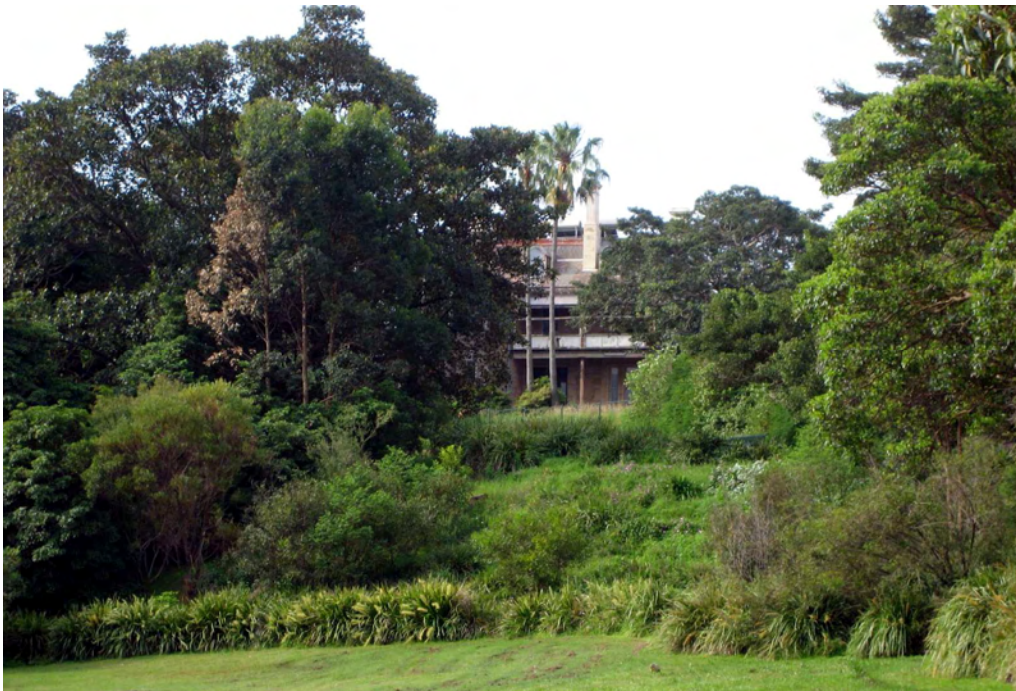
Figure 3.5 The house complex from the lower terrace (former tennis court area). The mature vegetation on the upper (and lower) embankment now largely obscures the house from view.
Source: Tanner Architects.

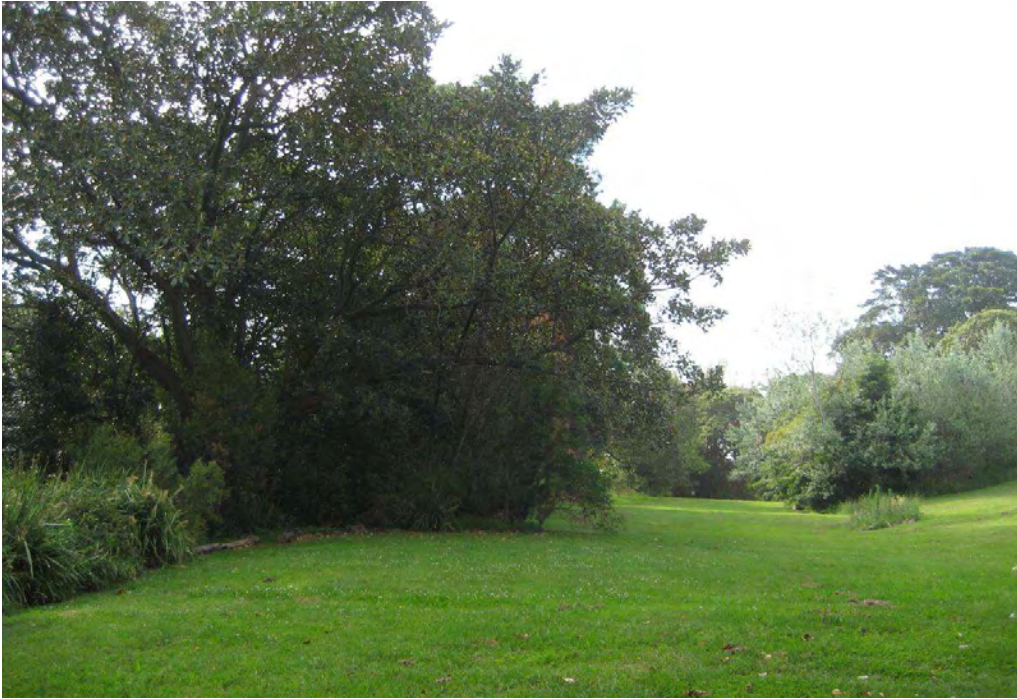
Figure 3.6 The middle terrace, looking west. The middle terrace was the site of tennis courts during the early convalescent use of the site.
Source: Tanner Architects.

Terraces	Terracing has created level areas for buildings (the upper terrace), grassed areas for recreation (tennis courts – middle terrace) (Figure 3.6) and for earlier horticulture (the orchard and gardens – lower terrace) (Figure 3.7).
Embankments	The embankments have been generally mass planted whilst retaining evidence of former driveways, paths/tracks and other potential archaeological features (Figure 3.8). The lower terraced embankment was the site of a vineyard established on narrow stone wall retained terraces (Figure 3.5).
North-west Slope	An area to the west of the House Complex, once part of a cow paddock, has been subjected to later fill with building rubble and soil (the north-west slope) (Figure 3.9).

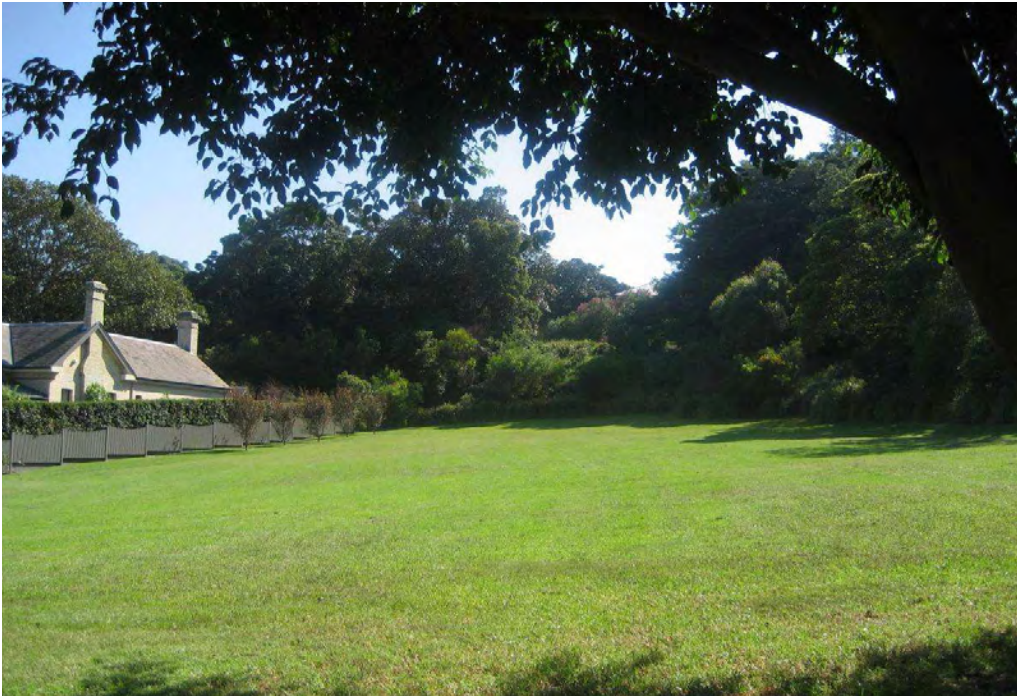
Figure 3.7 The lower terrace, looking north from the Union Street entrance, with Kiaola and the row of Prunus shrubs on the left hand side.
Source: Tanner Architects.

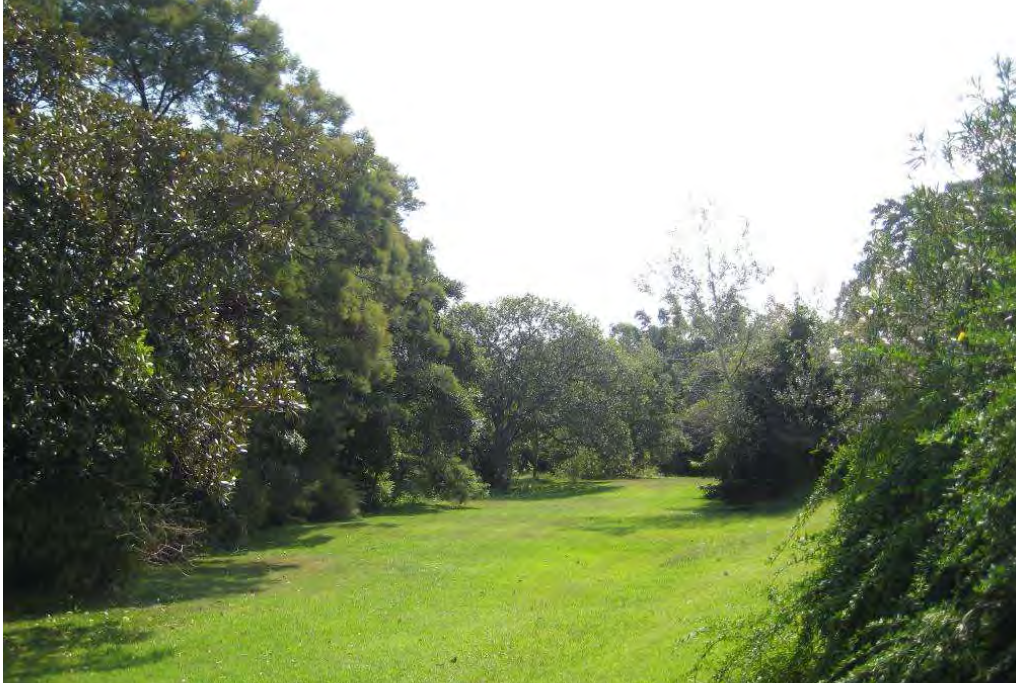
Figure 3.8 Mass planting along the slope between the middle and lower terraces
Source: Tanner Architects.

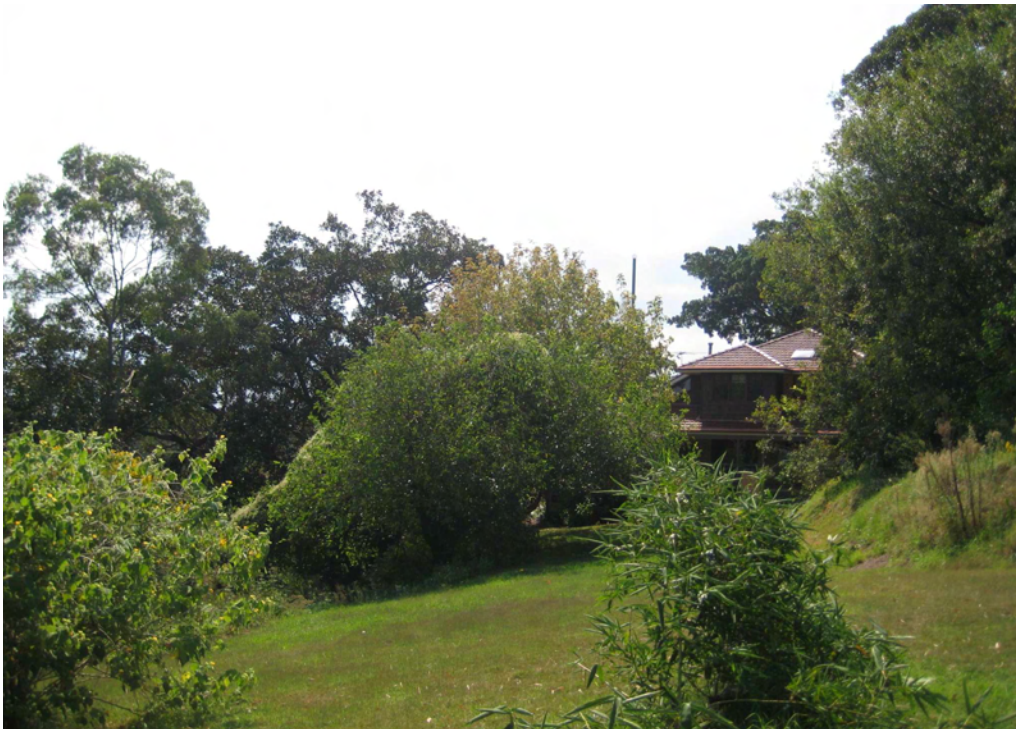
Figure 3.9 The upper part of the north-west slope, looking north towards the Headmaster's house, comprising fill.
Source: Tanner Architects.

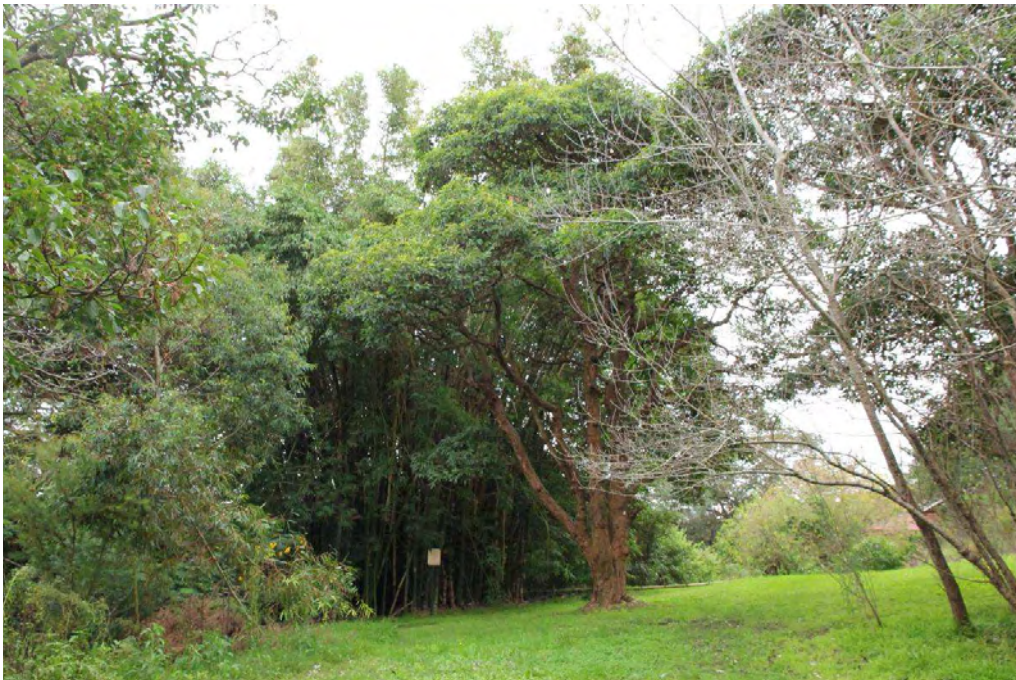
Figure 3.11 Nineteenth century clump of bamboo (T164) on the middle terrace.
Source: Tanner Architects

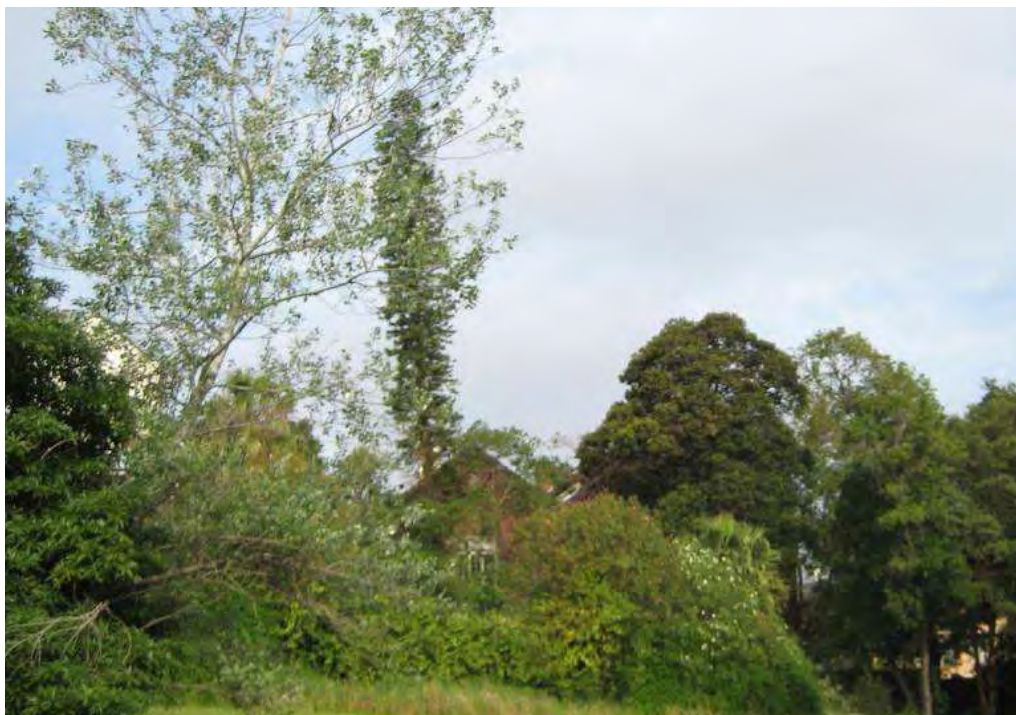
Figure 3.12 The landmark *Araucaria columnaris* (T49) tree located just within the eastern boundary on the upper slopes, adjacent to the eastern boundary with Shore.
Source: Tanner Architects.

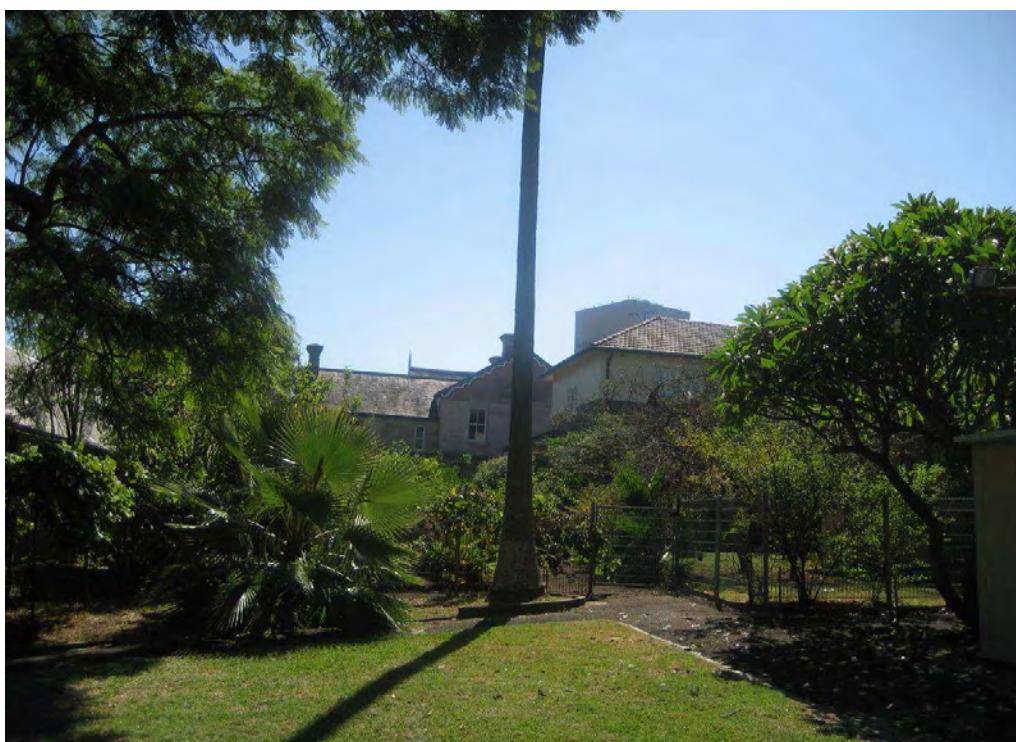
Figure 3.13 Remnant formal garden, to the west of Graythwaite House, looking north.
Source: Tanner Architects.

Individual tree plantings	<p>Individual tree planting is evidenced on the upper terrace adjacent to the house complex, the Union Street frontage and the landmark <i>Araucaria columnaris</i> tree (T49) located just within the eastern boundary on the upper slopes (Figure 3.12). This tree may date from the 1860s and may have originally been located within Millers property.</p> <p>The conspicuous individual trees on the upper terrace area are; <i>Ficus rubiginosa</i>, <i>Jacaranda mimosifolia</i> and <i>Washingtonia robusta</i> (Figure 3.14) whilst on the Union Street frontage and within the former orchard paddock are: <i>Ulmus parvifolia</i>, <i>Eucalyptus nicholii</i> and <i>Lophostemon confertus</i>.</p>
Garden areas	Garden areas within courtyards to the east and west (Figure 3.13) of the House complex.

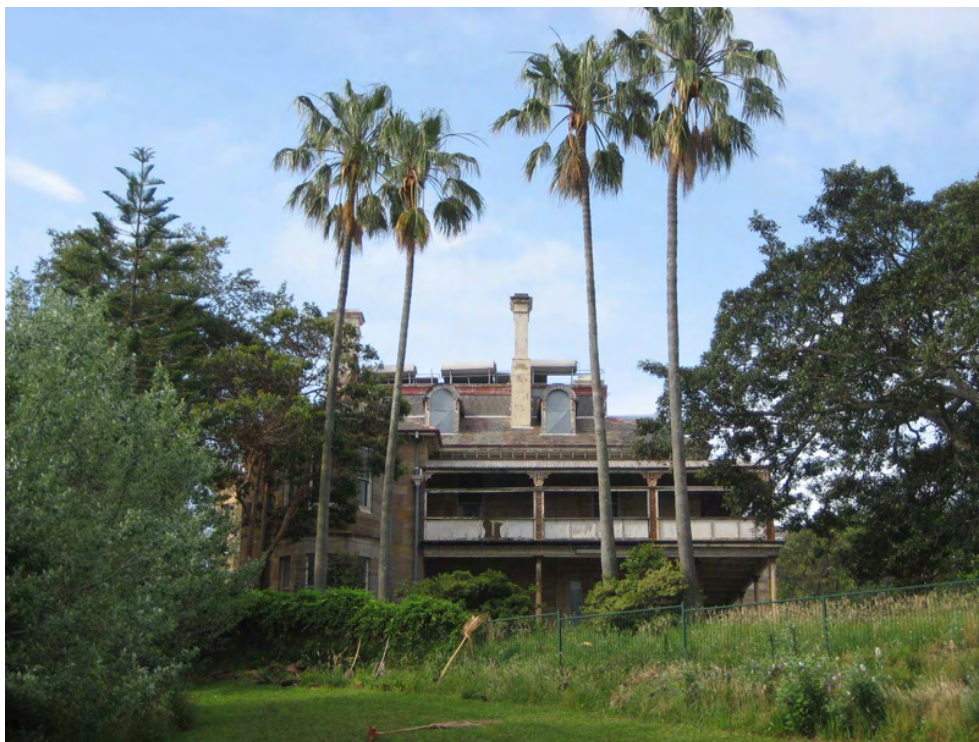
Figure 3.14 *Washingtonia robusta* (T61, T61a, T190, T191) on the south margins of the upper terrace.
Source: Tanner Architects.

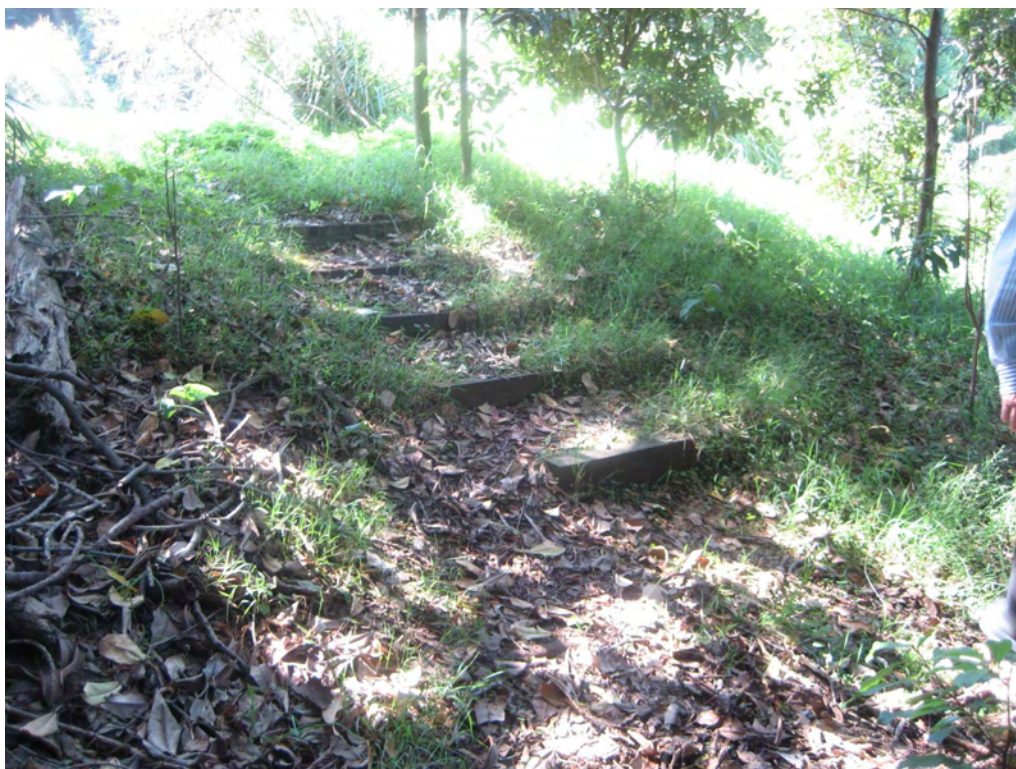
Figure 3.15 Recent timber steps in the lower terraced embankment.
Source: Tanner Architects.

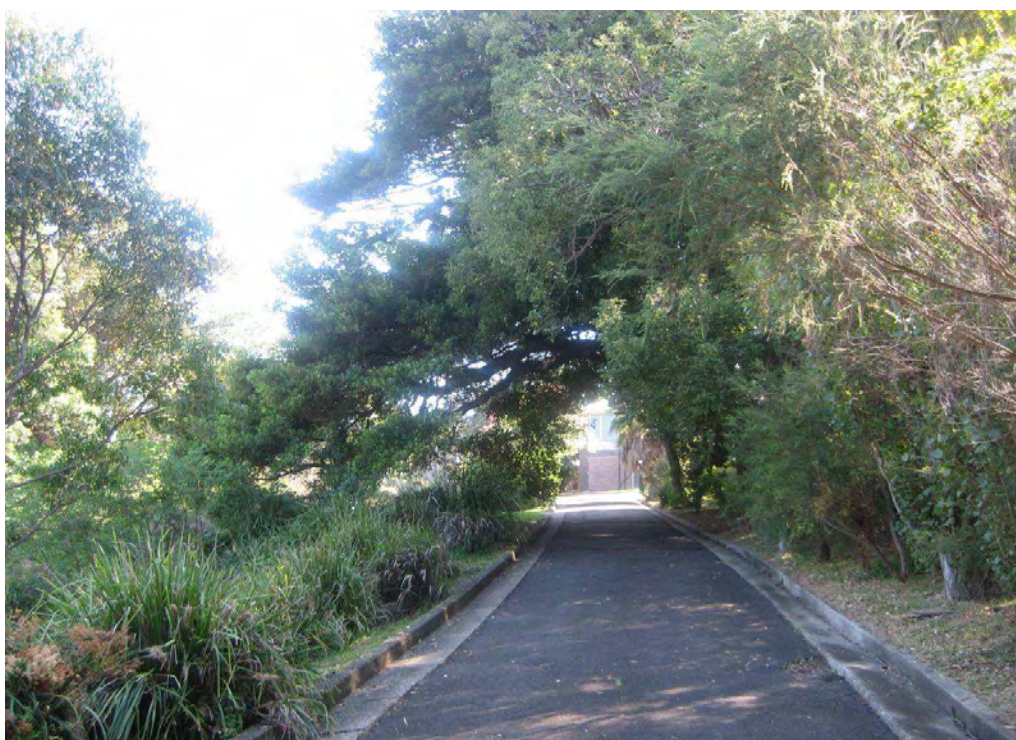
Figure 3.16 Bitumen driveway, looking north.
Source: Tanner Architects.

Buildings	Sandstone buildings represent the nineteenth century whilst the brick buildings generally represent the twentieth century. The Ward Building and associated recreation room and lavatory is of timber framing and weatherboards.
Fences	Fences are a combination of timber paling, chain wire, timber rail, painted timber picket and metal palisade types.
Gates	The entrance gates and fences at Union Street and Edward Street and to the upper drive/upper terrace are tubular steel metal-framed structures.
Walls	Walls are generally dwarf wall height brick acting as a retaining wall along the Union Street boundary and integrated with brick gate piers at the main entrance drive (Figure 3.68).
Steps	The rock cut steps on the margins of the middle terrace and the recently constructed steps in the lower terraced embankment (see Figure 3.15).
Driveways	The bitumen driveways with concrete kerbing generally associated with the twentieth century whilst sections of brick drain edges are remnants of the Federation period during the Dibbs family occupation (Figure 3.16, Figure 3.17).
