PLAN SHOWING BOUNDARIES, AREAS AND  
VOLUMES OF KIRRAWEE BRICK PIT (STAGE 3)  
AT FLORA ST, KIRRAWEE

CONTOUR AND DETAIL SURVEY  
KIRRAWEE BRICK PIT  
AT PRINCES HIGHWAY & FLORA ST, KIRRAWEE

# **Site Service and Infrastructure Drawings and Specifications**

## Site Characterisation Information Sheet

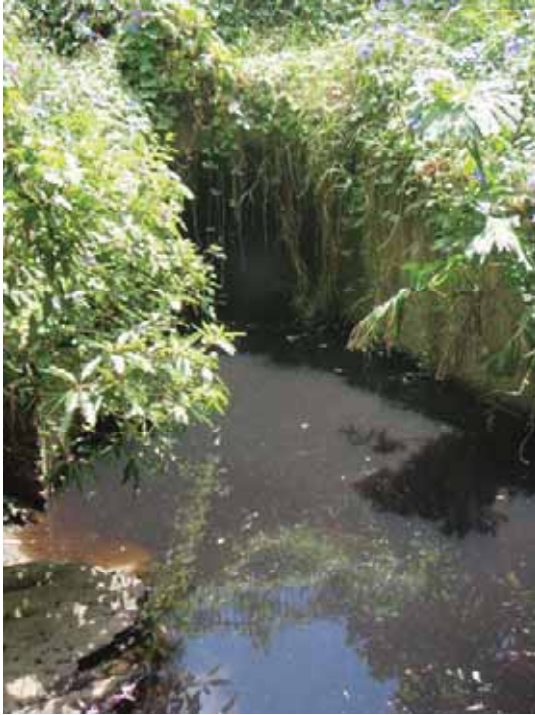
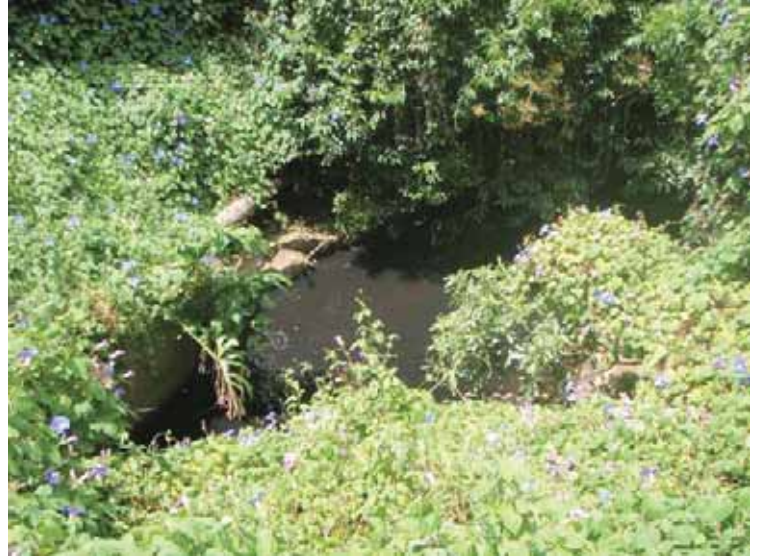
### Dents Creek Site 1

*Left:* stormwater outlet (start of Dents Creek)  
*Above:* weeds around outlet

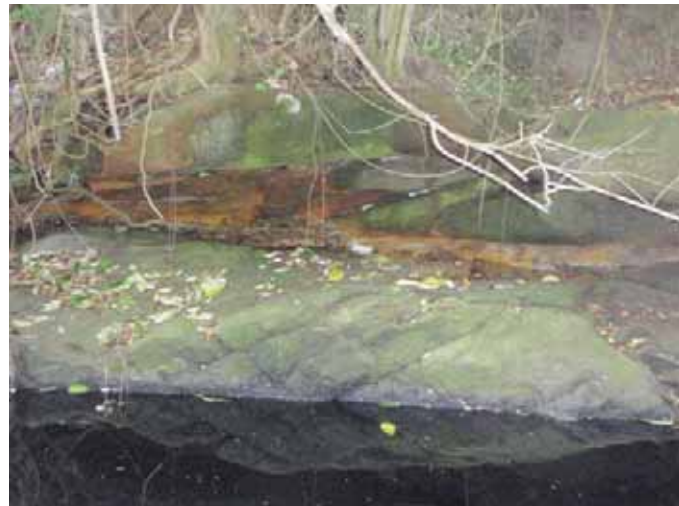
Sandstone walls of stormwater drainage canal

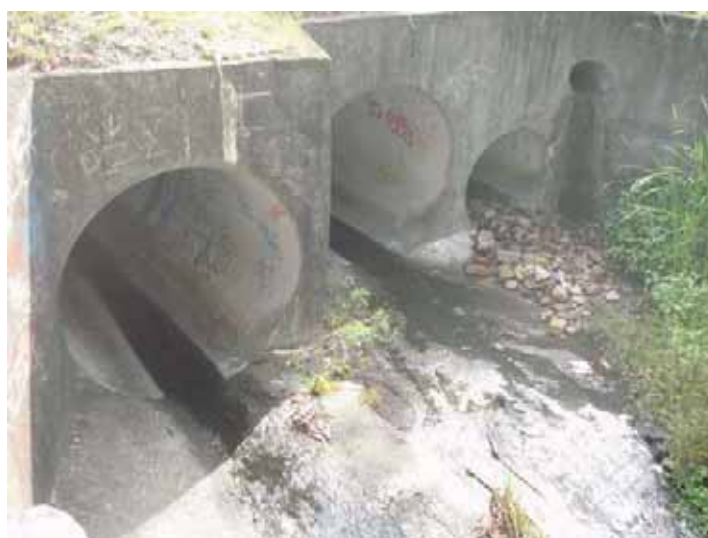
*Above: culvert under Rulwalla Street*

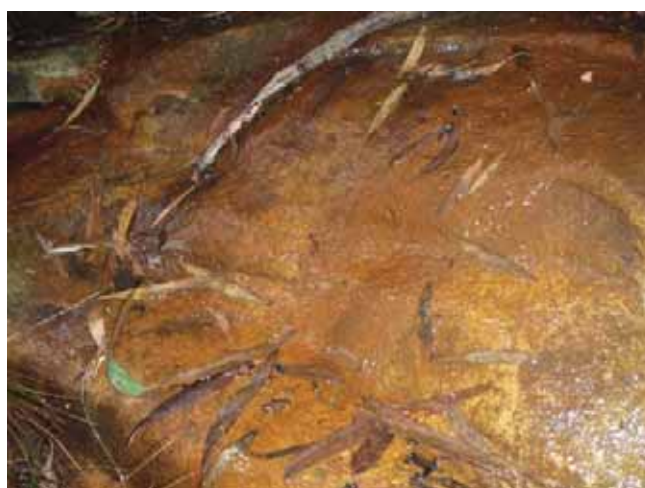
*Above: Iron stained sandstone within the creek*

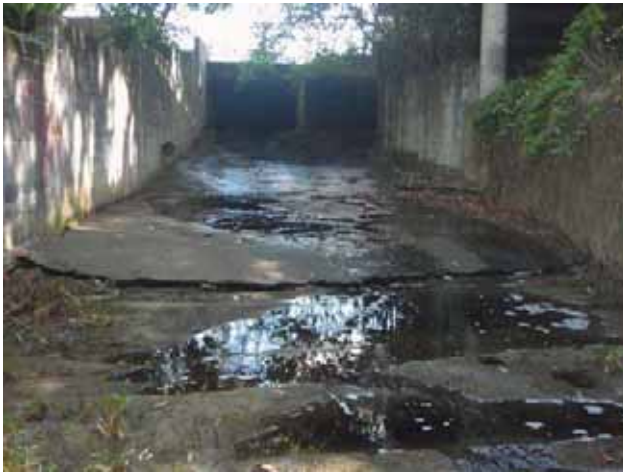
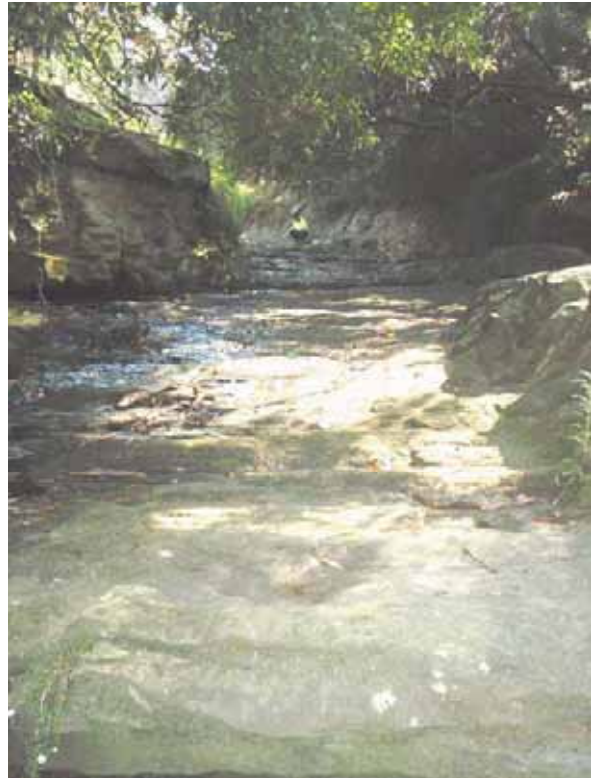
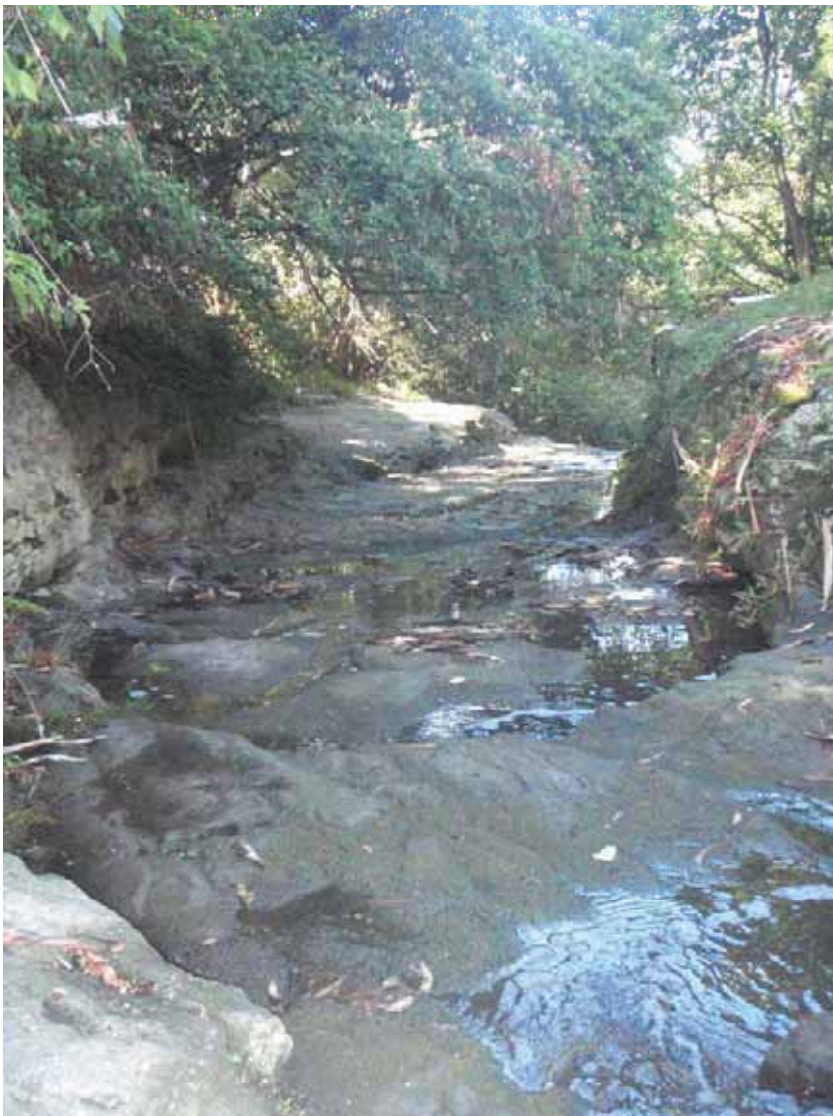
### Dents Creek Site 3

*Above:* view upstream of Site 3 into stormwater canal

*Right:* sandstone walls and base of channel

*Below:* view downstream of Site 3 location

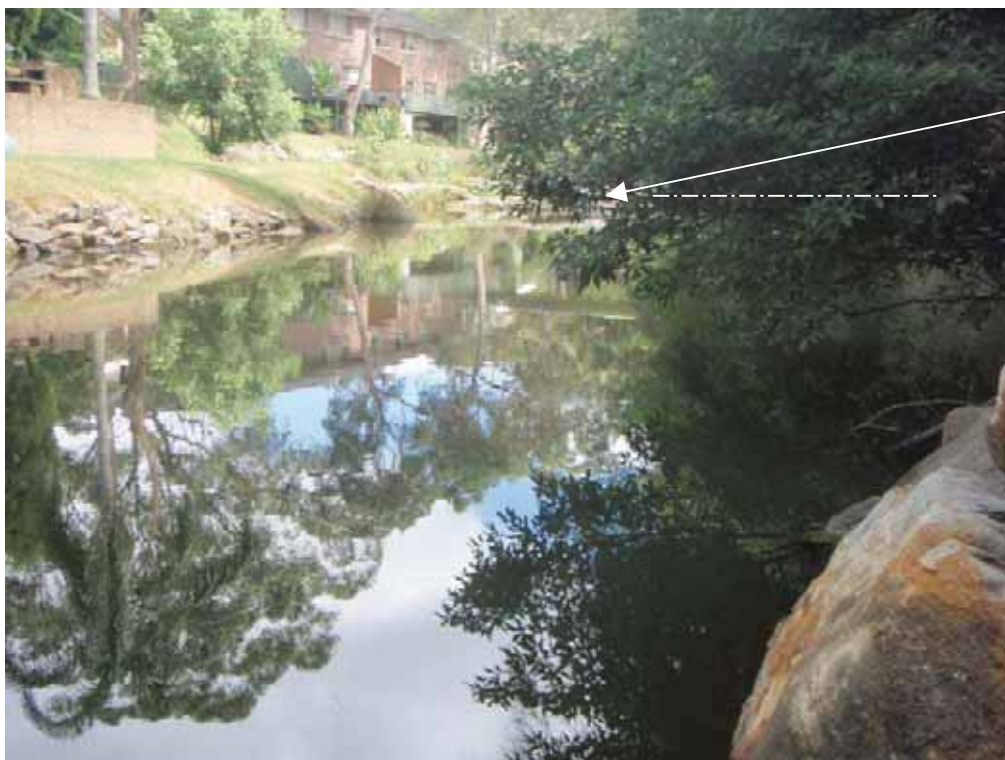
Sandstone bench,  
believed to be the  
saltwater /  
freshwater interface,  
approximately  
80 metres upstream  
from Site 6

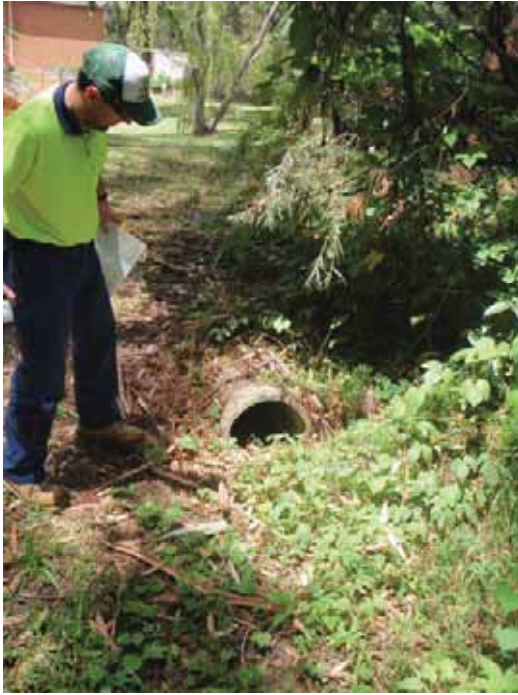
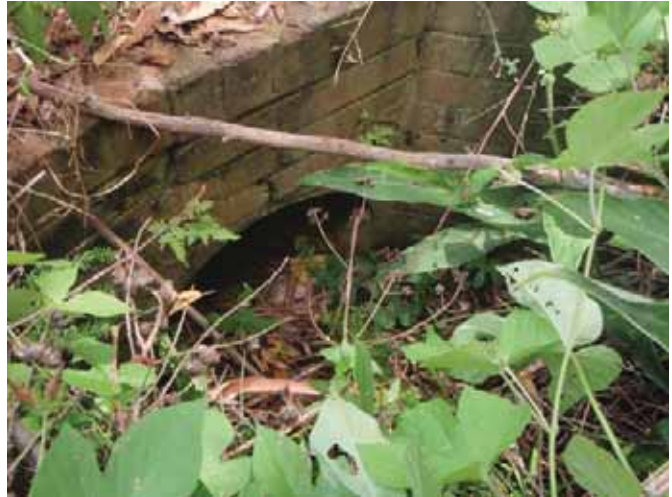
## Oyster Gully Creek Site 1

*Left:* outlet from stormwater collection in upper section of park

*Above:* inlet to stormwater pipe at down gradient section of park

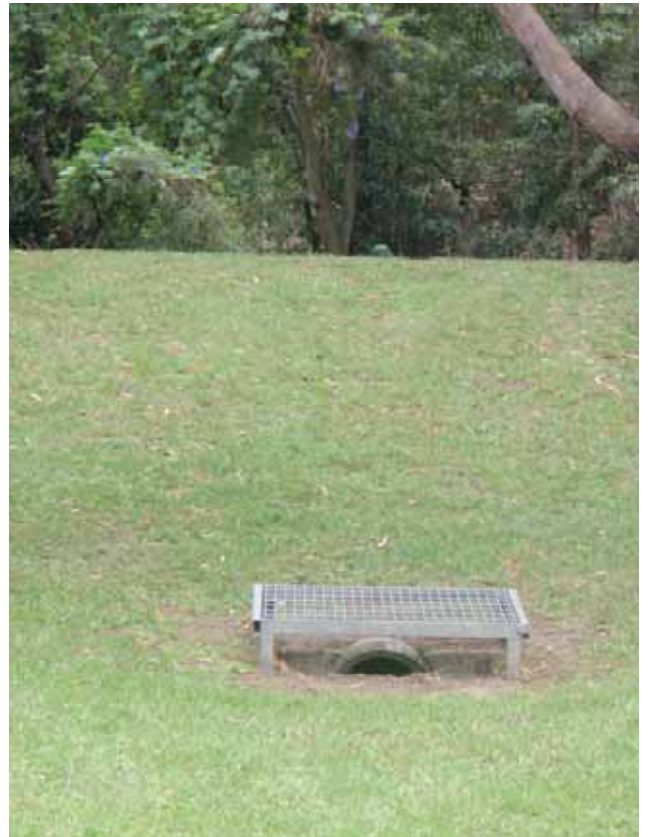
*Right:* park stormwater collection point

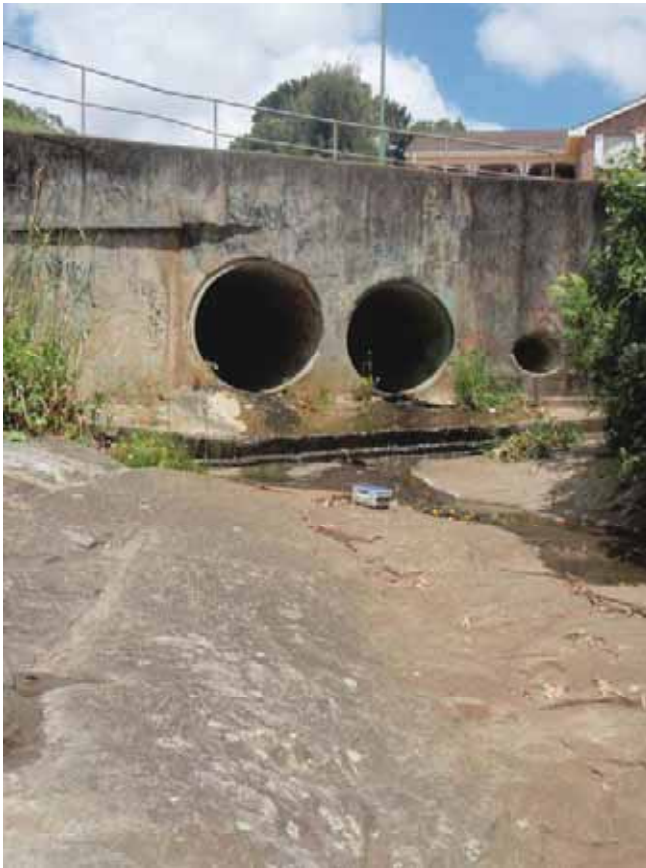
## Oyster Gully Site 2

View of stormwater outlet pipes beneath  
Stirling Avenue

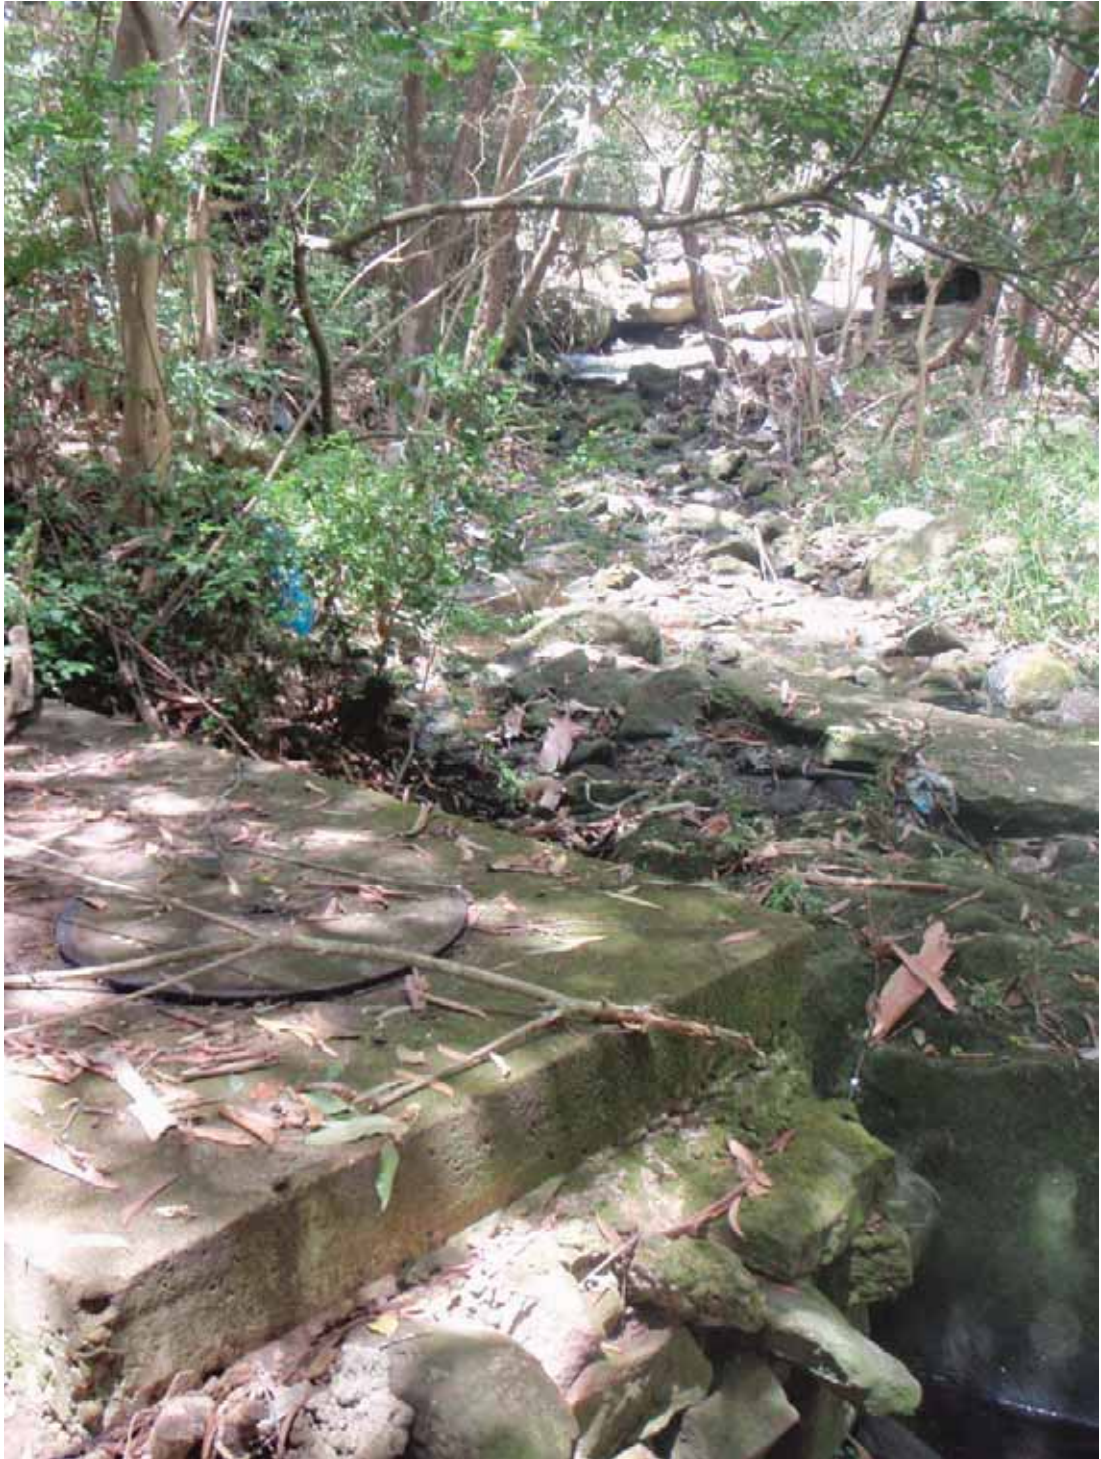
## Oyster Gully Creek Site 4

*Note:* the sewer pipe manhole in foreground. The connecting pipe ran parallel to the creek in the background of this photograph

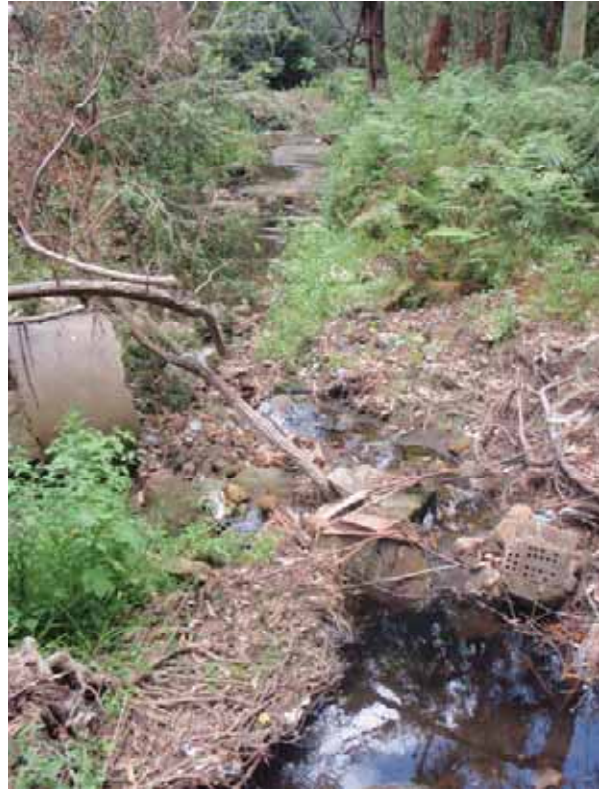
View downstream of Site 7, note the large amount of rubbish

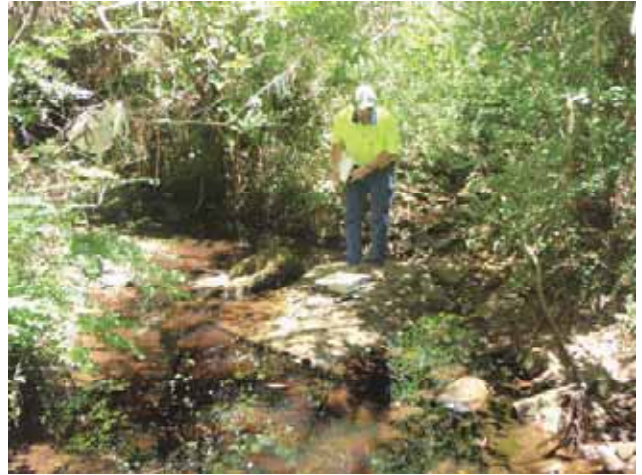
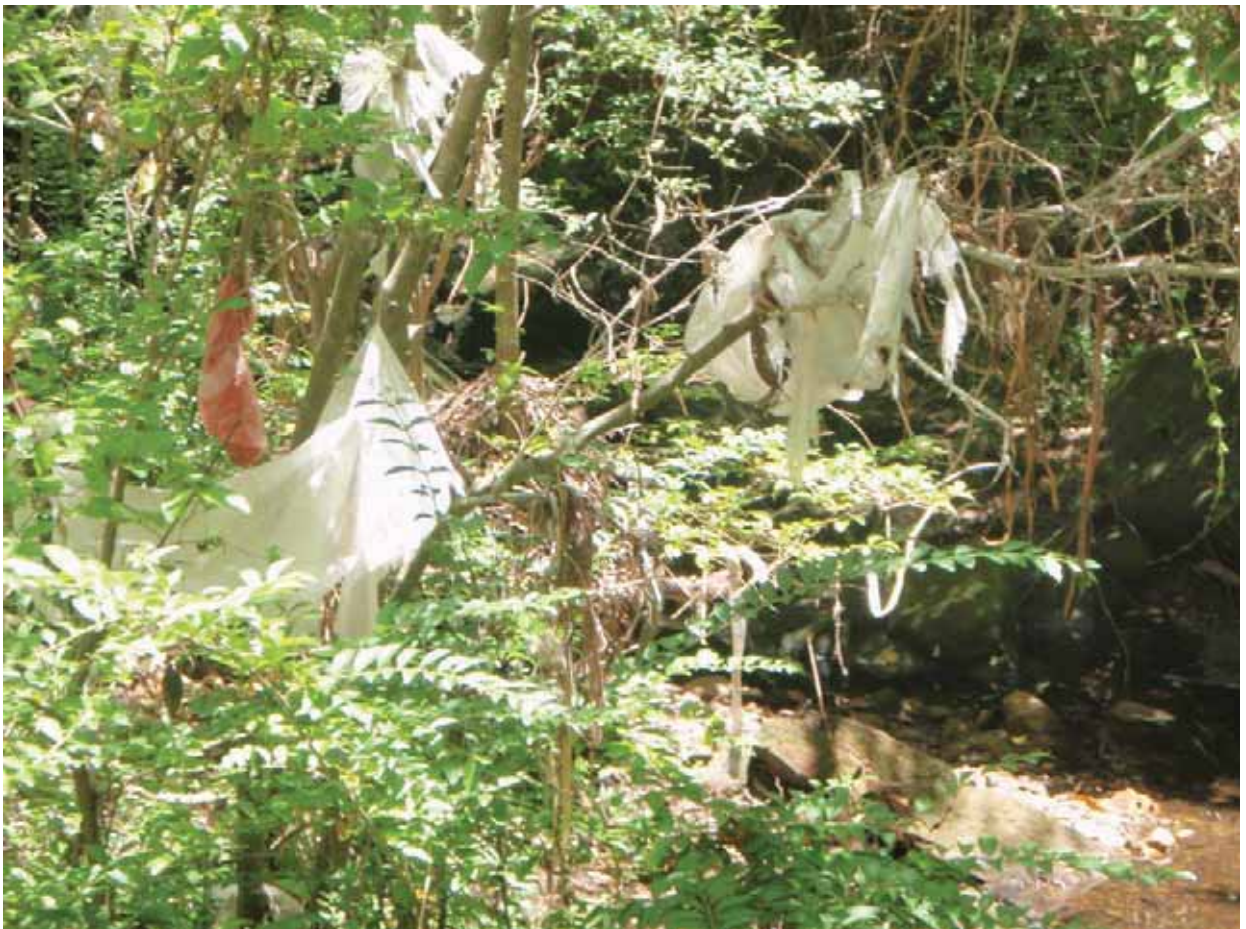
## Oyster Gully Creek Site 8

*Left: view upstream of Site 8  
Above: junction between tributaries along  
Oyster Creek Gully.*

*Below: rubbish perched in trees as a result  
of floodwater*

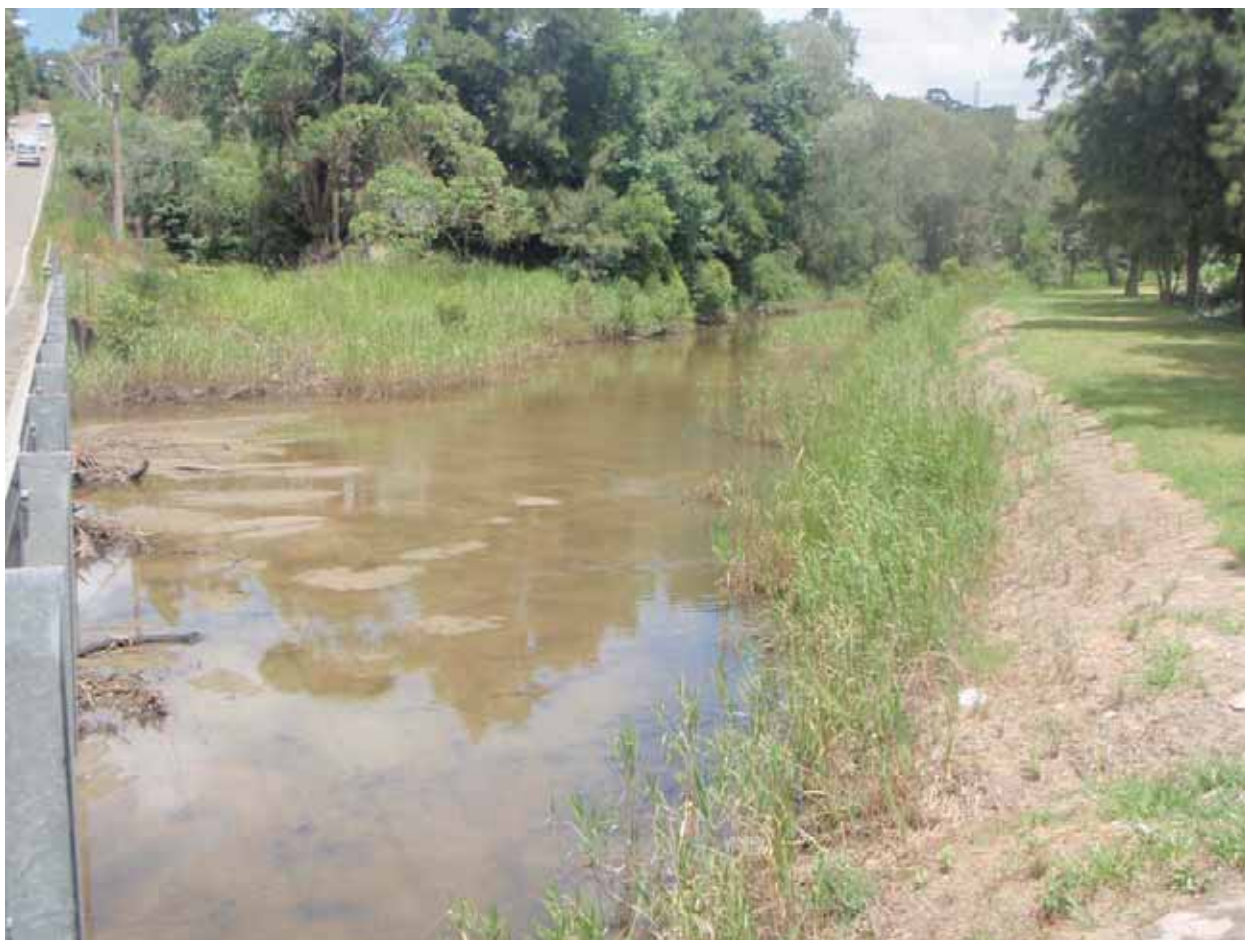
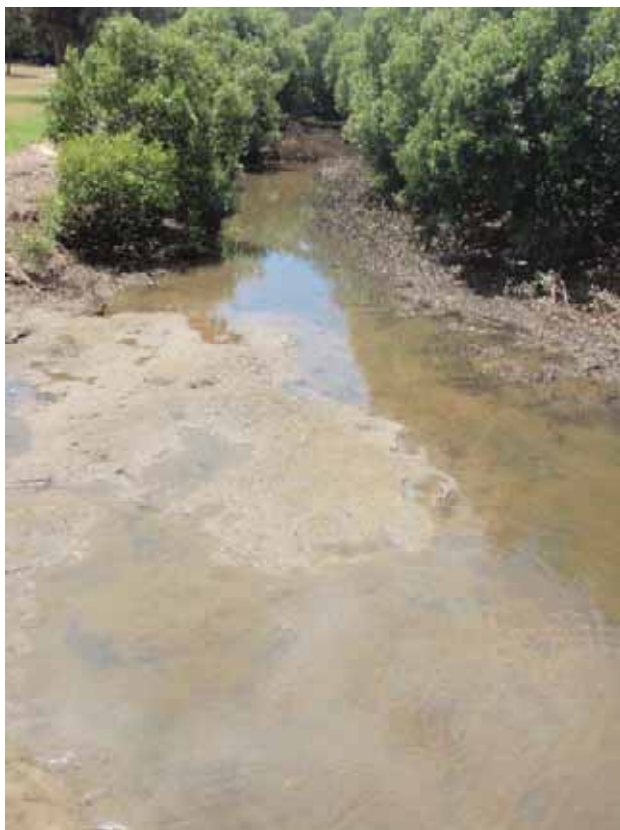
## Oyster Gully Creek Site 10

*Above:* view upstream of Site 10,  
Bates Drive bridge in left of picture

*Left:* view to the north-east of Bates  
Drive Bridge. Mangrove tidal  
environment.
