3 SITE SURVEY.

Site inspection was completed by Dr. Edward Higginbotham on 19 December 2001.

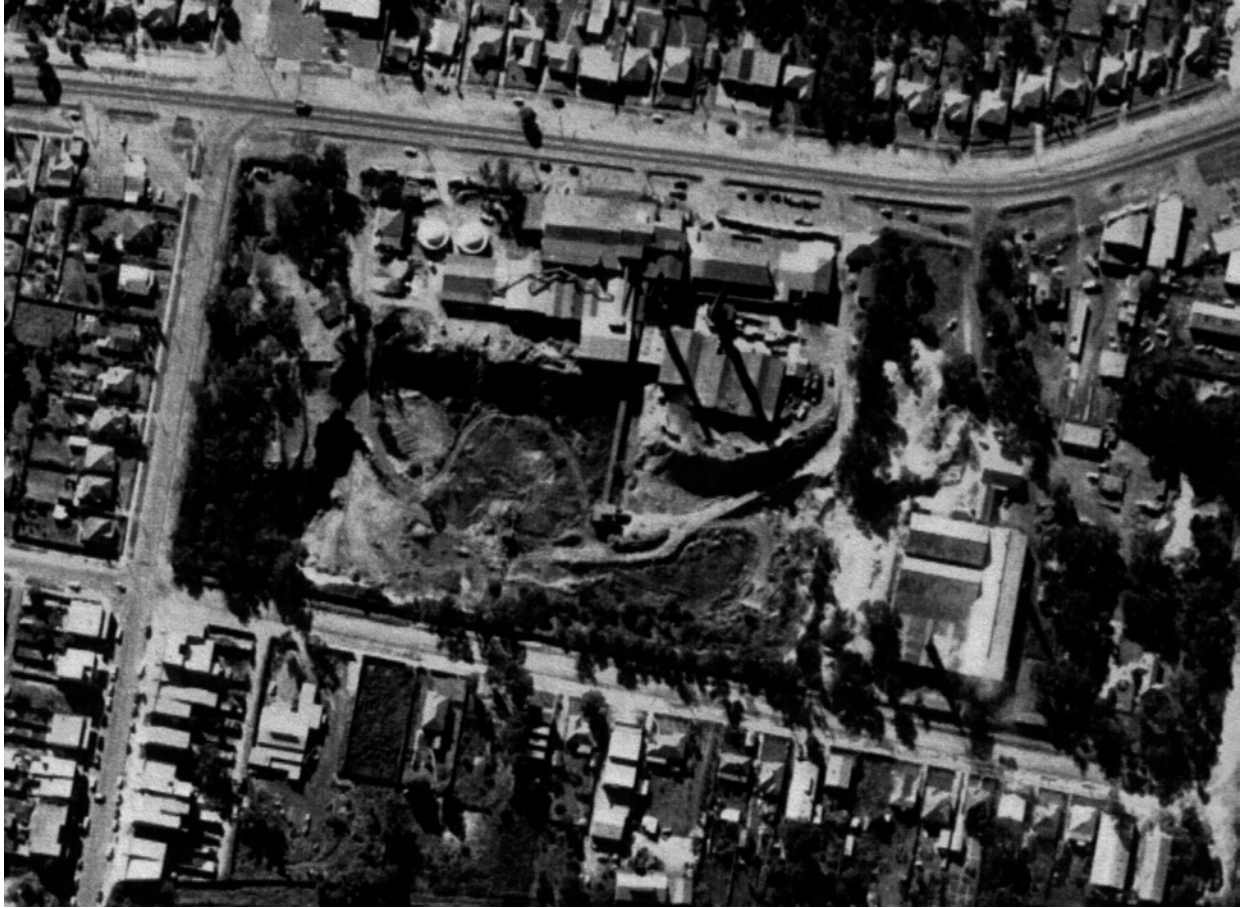
Figure 2.7 Aerial photo of 1961. (Source: Lands, Aerial photo, Cumberland 1961 Series, Run 46, 836-5037)

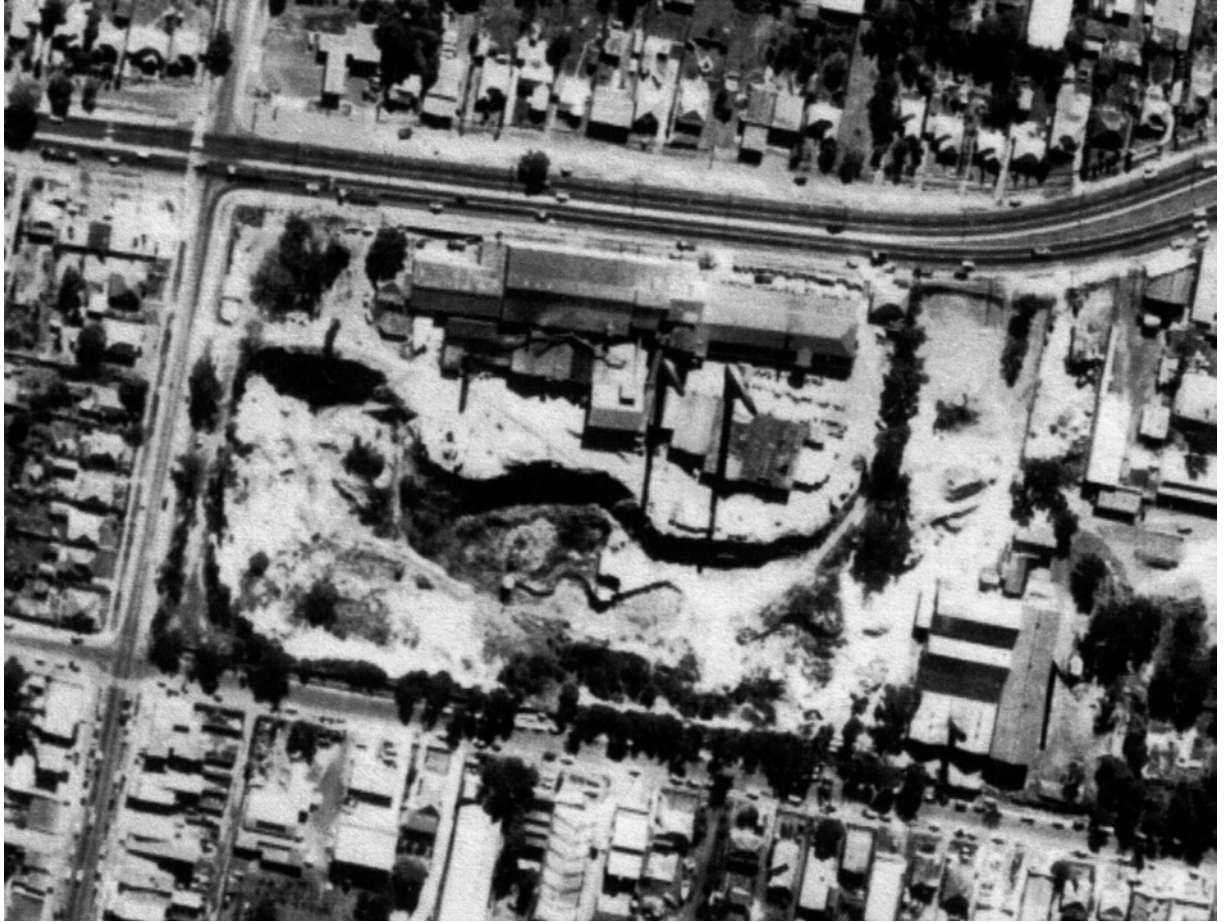
Figure 2.8 Aerial photo of 6 July 1970. (Source: Lands, Aerial photo, Cumberland 1970 Series, Run 24, 1906-5195)

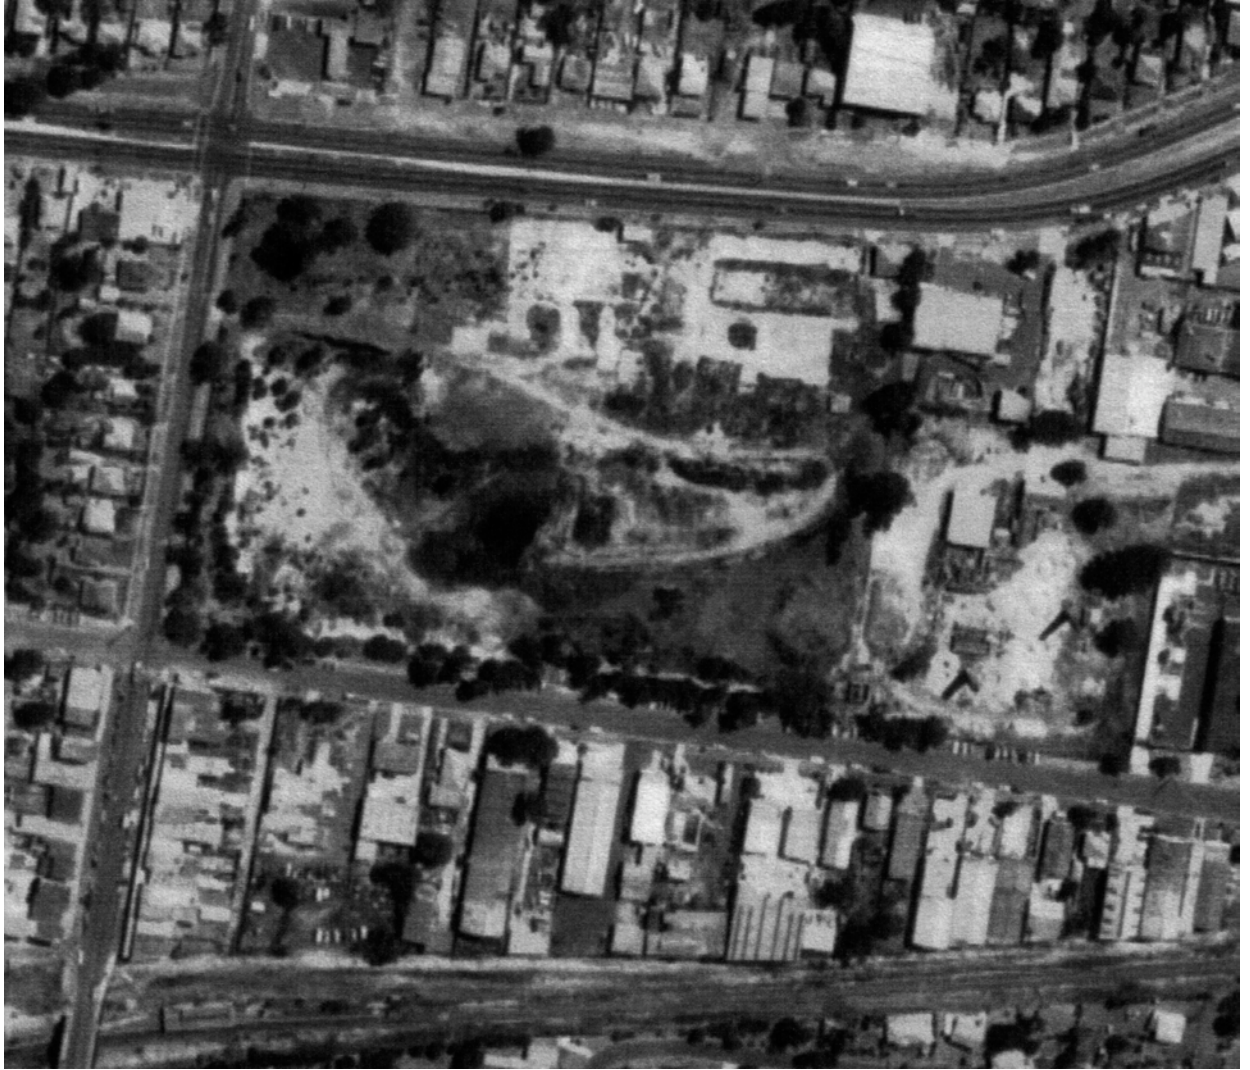
Figure 2.11 Aerial photo of 26 February 1979. (Source: Lands, Aerial photo, County of Cumberland, Run 23E, 2763-197)

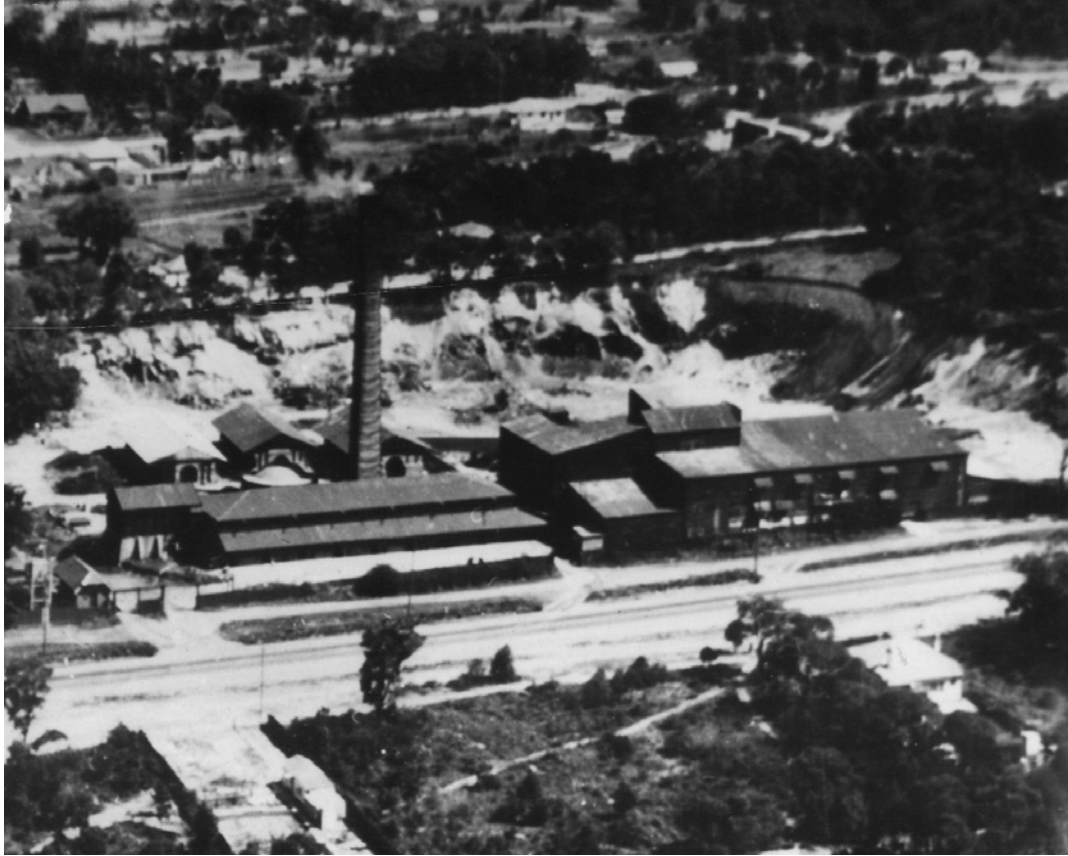
Figure 2. 12. Aerial view of Brickworks, undated. Source: Local resident.

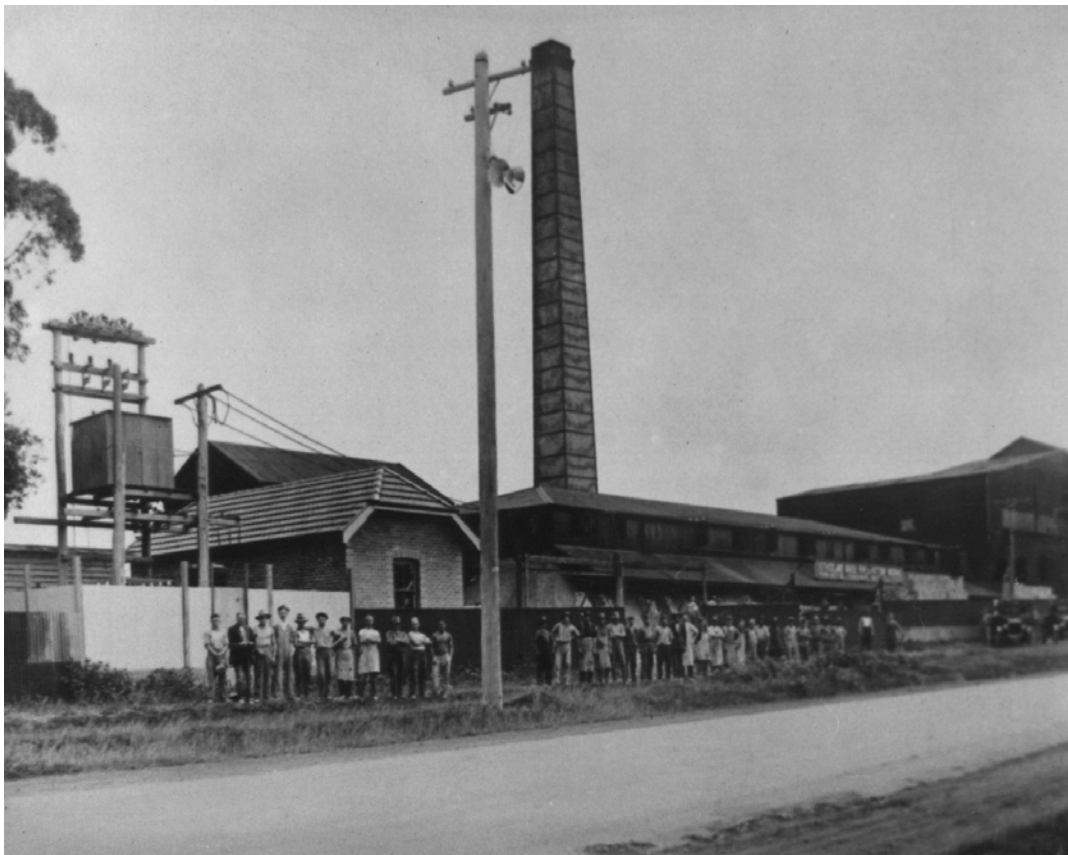
Figure 2.13. View of Brickworks from Princes Highway, undated. Source. Local resident, Kirrawee.

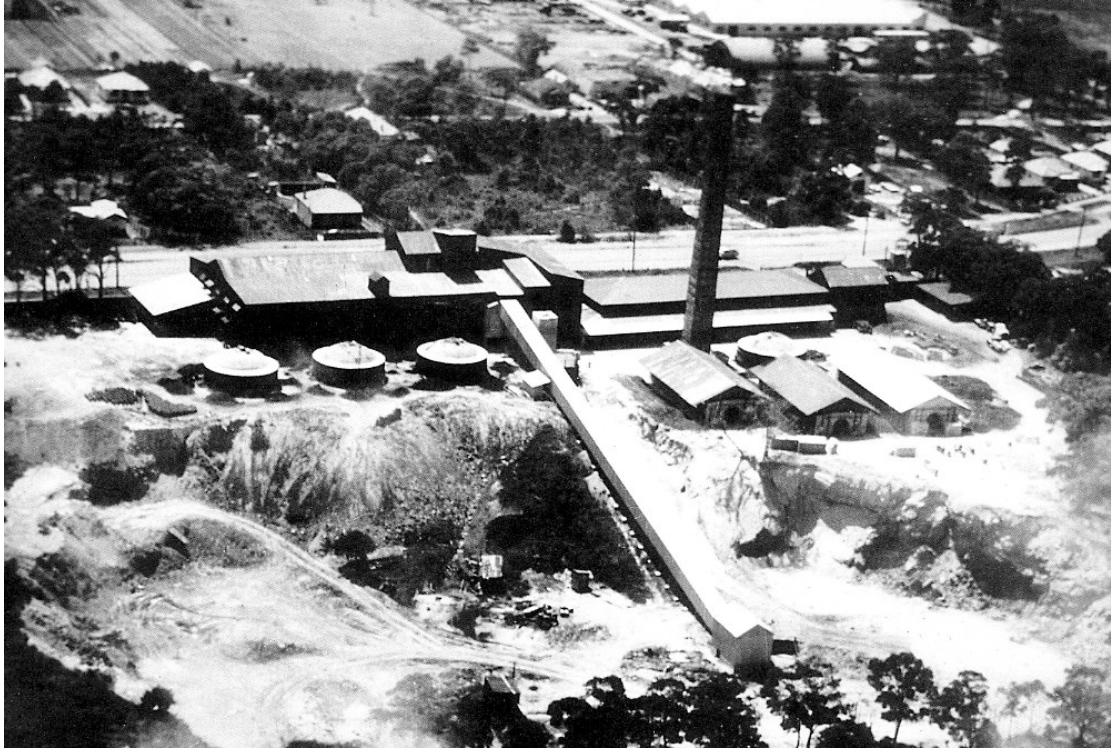
Figure 2.14. Oblique aerial view of Brickworks from the south undated. Source. Ron Ringer, *The Brickmasters 1788-2008*, Dry Press Publishing, Sydney, Horsley Park, 2008, p 281.

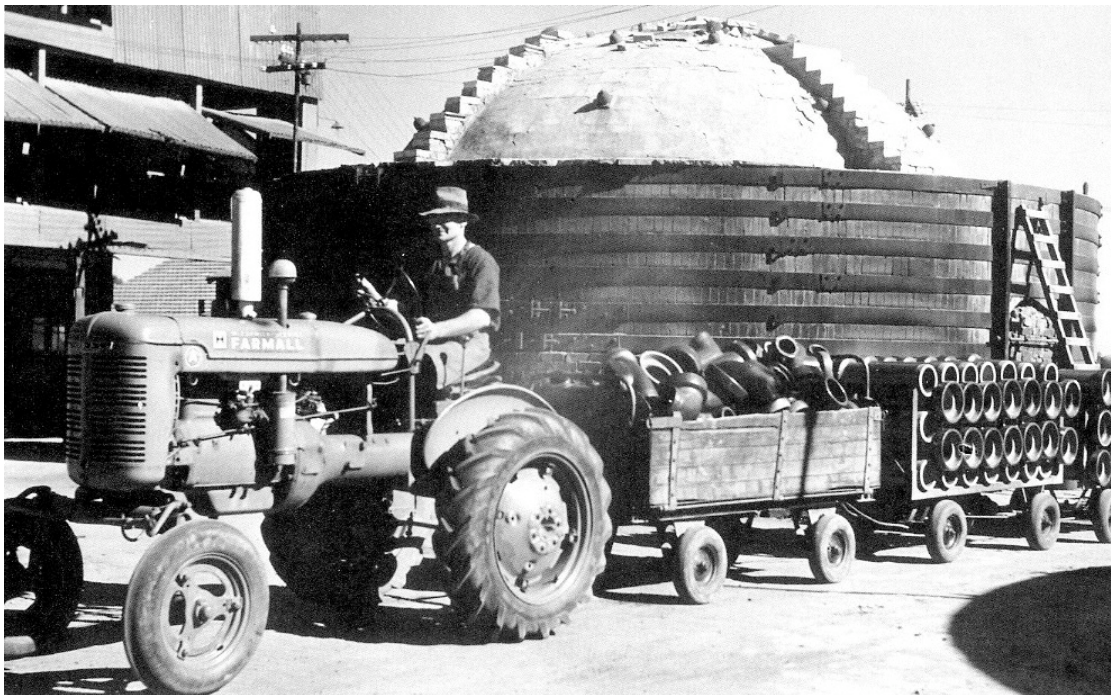
Figure 2.15. The fired pipes being transferred from the pipe kilns, c.1959. Source. Ron Ringer, *The Brickmasters 1788-2008*, Dry Press Publishing, Sydney, Horsley Park, 2008, p 281.
