## Appendix B

### Boreholes Logs, Core Photos and Well Construction Details

URS Australia Pty Ltd  
Level 3, 116 Miller St North Sydney NSW 2060Phone 02 8926 5500  
Fax 02 8926 5555Project Reference: **Kirrawee Brick Pit  
Geotech  
Investigation**  
Project No.: **43167393**Client: **Sydney Water Corporation**  
Location: **Kirrawee**Drilling Contractor: **McDermott Drilling PTY LTD**Logged By: **A. Hitchon**  
Checked By: **SGR**  
Date Started: **11-10-06**  
Date Finished: **11-10-06**Bore Size: **HW mm**  
Total Depth: **4.00 m**  
Casing Size: **HW mm**Relative Level: **97.11 mRL**  
Coordinates: **6232553.40 mN  
322128.60 mE**  
Permit No:Drill Type: **Solid flight Auger, V-bit, TC bit**  
Drill Model: **B40**  
Drill Fluid: **None**

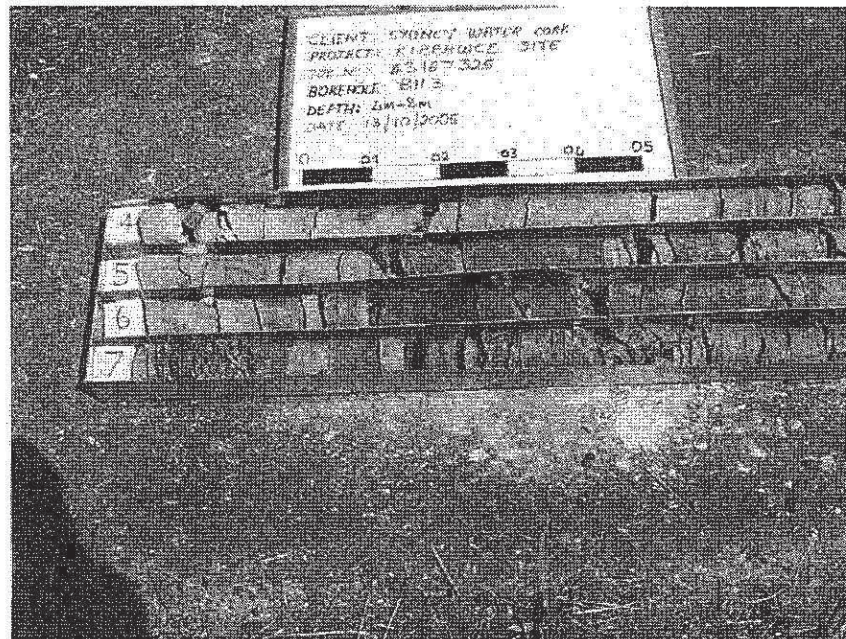
BH3: 4.0 – 8.0 m

| METHOD | TESTING | WEATHERING | STRENGTH | RQD (%) | DEFECT SPACING (mm) | DEPTH (m) | DEFECT DESCRIPTION | GRAPHIC LOG | DESCRIPTION OF STRATA | GEOLOGICAL DESCRIPTION |
|---|---|---|---|---|---|---|---|---|---|---|
| | | DW | | | | 4 | 4.07-4.1 2x BP 5° Pl, S, KL<1mm<br>4.14-4.43 2x BP 10° Pl-Ir, Sr, KL<1mm | | SHALE: Extremely Low to Very Low strength, Extremely weathered to Distinctly weathered, dark gray, poorly developed bedding | |
| | | | | | | 5 | 4.80-4.94 2x BP 15° Pl-Ir, S-Sr, KL<1mm<br>JN 90-95° Pl, S, KL<1mm | | | SHALE |
| | | XW<br>DW | | | | 6 | DI fracture BP 10-20° Pl, Sr, KL<1mm<br>JN 50° Ir, Sr, KL<1mm & BP 20° Pl, Sr, KL<1mm<br>5.35-5.72 3x BP 15° Pl, Sr, KL<1mm<br>BP 15° Pl, Sr, Rf<br>JN 50° Pl-Ir, Sr, KL<1mm<br>5.83-5.94 2x BP 15° Pl, S, KL<1mm<br>JN 75° Ir, Sr, KL<1mm<br>BP 20° Ir, Sr, KL<1mm<br>5.22-6.25 2x BP 15° Pl-Ir, Sr, KL<1mm<br>JN 55° Pl, S, KL<1mm<br>6.60-6.65 2x BP 20° Pl-Ir, Sr, KL<1mm<br>JN 40° Pl, S, KL<1mm | | SHALE: Very Low- Low strength, Extremely weathered-Distinctly weathered, dark brown and grey/brown, thinly laminated, poorly to well developed bedding, fractured to highly fractured, with occasional Extremely Low strength, Extremely weathered bands<br>CLAY: high plasticity, grey to dark grey with some rock fragments<br>SHALE: Very Low- Low strength, Extremely weathered-Distinctly weathered, gray, poorly developed fabric, fractured to highly fractured, with occasional Very Low strength, Extremely weathered bands | SHALE<br>CH<br>SHALE |
| | | XW<br>DW | | | | 7 | 7.05-7.15 CZ 5° Ir, R, Rf, 100mm<br>7.37-7.60 2x BP 0° Pl, S-Sr, KL<1mm<br>BP 10° Ir, Sr-R, Rf<br>7.50-7.60 2x BP 10° Pl-Ir, S-Sr, KL<1mm<br>JN 75° Pl, Sr, KL<1mm | | | SHALE |

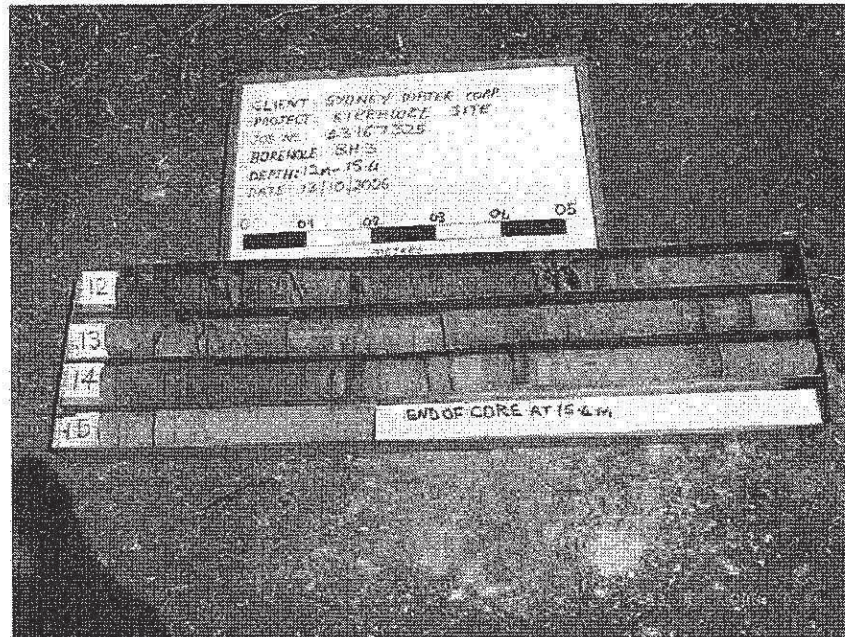
BH3: 12.0 - 15.4 m

| METHOD RUN | | TESTING | WEATHERING | STRENGTH | | RQD (%) | DEFECT SPACING (mm) | DEPTH (m) | DEFECT DESCRIPTION | GRAPHIC LOG | DESCRIPTION OF STRATA | GEOLOGICAL DESCRIPTION |
|---|---|---|---|---|---|---|---|---|---|---|---|---|
| 14.4 | 100% CR | PL 14.32m<br>D=2.30 A=2.87 | | | | | | 14 | BP 5° Pl-Ir, Sr, KL<1mm<br>DI fracture BP 5° Pl-Ir, Sr, KL<1mm<br>14.34-14.47 BP 10° Pl-Wa, S-Sr, KL<1mm<br>BP 0° Pl, S, KL<1mm<br>15.00-15.08 3x DI fractures 5° Pl-Ir, Sr, KL<1mm | | As above with shale interbeds, gray<br><br>SANDSTONE: High strength, Slightly weathered, yellow/ brown, massive bedding, fine to medium grained, with trace bedding, slightly fractured | SANDSTONE |
| | | | | | | | | 16 | | | End of borehole @ 15.4m | |
