**Tweed Shire Council**  
Report for West Valley Quarry  
Preliminary Study  
September 2011

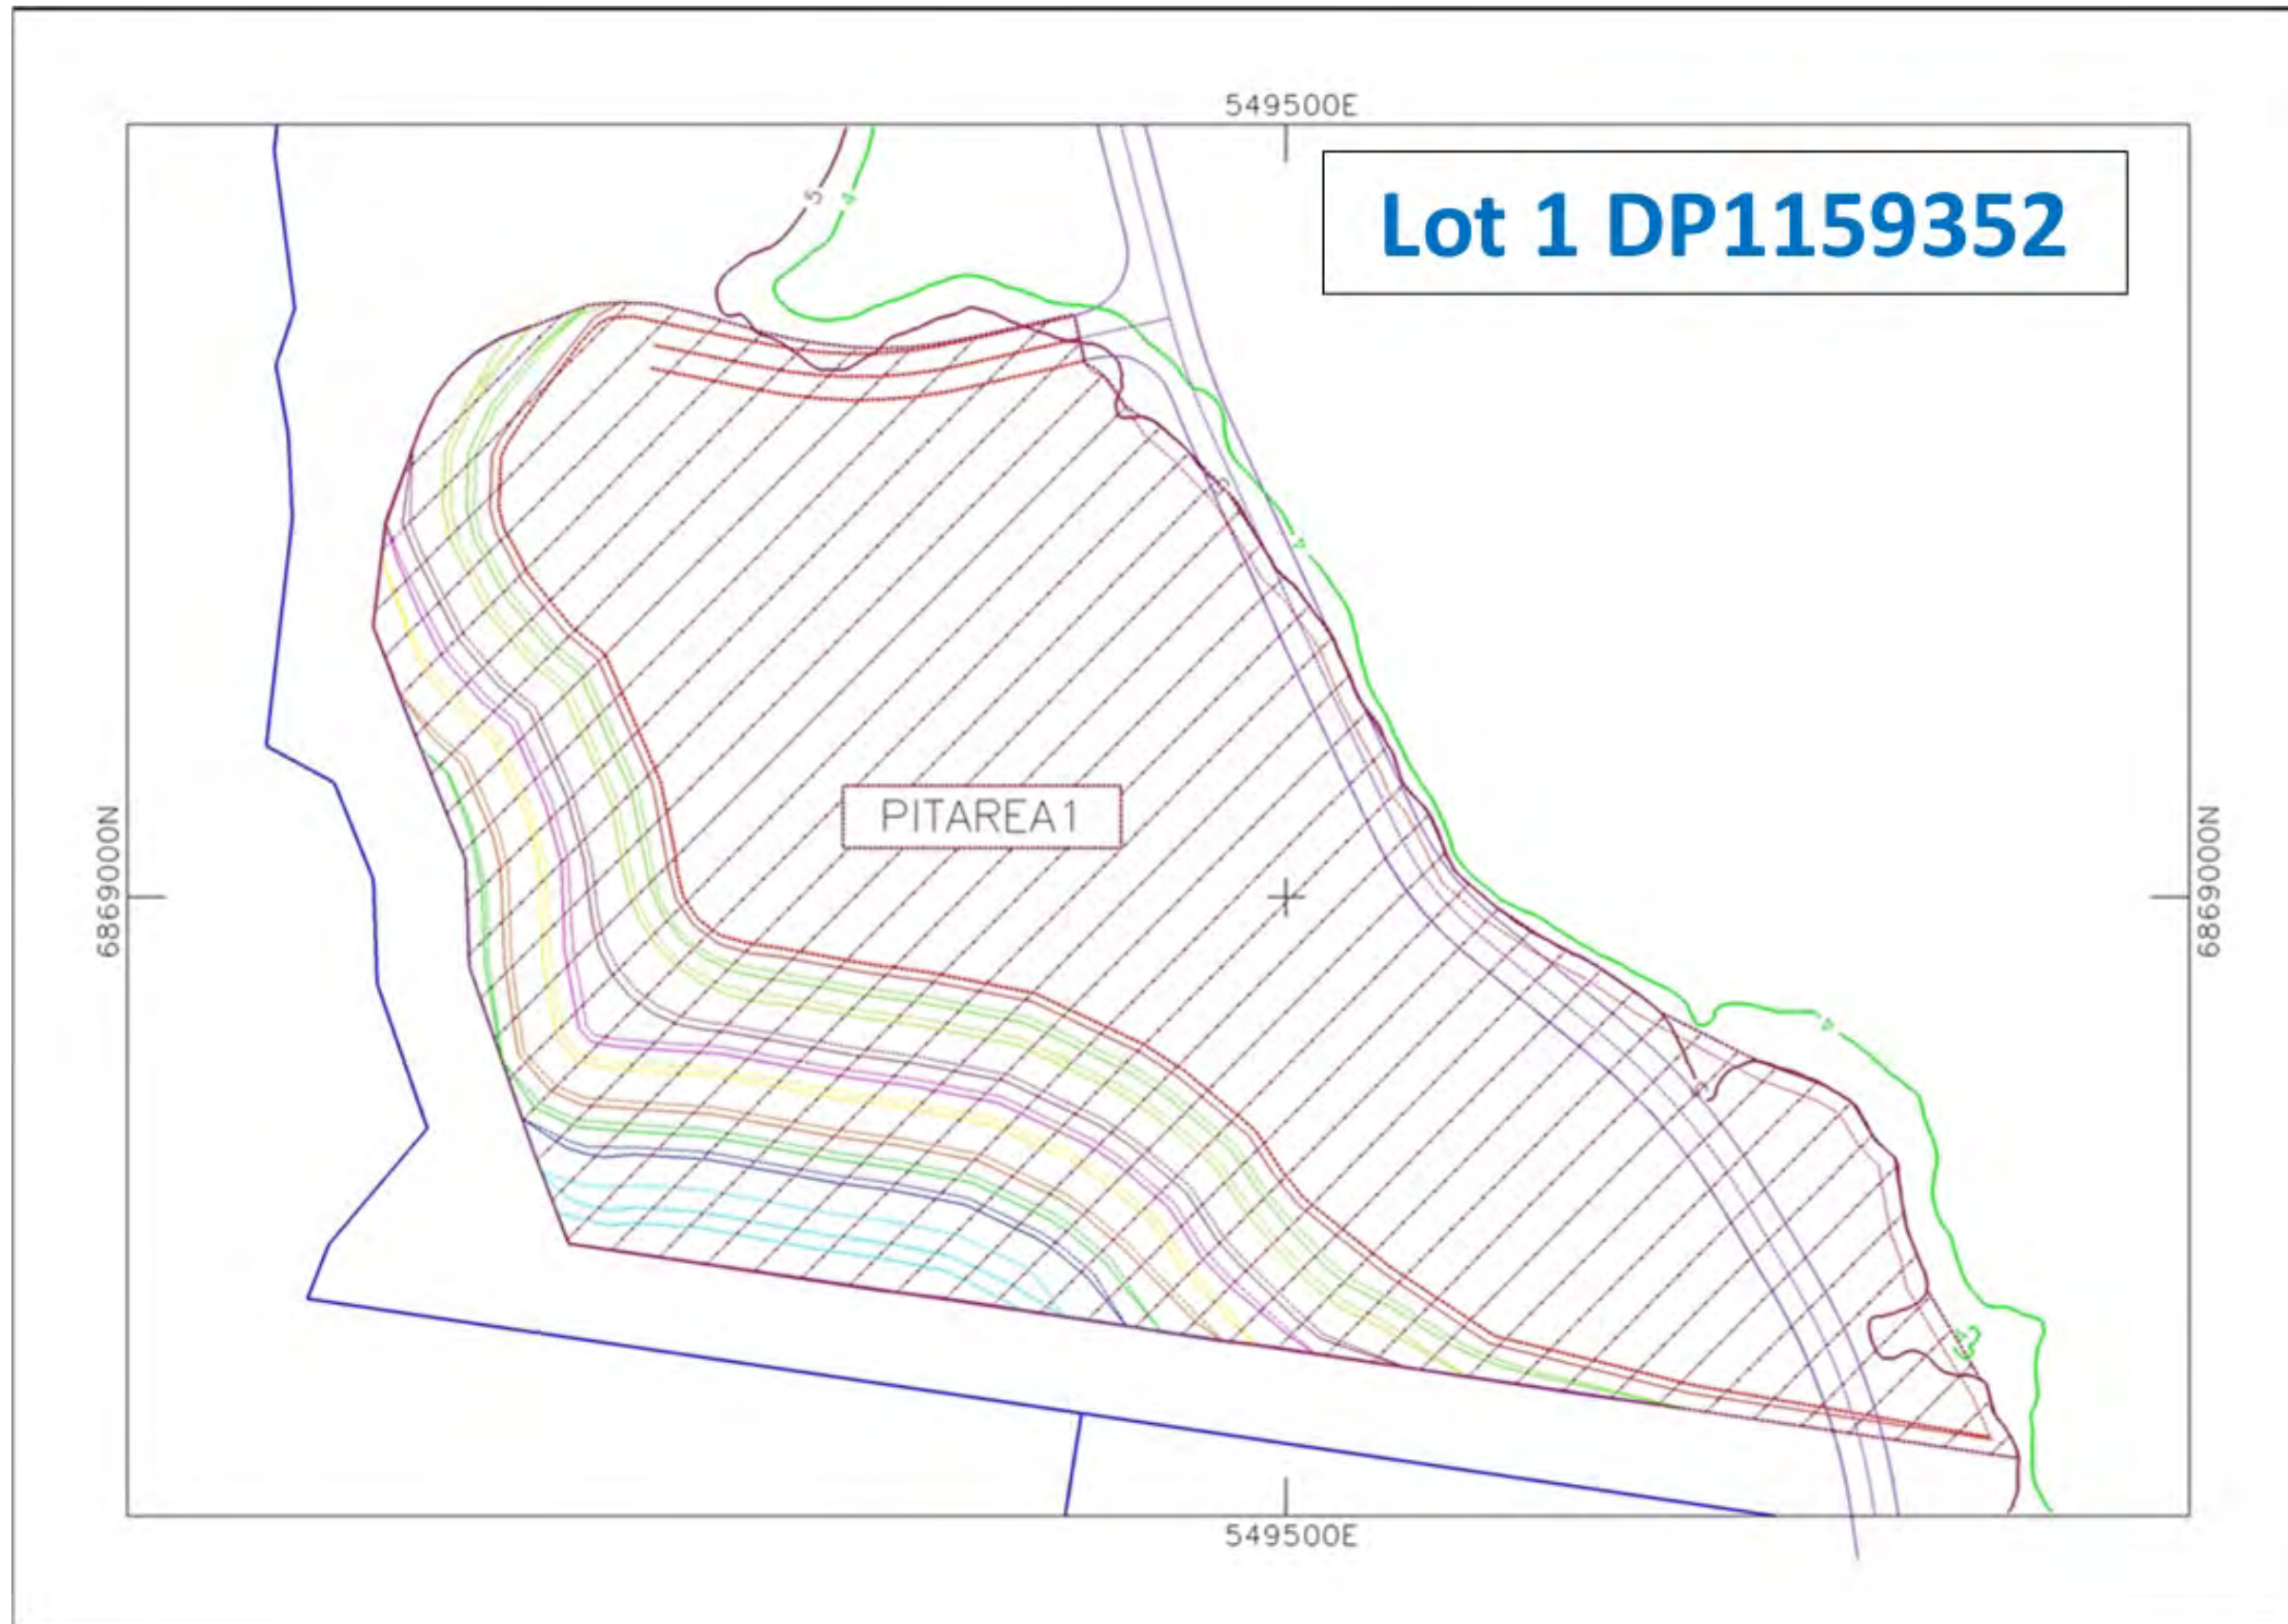
Initially there is a high stripping ratio relationship of overburden (soil/weathered NF) to fresh Neranleigh-Fernvale combinations; however this ratio reduces considerably in the lower benches.

Figure 15 Stage plans for Proposed West Valley Quarry area. Different colour lines represent each bench

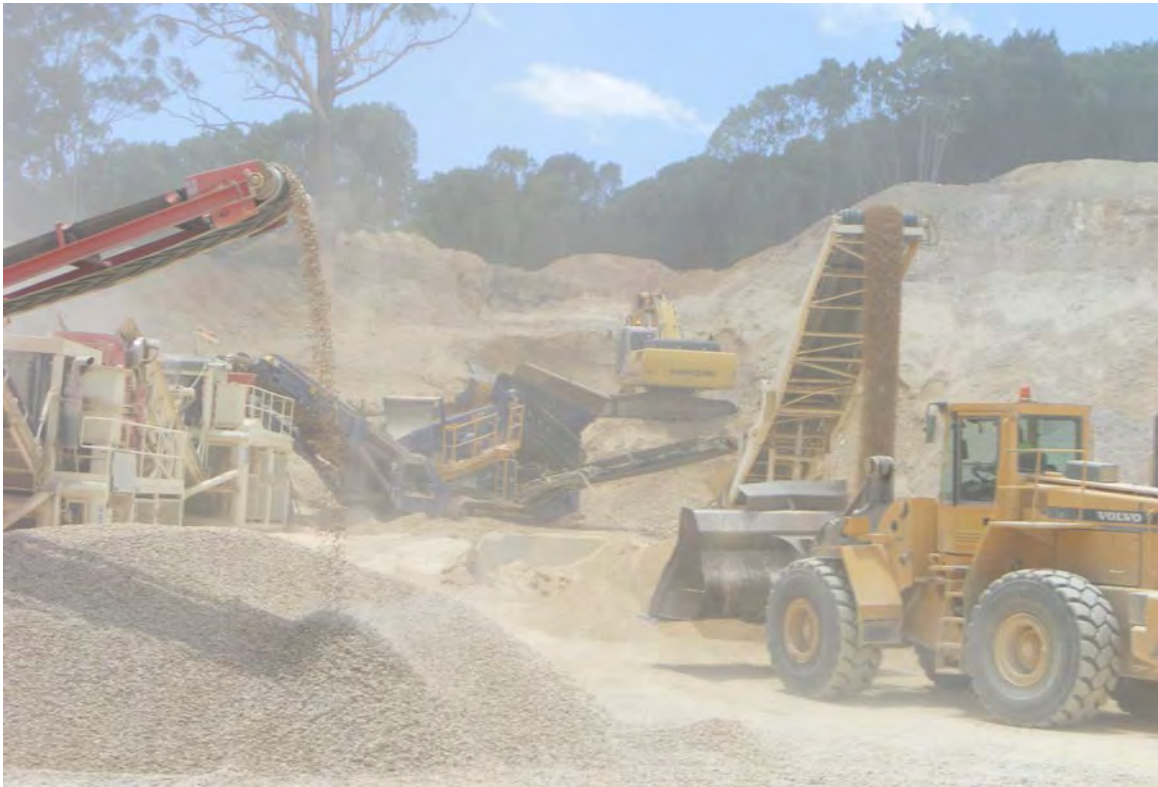
**Figure 16 Example Quarry processing activities**

Processing of quarry products and location of this activity is dependent on the access and design of the quarry area to enable these activities to be undertaken. The most cost effective way to process the material is directly from the point of extraction. This methodology can be seen in the existing Quirks Quarry.

It is proposed that the North and West Valley quarry areas operate this way when possible, therefore reducing the overall footprint of the development.

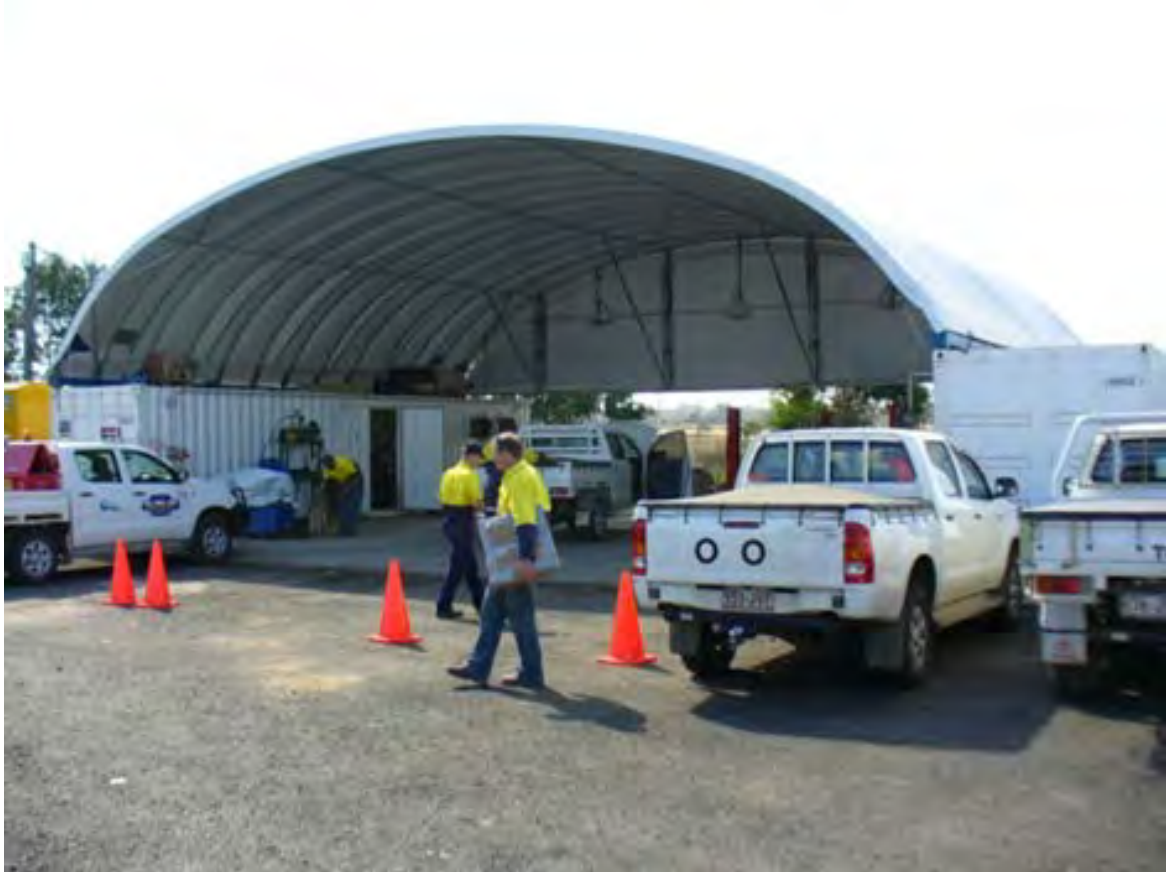
**Figure 17 Workshop Configuration Example**

The illustrated facility consists of a 24 m x 12 m concrete slab with customized shipping containers either side. One container is used for storage of tools and light plant equipment whilst the other is an office/storage combination. A 12 m x 12 m canopy spans the containers, protecting the facility from the environment. This canopy includes an end-wall allowing for control of airflow through the service bay area.

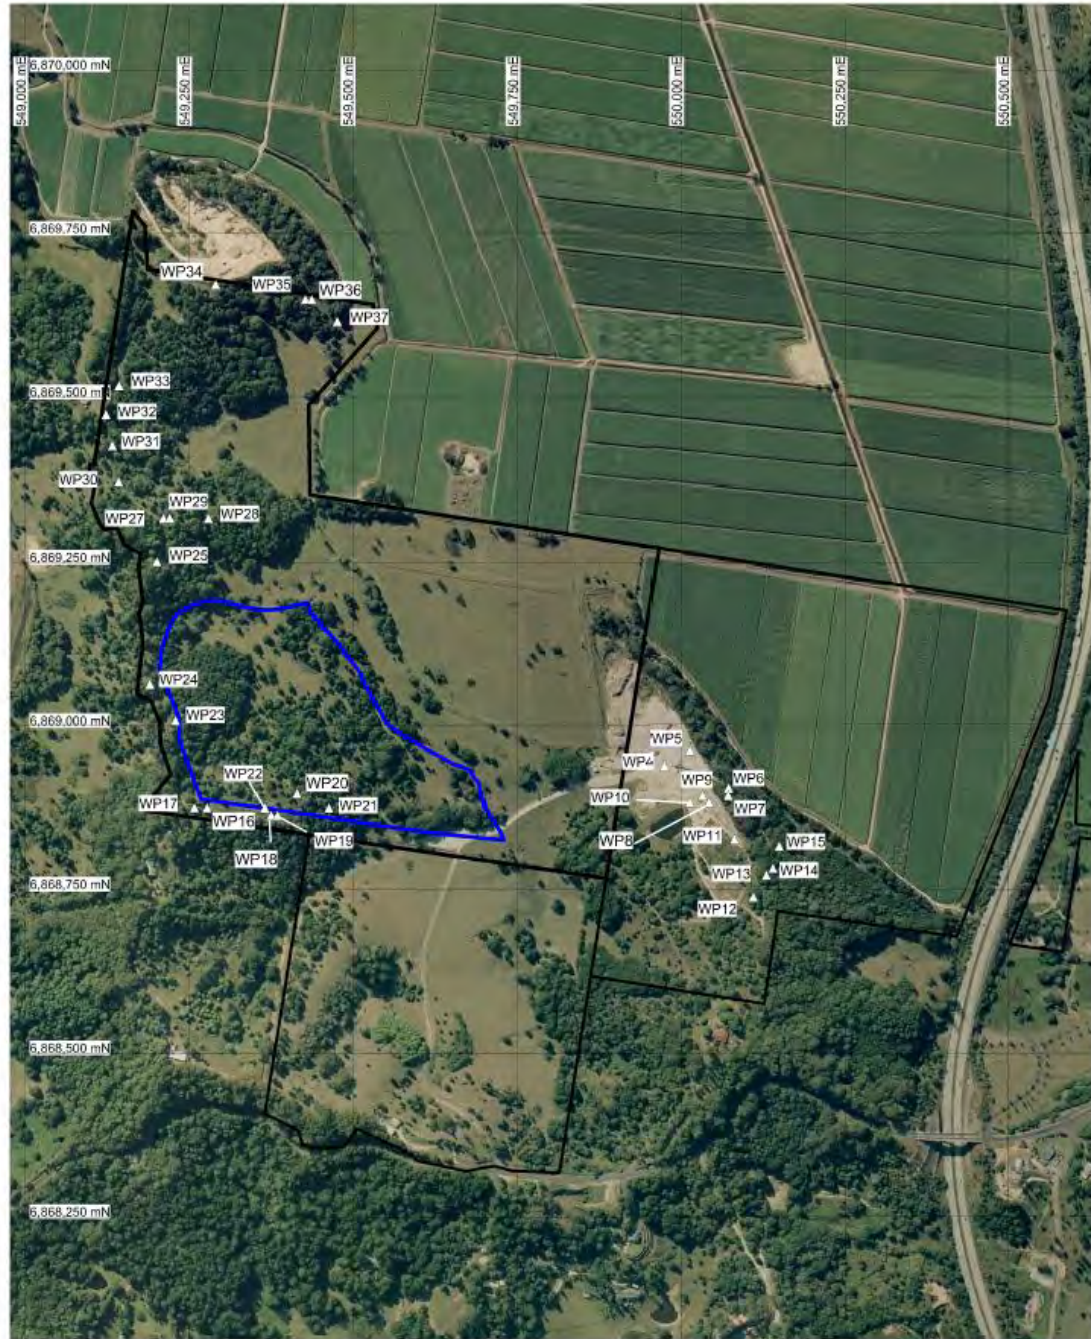
**Figure 2 Location and Mapping ID Sample Points**

Location data was obtained using a Garmin GPS62. Refer to Figure 2 for GPS sample points information and Appendix A and Table 1 for coordinates and field notes of waypoints.

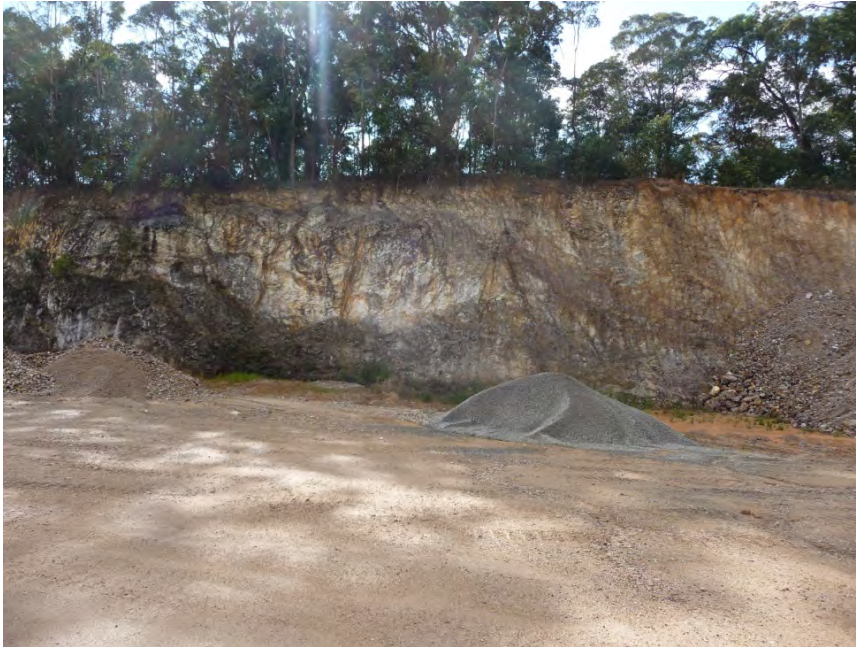
**Figure 4**      **Photograph – Waypoint 5 – East Facing – Exposed quarry face displaying siltstone top unit and Chert bottom with thin soil overburden.**

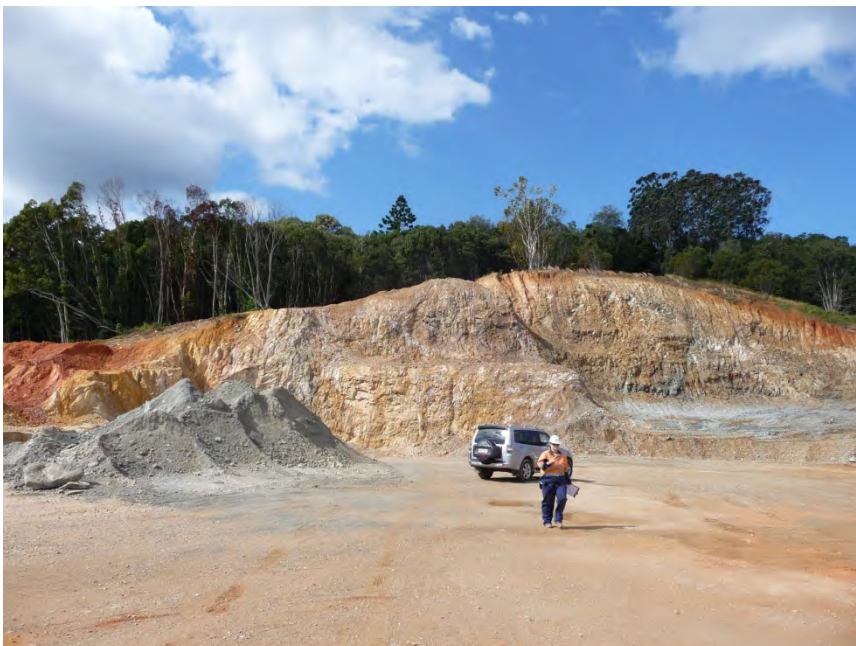
**Figure 5**      **Photograph – Waypoint 11 – South East Facing – Exposed quarry wall face of predominately chert with siliceous siltstone showing zones of oxidation on the side of the hill**

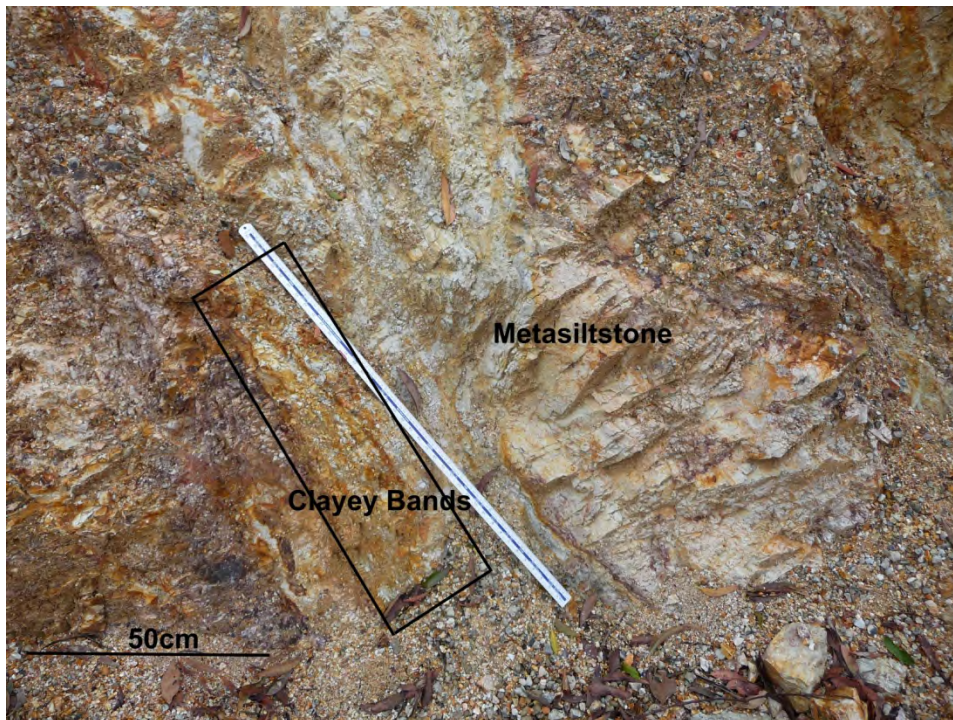
**Figure 6**      **Photograph – Waypoint 6 – North Facing Quarry Face – Siltstone with quartz and clayey bands**

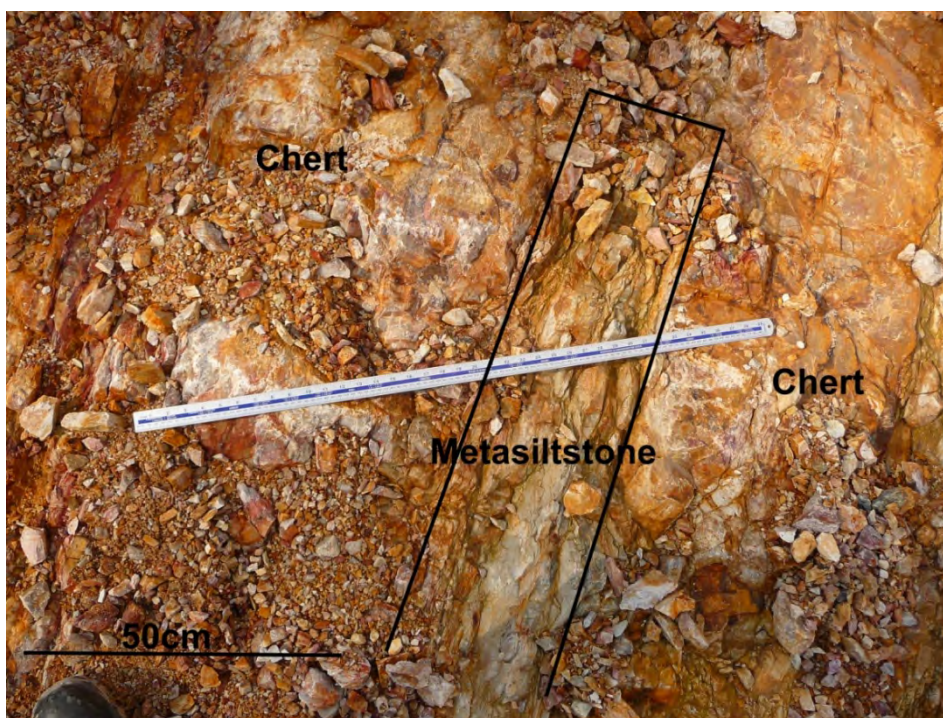
**Figure 7**      **Photograph – Waypoint 9 – On Quarry Floor – Chert interbedded with Siltstone**

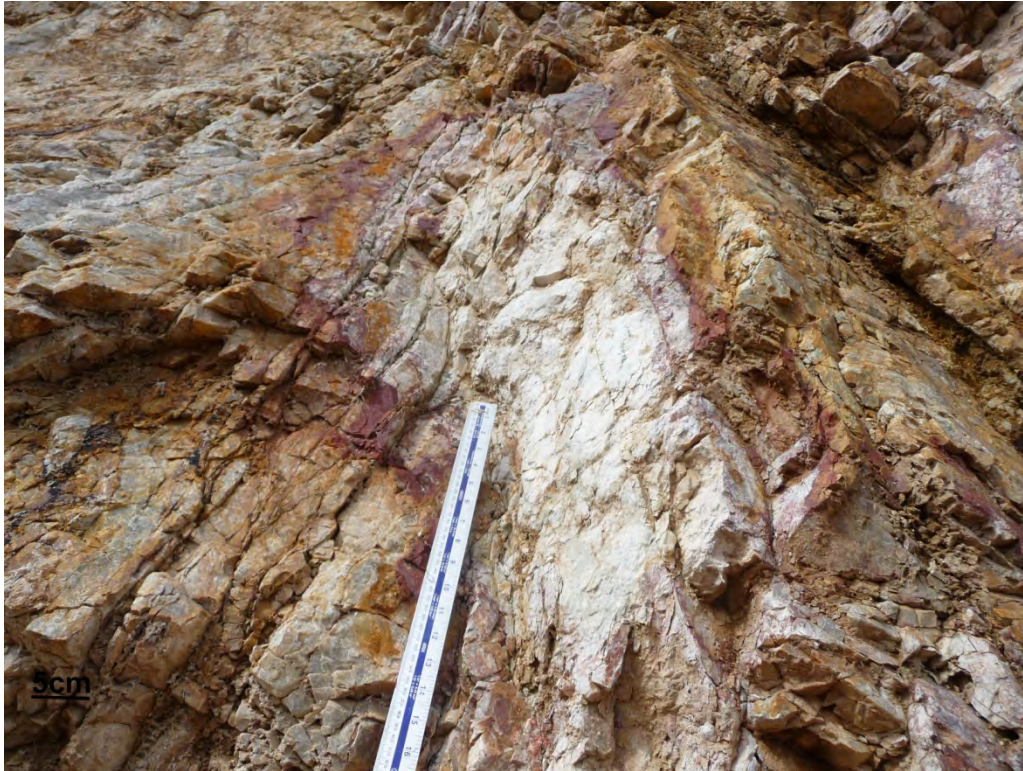
**Figure 8**      **Photograph – Waypoint 13 – South East Facing Quarry Wall – Chert with siliceous siltstone, possible bedding (dip-dip direction) 70-300°**

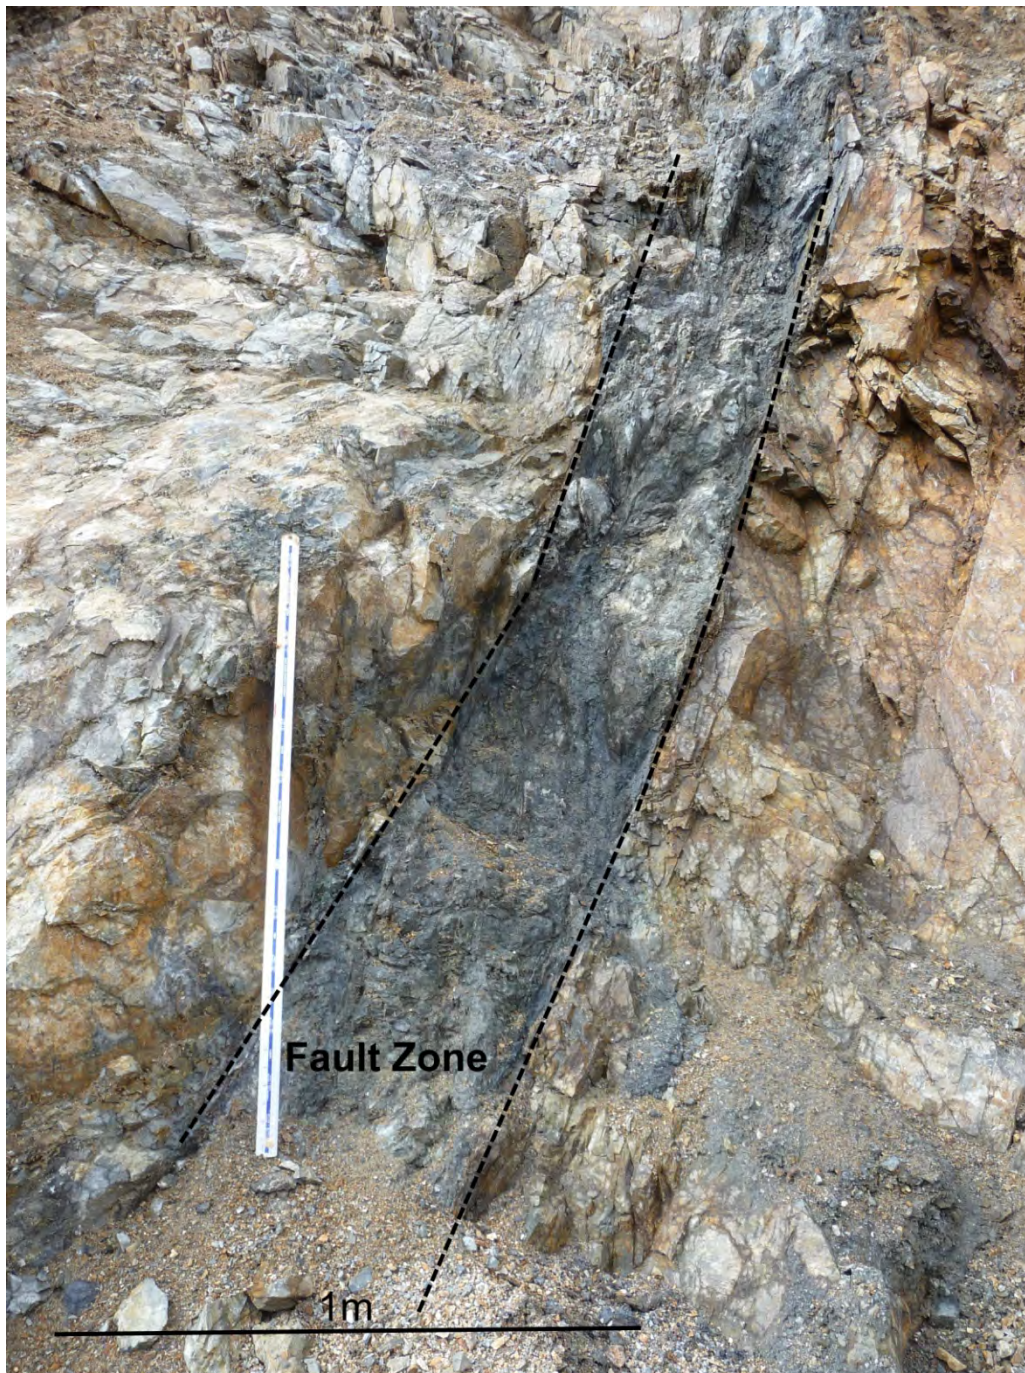
**Figure 9**      **Photograph – Waypoint 12 – South East Facing Quarry Wall, Blocky/Jointed siltstone with fault (dip-dip direction 70-315°) gouge of silts/clays**

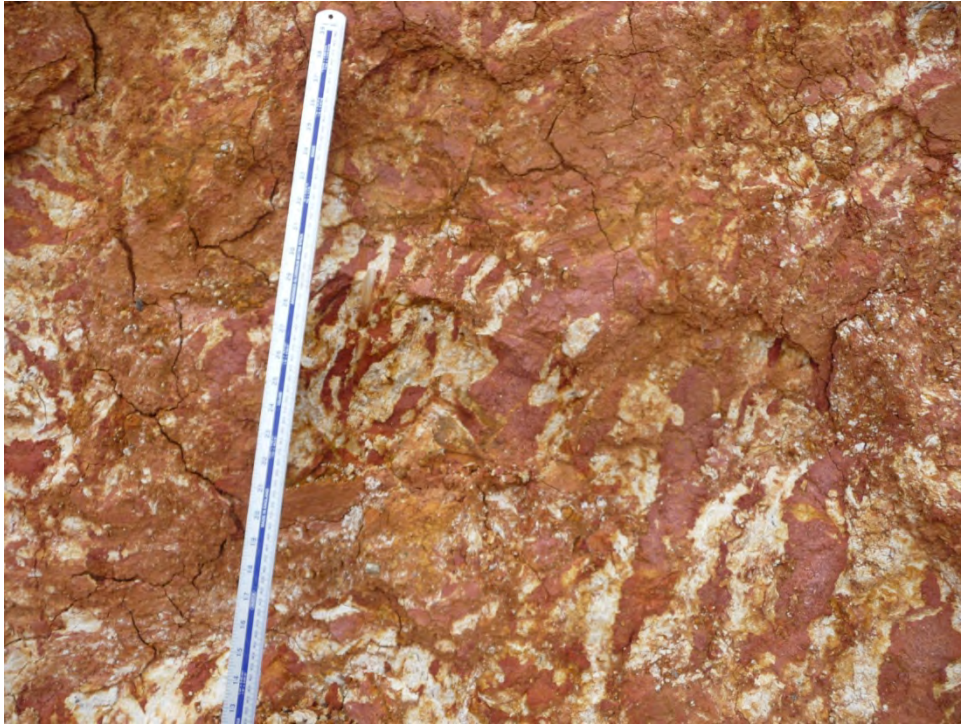
**Figure 10** Photograph – Waypoint 7 – North East Facing – Extremely weathered rock – clay with remnant rock structure of siltstone (possible mottled zone)

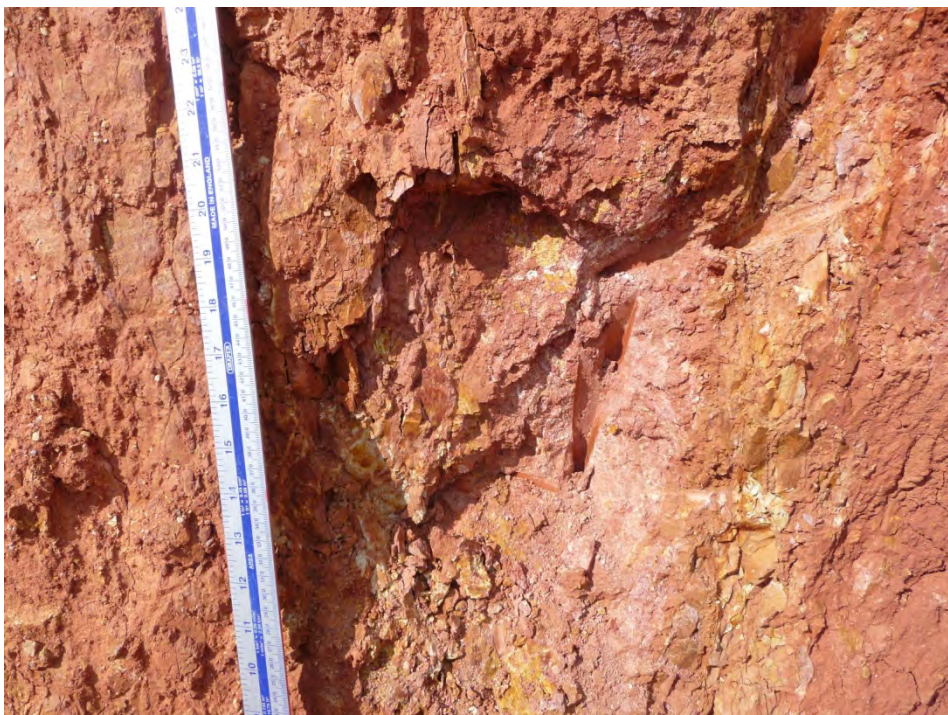
**Figure 11** Photograph – Waypoint 15 – South East Facing – Extremely weather rock – clay with remnant rock structure, possible siltstone/chert

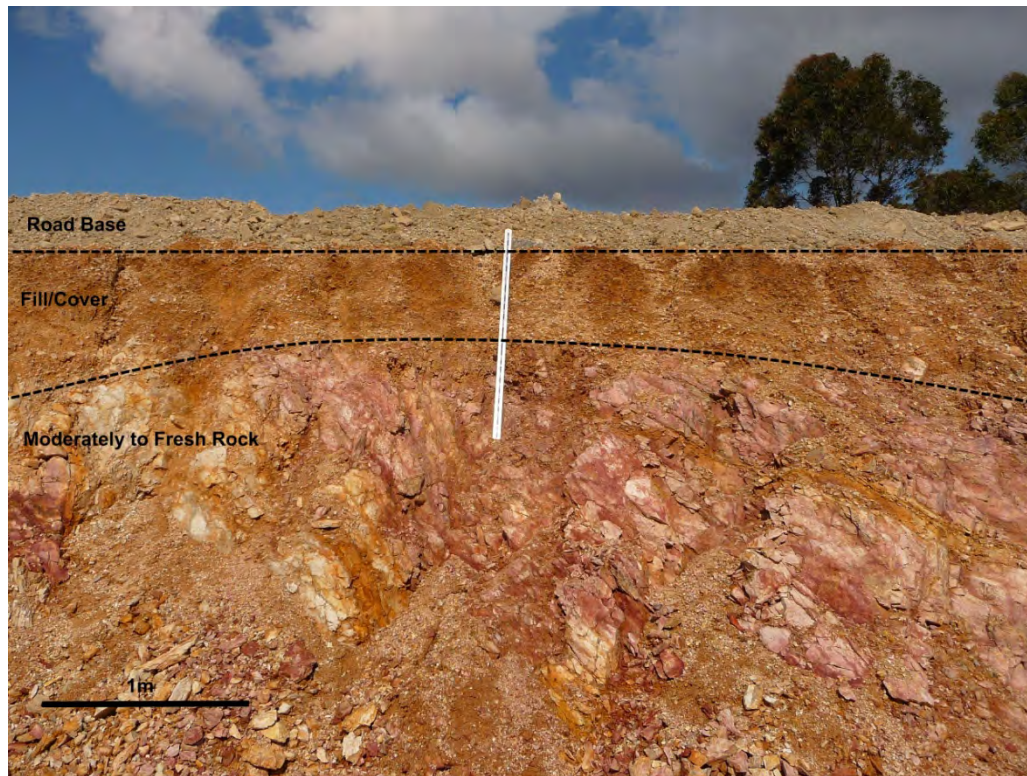
**Figure 12** Photograph - Waypoint 8 – South Facing Quarry Wall - Weathering profile showing shallow overburden with extremely weathered rock to moderately/fresh weathered rock zones.

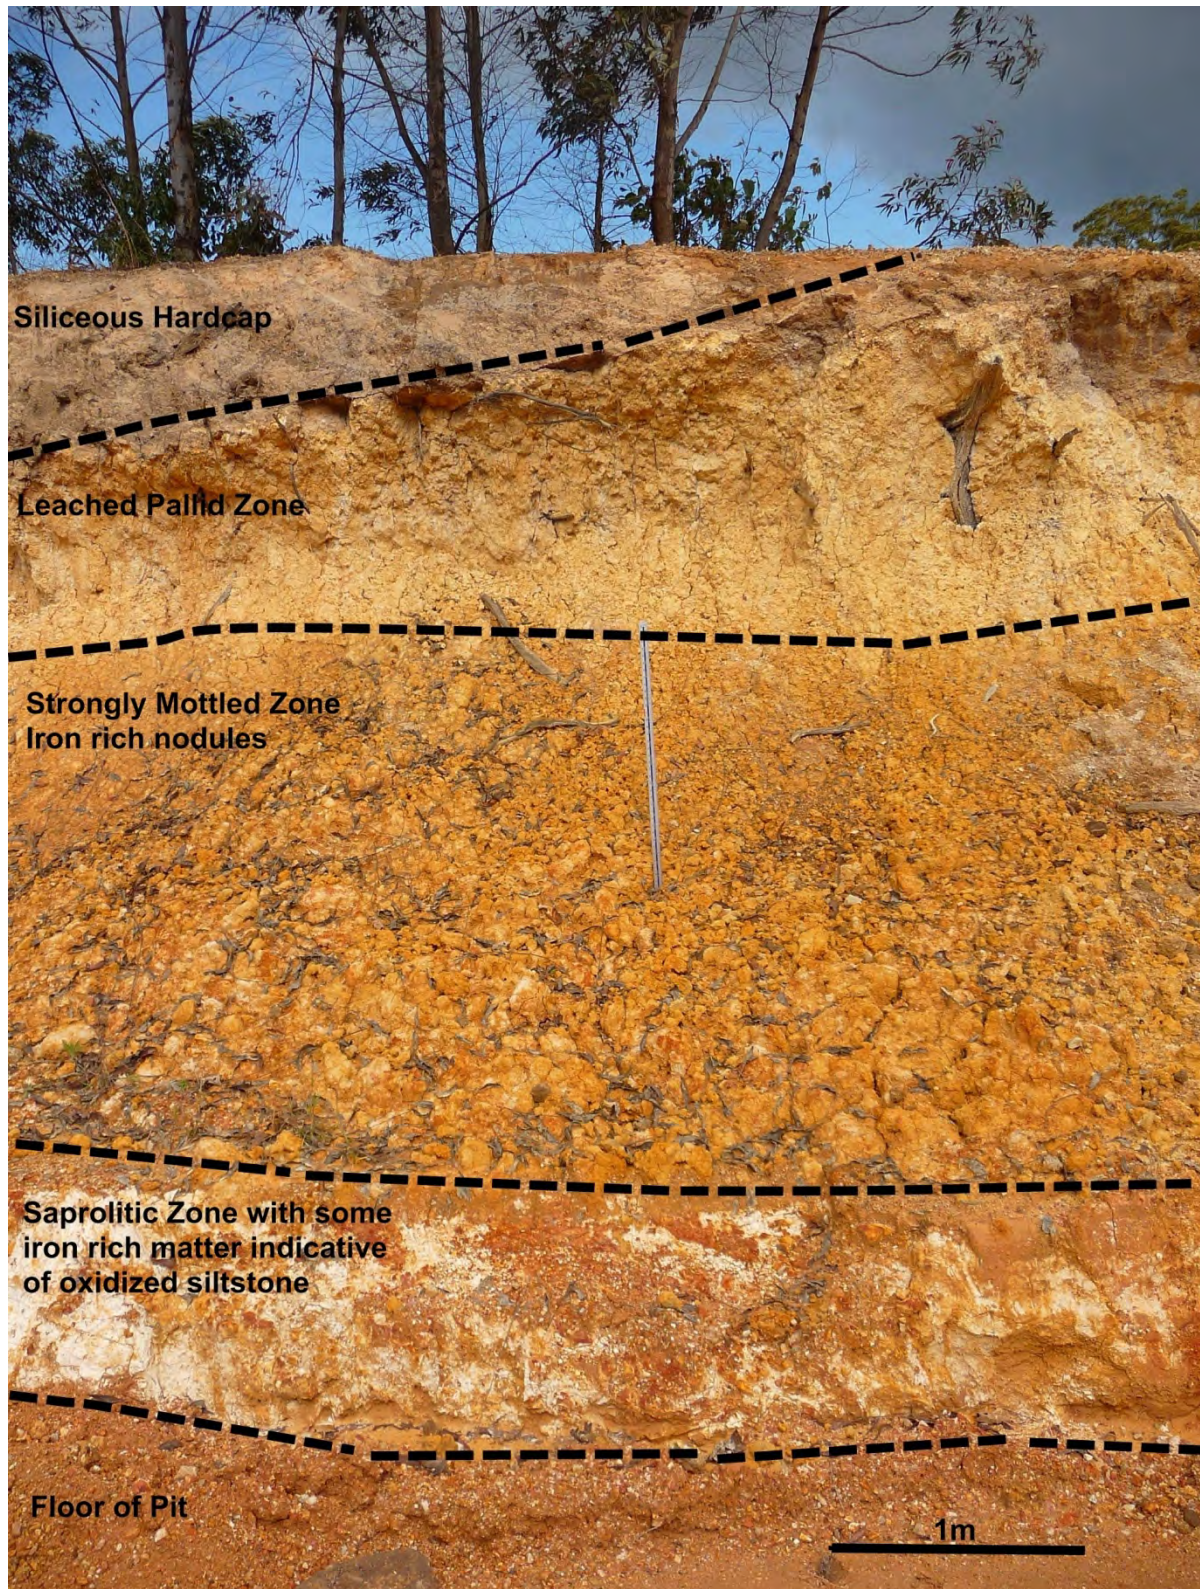
**Figure 13** Photograph - Waypoint 10 – South West Facing Quarry Wall - Weathering profile showing various weathering zones, shallow overburden with extremely weathered rock to moderately/fresh weathered rock zones

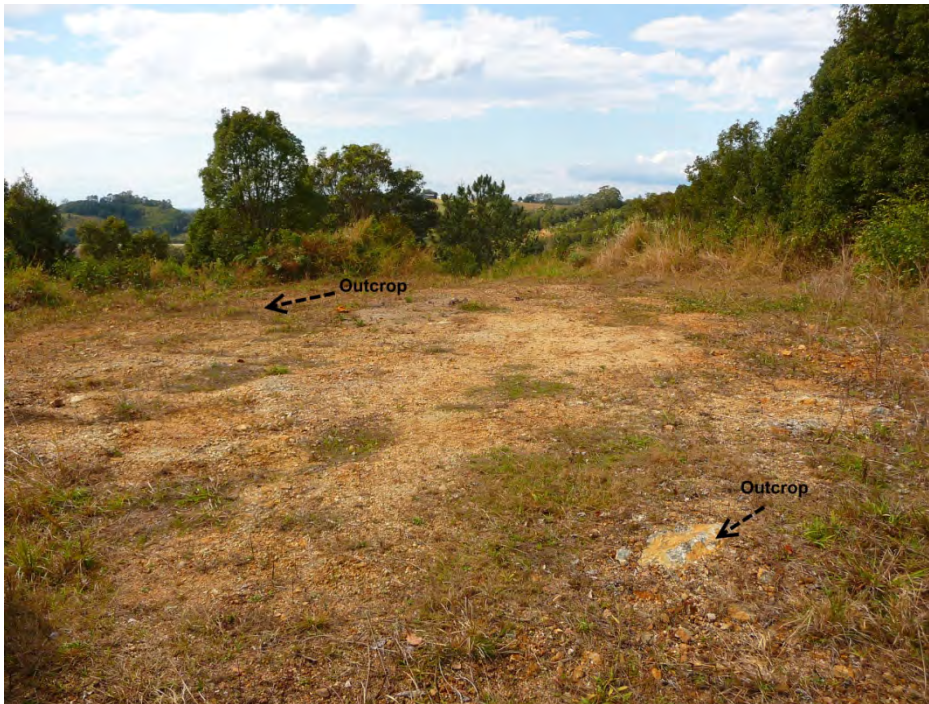
**Figure 14** Photograph – Waypoint 18 – Minor exposed outcrops of Chert – location of drillhole TSCBH01

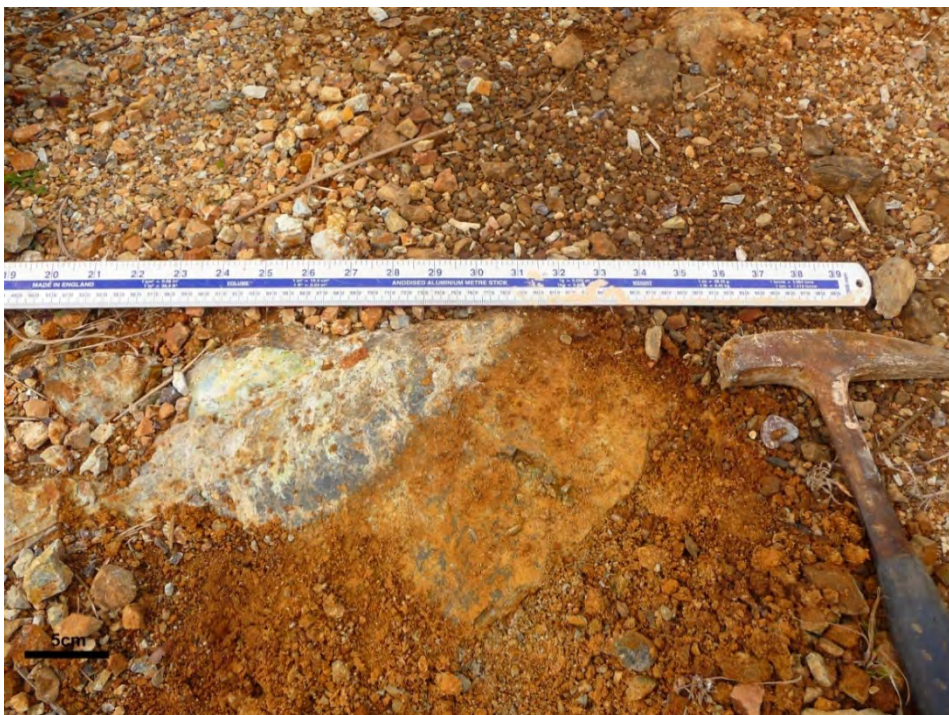
**Figure 15** Photograph – Waypoint 18 – Exposed outcrop of chert – foliation (dip-dip direction 20-020°)

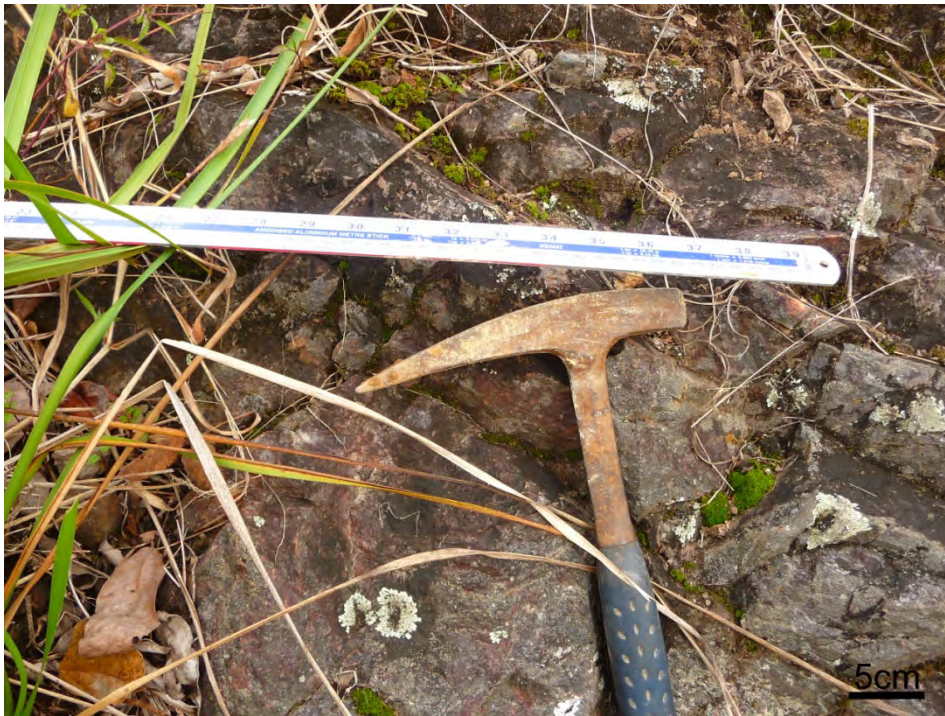
**Figure 16** Photograph – Waypoint 20 – South West Facing – Chert/Quartzite to siliceous siltstone exposed in drainage cutting.

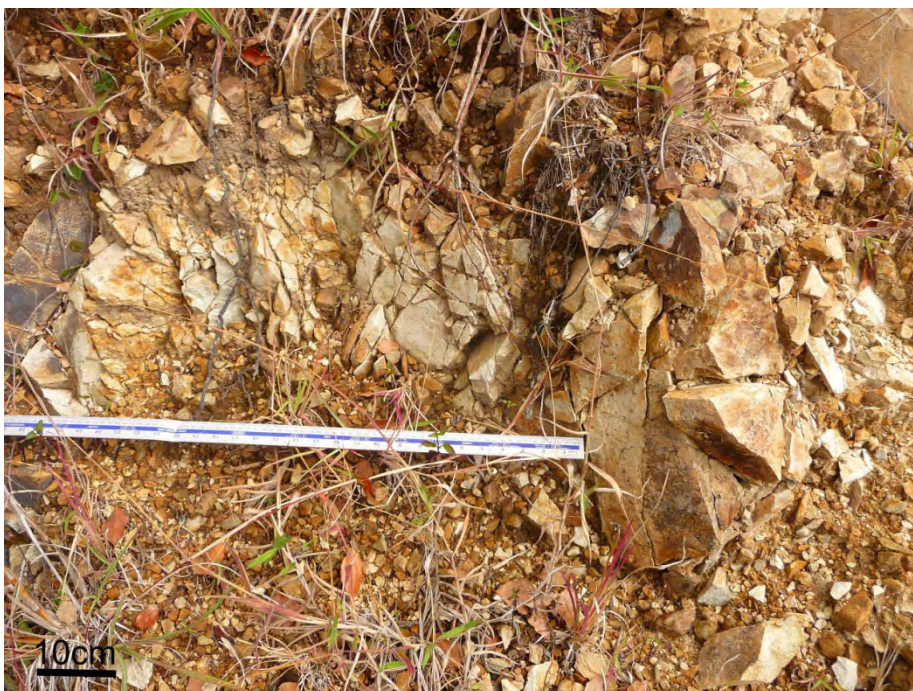
**Figure 17** Photograph – Waypoint 27 – South West Facing – Greywacke in road cutting. Note blocky material.

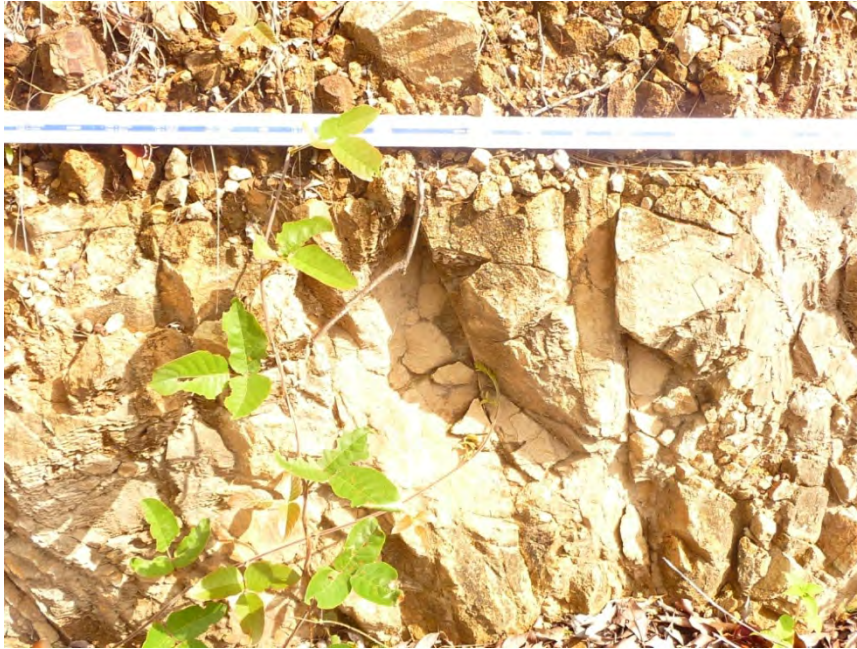
**Figure 18** Photograph – Waypoint 30 – South West Facing – Greywacke in road cutting with Blocky joints with dip-dip directions of 75-020°, 75-125° and 45-280°

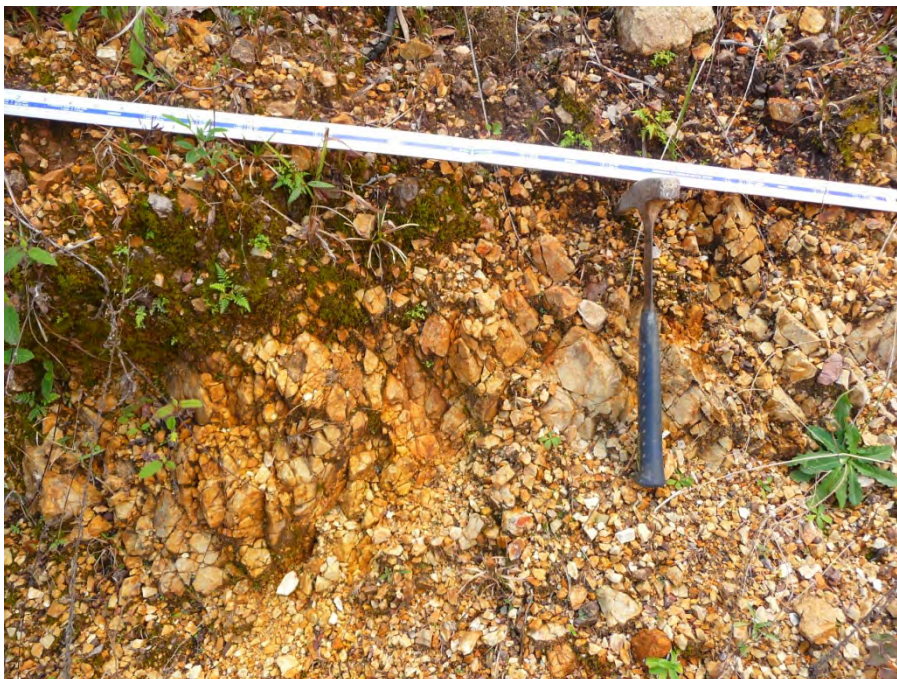
**Figure 19** Photograph – Waypoint 36 – Chert in a road cutting

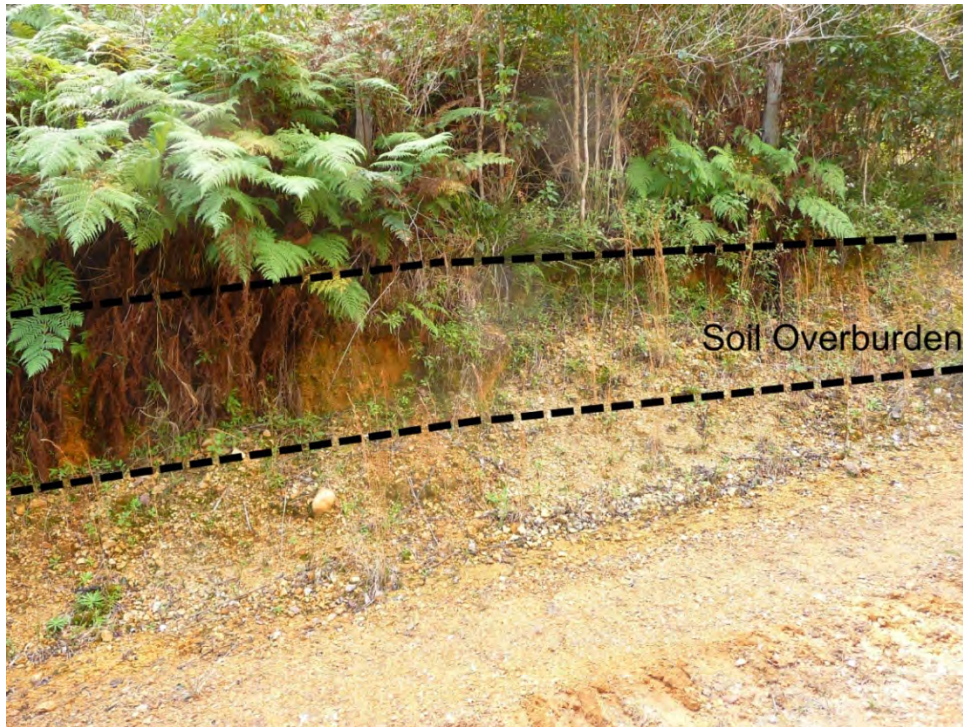
**Figure 20** Photograph – Waypoint 35- North Facing – road cutting of extremely weather rock showing overburden of ~1 m Vegetation growing off cut face

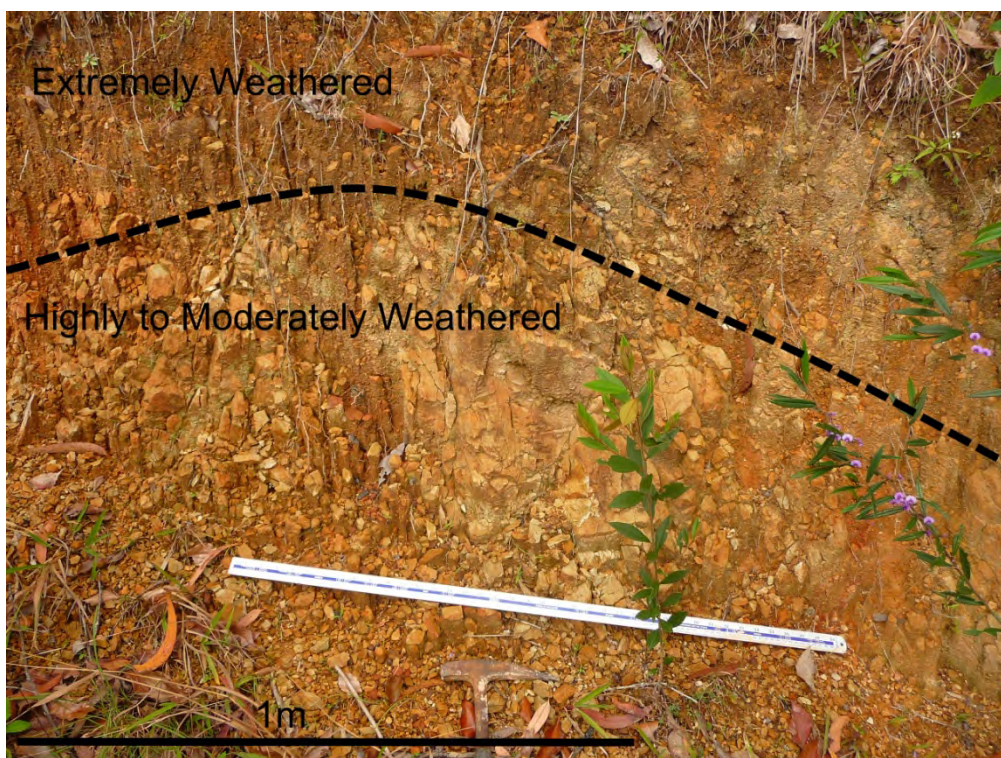
**Figure 21** Photograph – Waypoint 17 – South Facing – Siltstone to siliceous siltstone in road cutting.
