**Tweed Shire Council**  
Report for West Valley Quarry  
Preliminary Study  
September 2011

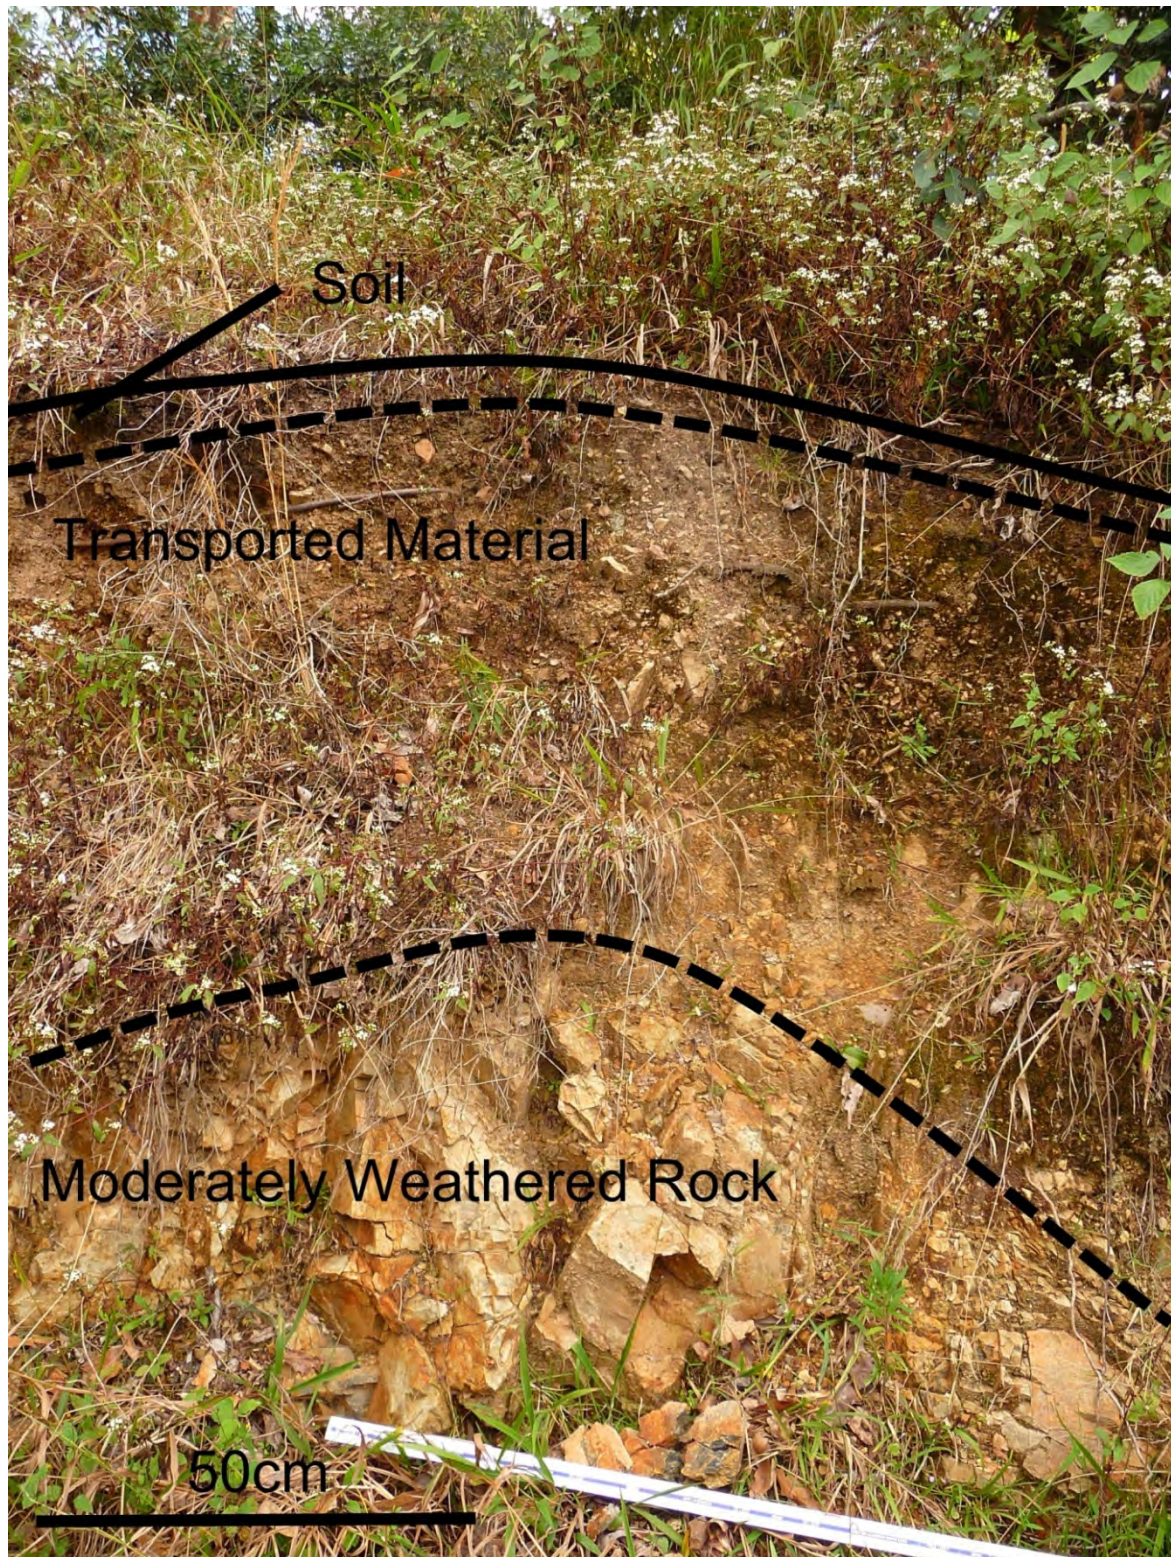
**Figure 22** Photograph – Waypoint 32 – West Facing – Weathering profile of greywacke displacing ~10 cm soil with transported material and moderately weathered rock.

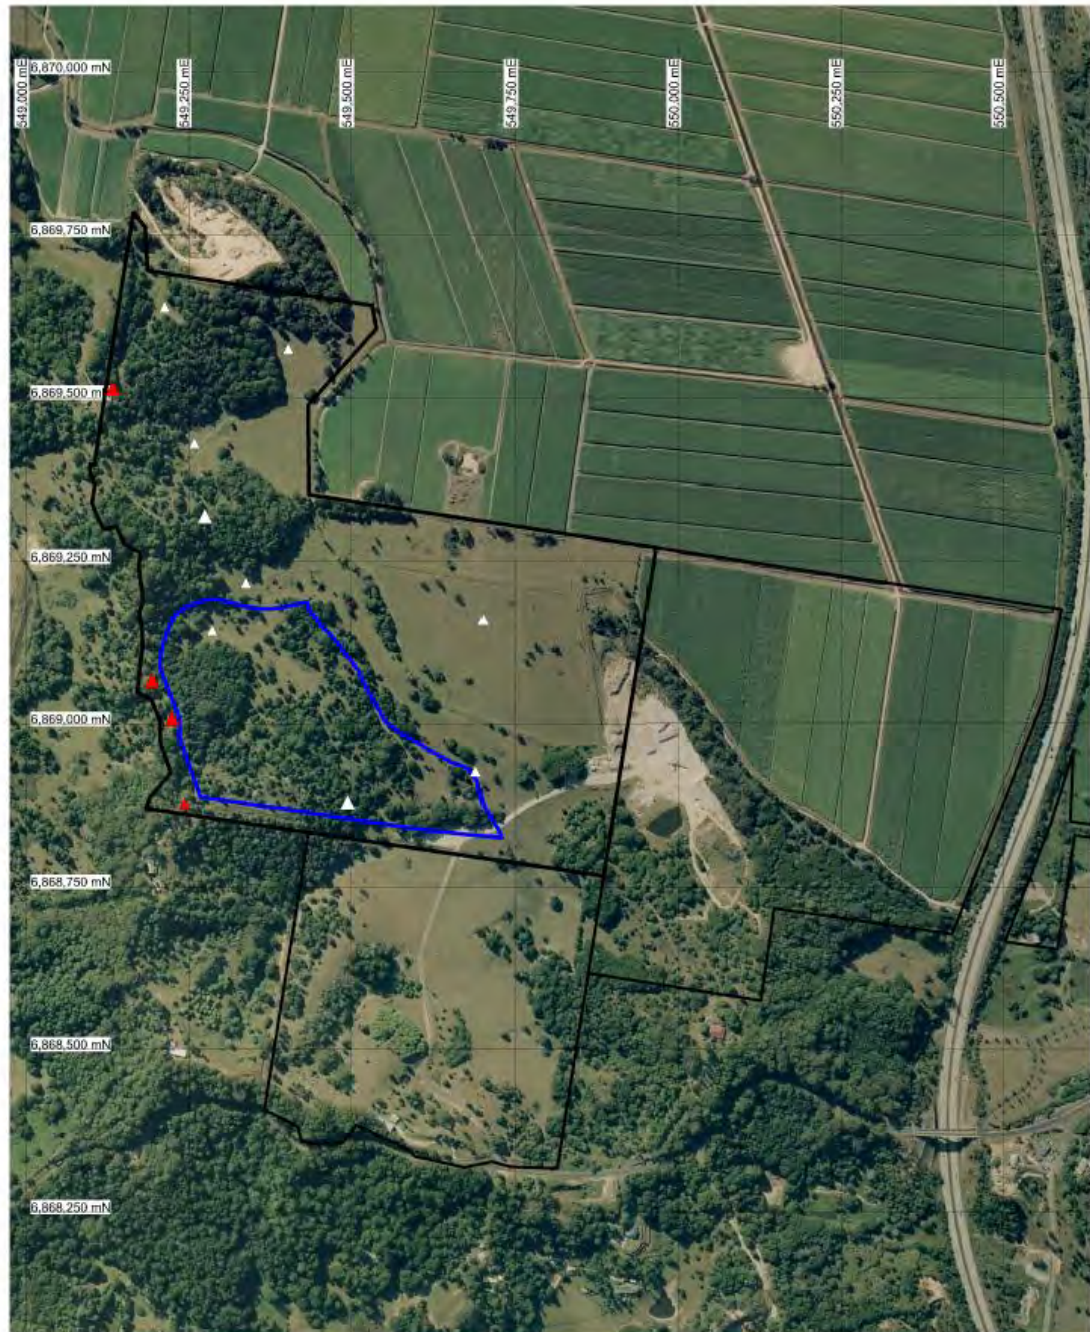
**Figure 29 Possible Future Drillhole Locations**

A significant number of drill sites will need significant site preparation, and subject to assessment by an experienced driller and the obtaining of relevant statutory approvals could be drilled. Refer to Table 2 and Figure 28 and Figure 29 for possible drillhole locations.

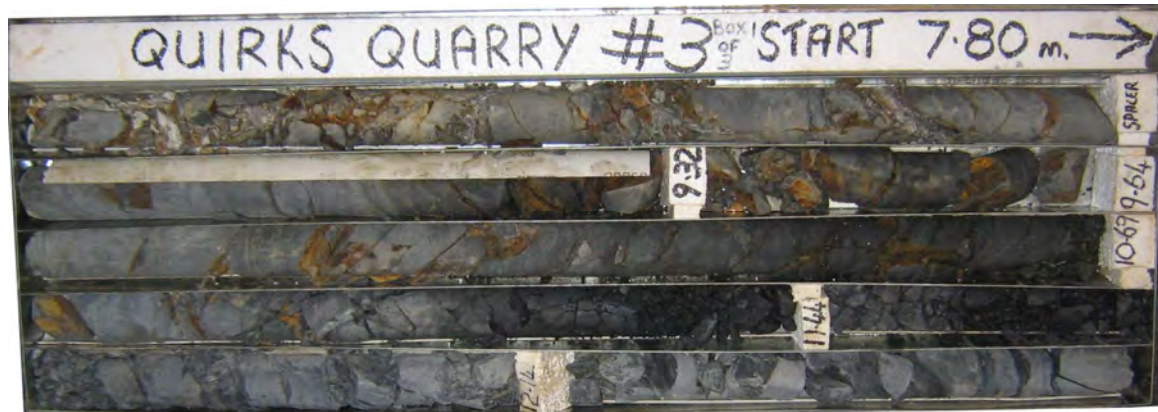
Borehole Number		BH 03A	
Box	1	of	3
Depth	7.80	to	12.94
Project	West Valley Quarry Investigation		
Number	41/20806/03		
Client	Tweed Shire Council

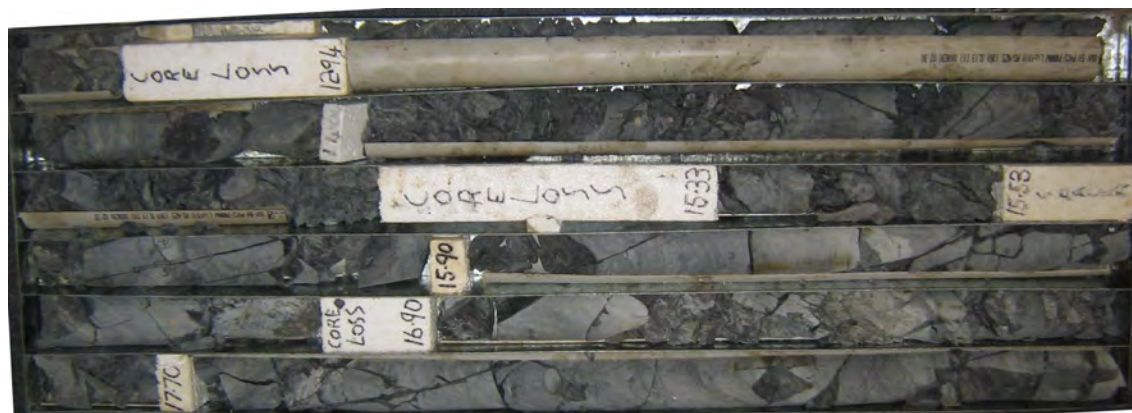
Borehole Number		BH 03A	
Box	2	of	3
Depth	12.94	to	17.70
Project	West Valley Quarry Investigation		
Number	41/20806/03		
Client	Tweed Shire Council

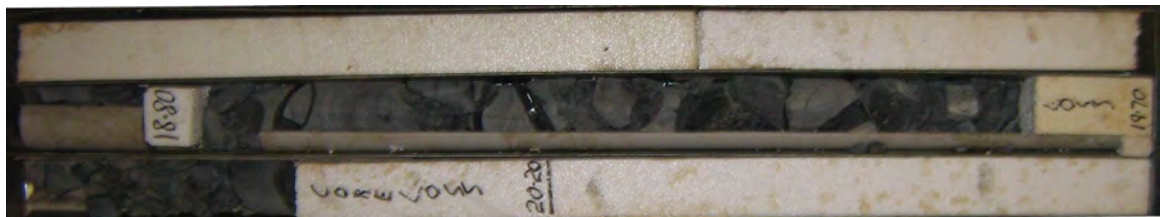
Borehole Number		BH 03A	
Box	3	of	3
Depth	17.70	to	20.20 E.O.H.
Project	West Valley Quarry Investigation		
Number	41/20806/03		
Client	Tweed Shire Council

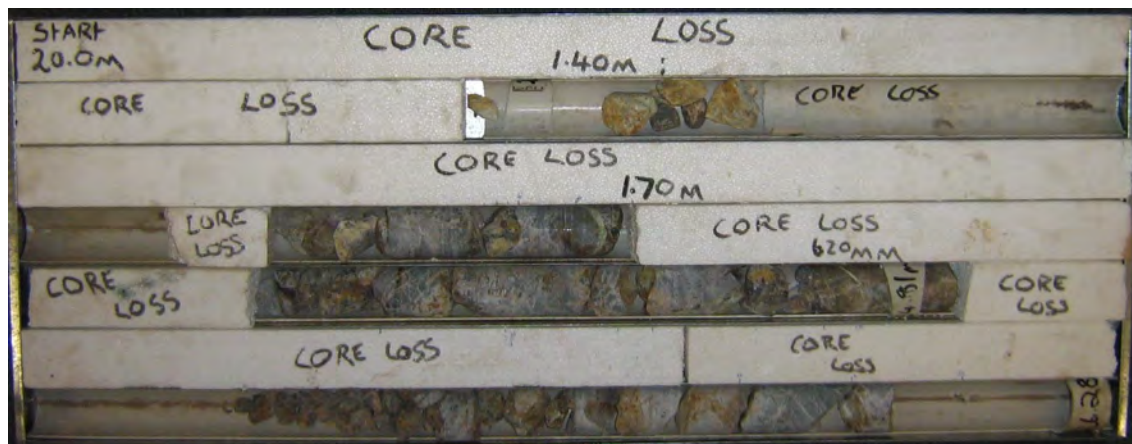
Borehole Number		BH 01	
Box	2	of	9
Depth	20.00	to	26.28
Project	West Valley Quarry Investigation		
Number	41/20806/03		
Client	Tweed Shire Council

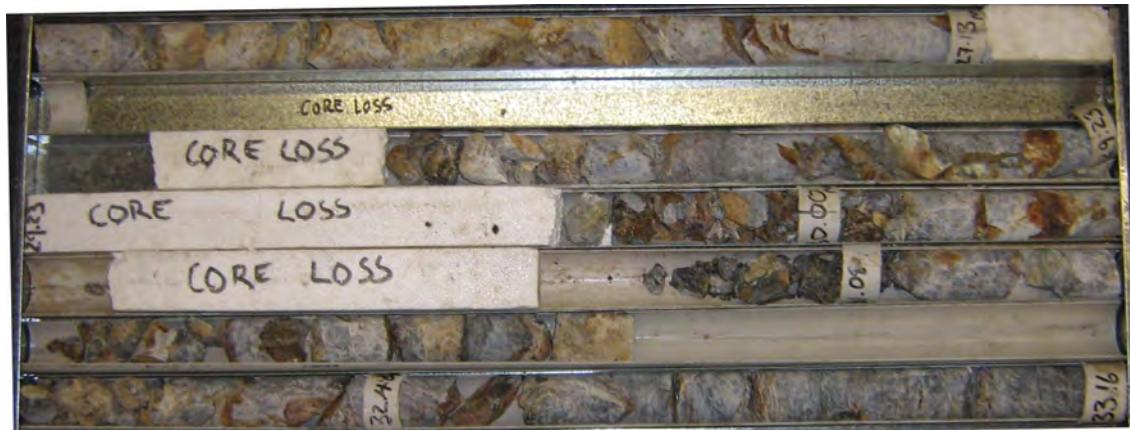
Borehole Number		BH 01	
Box	3	of	9
Depth	26.28	to	33.16
Project	West Valley Quarry Investigation		
Number	41/20806/03		
Client	Tweed Shire Council

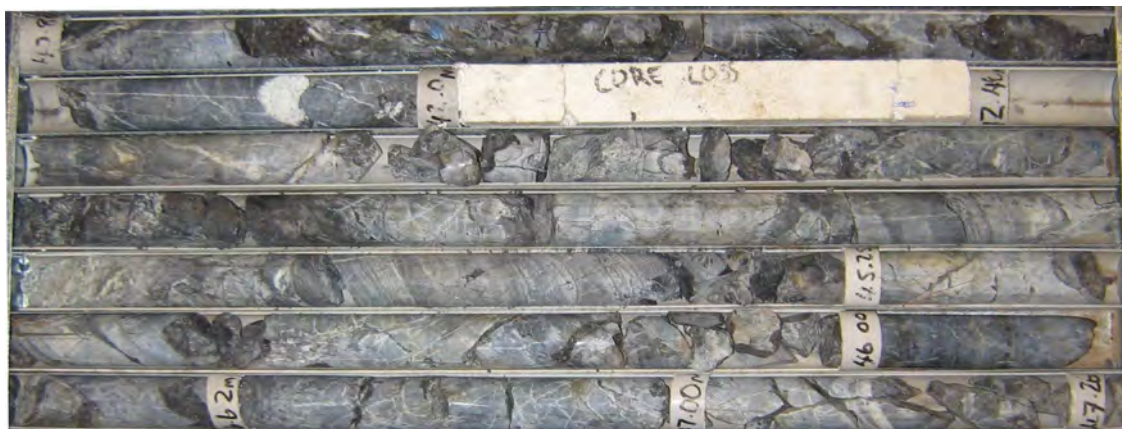
Borehole Number		BH 01	
Box	5	of	9
Depth	40.80	to	47.20
Project	West Valley Quarry Investigation		
Number	41/20806/03		
Client	Tweed Shire Council

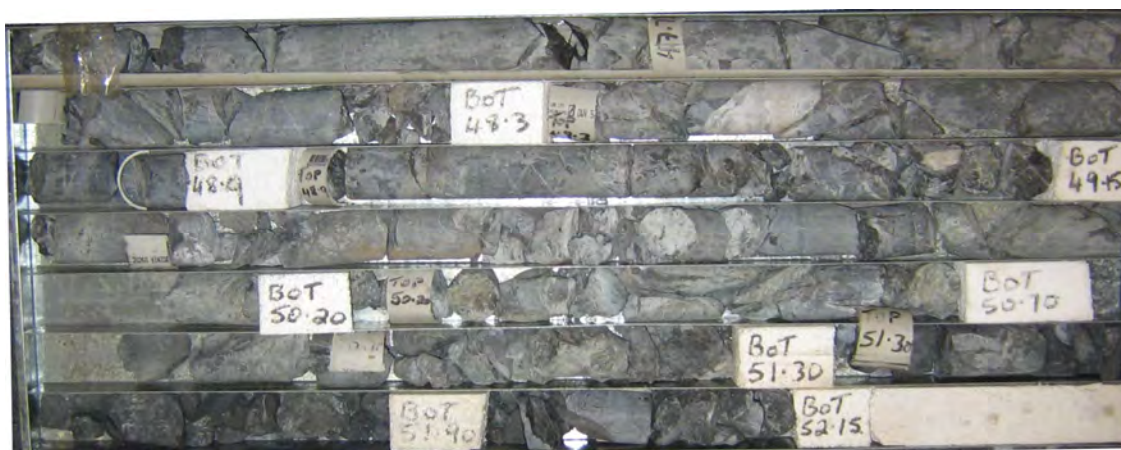
Borehole Number		BH 01	
Box	6	of	9
Depth	47.20	to	52.15
Project	West Valley Quarry Investigation		
Number	41/20806/03		
Client	Tweed Shire Council

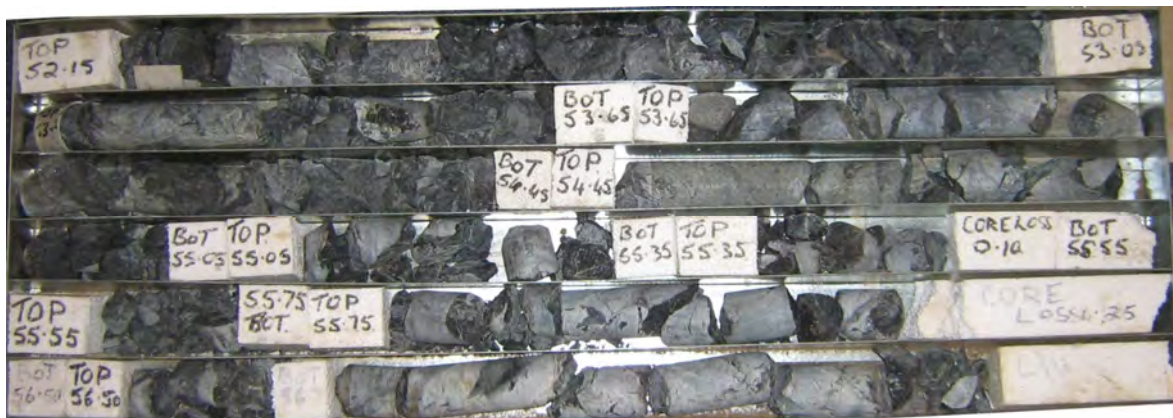
Borehole Number		BH 01	
Box	7	of	9
Depth	52.15	to	56.70
Project	West Valley Quarry Investigation		
Number	41/20806/03		
Client	Tweed Shire Council

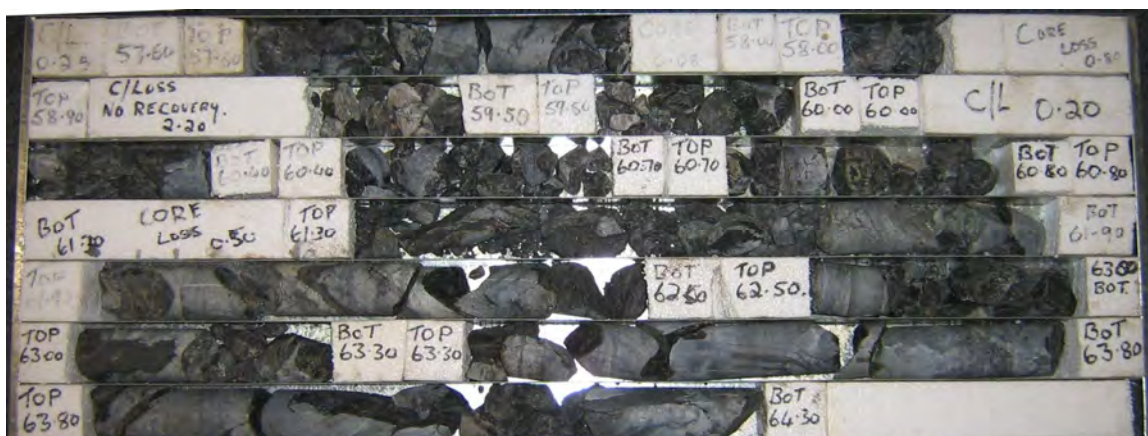
Borehole Number		BH 01	
Box	8	of	9
Depth	56.70	to	64.30
Project	West Valley Quarry Investigation		
Number	41/20806/03		
Client	Tweed Shire Council

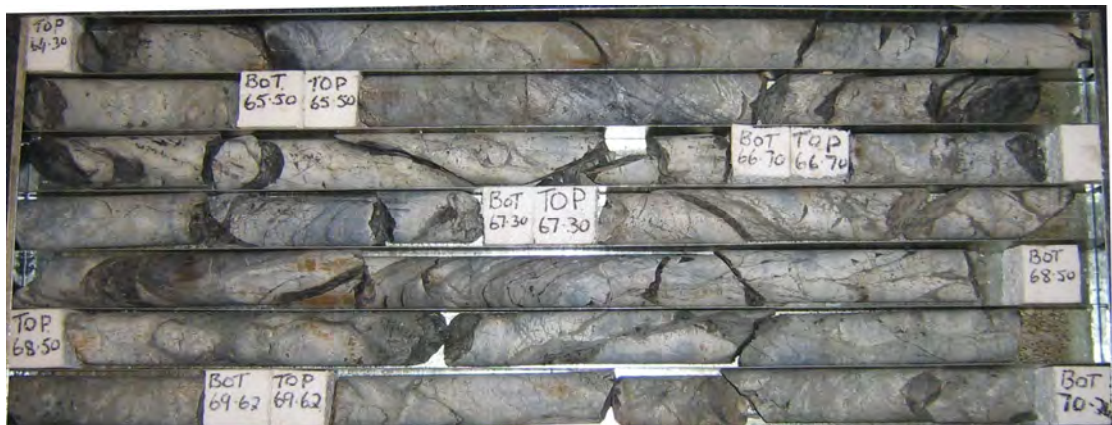
Borehole Number		BH 01	
Box	9	of	9
Depth	64.30	to	70.25 E.O.H.
Project	West Valley Quarry Investigation		
Number	41/20806/03		
Client	Tweed Shire Council

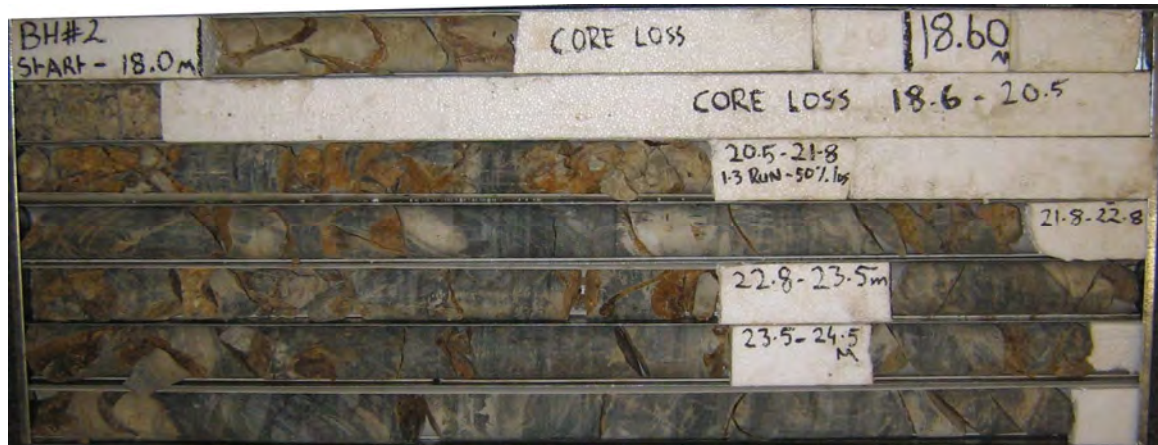
Borehole Number		BH 02B	
Box	1	of	6
Depth	18.00	to	24.50
Project	West Valley Quarry Investigation		
Number	41/20806/03		
Client	Tweed Shire Council

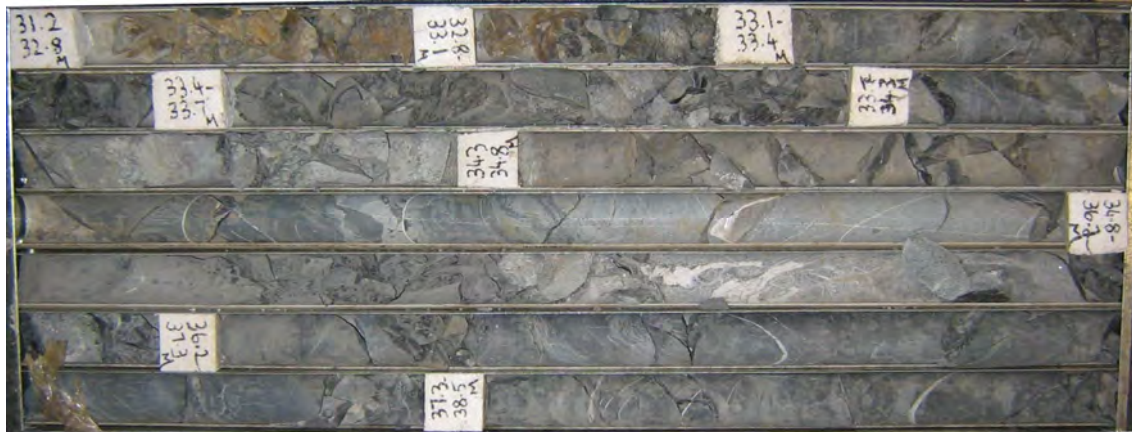
Borehole Number		BH 02B	
Box	3	of	6
Depth	31.20	to	38.50
Project	West Valley Quarry Investigation		
Number	41/20806/03		
Client	Tweed Shire Council

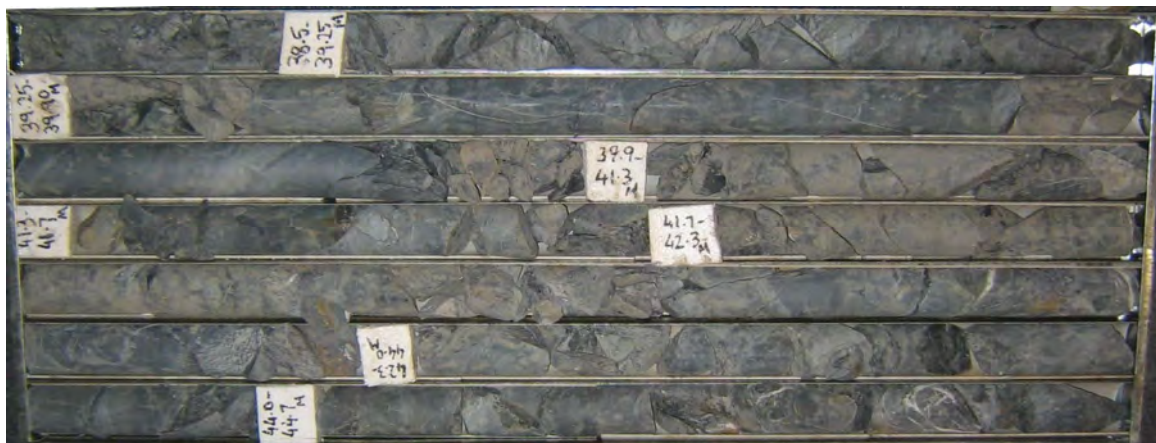
Borehole Number		BH 02B	
Box	4	of	6
Depth	38.50	to	44.70
Project	West Valley Quarry Investigation		
Number	41/20806/03		
Client	Tweed Shire Council

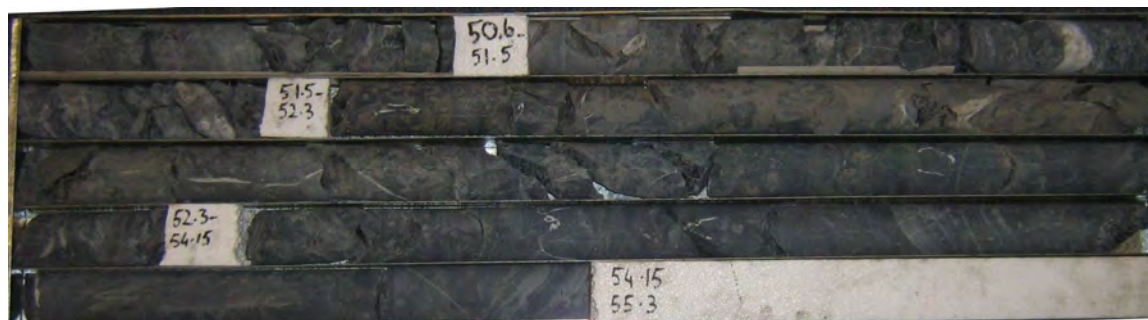
Borehole Number		BH 02B	
Box	6	of	6
Depth	50.60	to	54.15 E.O.H
Project	West Valley Quarry Investigation		
Number	41/20806/03		
Client	Tweed Shire Council

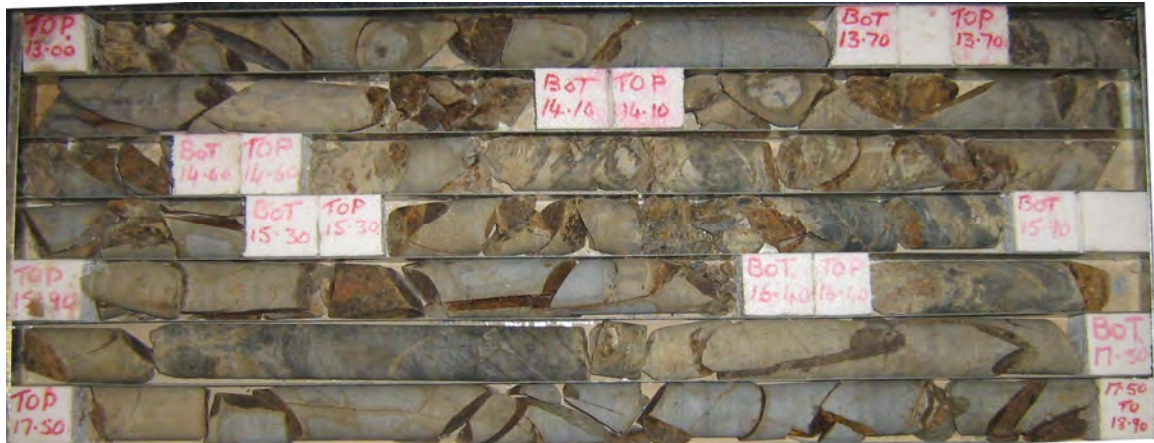
Borehole Number		BH 03B	
Box	1	of	9
Depth	13.00	to	17.50
Project	West Valley Quarry Investigation		
Number	41/20806/03		
Client	Tweed Shire Council

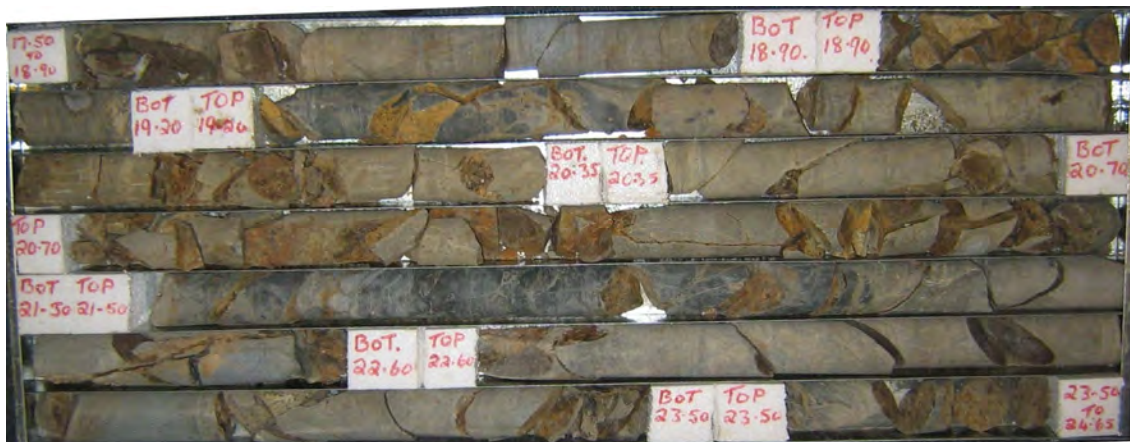
Borehole Number		BH 03B	
Box	2	of	9
Depth	17.50	to	23.50
Project	West Valley Quarry Investigation		
Number	41/20806/03		
Client	Tweed Shire Council

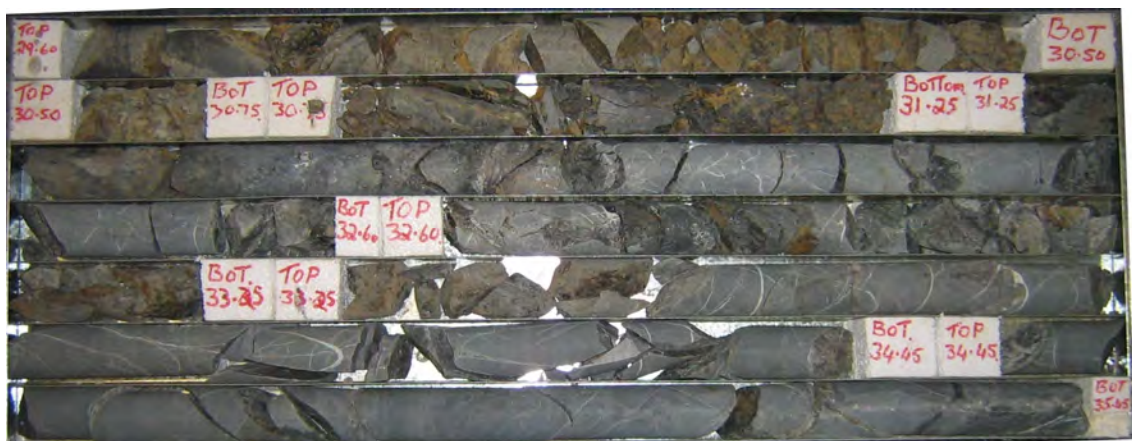
Borehole Number		BH 03B	
Box	4	of	9
Depth	29.60	to	35.65
Project	West Valley Quarry Investigation		
Number	41/20806/03		
Client	Tweed Shire Council

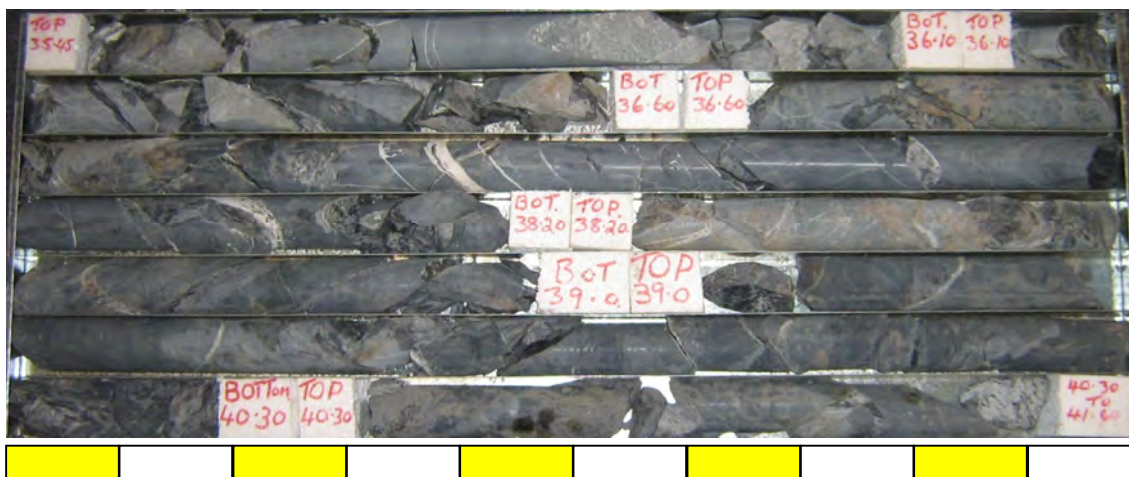
Borehole Number		BH 03B	
Box	5	of	9
Depth	35.65	to	40.30
Project	West Valley Quarry Investigation		
Number	41/20806/03		
Client	Tweed Shire Council

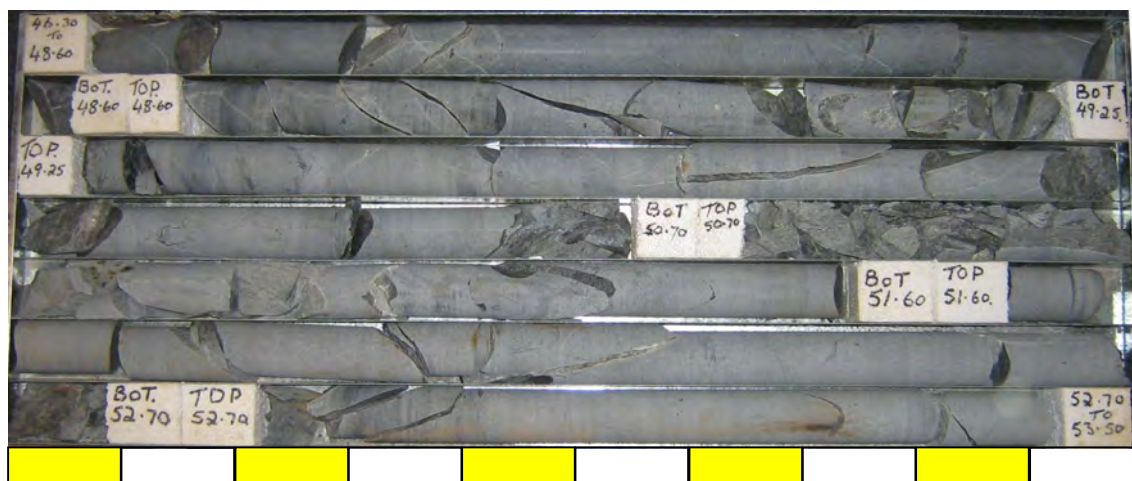
Borehole Number		BH 03B	
Box	7	of	9
Depth	46.30	to	52.70
Project	West Valley Quarry Investigation		
Number	41/20806/03		
Client	Tweed Shire Council

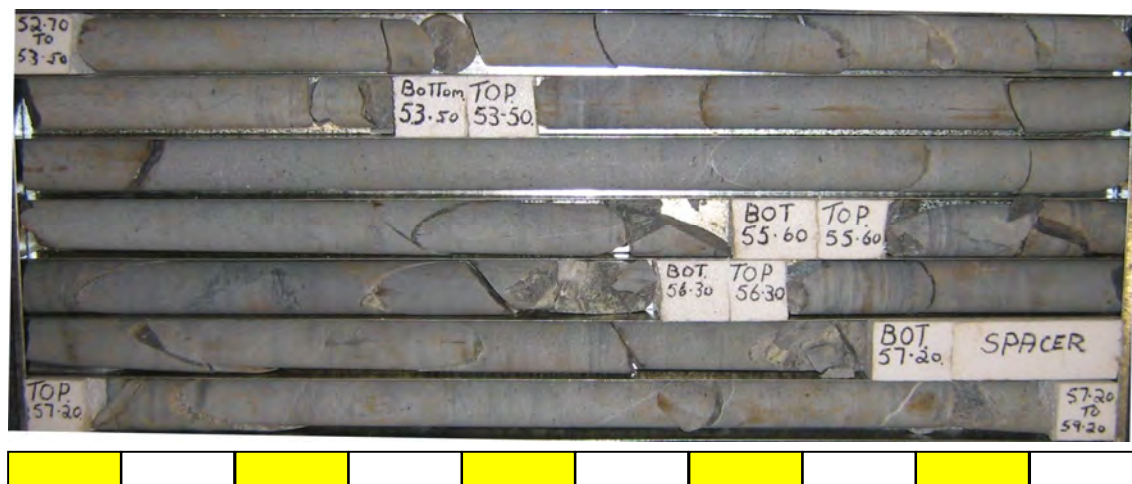
Borehole Number		BH 03B	
Box	8	of	9
Depth	52.70	to	57.20
Project	West Valley Quarry Investigation		
Number	41/20806/03		
Client	Tweed Shire Council
