# Claymore Urban Renewal

## Preliminary Contamination Assessment Report

This report presents the results of the preliminary contamination assessment (PCA), carried out by Geotechnique Pty Ltd (Geotechnique) for and on behalf of Landcom, for the Claymore Urban Renewal Project, a proposed residential subdivision at Claymore.

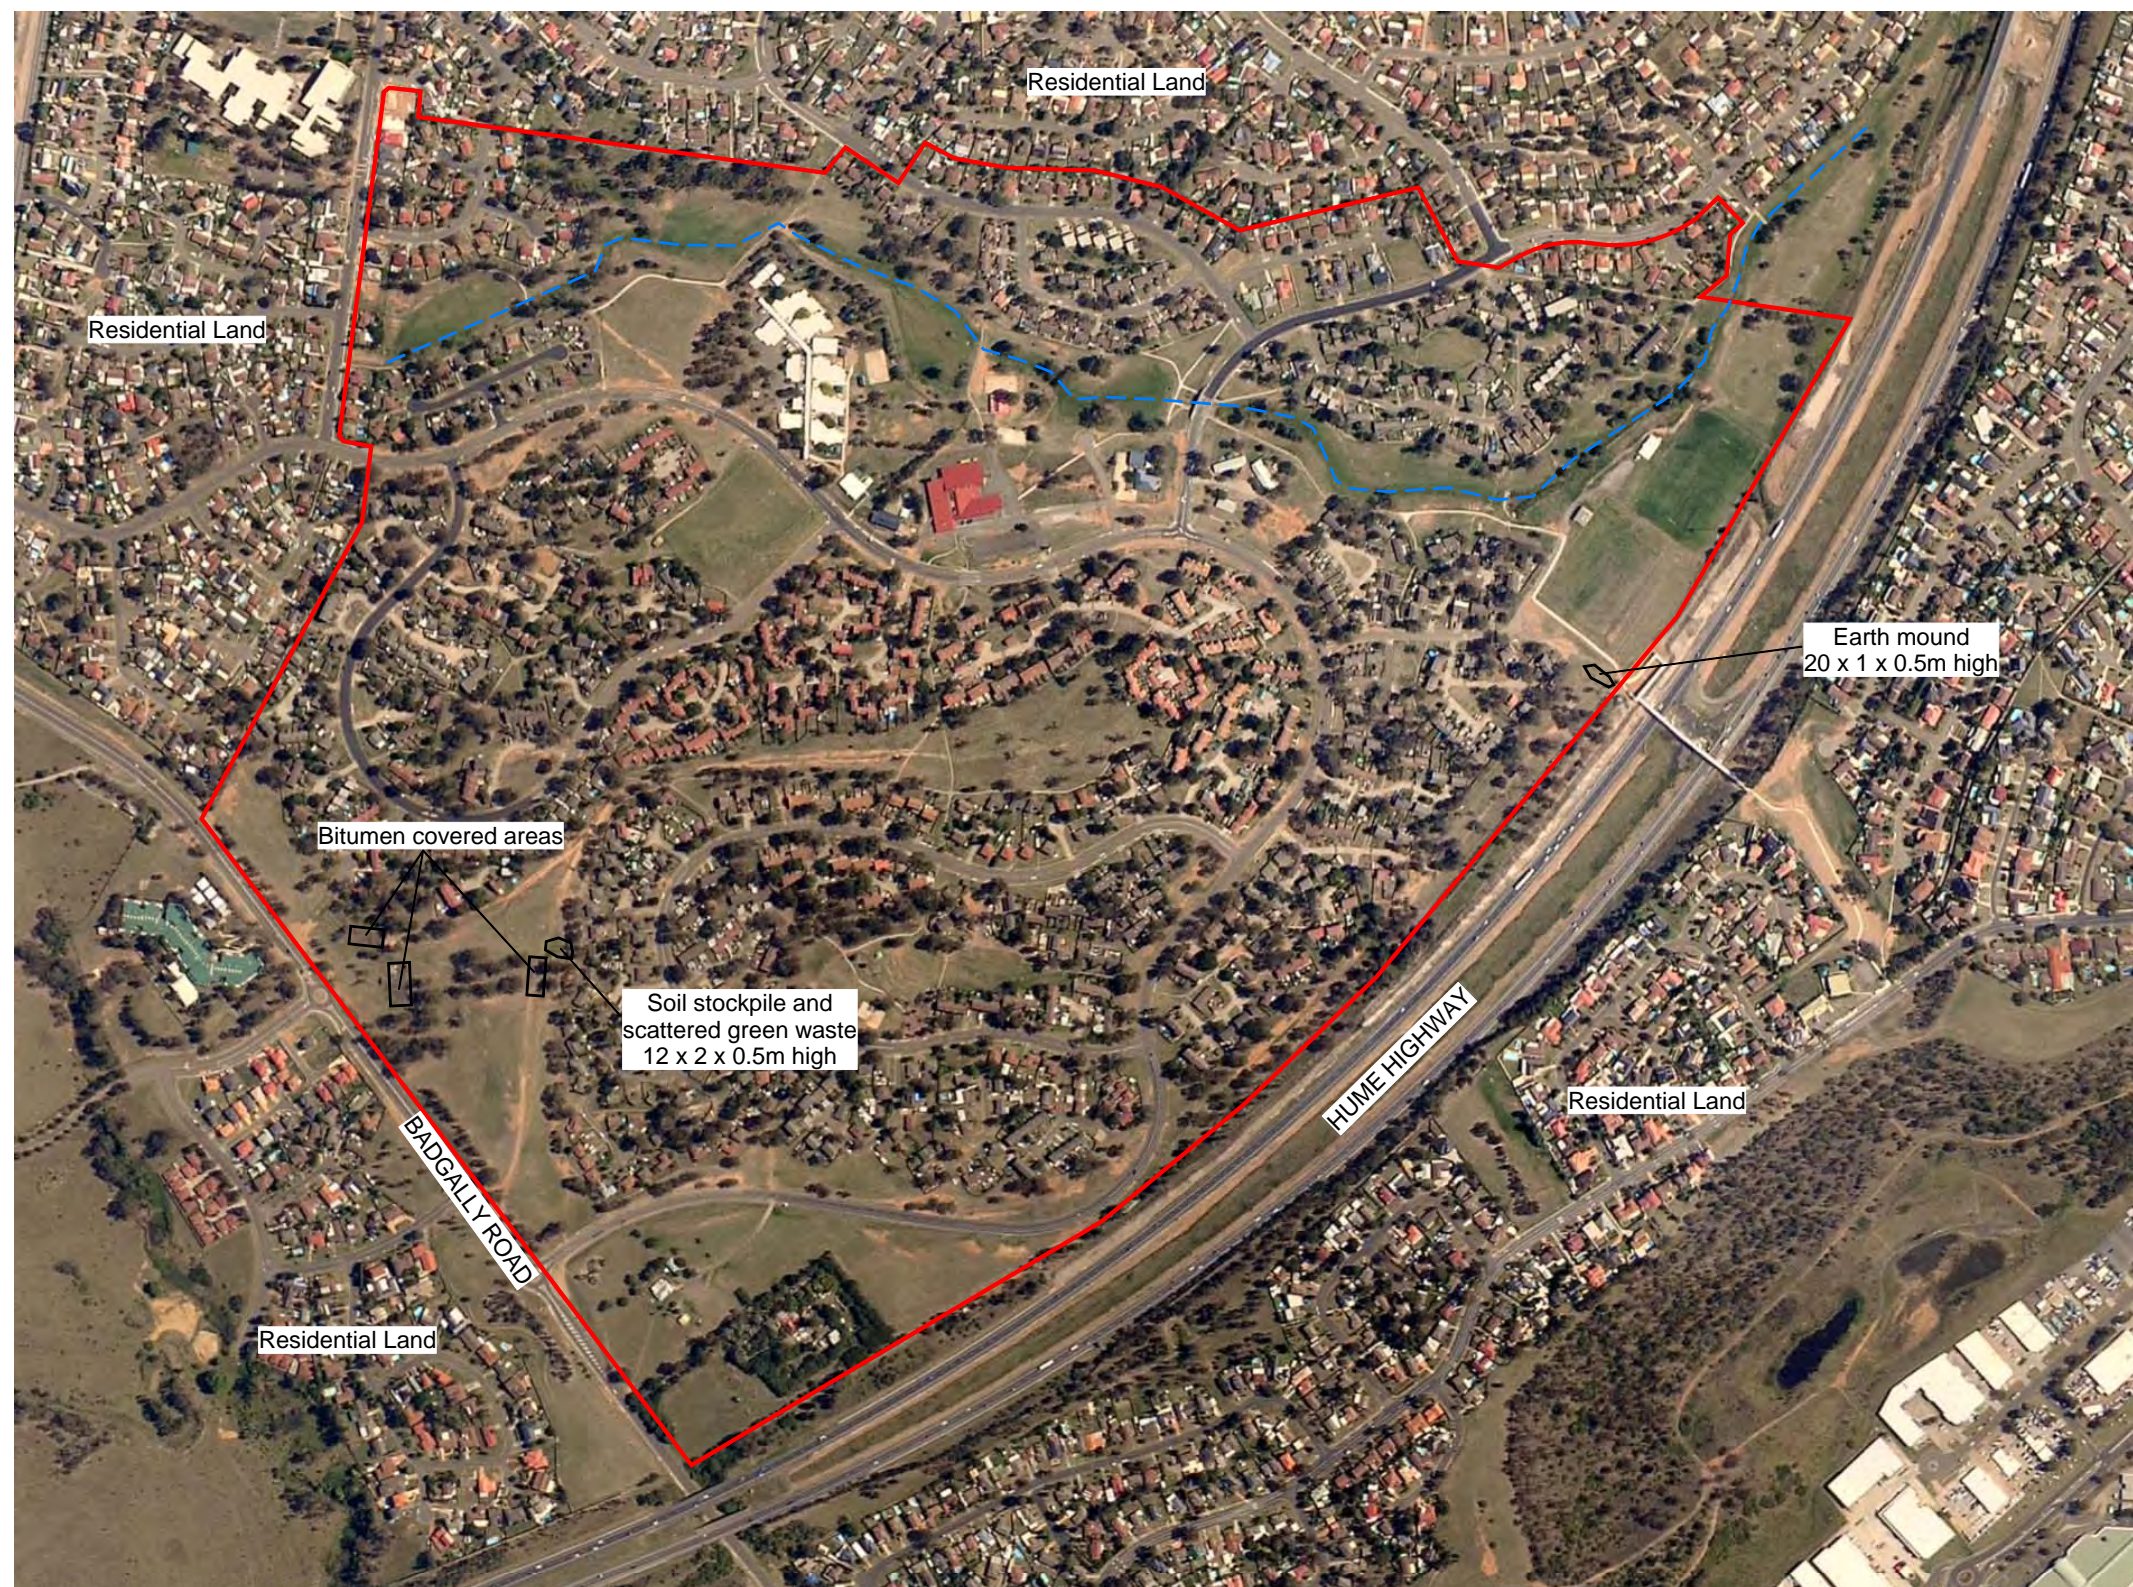
Drawing No: 12467/2-AA1  
Job No: 12467/2  
Drawn By: MH  
Date: 10 May 2011  
Checked By: AB

The site features are indicated on Drawing No 12467/2-AA1 in Appendix 1.

A soil stockpile (12m x 2m x 0.5m high) and few bitumen covered areas are noted in the south western portion of the site. An earth mound (20m x 1m x 0.5m high) is observed in the north eastern portion of the site, as indicated on Drawing No 12467/2-AA1 in Appendix 1.

There is a significant drainage depression dipping towards the east along the northern site boundary. Several other minor drainage depressions were noted dipping from the southern portion of the site towards the main drainage depression in the northern portion.

In general, ground surface across the site dips from the south towards the north west. However, locally the ground surface dips easterly or westerly towards the minor drainage depressions. Although ground surface slopes in most portions of the site range from about 5% to 15%, isolated areas of steep slopes were also noted.

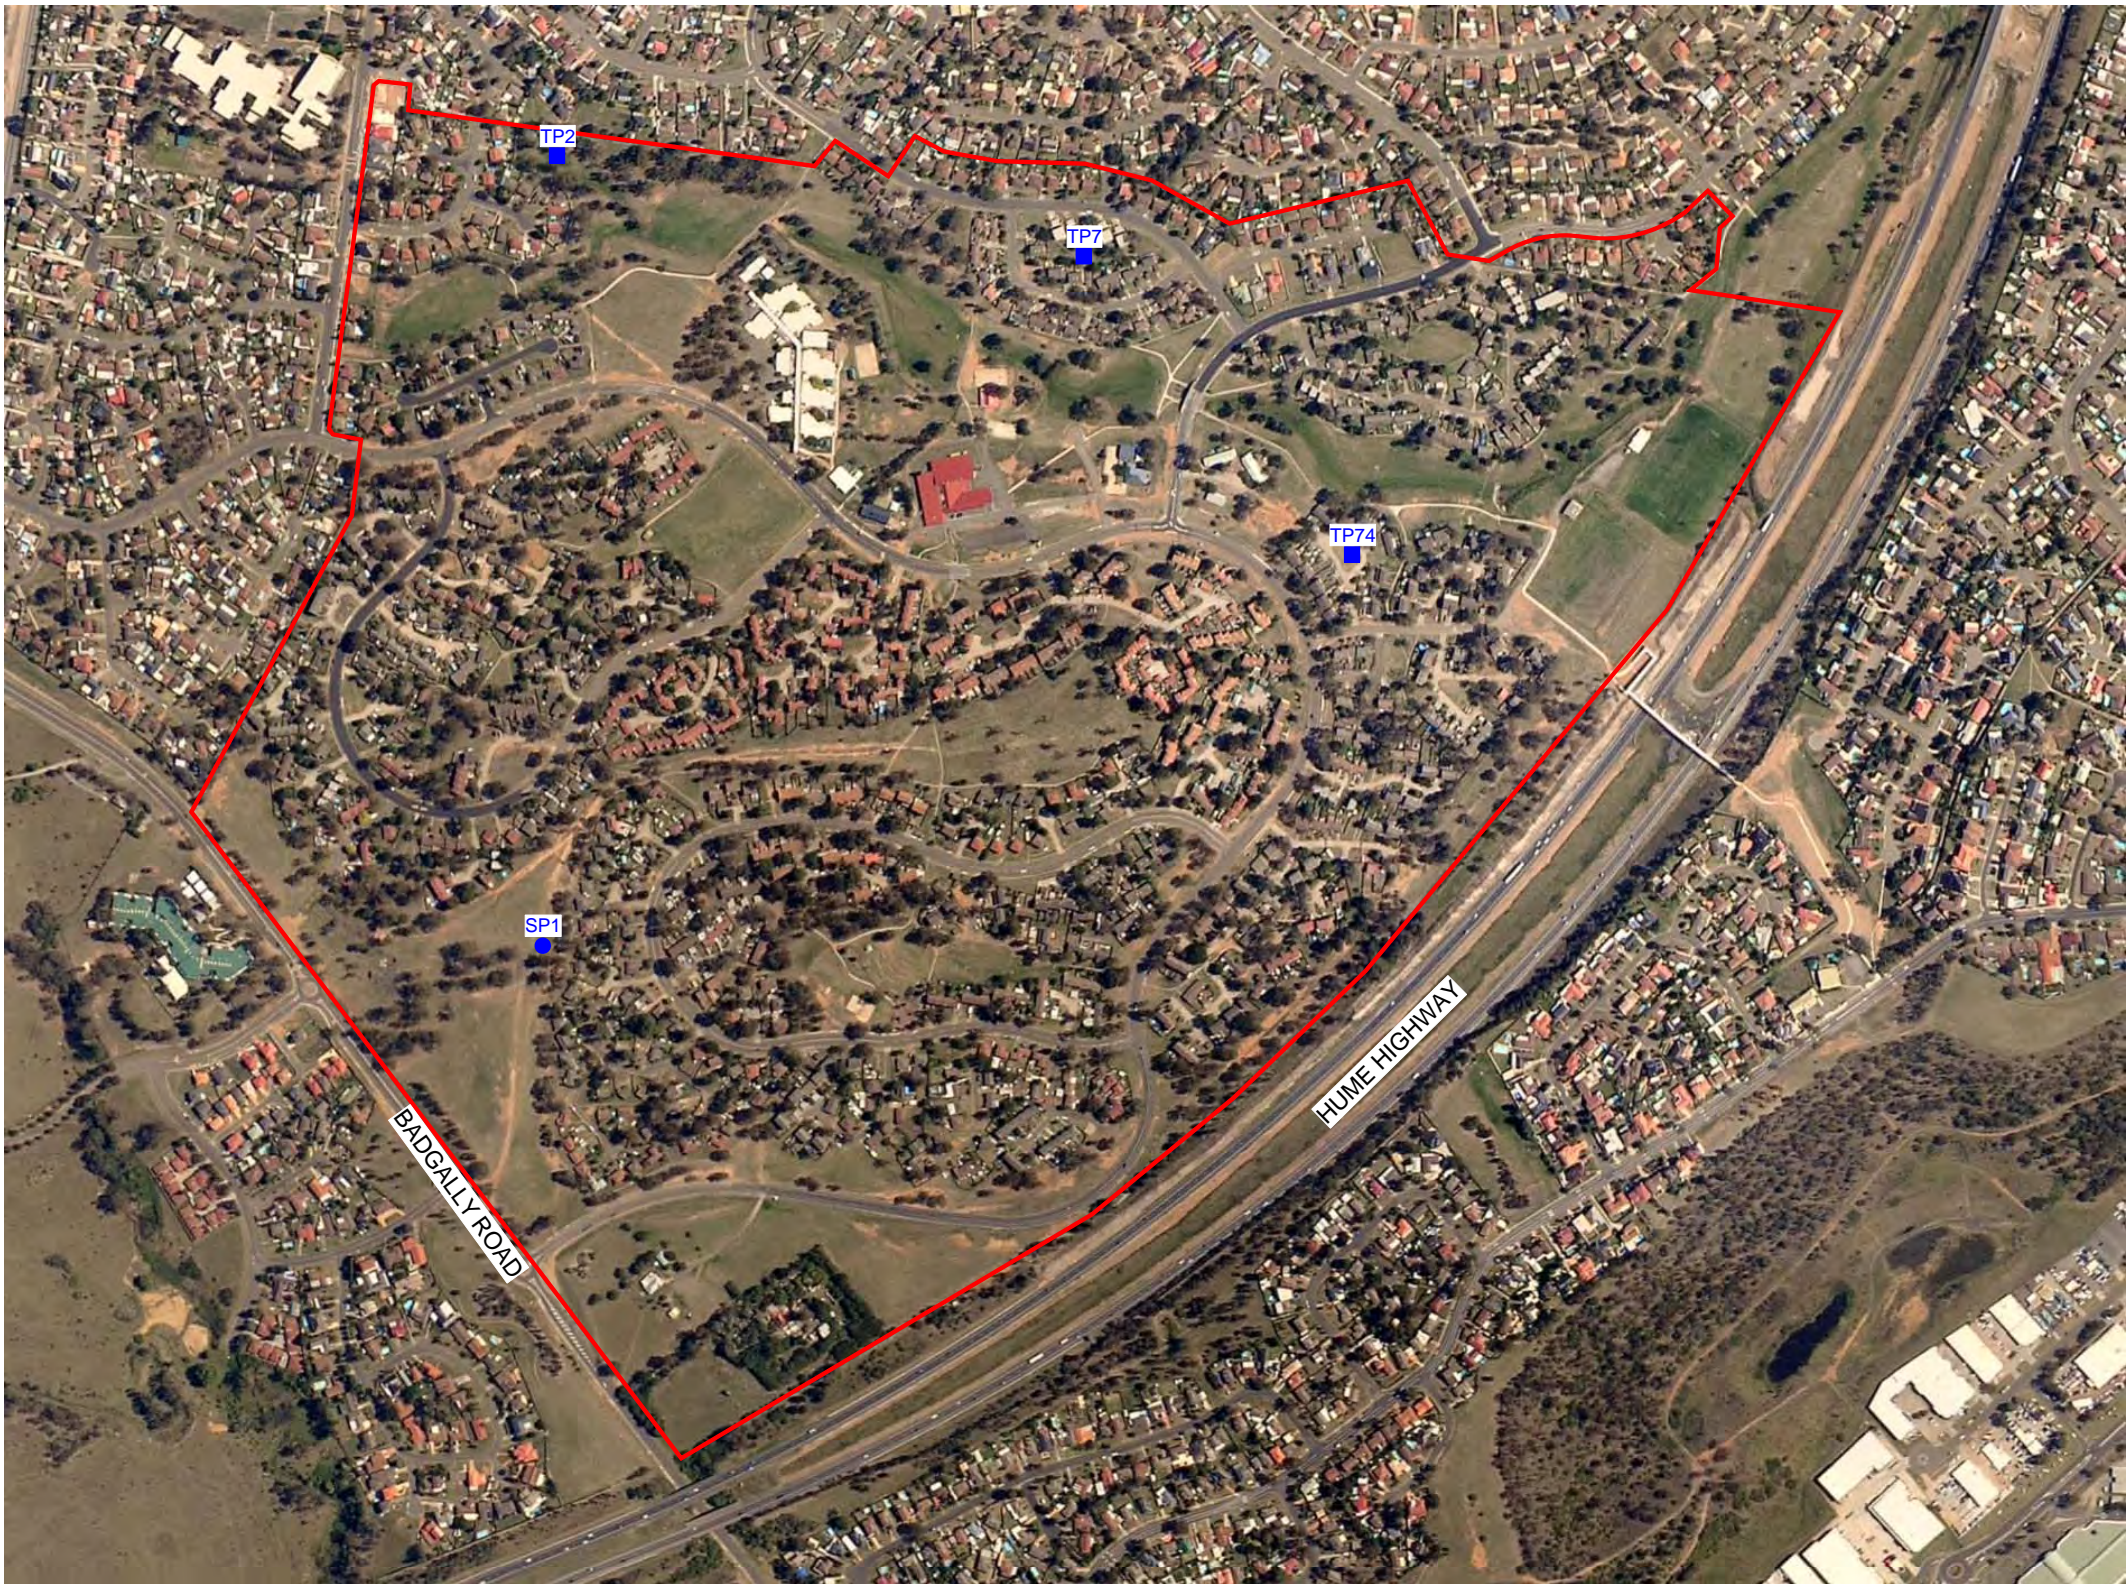
All chemical laboratory data and data sets, satisfied the criteria for stating that the analytes selected are either not present (i.e. at concentrations less than laboratory reporting limits), or present in the sampled soils at concentrations that do not pose a risk of hazard to human health or the environment, under a residential form of development, with the exception of topsoil sample TP7 (0-0.15m), which presents a risk of harm to human health due to elevated lead (Pb) concentration, and topsoil sample TP2 (0-0.15m) and soil stockpile sample SP1 (0-0.5m) which could potentially impact on the growth of certain plant species but would not present a risk of harm to human health due to elevated zinc (Zn) concentrations. The fibro-cement pieces encountered in the fill profile between 0.15m and 0.6m below ground level at test pit location TP74, contain Chrysotile Asbestos. These identified locations of concern are indicated and tabulated on Drawing No 12467/2-AA2 in Appendix 1.

Sample Location	Depth (m)	Contaminant / Concern	Concentration (mg/kg)	Level (mg/kg)	
				PPBIL	HIL 'A'
TP2	0-0.15	Zinc (Zn)	280	Zn = 200	Zn = 7000
TP7	0-0.15	Lead (Pb)	2400	Pb = 600	Pb = 300
TP74	0.15-0.6	Asbestos-cement pieces	NA		
SP1	0-0.5	Zn	280

- Following demolition and removal of houses, garages and clearing of roads, an inspection and/or sampling and testing of soils beneath the feature should be carried out by an Environmental Consultant. In the event that soil beneath the site feature(s) is contaminated, detailed sampling, testing and remediation will be required. Demolition and removal of the houses and garage should be carried out by appropriately licensed contractors. A hazardous materials survey and controlled removal process must be carried out/implemented by an occupational hygienist prior to commencement of demolition works. Any fibro structures might impact on surface soils if demolition is not carried out properly.

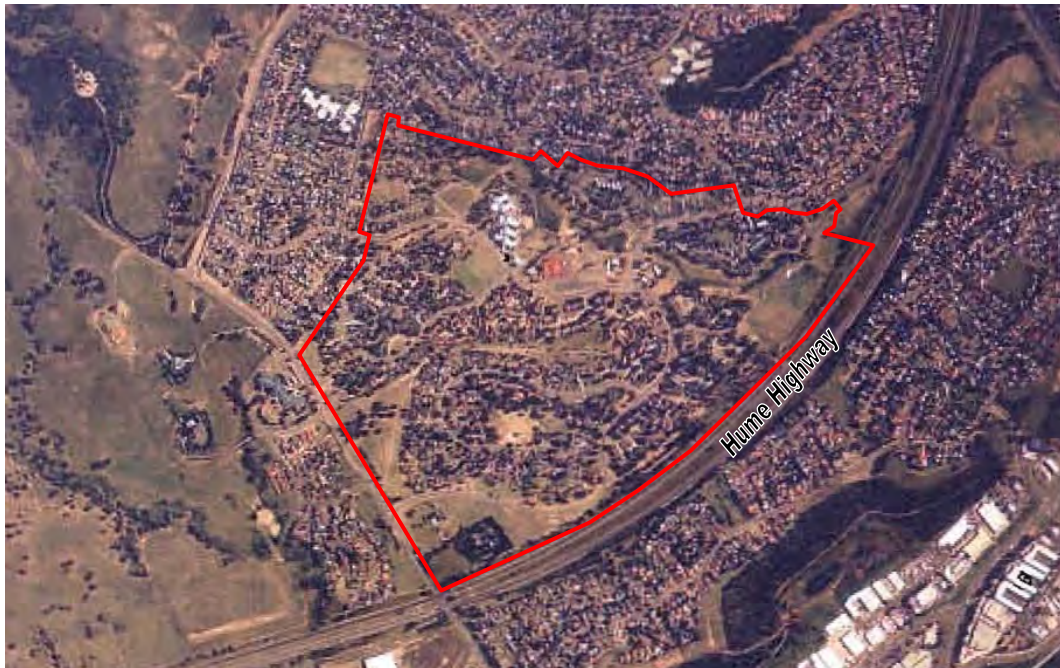
**2005**

Historical aerial photographs indicate that the site and adjoining properties were part of a large parcel of farmland until residential development in the late 1960s to early 1970s. The area remains essentially unchanged since then.

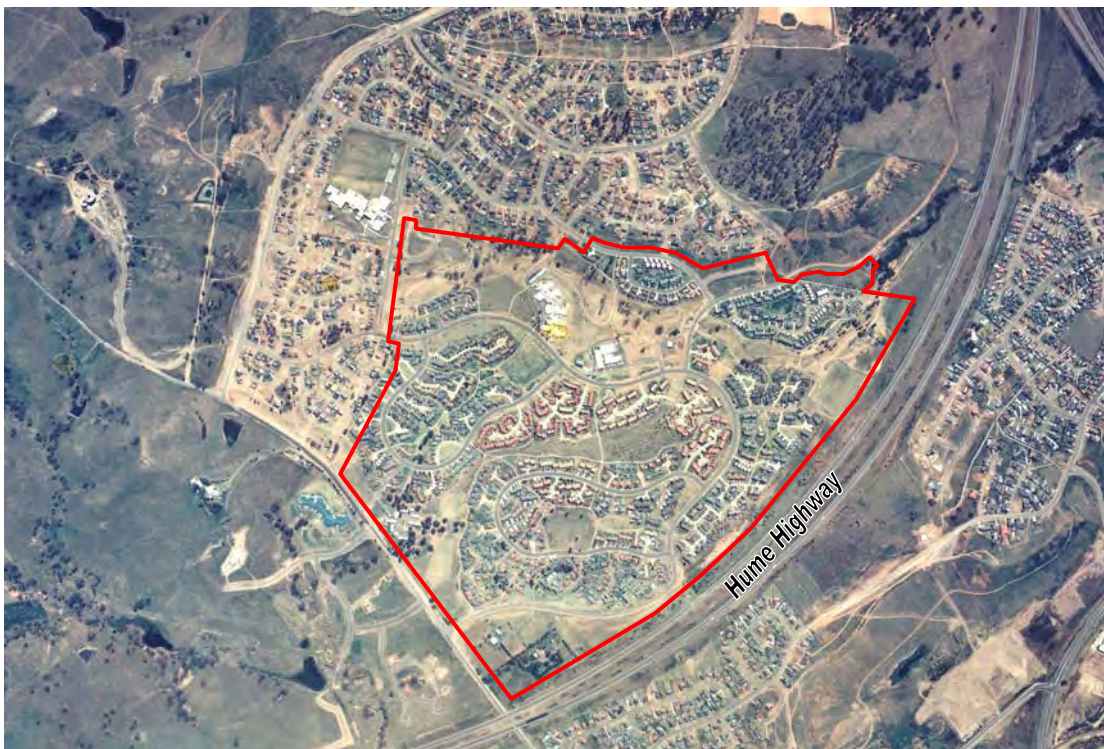
**1984**

- 1970** The conditions of the site and adjoining properties are very much the same as in the 1961 aerial photograph.
- 1984** The site has been developed into a new residential estate so as the adjoining northern, western and southern properties. Hume Highway borders the site to the east.
