### 6.3.12 Store

#### 6.3.12.1 Exterior

The Store comprises the older of the two handball courts built on the site, c.1908-9, with later alterations.

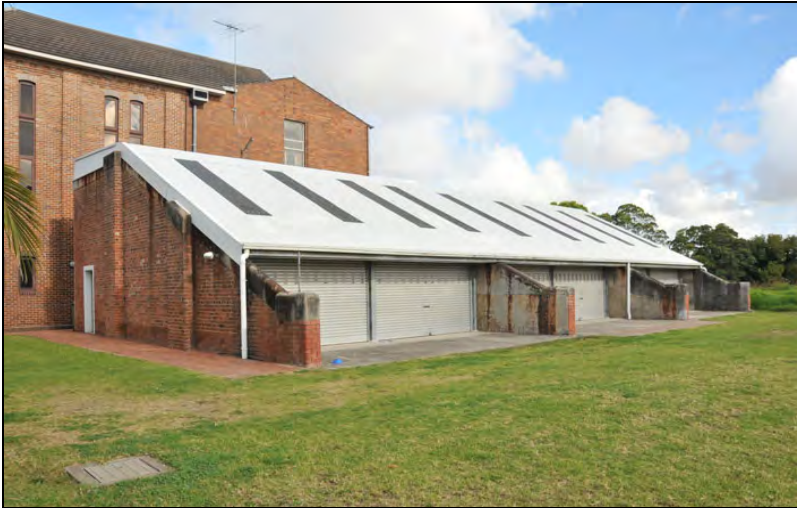
**Figure 240: Northern and eastern elevations. The walls of the individual courts, which extend beyond the roof area, are capped in concrete.**

The building is a single storey, free standing face brick building with a steeply sloping corrugated iron (or equivalent) roof with skylights. The eastern and western elevations are blind, within the exception of a door. The once open courts on the northern side have been enclosed with roller doors. There is a narrow, caged, skillion along part of the southern elevation. The brickwork has been painted within this skillion area. Refer to Figures 240 to 242.

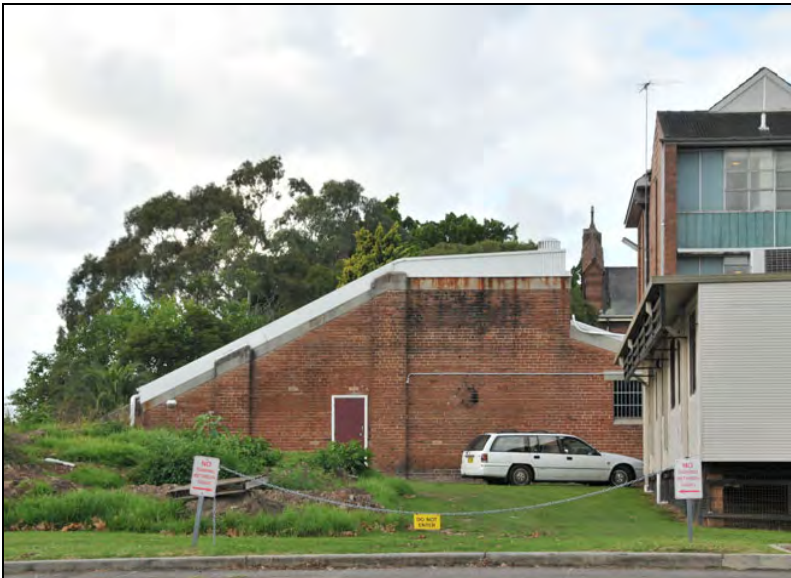
**Figure 241: Western elevation.**

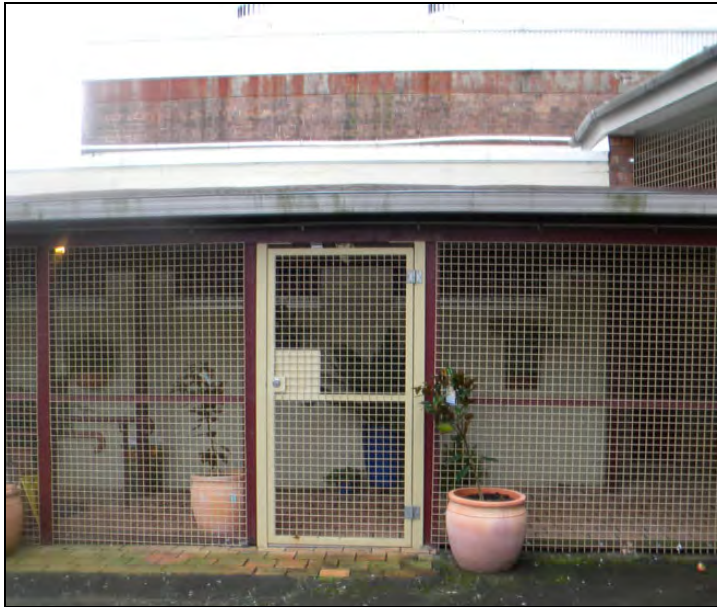
**Figure 242: Detail of the caging in of the southern elevation.**

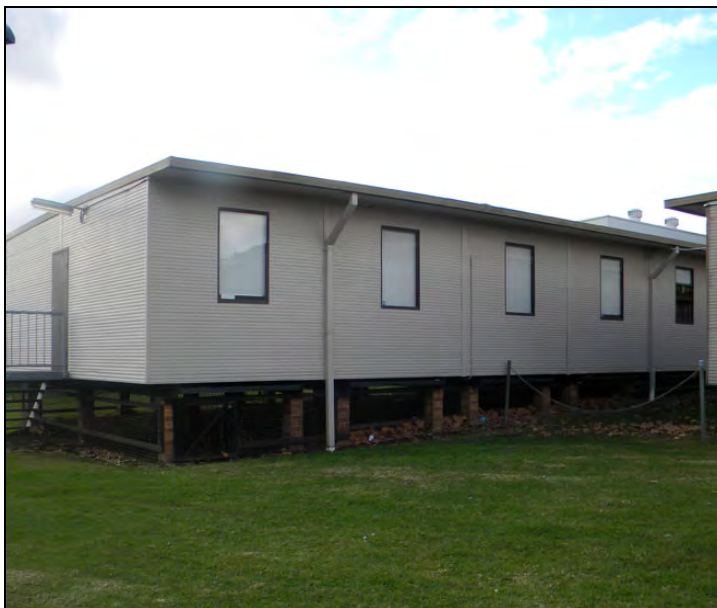
There are two, free standing, single storey demountable buildings with Colorbond (or equivalent) clad walls, aluminium framed windows and low pitched roofs. These buildings are mounted on brick piers behind the store building described above. Refer to Figure 243.

**Figure 243: One of two demountable buildings.**

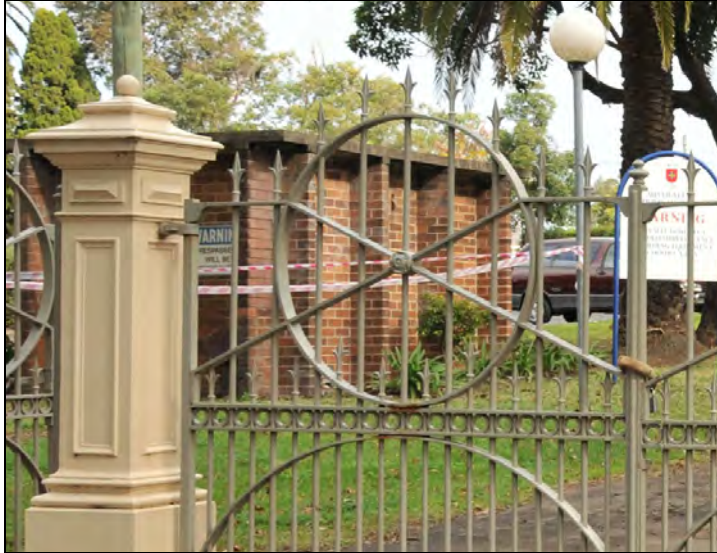
The plant building is a small freestanding single storey building. The walls are constructed of face brick with engaged piers, which support the overhang of the flat concrete roof. Refer to Figure 244.

**Figure 244: Looking towards the plant building from Albert Road.**

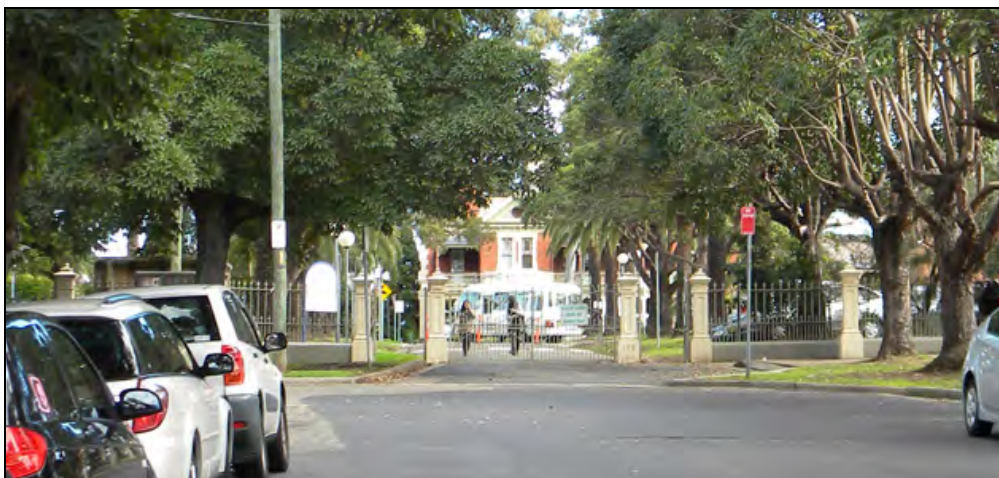
The gates are symmetrical in arrangement and comprise a central set of two wrought iron carriage gates, of a simple design, hung from rendered masonry piers. There are matching pedestrian gates hung from matching piers to either side of the main gates. The pedestrian gates are in turn flanked by a section of palisade fencing, mounted on a low, rendered curving wall, terminating in a matching rendered pillar. There are faint remnants of the name 'Mount Royal' visible in the render of the northern carriage gate post. Refer to Figures 245 and 246.

**Figure 245: Mount Royal Gates, off Albert Road.**

The gates have high significance under this criterion. It is noted, however, that they have been moved further away from the villa. Their linear relationship with the villa is, however, significant. While substantially intact, distinct cross pieces with lights, have been removed from the top of the pillars.

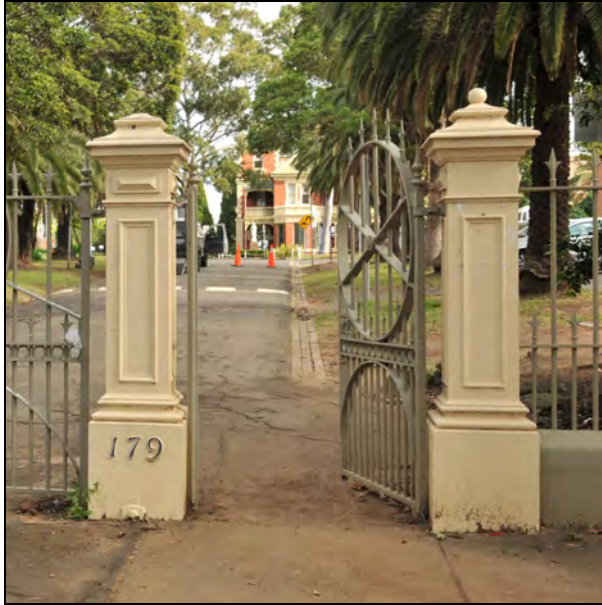
**Figure 246: Detail of the gate posts and gate pattern.**

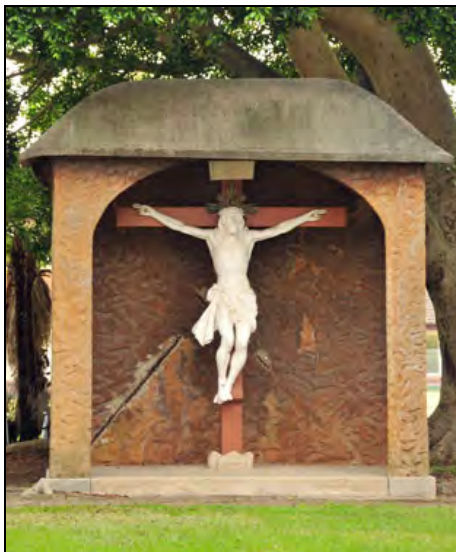
The *Limpas Crucifix* is a small, free standing, concrete structure, consisting of a masonry life size crucifix set within a cast concrete shelter. The walls are rough cast and painted to resemble stone; the roof is curved. A plaque on the side of the crucifix records the gift of the shrine in 1933. Refer to Figures 247 and 248.

**Figure 247: Limpas Crucifix.**

The *Limpas Crucifix* is substantially intact. It is, however, being de-stabilised by the nearby fig tree and some of the supporting metal rods are rusting through.

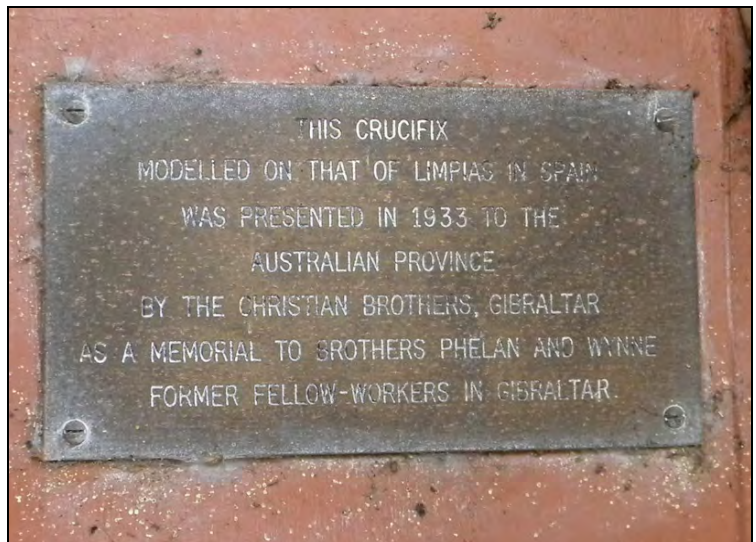
**Figure 248: Plaque attached to the crucifix.**

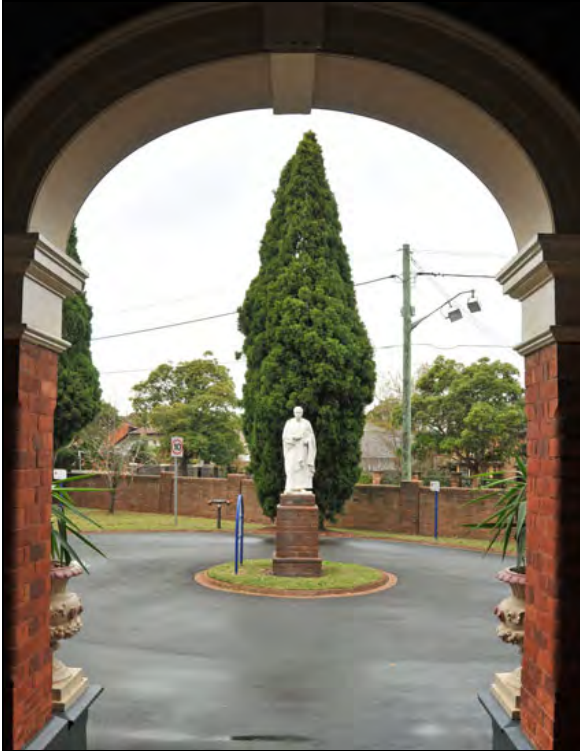
The statue of Edmund Rice is constructed of white painted masonry mounted on a face brick plinth. A plaque records the donation of the statue by the Late Hon. F. McDonnell, M.C.A. Brisbane. The date of this statue and when it was erected has not been determined; it does not appear to be present, at least in its current location, outside of the front entrance to the *Edmund Rice Building*, in the 1943 aerial photograph.

**Figure 249: Edmund Rice Statue.**

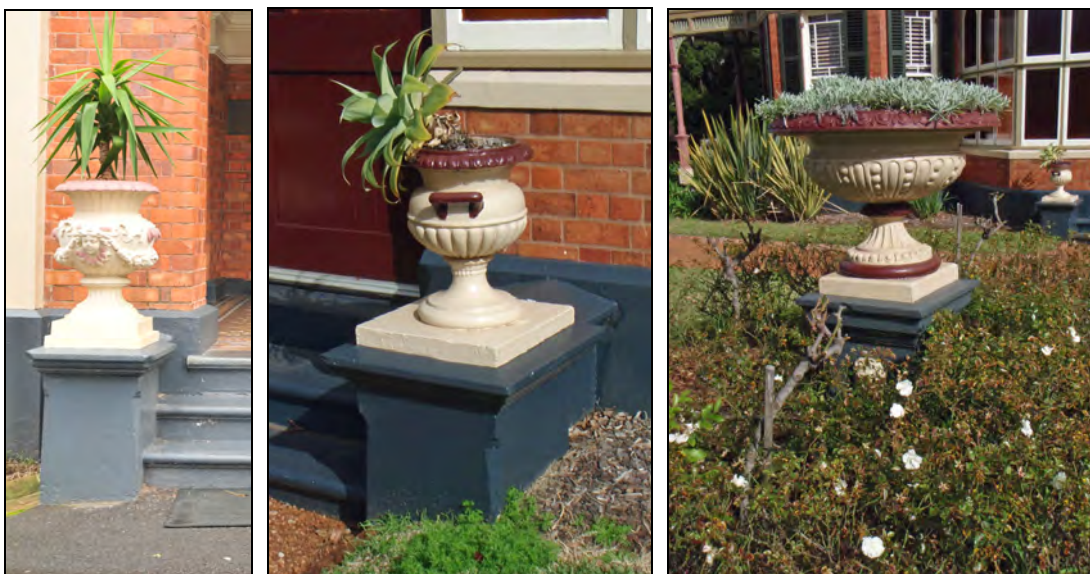
Two matching urns flank the main entrance stairs on the southern side of the villa. One of these urns is shown by Figure 253.

Two urns flank the entrance into the enclosed verandah on the eastern side of the villa. One of these urns is shown by Figure 254.

A large urn, shown by Figure 255, stands on a pedestal within the garden bed to the east of the main section of the villa. This urn and its pedestal appears to be that shown by the historic photograph, Figure 39, where they appear to form part of a fountain.

**Figure 253: One of two decorative urns that stand at the main entrance into the villa.**

**Figure 254: One of two urns that stand at the entrance into the enclosed eastern verandah.**

**Figure 255: Urn on decorative pedestal in the garden on the eastern side of the villa.**

Building/ Element	Level of Overall Significance	Remarks
	Urns near <i>Mount Royal</i>	B	Appear to be early site elements. Indicative of the Victorian period. The urn and pedestal in the garden to the east of Mount Royal appears to be part of an original fountain noted on plans predating the Brothers.
	Brick edging to Albert Road driveway	B	Possibly contemporary with <i>Mount Royal</i>
	Bunya Pines	B	Associated with now demolished Victorian villa. Evocative planting of the period.
	Avenue of trees, Palm trees and gum trees, lining the drive to Mount Royal	A	Date Palms are indicative of the plantings carried out by the Brothers. Gum trees are remnant street plantings, prior to the move of the gates. Avenue defines an important vista

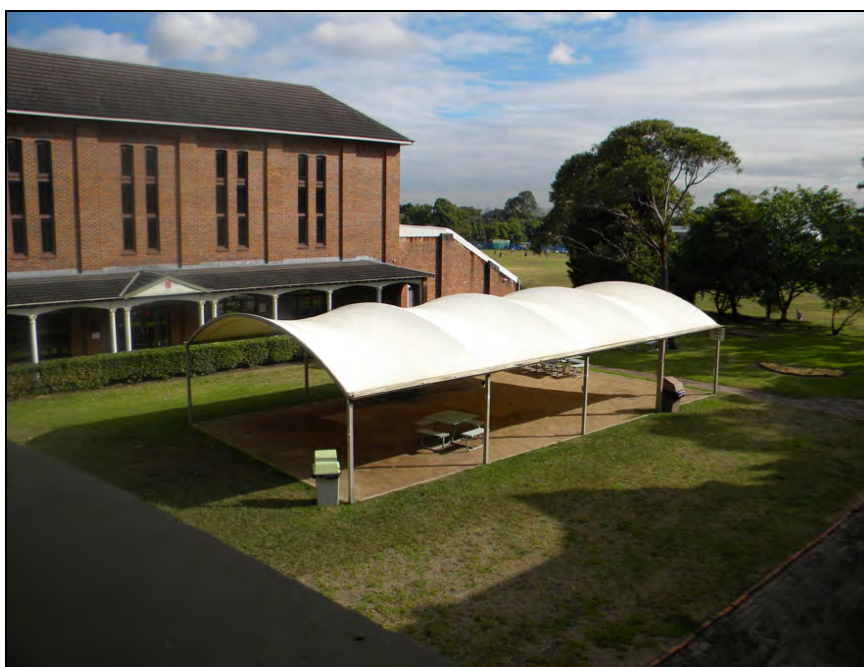
There is a modern, free-standing structure within the courtyard formed by the *Library*, the *Edmund Rice Building* and the *Barron Chapel*.

**Figure 256: Modern shelter.**

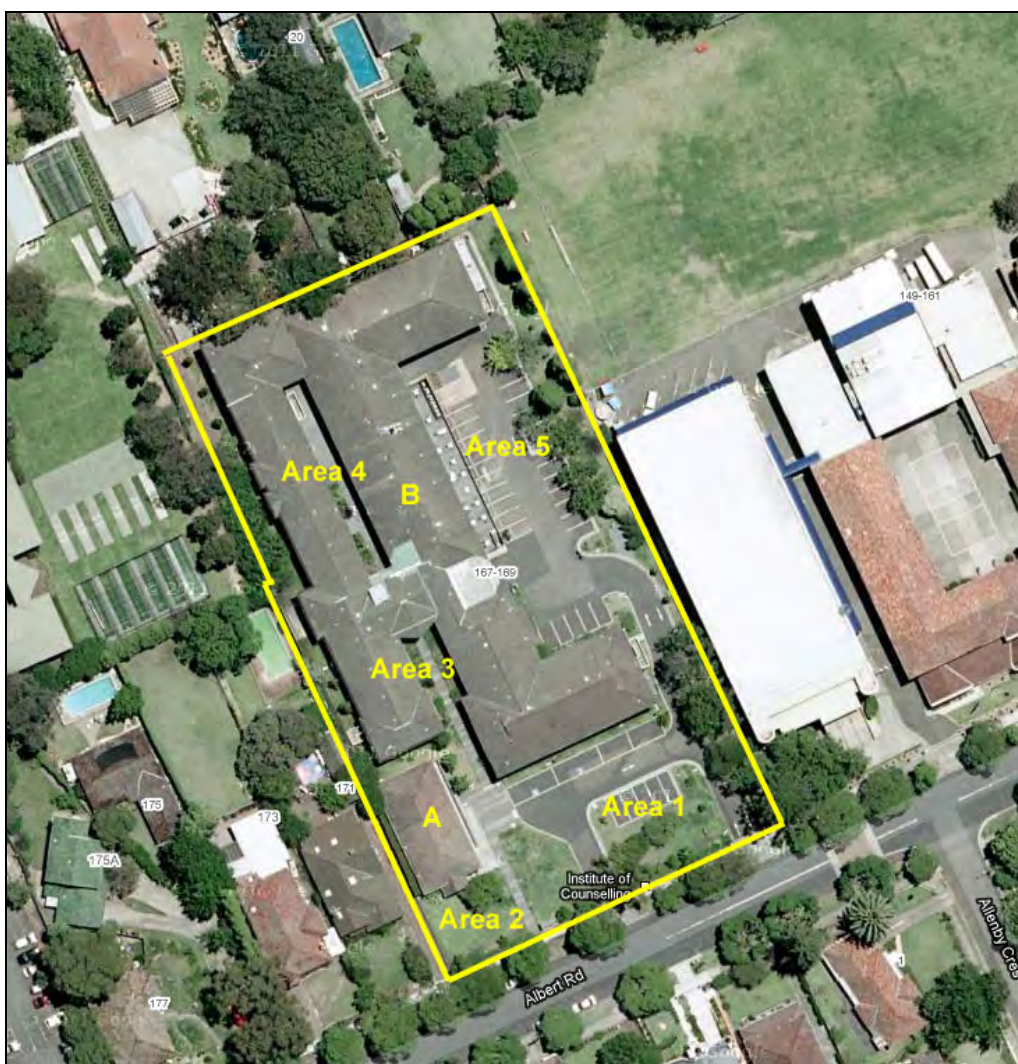
Building 'A' in Figure 269 is the Institute of Counselling and is described in Section 7.3 below.

Building 'B' in Figure 269 is the Edward Clancy Building and is described in Section 7.3 below.

**Figure 269: The Site**  
**Google Maps; annotations by A.F.**

As shown by aerial photograph Figure 269, there are two buildings on the site.

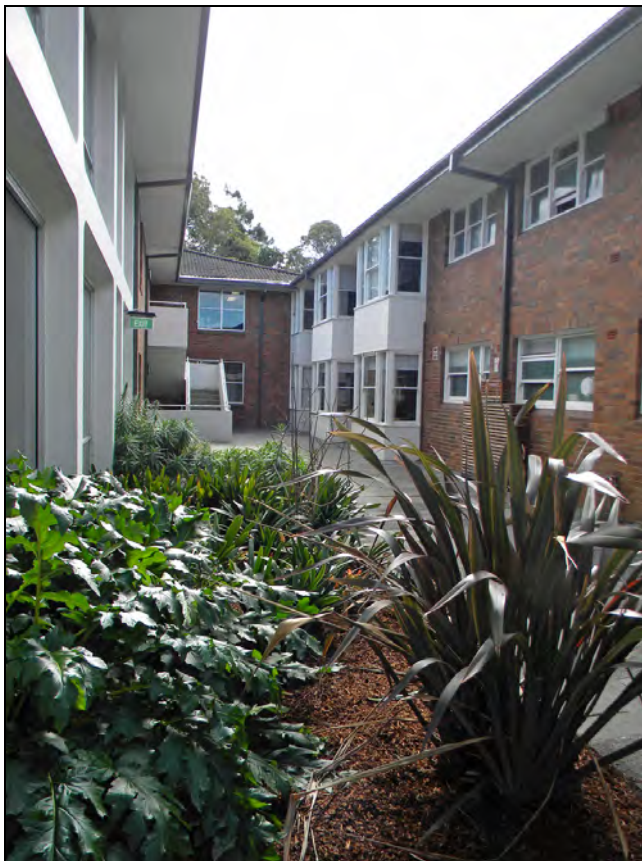
Area 4 is a long, narrow, internal courtyard within the *Edward Clancy Building*. The area is characterised by concrete paving and garden beds with low planting.

**Figure 273: Internal courtyard within the *Edward Clancy Building*.**

As shown by Figures 280 to 284 below and Figures 272 (main entrance) and 273 (internal courtyard) above, the elevations of this building share common characteristics. The straight line of the elevations is alleviated by projecting two storey bays with rendered and painted (or fibro clad and painted) walls and bands of aluminium framed windows. Elevations other than the southern elevation also have a number of timber framed, double hung windows.

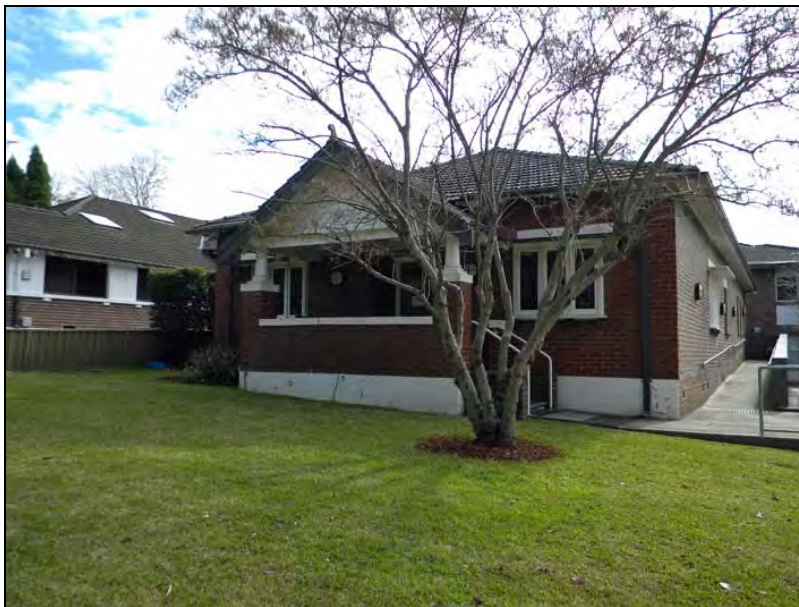
gable is finished with fibro sheeting (or equivalent) with mock timber battening; the gable apex has a terracotta finial. The porch has a solid brick balustrade with rendered cap. Brick piers rise at either end. These piers are topped with short rendered columns that support the porch roof. Stairs lead into the porch on the eastern side. The front entrance is recessed beneath the porch. There is a set of three timber framed casement windows (fitted with leadlight) to either side of the porch.

**Figure 276: Front (southern) elevation.**

The southern, front, elevation of this building demonstrates a high degree of integrity, with the exception of the replacement of the porch floor with pebble-crete. As for the Barron Chapel, grills have been removed from the narrow openings in the entrance porch. The main entrance doors remain, but are blocked off internally.

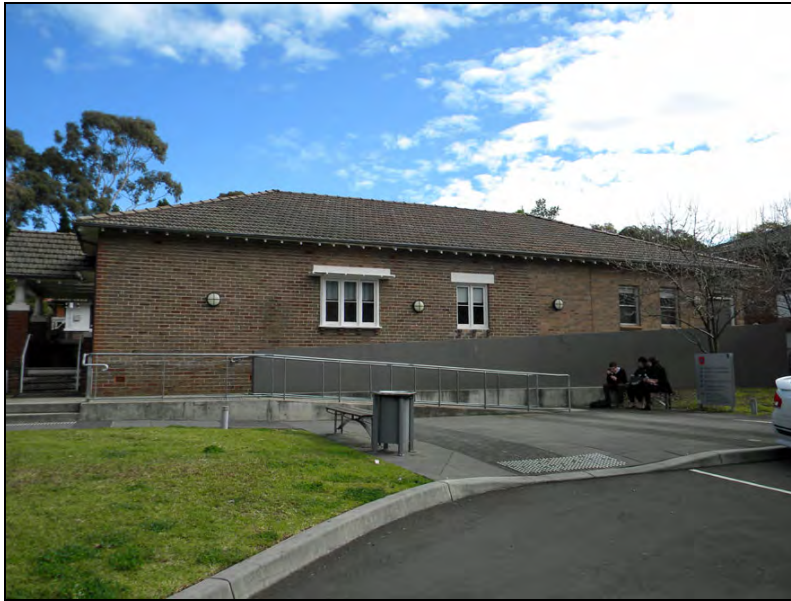
The northern part of this elevation is constructed of a different brick, indicating that it is a reconstructed wall or a later addition. There are two double hung windows with brick sills and a door in this part of the elevation. A rendered wall partially conceals the elevation.

**Figure 277: The eastern elevation**

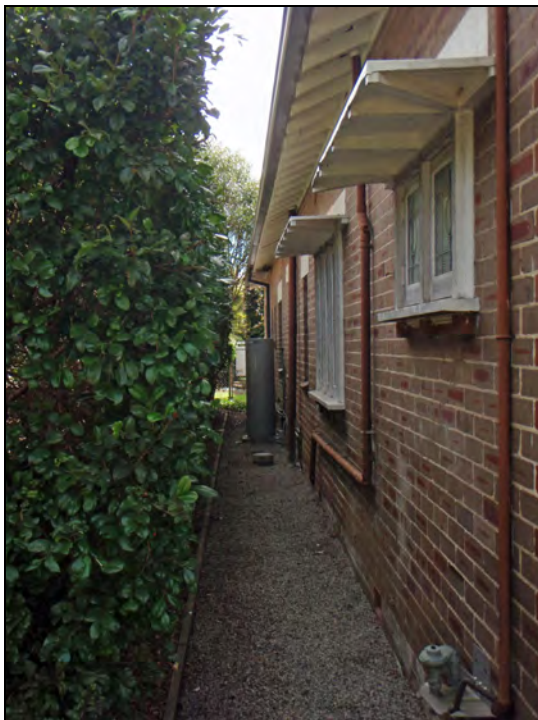
The western elevation is similarly constructed of common brick and has a combination of timber casement windows and timber framed double hung windows. The casement windows retain lead lighting, have rendered lintels, timber sunhoods and timber sills.

**Figure 278: The western elevation.**

The western and northern elevations are similarly intact, with the exception of the removal of a fire stair and its replacement with a window.

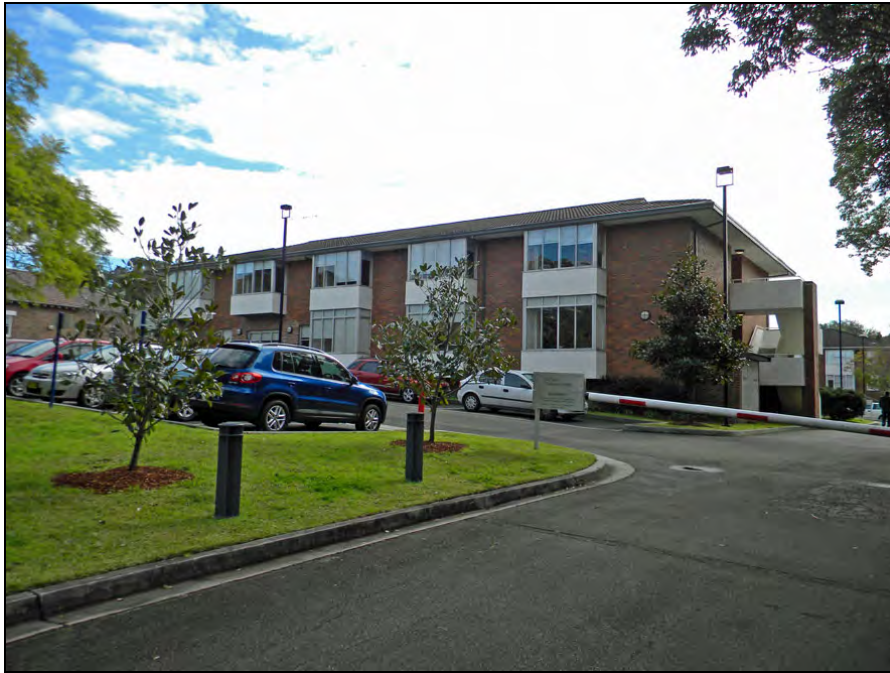
**Figure 280: South facing wall, addressing Albert Road.**

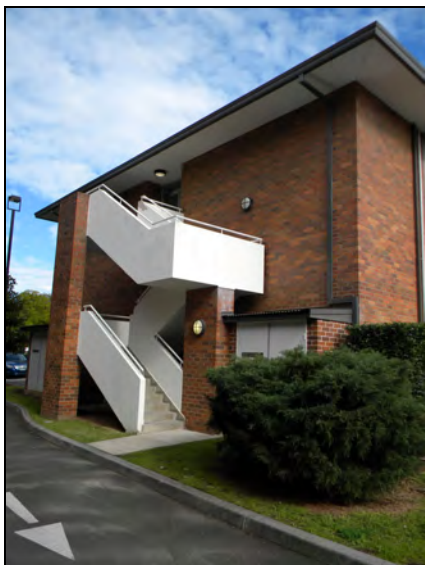
**Figure 281: East facing wall, showing typical fire stairs.**

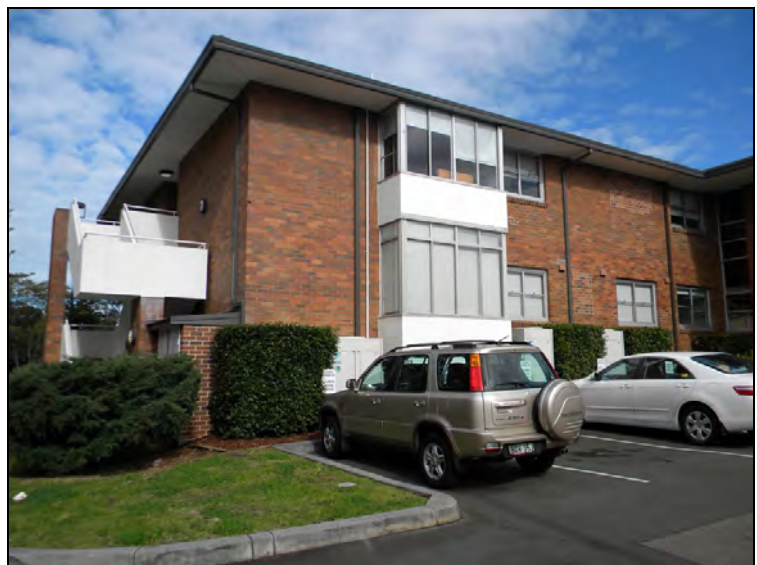
**Figure 282: North facing wall from Area 5. Note the patching the brickwork, indicating changes to openings.**

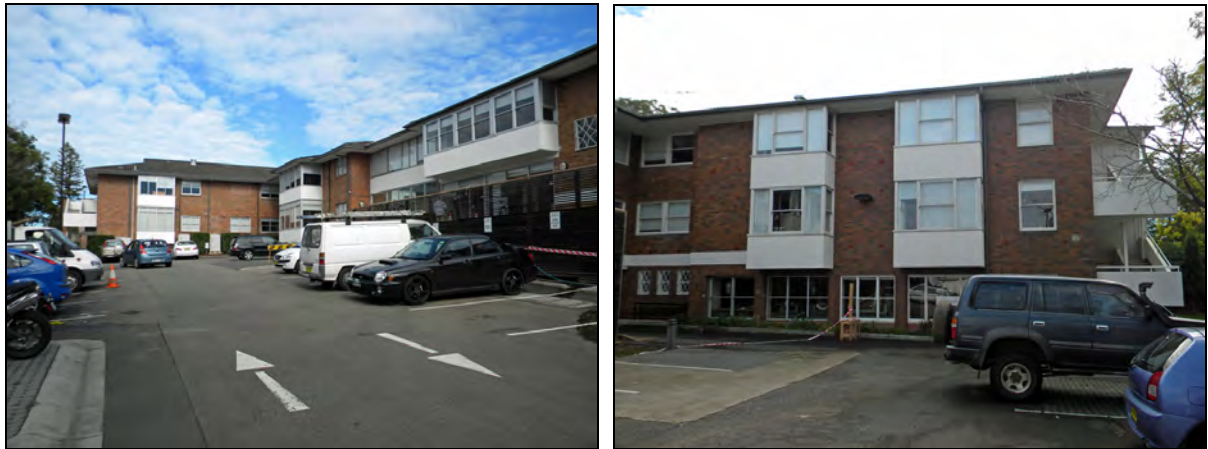
**Figure 283: Northern and Eastern facing walls from Area 5.**

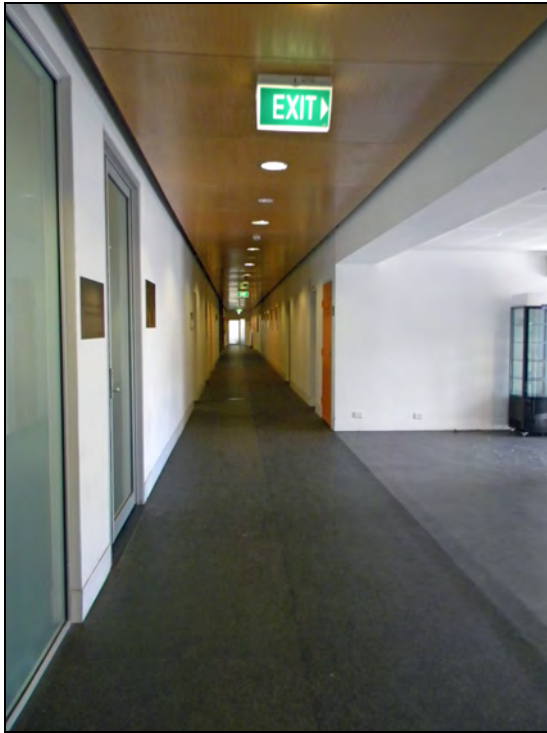
The interior of this building was not examined in detail. It is characterised by long hallways with rooms opening to either side. Finishes are stream lined and include, in hallways, drop down ceilings with shadow lines, metal framed glass doors, solid panel doors and shallow architraves.

**Figure 285: Typical hallway in the  
*Edward Clancy Building.***

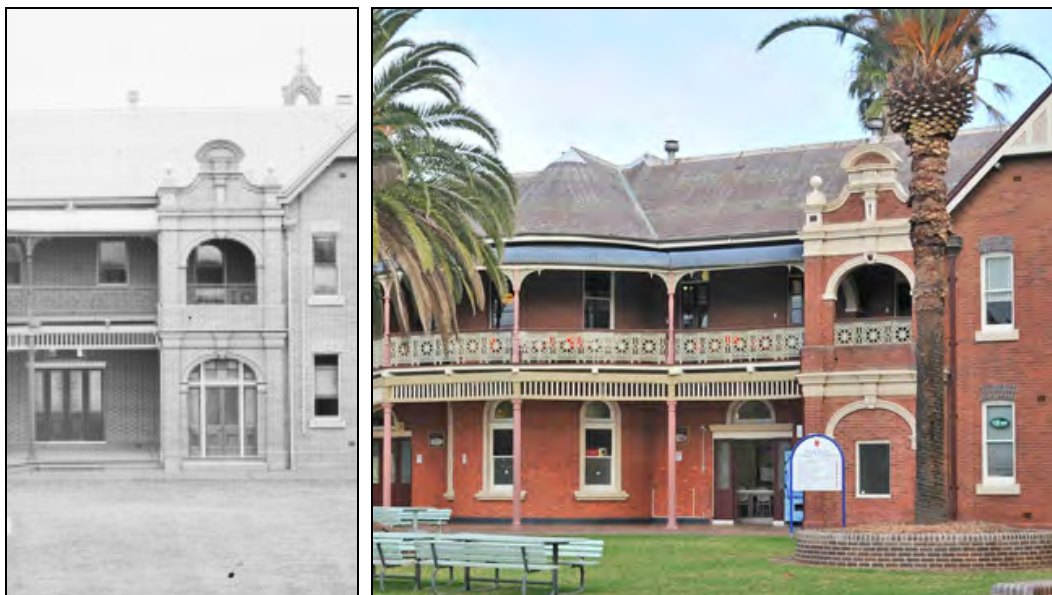
Figure 288 provides a second example of undocumented works. The timber door with side and fanlights shown beneath the tower element has been partially bricked up and a window inserted. The small windows at first floor level, beneath the verandah, have been replaced with larger openings with fanlights. Other, less significant alterations, include changes to window glass and the addition of security bars to some windows.

**Figure 288: Showing an earlier door with side and top light that has been partially bricked up and replaced with a window. The openings at first floor level, beneath the verandah, have been enlarged.**

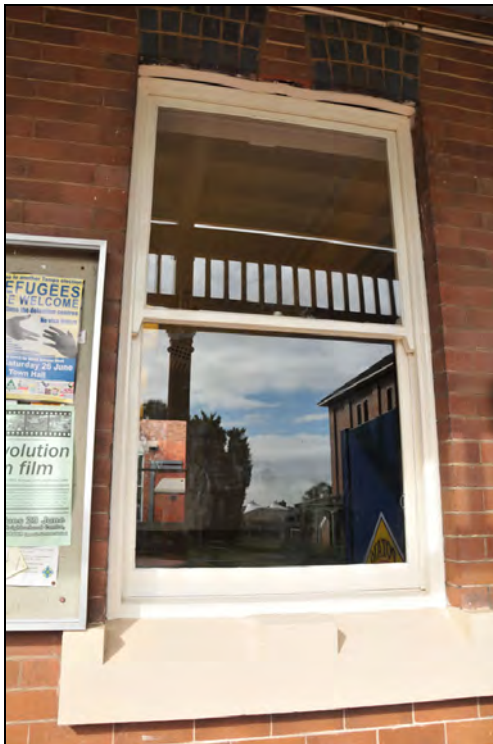
**Figure 289:**

The northern elevation of the 1908-9 addition is substantially intact, but shows some evidence of later alteration to the pattern of later openings. Physical evidence clearly shows that what were once pairs of narrow windows were later widened to become single, large windows (Figure 289).

**Evidence of the replacement of two narrow windows with a larger window provided by the two brick headers above the window and the division within the sill.**

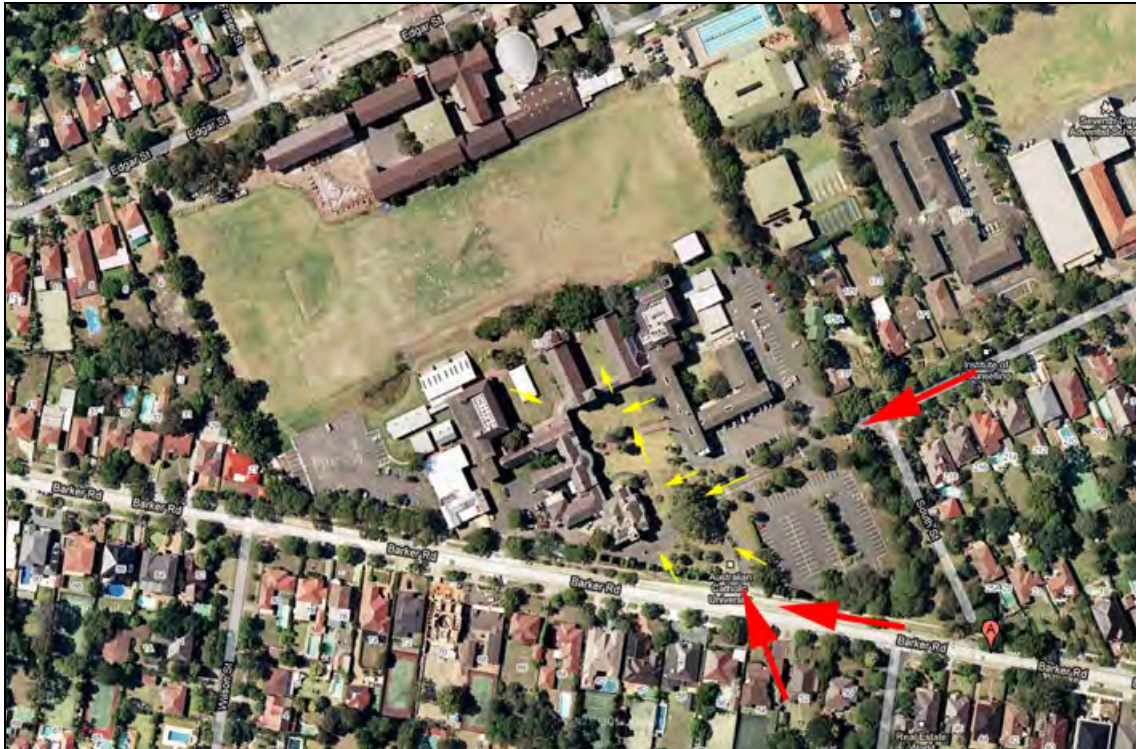
For the following, refer to the annotated aerial photograph, Figure 290. The most significant view corridors into the site from the public domain are identified by the red arrows. View corridors within the site are identified by the yellow arrows.

**Figure 290: View corridors into the site from the public domain (red) and within the site (yellow).**  
Google Maps; annotations by Weir Phillips

As demonstrated by the yellow arrows in Figure 290, there are many view corridors within the site.

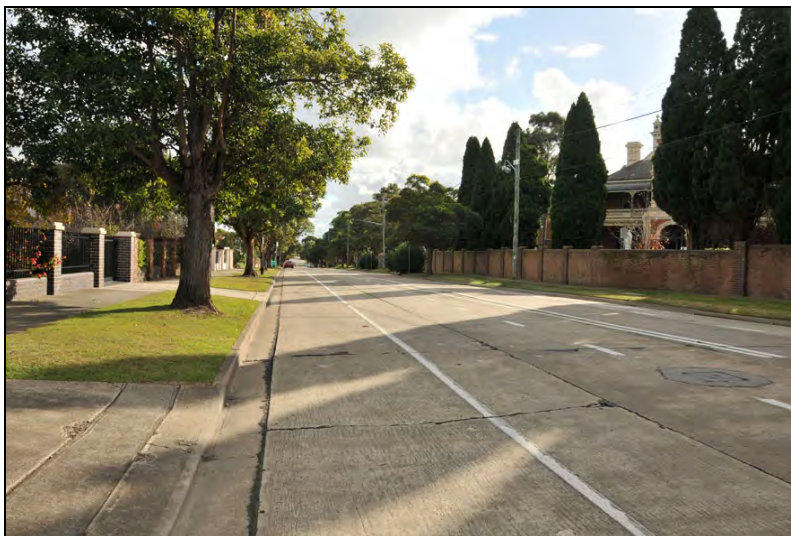
When close to the site, the upper half of the building is visible, but screened by the high brick wall and cypress hedge.

**Figure 292: Closer to the site, looking towards the Edmund Rice Building, showing how it is partially concealed by the high brick wall and Cypress Hedge.**

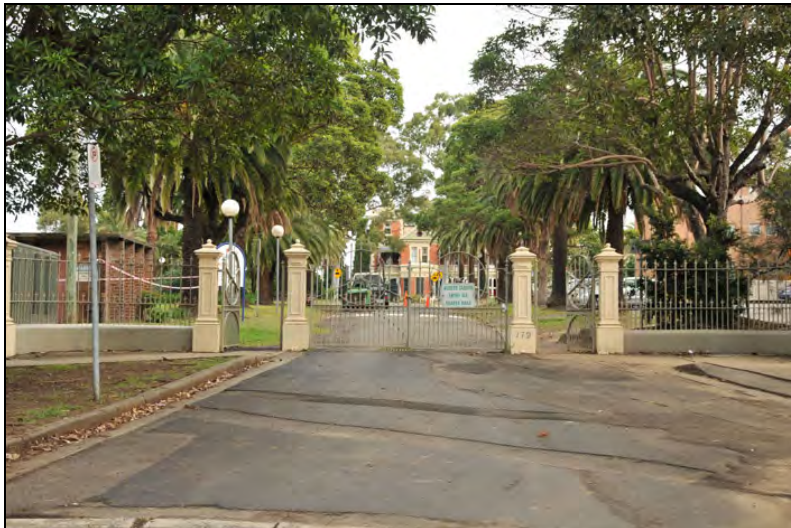
There is a significant view corridor into the site from Albert Road. This view corridor passes through the original *Mount Royal* gates and towards the *Edmund Rice Building*. This is the oldest, planned, view corridor into the site. Kent would have been aware when designing the villa that this view into the site terminated Albert Street, one of the most prestigious addresses in Strathfield. This view remains, although altered by the moving of the gates further to the east of their original position. The street planting in Albert Road and the trees lining the driveway frame the view.

**Figure 299: View into the site from outside the gates on Albert Road.**

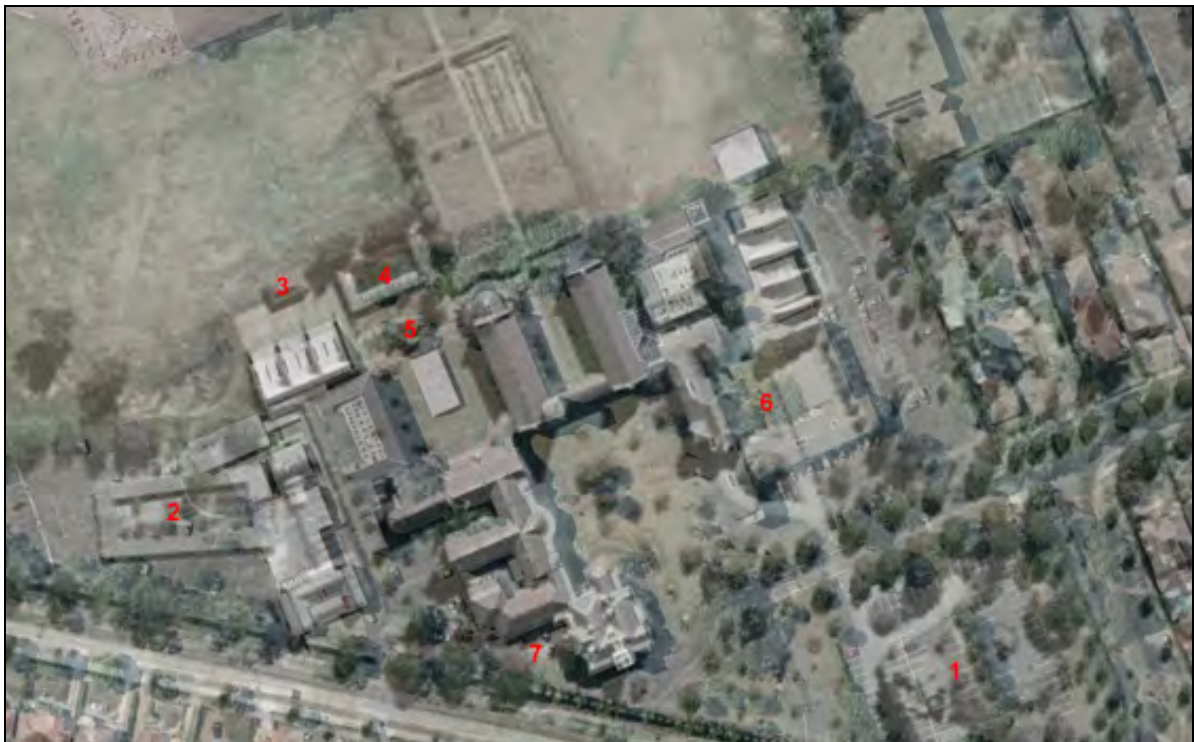
While not including an assessment of archaeological potential, the following observations can be made based on the known history of the site and the site survey. Figure 302 shows areas of potential archaeological remains. Note: this is a guide only. An assessment by an archaeologist may be required.

**Figure 302: Areas of Potential Archaeological Remains.**
