### **6.3.3 The Mullens Building**

#### **6.3.3.2 Interior**

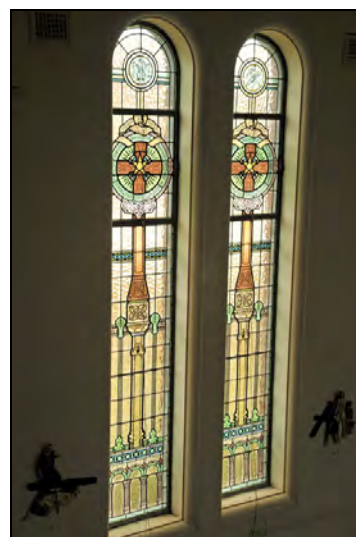
**Figure 184: Detail of the stained glass windows. The Celtic design commemorates the Irish origins of the Christian Brothers.**

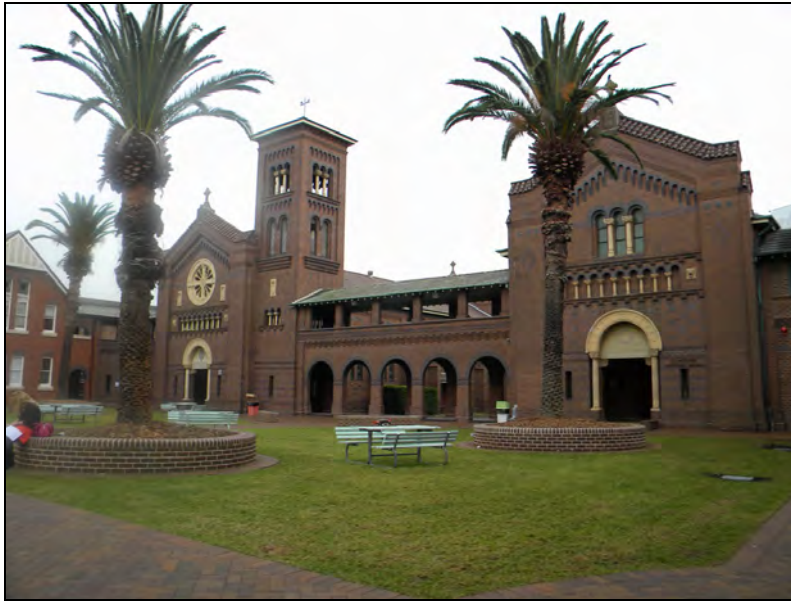
The principal elevation is the southern elevation, which rises into a gabled parapet capped with Cordova tiles and with a stone coloured terracotta finial in the form of a cross. The decorative brickwork to the top of the parapet matches that of the Chapel.

**Figure 185: Showing the southern elevation of the *Mullens Building* on the right hand side as complementary to the southern elevation of the Chapel on the left hand side.**

The following photographs, Figures 185 and 186, show the two tone brickwork and terracotta detailing of the southern elevation.

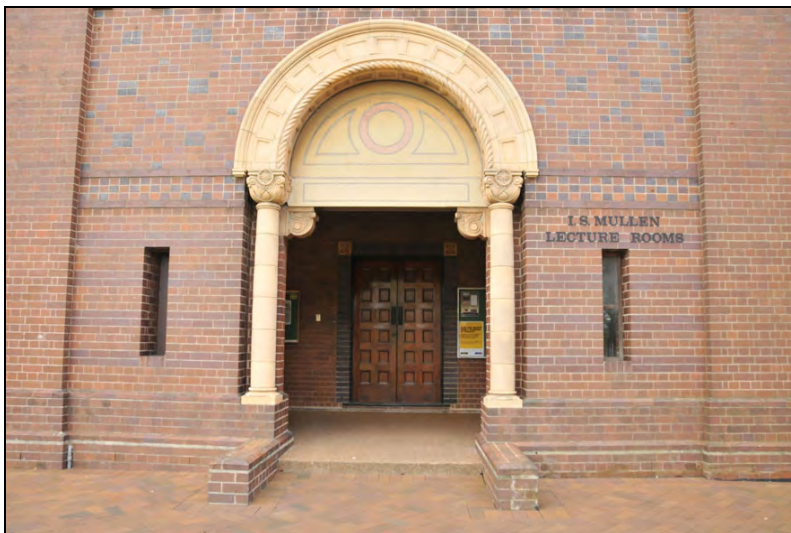
What was originally the main entrance into the building lies beneath a large stone coloured terracotta framed arch supported by pillars; the top of the arch is in filled with a terrazzo design. There is a row of small, blind brick arches with stone coloured terracotta columns above the arch. Two decorative terracotta plaques lie to either end of the row. Above this row, there is a set of three windows, separated by terracotta pillars.

**Figure 186: Detail of the terrazzo and terrazzo arch at the entrance to the *Mullens Building*. The porch floor is finished in pebble-crepe and the ceiling is timber lined.**

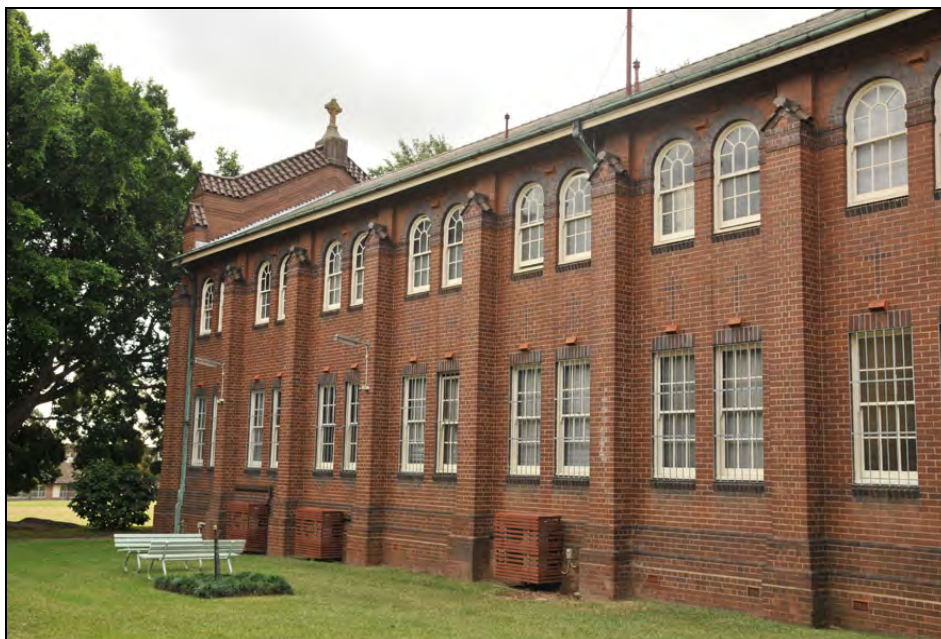
The western elevation is divided into eight bays by shallow engaged piers. This elevation is characterised by rows of timber framed, multi-paned, double hung sash windows, two to each bay at ground and first floor levels. The ground floor windows are rectangular with contrasting brick sills and headers above. The first floor windows are arched, with similar brick detailing.

**Figure 187: The western elevation of the Mullens Building.**

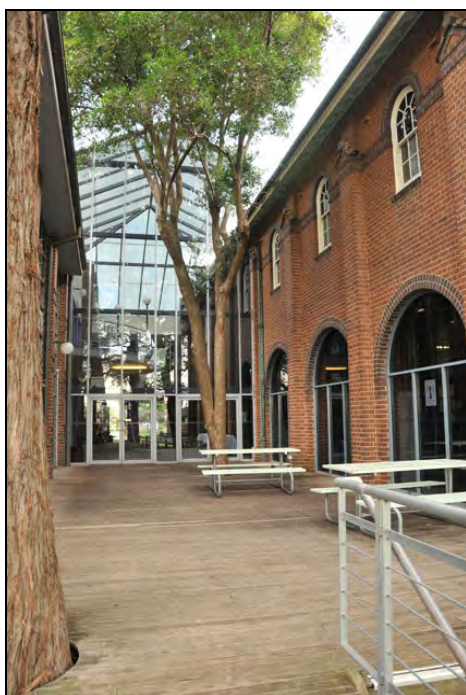
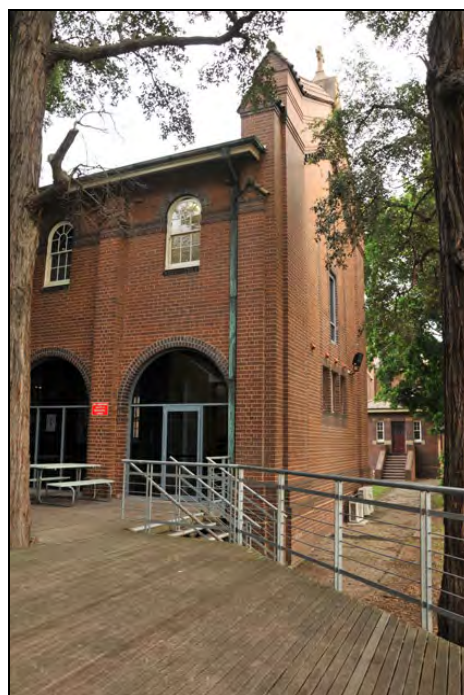
The eastern elevation is partially enclosed within a glass atrium, which connects the building to the *Gleeson Auditorium and Lecture Rooms* constructed in 1995. The eastern elevation is divided by engaged piers. The ground floor elevation is concealed beneath an arched brick colonnade, framed in contrasting bricks. Timber doors, of varying styles, and multi-pane windows open into the arcade. At first floor level, there are arched timber frame windows to match those at first floor level on the western elevation.

**Figures 188 and 189: The eastern elevation of the *Mullens Building*.**

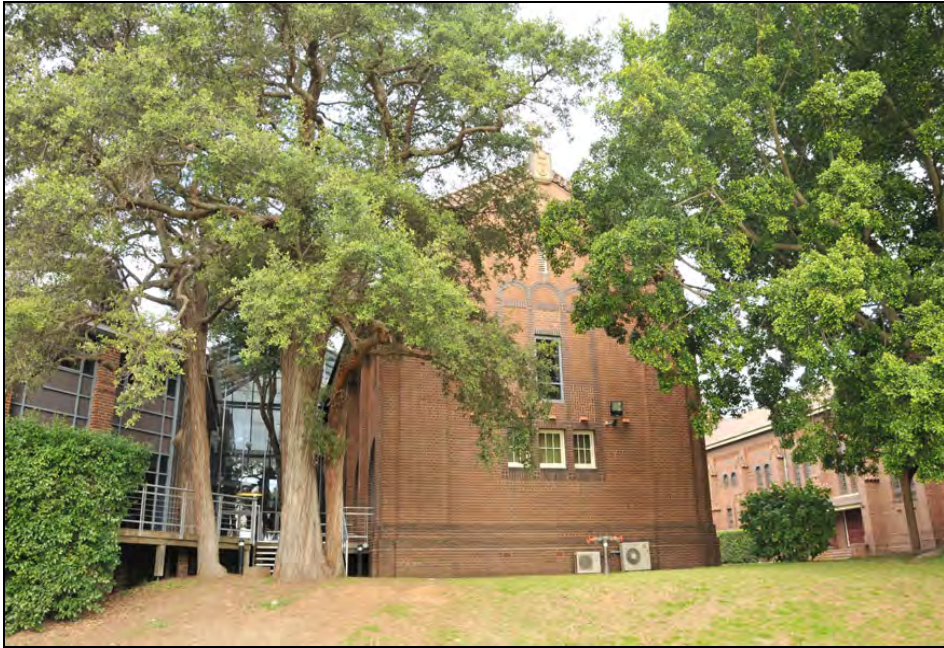
The northern elevation rises into a parapet to match the southern elevation. There are three small timber frame double hung sash windows at ground floor level and a narrow steel framed window to the stair well above. Visual relief within the brickwork is provided by the use of decorative brickwork around the windows framed by contrasting brick; the parapet is lined with Cordova tiles and there is a stone coloured terracotta finial in the form of a cross.

**Figure 190: Northern elevation of the Mullens Building.**

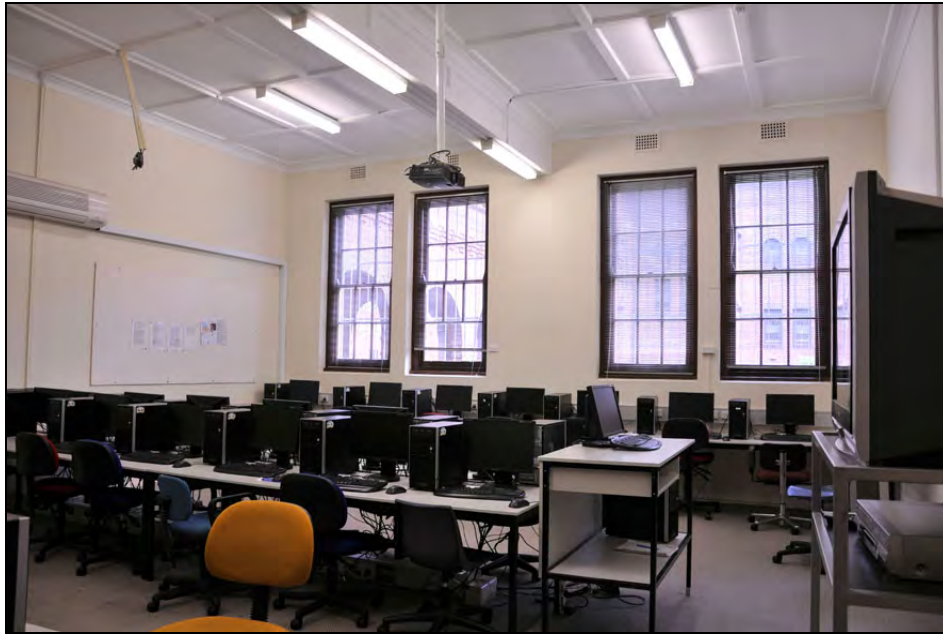
At ground floor level, there are three classrooms, now computer labs, with a timber stair (a recent addition) at the northern end. The rooms are characterised by dark, stained, timber framed windows on the western side. Some rooms have fibro lined ceilings with mock timber battens, while others have drop down panel ceilings that are later in date (Figure 191).

**Figure 191: Classroom, ground floor. This room has what appears to be an original mock timber battened ceiling.**

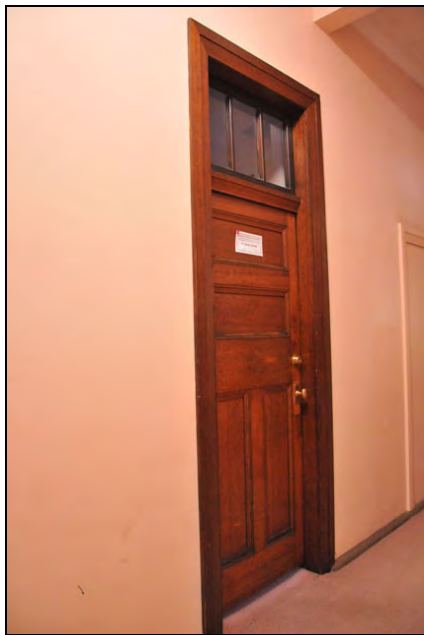
The first floor contains rooms off a central hallway. Figure 192 shows a typical panelled doors and segmented fanlights at this level. The interior of these rooms could not be inspected. Figure 193 shows the original wall tiling in one of the bathrooms on this level. The fittings in this bathroom are later in date.

**Figure 192: Door, first floor level.**

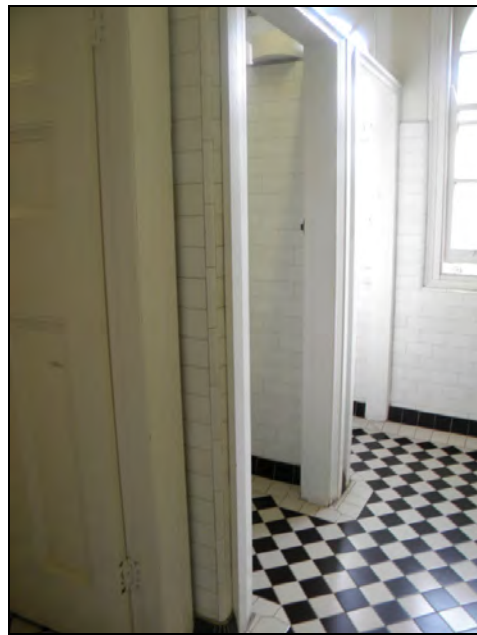
**Figure 193: Original wall tiling and partitioning in first floor bathroom. The floor tiles and fittings are later in date.**

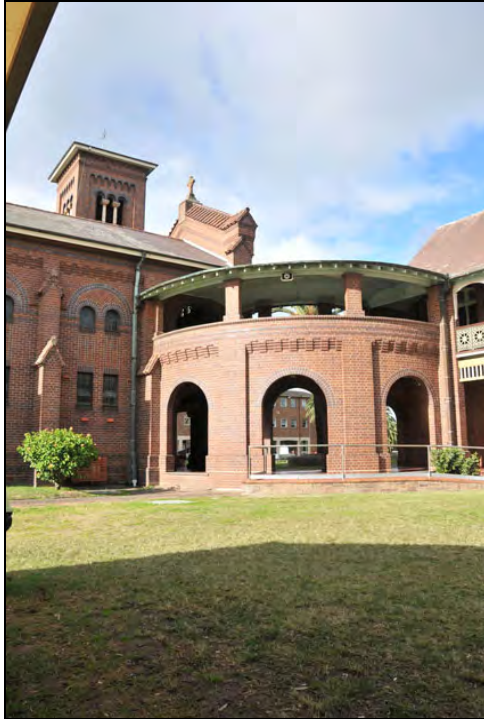
The brick arcades were designed to match the Romanesque Style of the *Barron Chapel* and the *Mullens Building* and are constructed of two-tone face brickwork. The ground floor is characterised by arches set within shallow engaged piers. The floor at this level is finished in small red tiles laid in a herringbone pattern with black within the borders; some areas of loss have been filled with red concrete. The underside of the roof is timber lined. The first floor level has a brick balustrade; ornamentation is achieved through the use of special bricks to the outside face of the balustrade. Brick piers support a pitched, slate clad, roof. The floor at this level is of timber and the underside of the roof is lined with timber with exposed rafters. The arcade curves outwards to the north as it connects the Chapel to the northern verandah of the *Edmund Rice Building*.

**Figure 194:** The arcade as it curves towards the north to link the *Chapel* with the *Edmund Rice Building*.

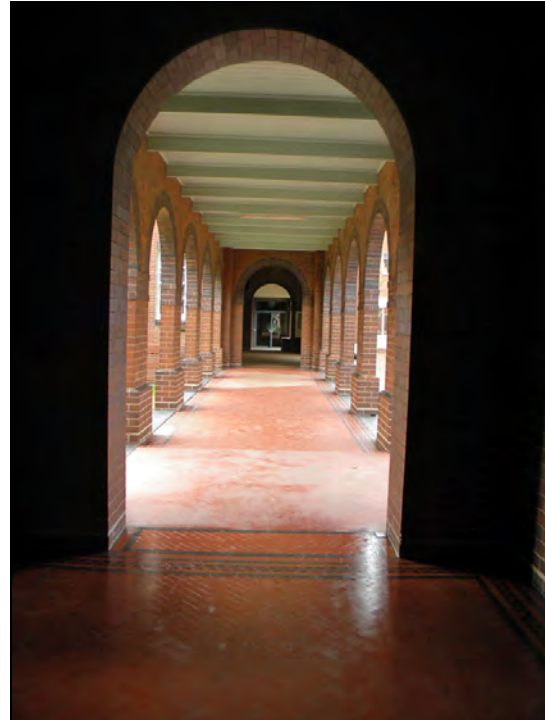
**Figure 195:** Ground floor, looking east, showing the tiling to the floor and timber lined ceiling.

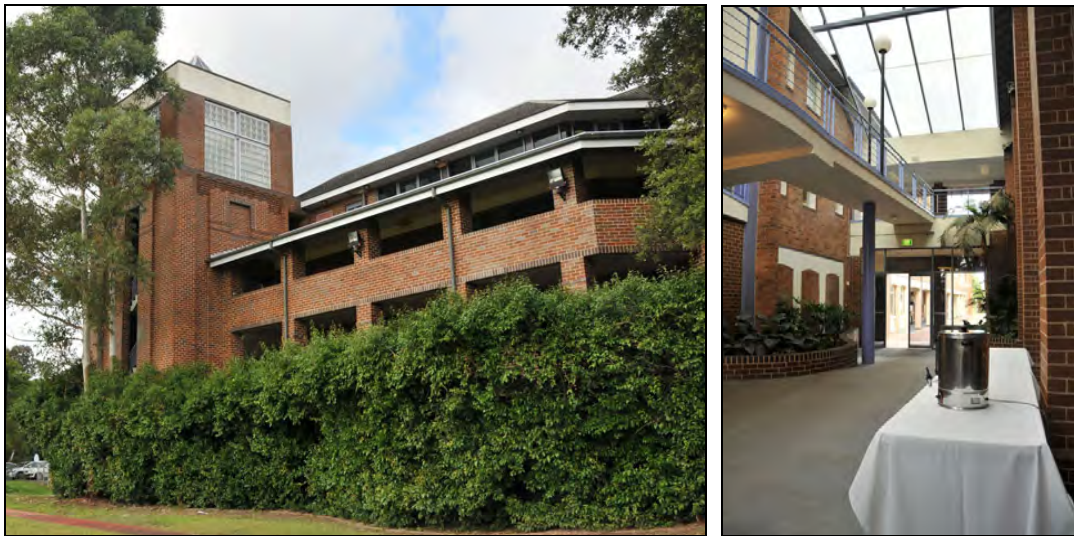
The building is a two and three storey building attached by means of a two storey height steel framed, glass atrium, to the eastern side of the *Mullens Building*. A two storey brick arcade, with pitched roof, at the southern end of the building conceals the majority of the glass roof from the courtyard. The building has face brick walls, with simple two tone brickwork and includes open brick verandahs to the northern and eastern sides and a tower element in the north eastern corner.

**Figure 197: Looking towards the north eastern corner of the *Gleeson Auditorium*.**

**Figure 198: Atrium between the *Mullens Building* and the *Gleeson Auditorium*.**

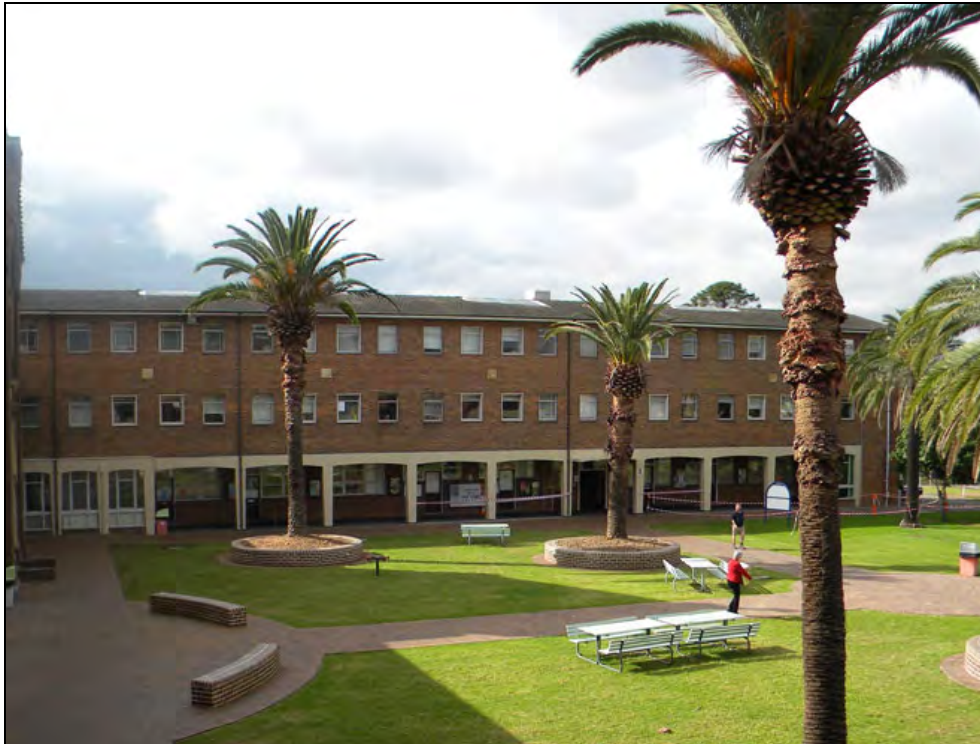
The west wing is a three storey face brick building with a rendered arcade at ground floor level along the western elevation and regularly spaced square aluminium framed windows to the floors above.

**Figure 199: The western elevation of the western wing of *St. Edmunds Building*.**

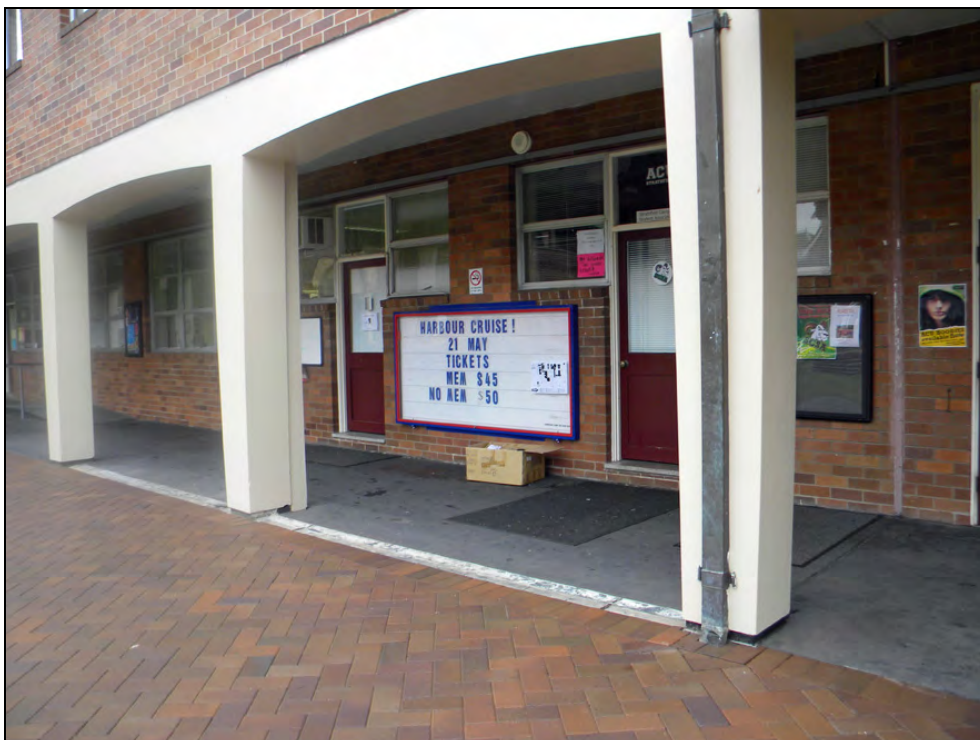
**Figure 200: Detail of the western elevation, showing timber doors with aluminium framed windows.**

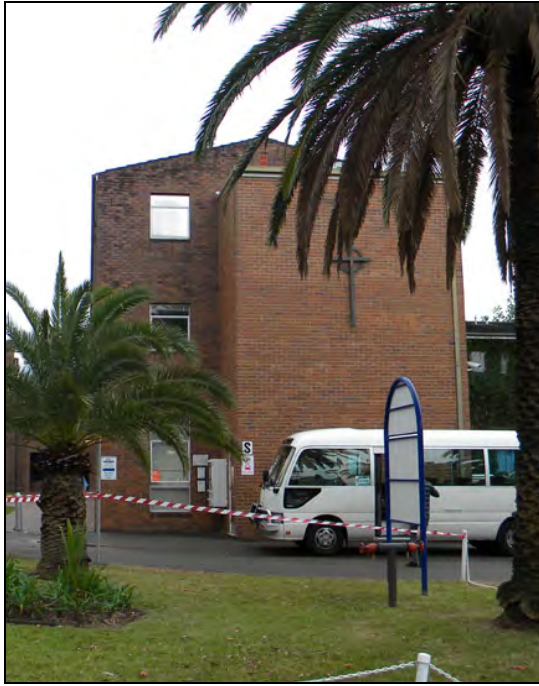
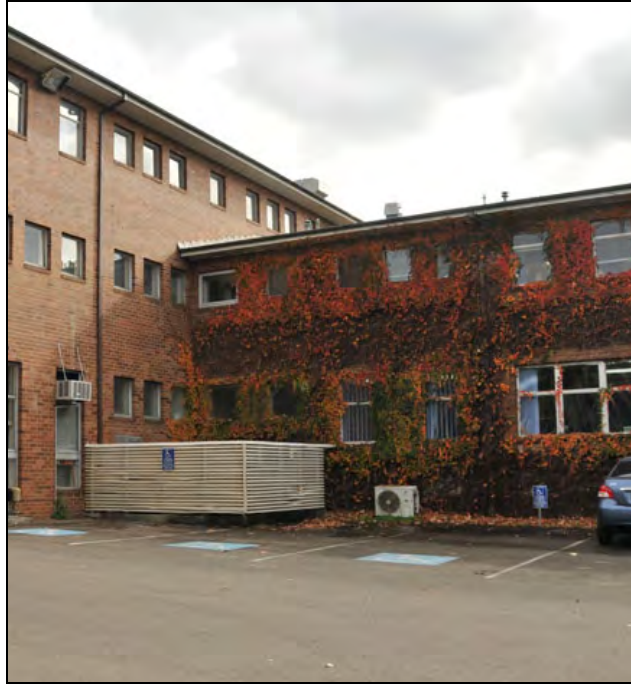
The southern elevation rises into a gabled parapet. Three aluminium framed windows run down one side of this elevation. A blind projecting brick bay occupies the other side; a large crucifix is fixed to the southern wall of this bay.

The eastern elevation of this wing is similarly detailed. There is a projecting bay attached to the southern end of this elevation. A shallow, part brick, part fibro and part aluminium framed glass bay projects outwards at ground and first floor levels. The uppermost floor is finished in fibro panelling with aluminium framed windows.

**Figures 201 and 202: The southern and eastern elevations of the western wing.**

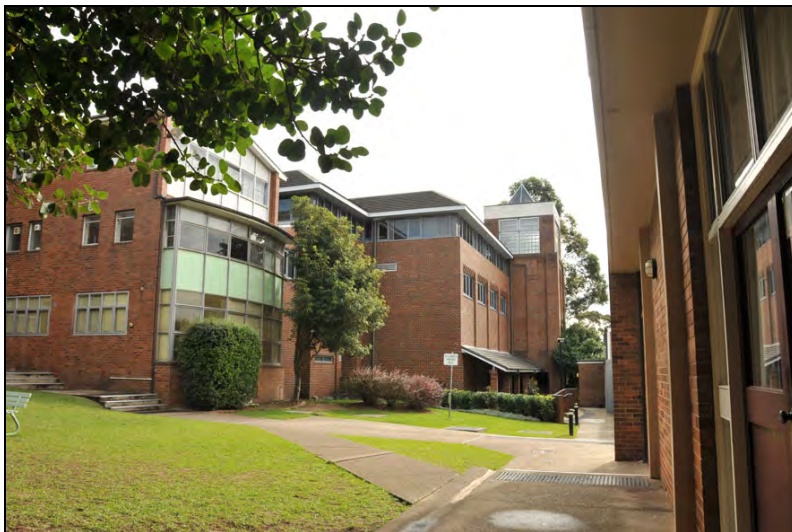
**Figure 203: Projection off the eastern elevation of the western wing.**

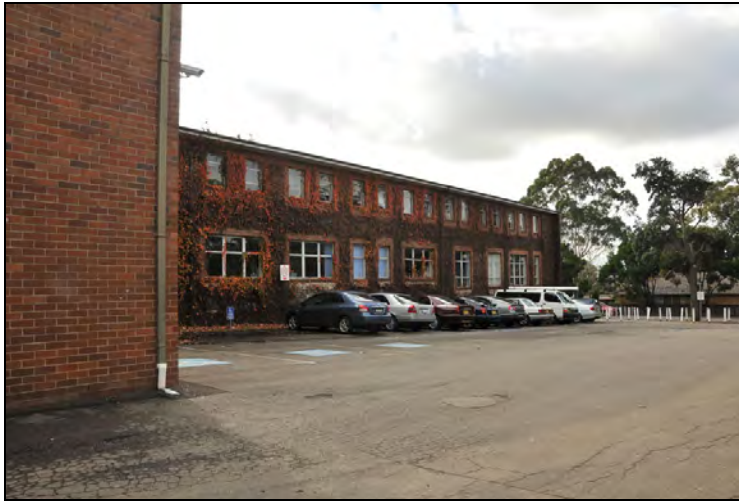
**Figure 204:**  
Southern elevation  
of the southern  
wing.

A two storey wing, referred to as the southern wing for the purposes of this report, runs at right angles from the southern end of the western wing. The elevations of this wing comprise face brick walls (matching the western wing) with rows of aluminium framed windows at ground and first floor levels. The brickwork is alleviated by rectangular panels of painted render beneath the windows. A covered walkway, supported on thin metal poles, runs along the northern elevation, opening into the internal courtyard.

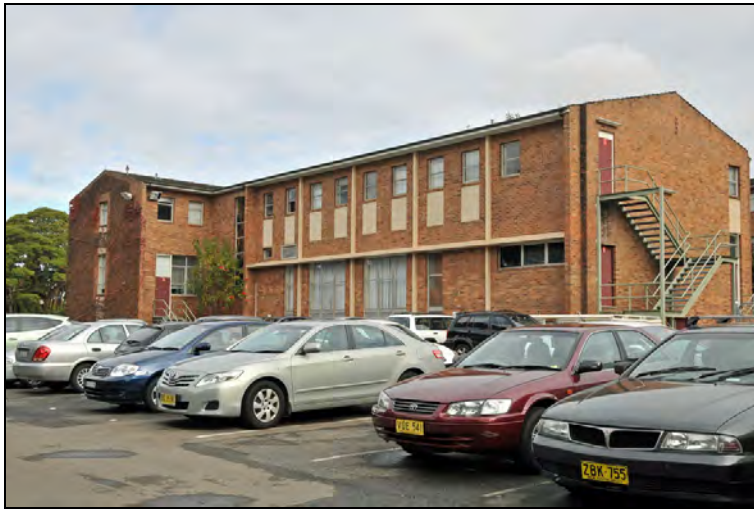
A third, shorter and slightly wider, wing runs at right angles to the southern wing and is referred to as the eastern wing for the purposes of this report. This wing is similarly constructed of face brick. With the exception of the northern elevation, the elevations are divided into bays by thin, slightly projecting, rendered fin walls; the ground and first floors are

defined by a shallow rendered projecting sill. Windows are aluminium framed; first floor windows have rendered and painted panels beneath.

**Figure 207: Eastern and northern elevations of the eastern wing.**

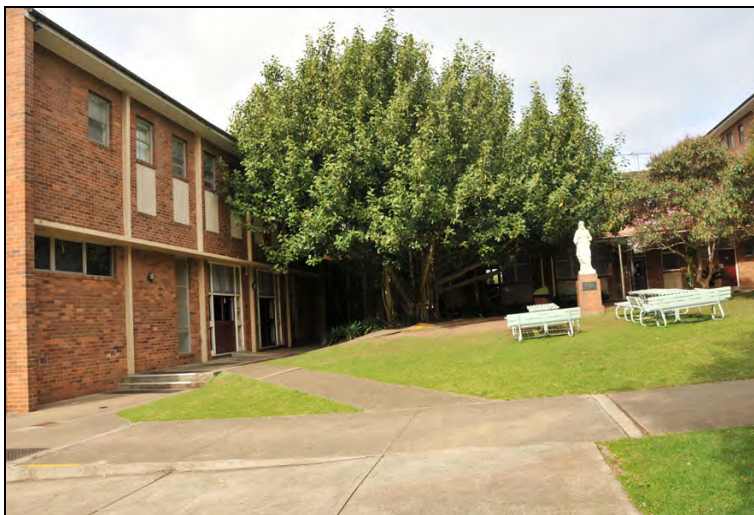
**Figure 208: Western elevation of the eastern wing.**

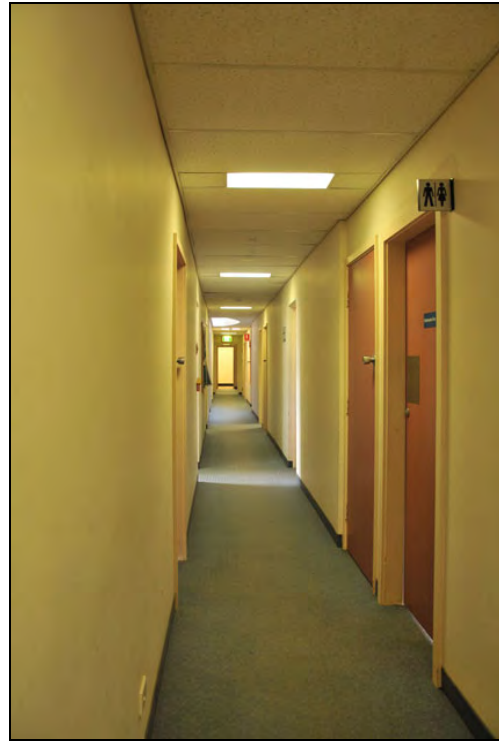
The ground floor rooms generally span the width of the building and are accessed externally. The upper floors are divided into narrow rooms off narrow hallways. Finishes are simple and include single panel doors and low panel ceilings. There are two large halls, one above the other, in the eastern wing, being the Murray Hall and the Edmund Rice Hall. The staircase leading from the ground floor to the first floor outside the Murray Hall is shown by Figure 191. Note the coloured glass in the stairwell window.

**Figure 209: Hall and stair outside the *Murray Hall* leading to the first floor.**  
**Figure 210: Typical hallway within the upper floors.**

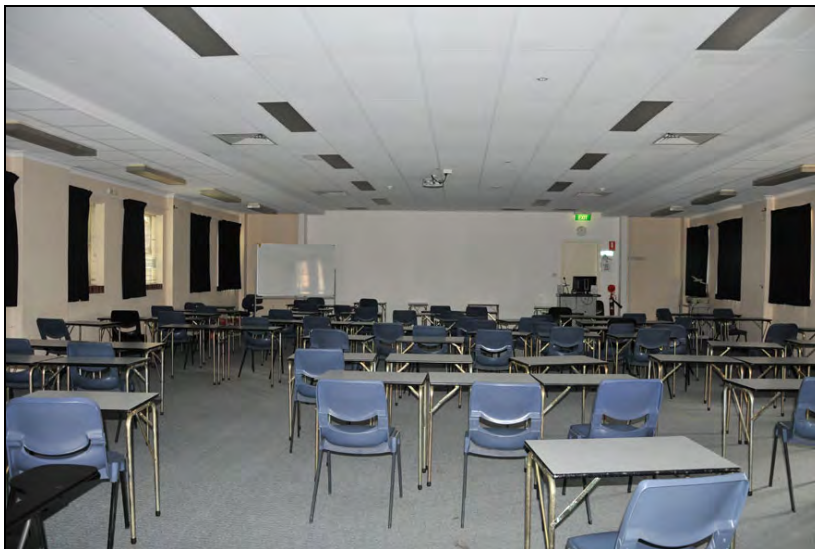
**Figure 211: First Floor Lecture Hall in *St Edmund's Building*.**

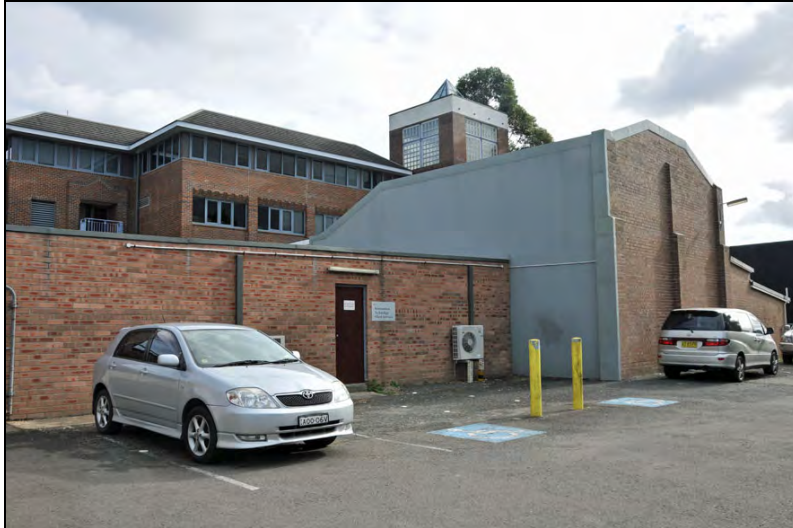
This building is a free standing, predominately face brick, structure, that has its origins as the handball courts attached to *St. Endas*. The building comprises a higher central section, with a lower wing to either side. Windows and doors building are timber framed and aluminium framed. Windows are generally set high in the walls. The attached wing on the southern side has a slightly sloping clip lock roof. The wing on the northern side steps down in height over two levels.

**Figure 212: Looking towards the eastern elevation of the Early Childhood Learning Centre.**

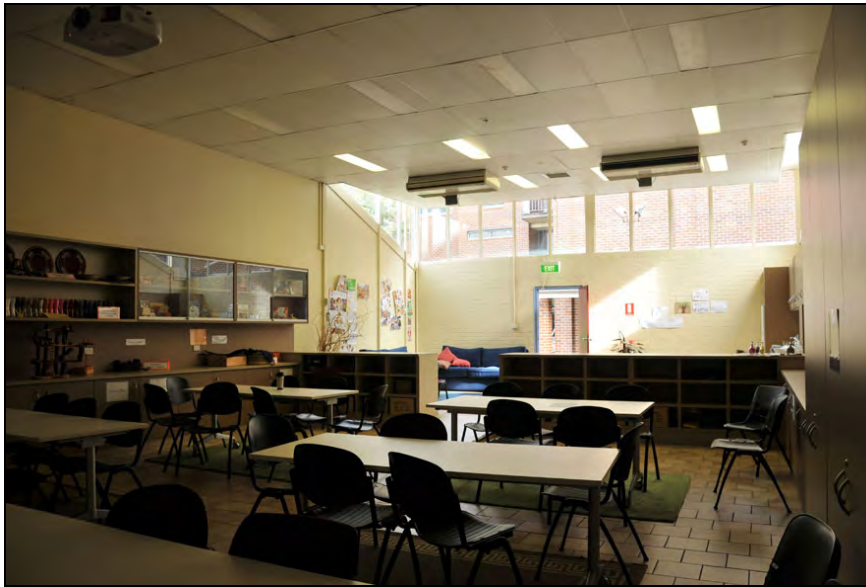
The three courts are no longer discernable within the current floor plan. Figure 215 shows the room in the central section of the building. The floor is tiled with modern tiles, the walls painted and the ceiling comprised of drop down acoustic panels.

**Figure 215: Former handball court space.**

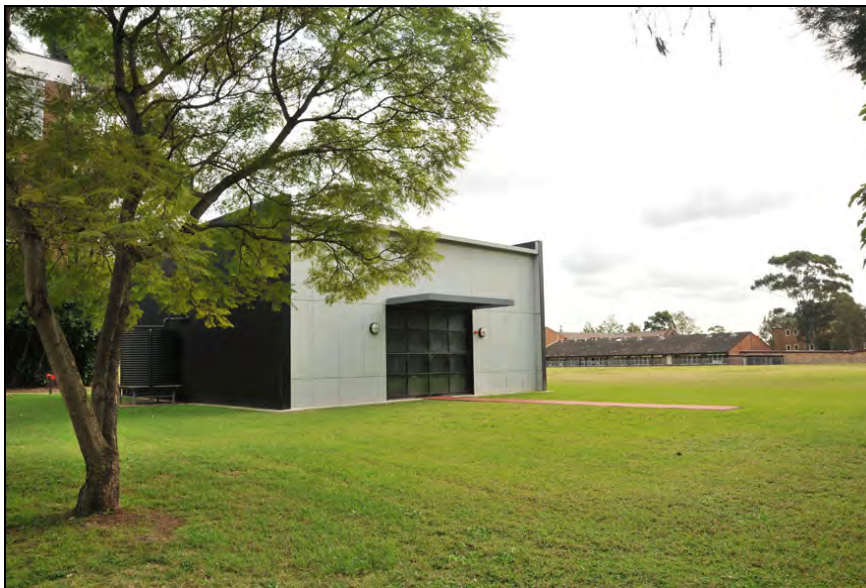
**Figure 216: Biomechanics Building.**

The biomechanics building is a recent free standing, steel framed, panel clad building, approximately two storeys in height, with a skillion roof. The northern and southern elevations are blind. The eastern and western elevations are characterised by a large opening with cantilevered awning.

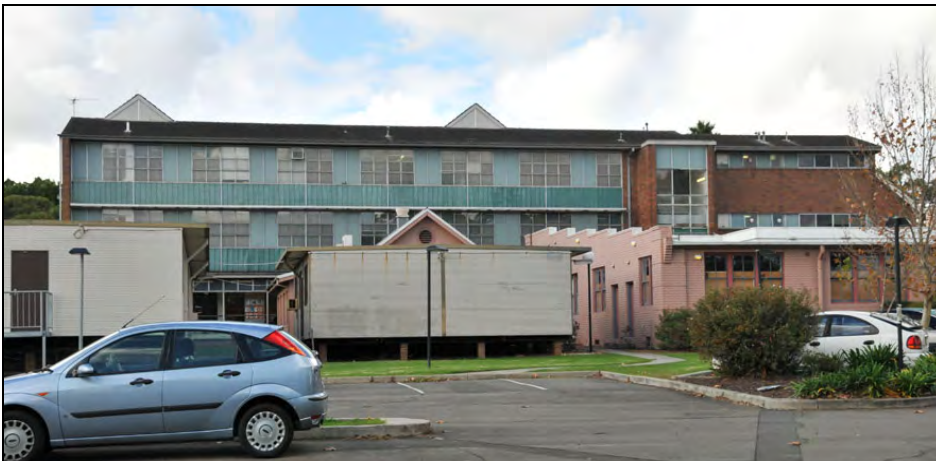
The western elevation comprises the 1959 building and is characterised by regularly spaced large aluminium framed windows. The ground floor walls are of face brick. The walls of the upper levels characterised by glass, aluminium and fluted steel spandrels finished in dark green baked enamel. The windows at first floor level were once shaded by a cantilevered aluminium awning fitted with louvres. The framework of this awning remains; the louvres have been removed. The stairwell protrudes outwards from the wall. The short, narrow, wing attached to the southern end of the building is described separately below.

**Figure 217: The western elevation of the library. The projecting element towards the southern end houses the stairwell.**

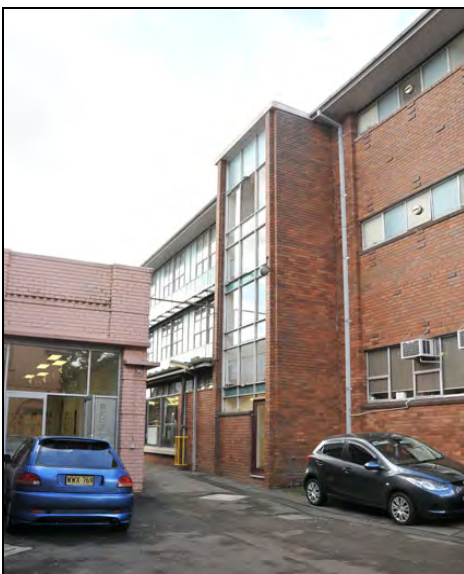
The oldest section of the library was erected in 1959 as the Scholastic and comprises the southern part of the building. This part of the building is three storeys in height and has a pitched, tiled roof. The building is a brick building with a reinforced concrete frame and aluminium curtain wall framing to the principal elevations. A substantial brick addition was constructed in 1991 on the northern and western sides.

**Figure 218:  
Western elevation of the  
library, showing the  
stairwell.**

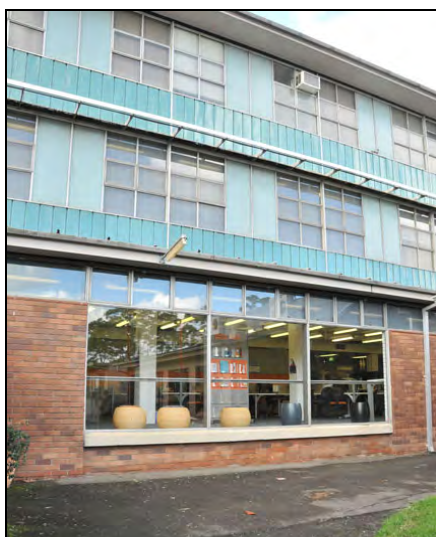
**Figure 219:** Detail of the ground floor elevation, western side. Note the large picture window and band of windows at ceiling height.

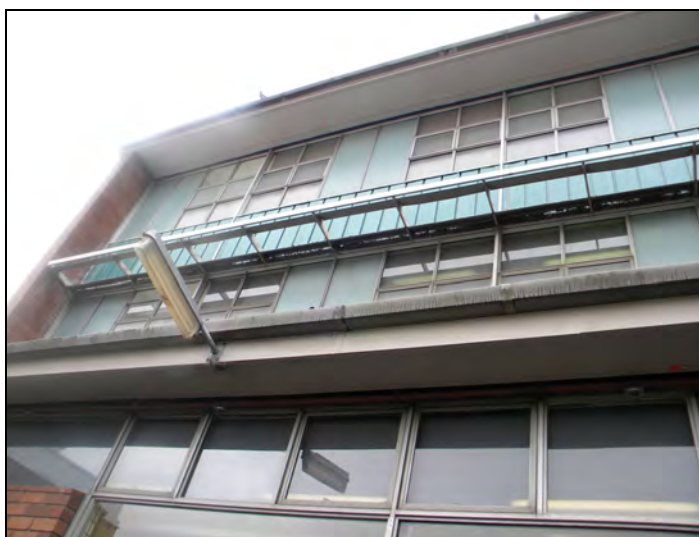
**Figure 220:** Detail of the first and second floor levels, showing the cladding materials, the depth of the eaves and the remnants of the aluminium awning.

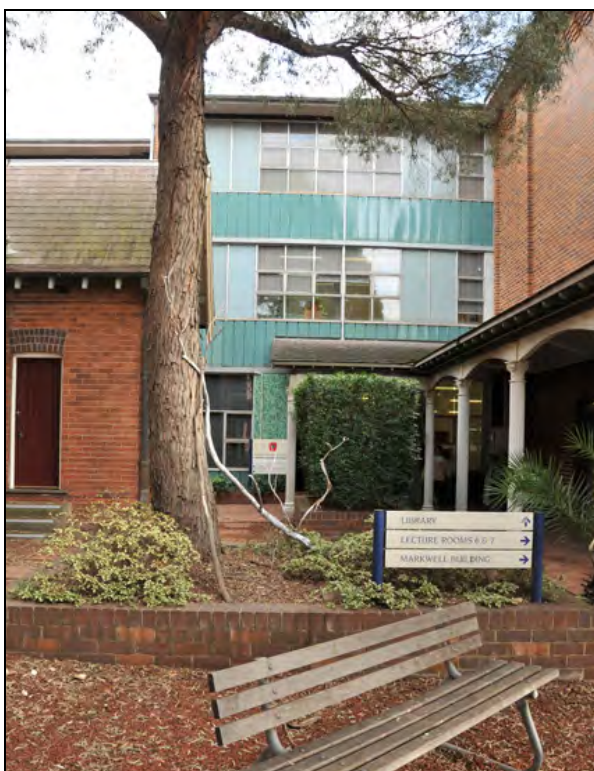
Only a small section of the eastern elevation of the 1959 building remains. The main entrance is inset within this section, beneath a small porch with a projecting canopy. This entrance is surrounded by small blue-green mosaic tiles. The 1994 addition is described separately below.

**Figure 221:**  
The entrance into the library,  
with later awning and original  
mosaic tiles.

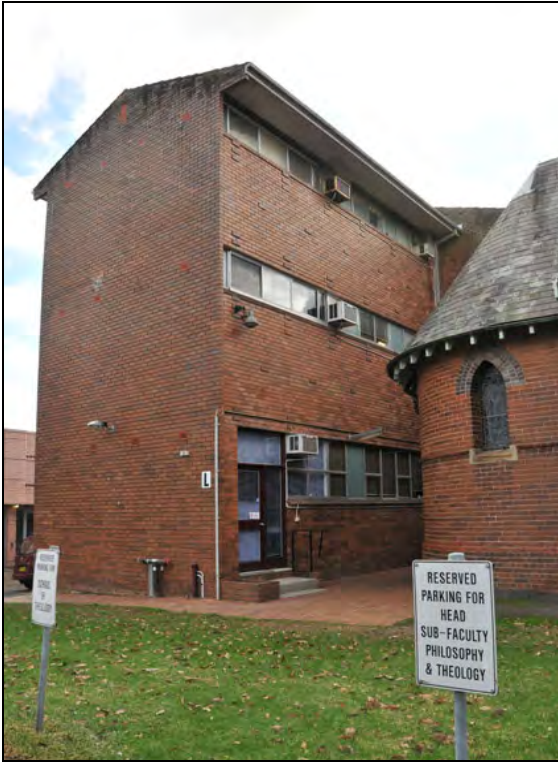
A small, narrower, wing protrudes from the southern end of the 1959 section of the building and is contemporary with it. The southern (end) wall of this wing is constructed of face brick and is blind. The eastern and western elevations are constructed of face brick and characterised by narrow bands of aluminium framed windows; the brickwork is alleviated by randomly spaced, slightly protruding bricks.

**Figure 222:**  
The eastern and southern elevation of the narrower brick wing at the southern end of the library. Refer back to Figure 201 for part of the western elevation.

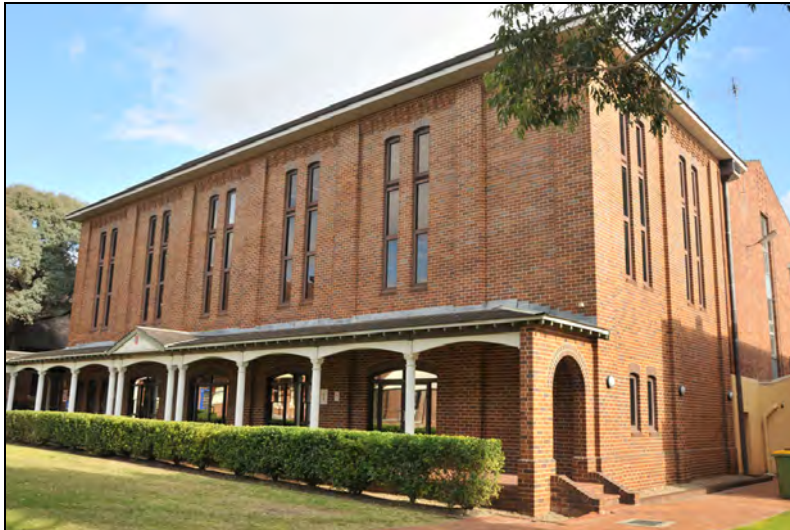
A substantial addition was constructed in front of the eastern side of the northern end of the earlier building in 1994. This addition is constructed of face brickwork and rises three storeys in height with a pitched tiled roof. A single storey verandah runs across the eastern face of the building at ground floor level. This verandah has a tiled roof supported by cast iron columns that approximately match those of the *Edmund Rice Building*; the under side of the roof is timber lined. The upper floors are characterised by pairs of long, narrow, vertically aligned windows.

**Figure 223: The eastern and northern elevations of the library extension. The northern end of the original building can be seen behind the later addition. Note the decorative brick cornice.**

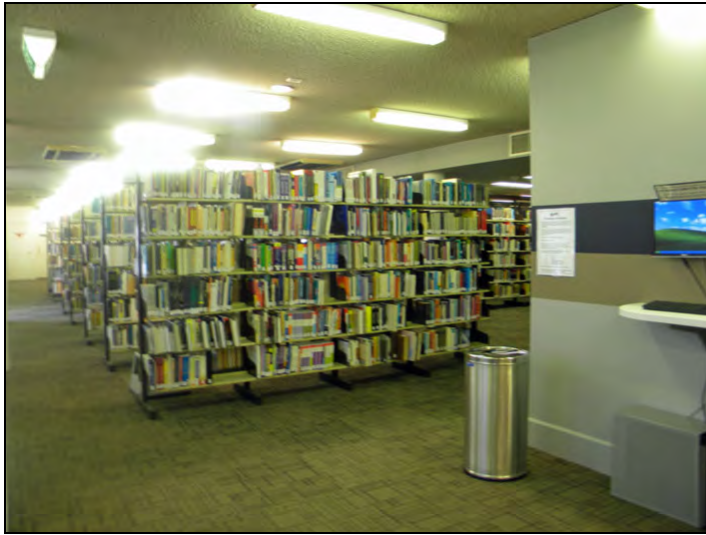
**Figure 225: First floor interior.**

Only a small area of the building was examined. Finishes are simple, with the ground, first and second floors comprising large open spaces with vermiculate ceilings.

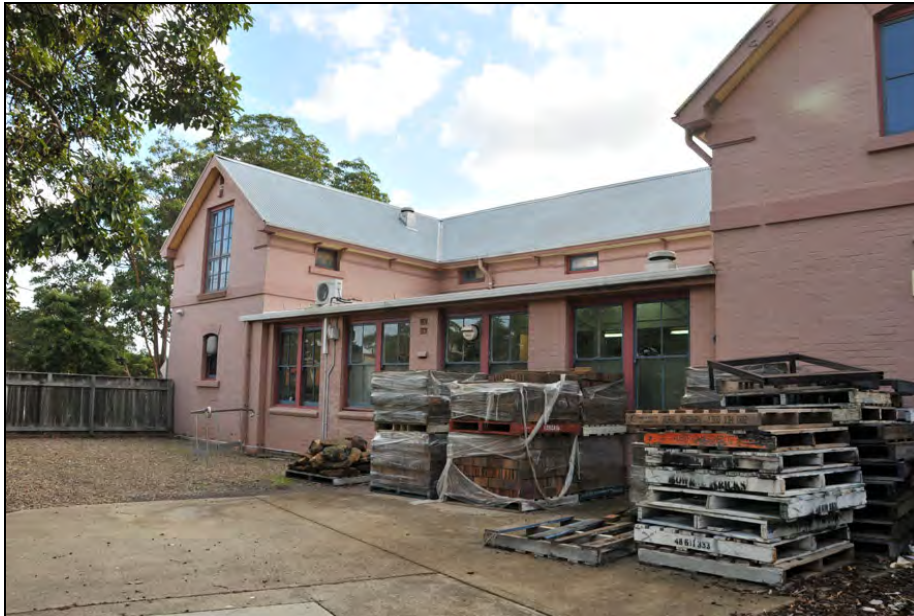
Two gable roofed projections extend outwards at either end from the main body of the building on the southern side. The western-most gable has a small timber framed window at ground floor level. At first floor level, there is a large multi-paned timber framed window. The ground floor of the eastern most projection is blind. At first floor level, there is a timber framed, double hung window with a single pane to each sash. The area between the two bays is occupied by a later brick infill with a skillion roof and pairs of large timber framed double hung windows with two panes to each sash. There are small, shallow, regularly spaced timber framed windows beneath the eaves along this elevation and continuing around the building.

**Figure 227: Southern elevation of the Arts Block, showing the 'U'-shape of the original stables buildings and the later infill. The sills in the original building are rendered and painted; the sills in the later infill are of moulded and painted brick. The large window at first floor level in the western gable was most likely a loft door when built.**

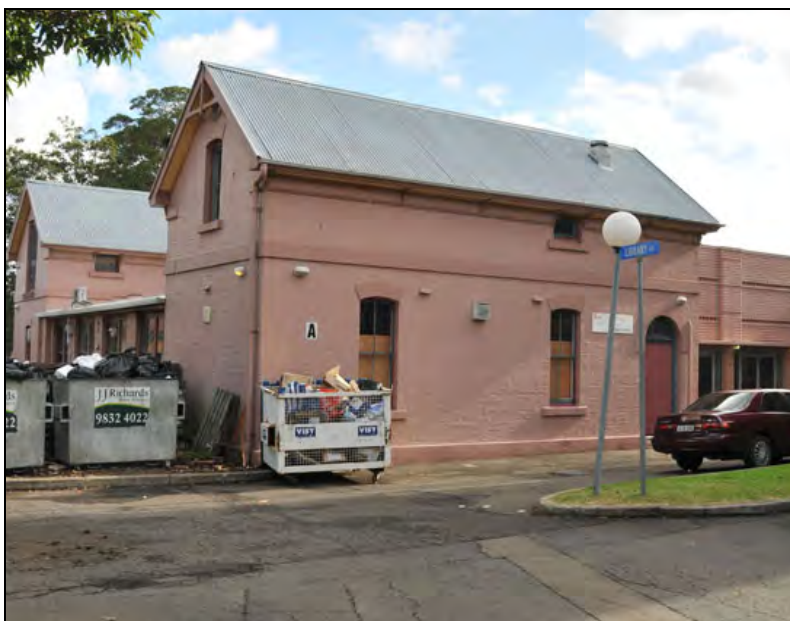
**Figure 228: Eastern elevation of the Arts Centre.**

The eastern elevation of the original section of the building has two large, narrow, timber framed double hung windows at ground floor level and a door with arched fanlight. The elevation is blind at first floor level, with the exception of a shallow timber framed window, set under the eaves.

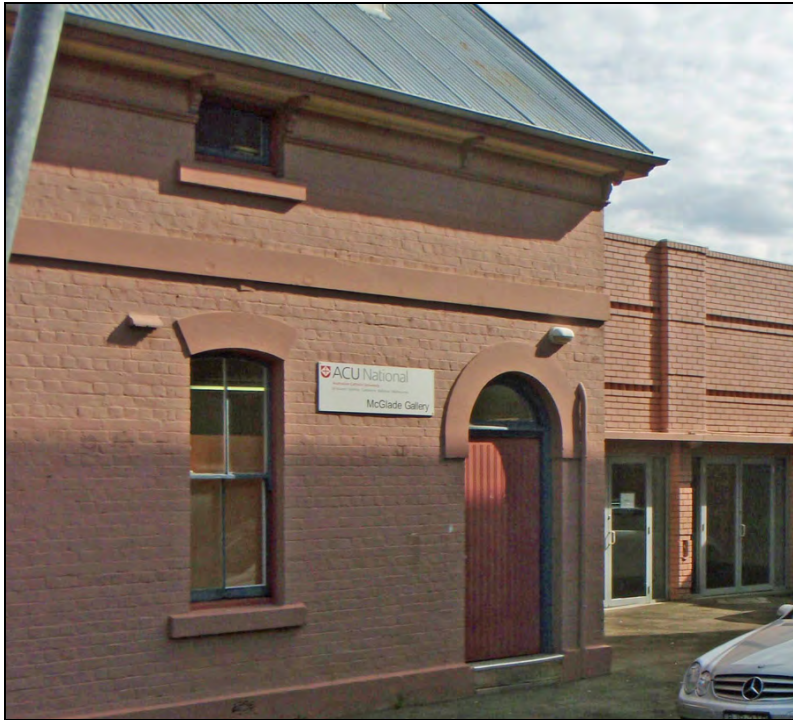
**Figure 229:**  
Detail of the openings on the eastern elevation of the original stable block. Note the decorative brackets under the eaves, the rendered brick sill that denotes the loft level and the use of rendered and painted brick sills and arches.

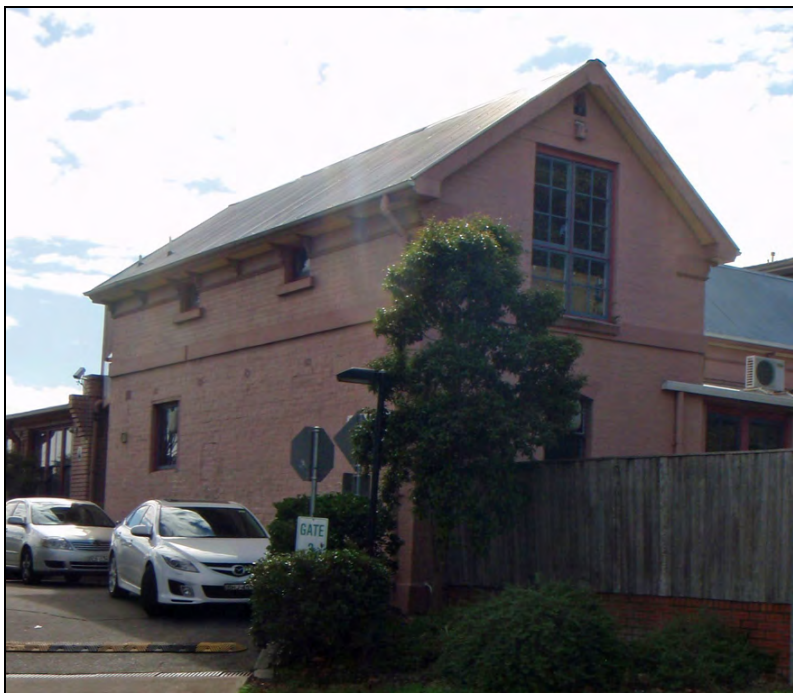
The western elevation of the original building has one small timber framed window at ground floor level. This opening does not have the rendered sill or arch of the eastern elevation windows. The only openings at first floor level are the small, shallow windows noted for other elevations beneath the eaves line. Refer to Figure 230.

**Figure 230:**  
The western elevation of the original stable building.

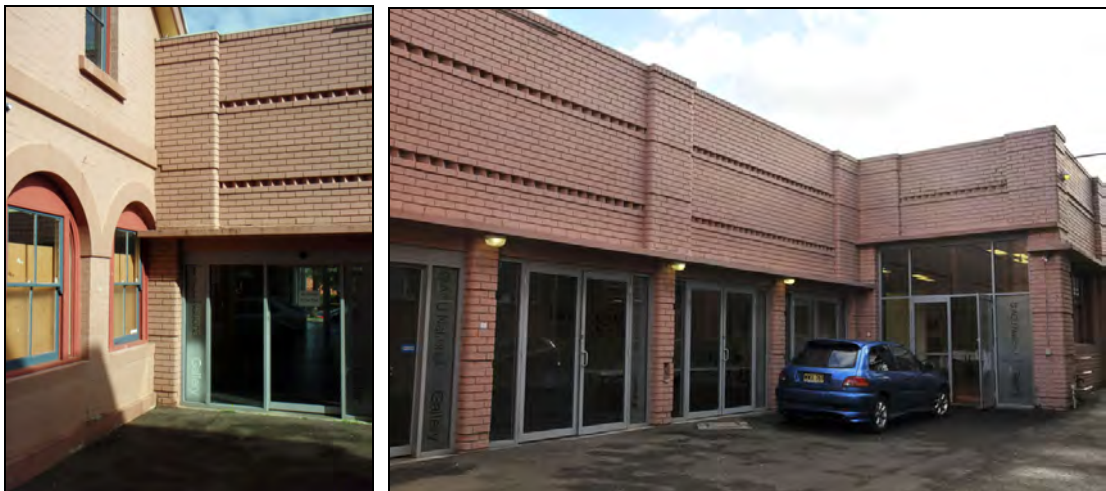
The eastern elevation of this addition is characterised by parapeted walls with bands of recessed and chevron brickwork set between engaged piers. A narrow concrete hood protects large steel framed doors and windows.

**Figures 231 and 232: The eastern end of the northern elevation of the original building and the eastern elevation of the c.1957-8 addition, showing the indented, chevron, brickwork.**

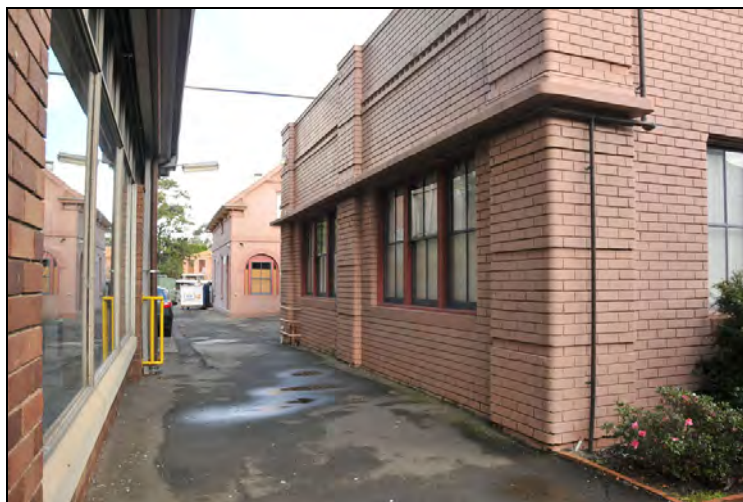
**Figure 233:**  
Looking south along the eastern elevation of the later addition. Showing the sets of three timber framed double hung windows with four panes to each sash.

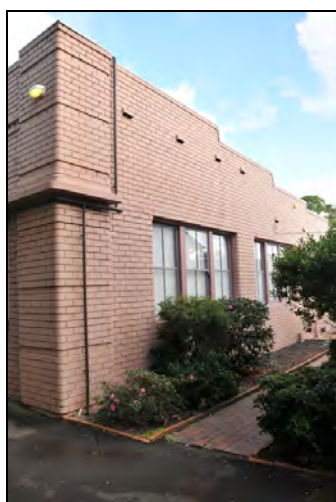
**Figure 234:** Looking west along the northern elevation, showing a detail of the corner element. Also showing how the parapet of the northern elevation steps down in height.

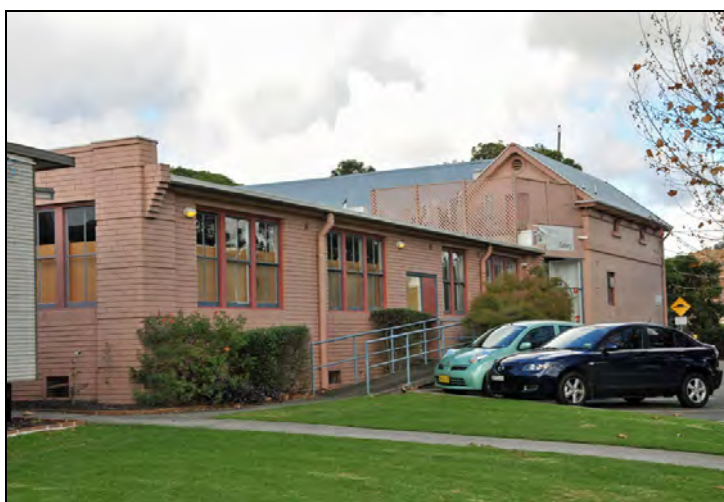
**Figure 235:** The western elevation of the later addition and the northern elevation of the original building, with its circular vent.
