### **6.3.3 The Mullens Building**

#### **6.3.3.2 Interior**

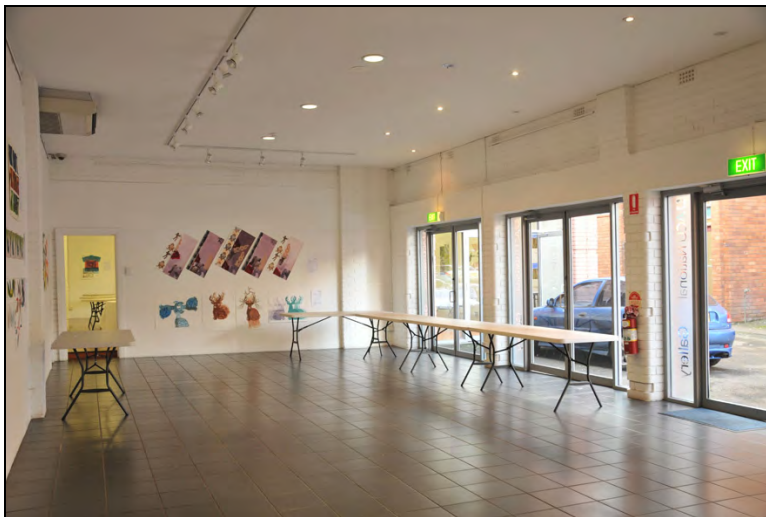
**Figure 237: Within the later addition, looking north.**

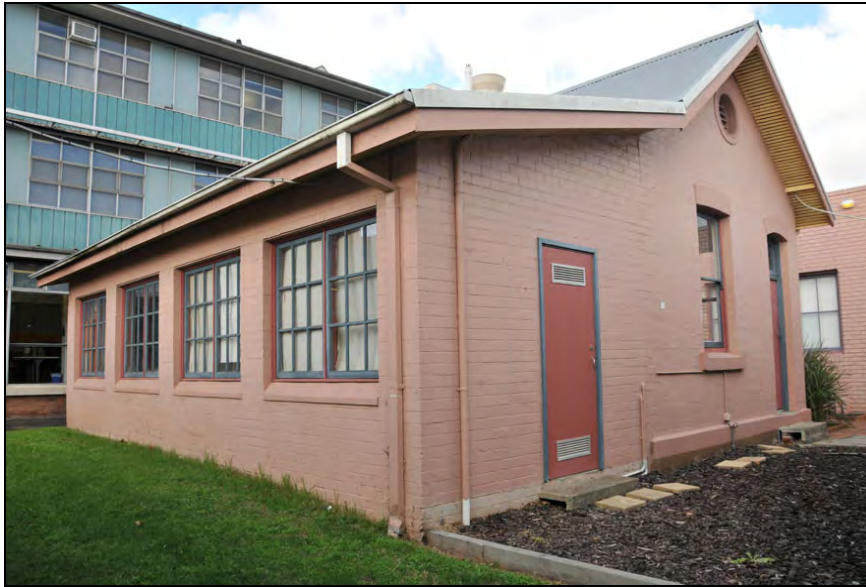
**Figure 238: The northern and western elevations.**

The *Ceramics Building* is a free standing, single storey building with painted brick walls and a pitched corrugated iron roof. A later, similarly painted, brick skillion addition runs along the northern side. The eaves overhang is wide and lined with slatted timber. The gable ends (to the east and west) have circular vents. Openings vary in size. The original section of the building is characterised by large, timber framed, double hung, windows (a single pane per sash) with rendered sills and a rendered brick arch above; door openings have matching detail. The northern elevation of the skillion addition has four pairs of large timber framed windows (multiple panes) with sloping sills.

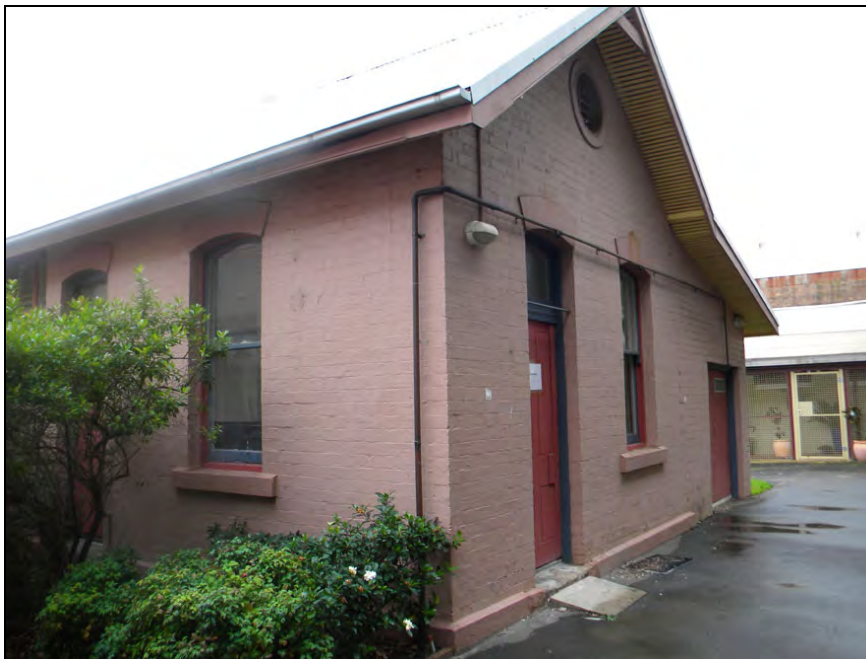
**Figure 239: Ceramics Building, looking towards the southern and eastern elevations. Note the rendered, slightly arched bands above the original openings and the square cut of later openings.**
