6.3.1.2 Interior

6.3.2 The *Barron Chapel*

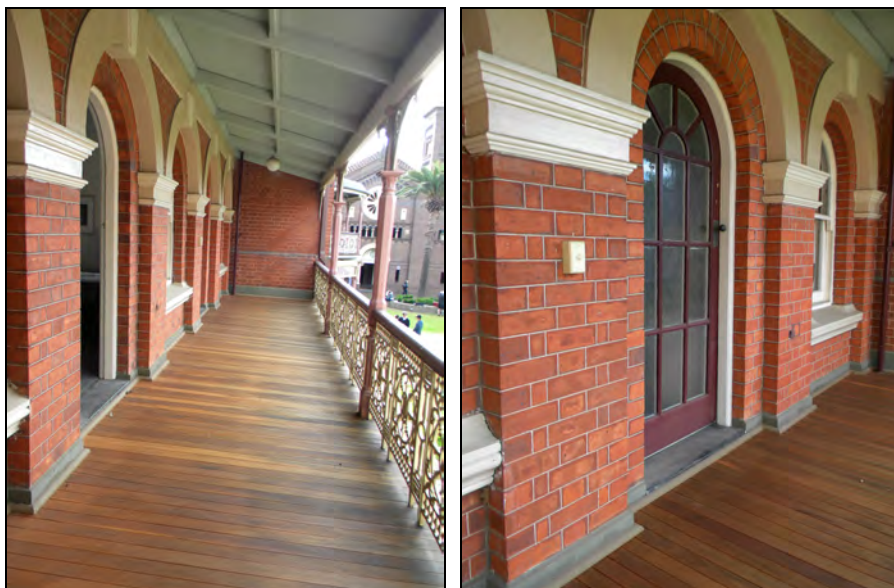
Figure 113: First floor of the rear wing. The timber floor has recently been renewed.

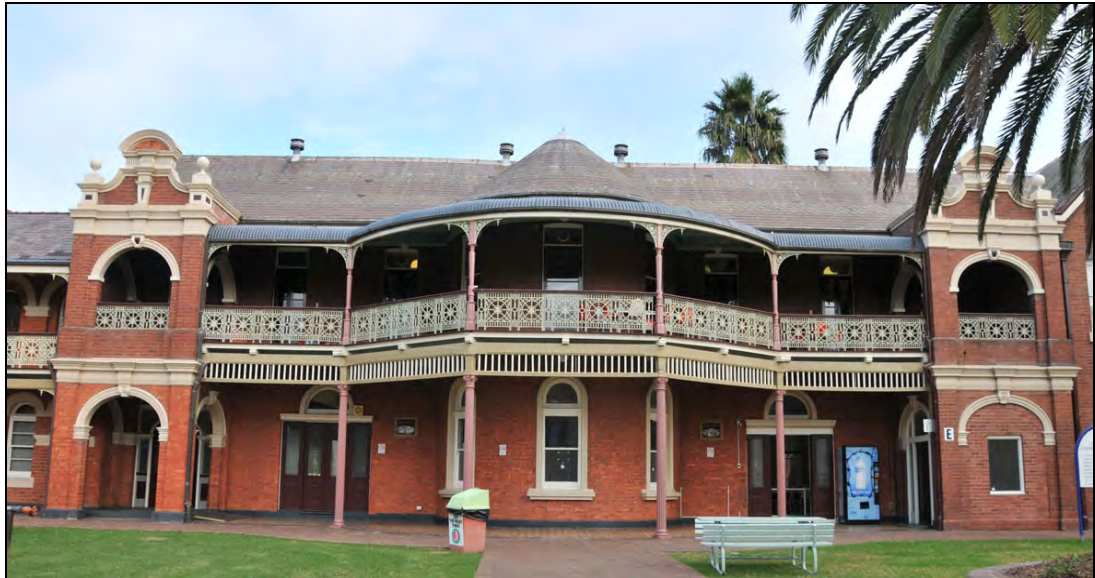
Refer to Figure 115.

The 'ballroom wing' abuts the end of this wing. This wing is constructed of face brick (matching the original villa) and has a pitched slate clad roof. Each end of the eastern elevation of the ballroom wing is defined by a two storey projecting tower with ornate parapets and arched openings at ground and first floor level. A two storey verandah runs between the two towers. This verandah curves outwards as it follows a large rounded two storey bay in the centre. At ground floor level, the verandah is supported by slender fluted cast iron columns and has a simple timber frieze; the floor is of encaustic tiles and the underside of the roof is timber lined. Large timber double doors with sidelights and panels of sand blown glass open onto the verandah. These doors have small arched top lights above. The windows in the rounded bay are timber framed double hung sash windows with two panes to each sash and arched fanlights surrounded by a rendered frame. At first floor level, the verandah has a cast iron balustrade (matching the pattern of the preceding section) and corner brackets. Double hung windows and french doors with top lights (some infilled with louvres) open onto the verandah; the underside of the roof is lined with timber boards

Figure 115: The eastern elevation of the 'ballroom wing.' The difference in brick colour suggests that the first floor of the northern most tower was constructed at the same time as a Chapel wing to match the detailing of the southern most tower. Note the ventilators rising out of the roof. The window in the ground floor in the tower on the right hand side was originally a door.

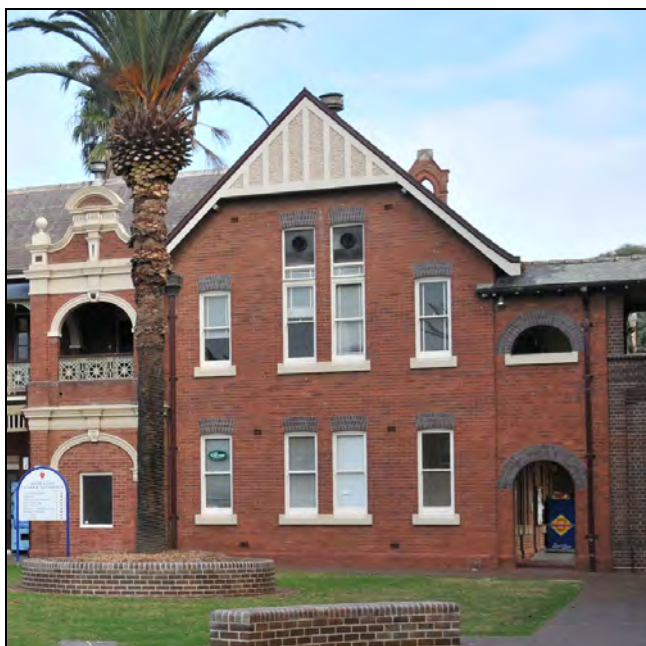
Refer to Figure 116.

Attached to the ballroom wing is the 1908-9 transverse wing designed by Sheerin & Hennessy. This wing is constructed of face brick on a brick base with a pitched roof clad in slate. The gable forming part of the eastern elevation is detailed in the Federation Style and has timber barge boards; the top of this gable is finished in roughcast render with mock timber battening. The eastern elevation is characterised by narrow timber framed double hung windows (with a single pane to each sash) with rendered sills and contrasting brick fans above. The pattern and sizes of windows are shown by the following photographs. The eastern end of the northern facing verandah has an arched opening framed by contrasting bricks at ground floor level and a similar, but smaller opening, at first floor level.

**Figure 116:
Northern end of the
eastern elevation,
showing the 1908-9
transverse wing.**

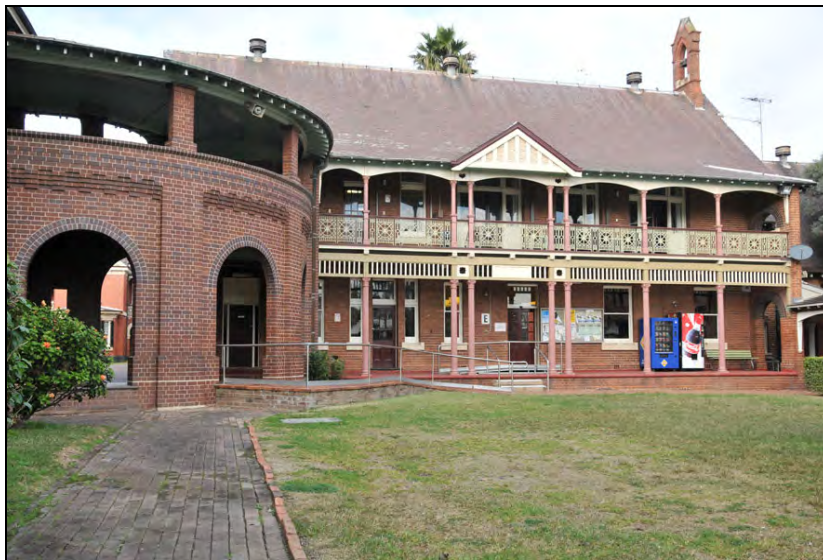
Refer to Figure 117.

The northern elevation of the building comprises the northern elevation of the 1908-9 wing and is characterised by a two storey verandah with slender fluted cast iron columns to ground and first floor levels. At ground floor level the verandah has a red cement floor, a timber lined ceiling and a timber frieze of the same simple pattern as the ground floor frieze of the eastern verandah of the ballroom wing. At first floor level, the verandah has a timber floor, timber lined roof, cast iron balustrade and timber frieze and the simple pattern shown in the accompanying photographs. The main roof breaks in pitch to continue over the verandah and rises into a small gable in the centre of the verandah. This gable has timber barge boards and is finished in rough cast render with mock timber battening. At ground floor level, double doors with fanlights and timber framed windows (two panes per sash) with rendered sills, open onto the verandah. At first floor level, double hung timber windows and french doors open onto the verandah. The 1908-9 Chapel bell rises above the western gable end.

Figure 117: Northern elevation of the 1908-9 Wing.

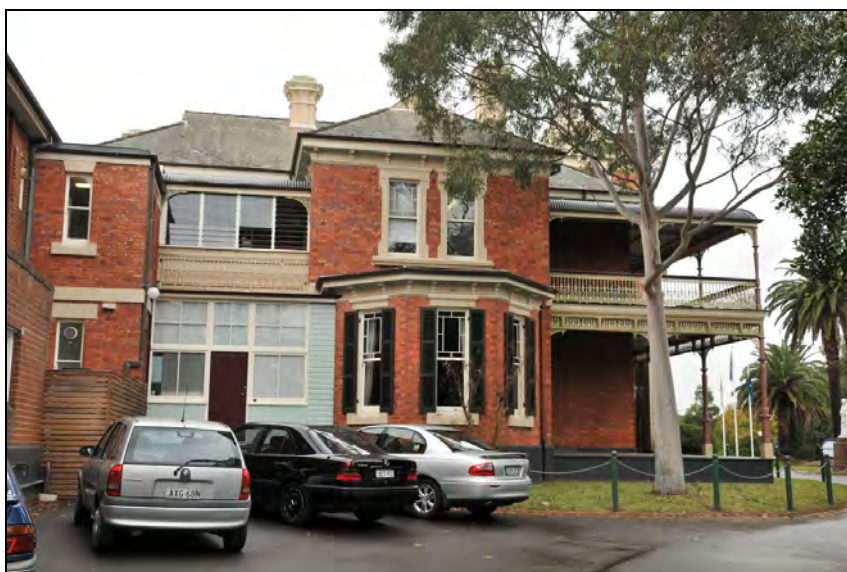
Refer to Figure 118.

The western elevation of the original section of the villa begins with the return of the southern (front) verandah, which ends at a projecting bay. Unlike the bays of the eastern elevation, this projection lies under a hipped roof with small gablet to the top. At ground floor level, the bay projects further into a three sided bay, each face with a timber framed window with timber shutters (with details matching the corresponding bay in the eastern elevation). There are two windows, set within a rendered frame, at first floor level. A short bull-nosed roof verandah on the northern side of this bay has been filled at ground floor level with timber and fibro panelling and timber framed windows, and at first floor level with fibro panelling and glass louvres; the cast iron balustrade has been retained in front of the panelling.

Figure 118: Southernmost end of the western elevation.

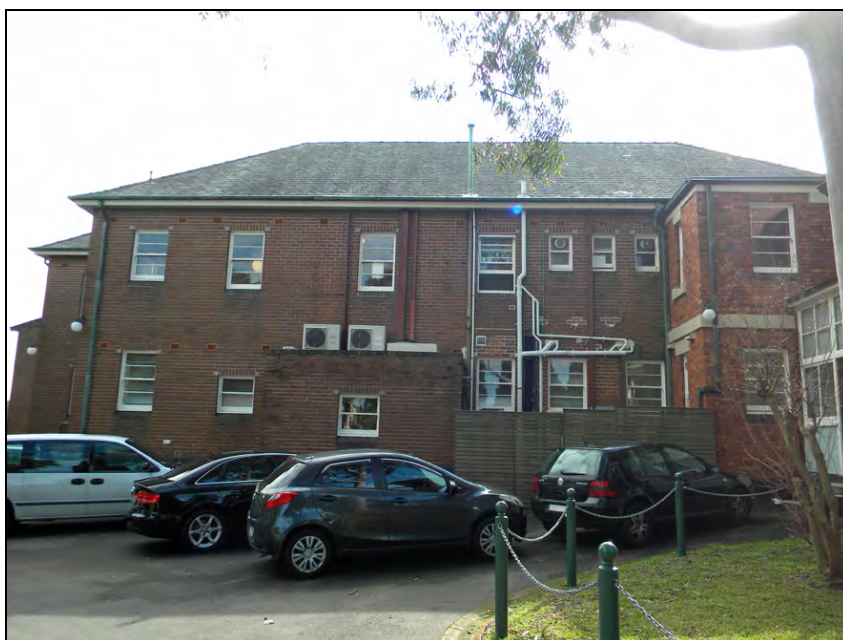
The **southern** most of the three wings running at right angles to the building is a two storey brick wing, on a high rendered and painted base, constructed in the late 1920s-early 1930s. This wing has a hipped roof clad in slate, wide closed eaves and is characterised by timber framed double hung windows; each sash is divided into two by a horizontal glazing bar. The windows have moulded brick sills and a line of headers across the top of the window. The northern elevation of this wing comprises a narrow two storey brick bay under a skillion roof. This elevation is divided into three bays by expressed piers. The upper level of this bay has fixed timber framed windows.

**Figure 119: The southern elevation of the southernmost wing.
Note the projecting single storey addition and the disfiguring services.**

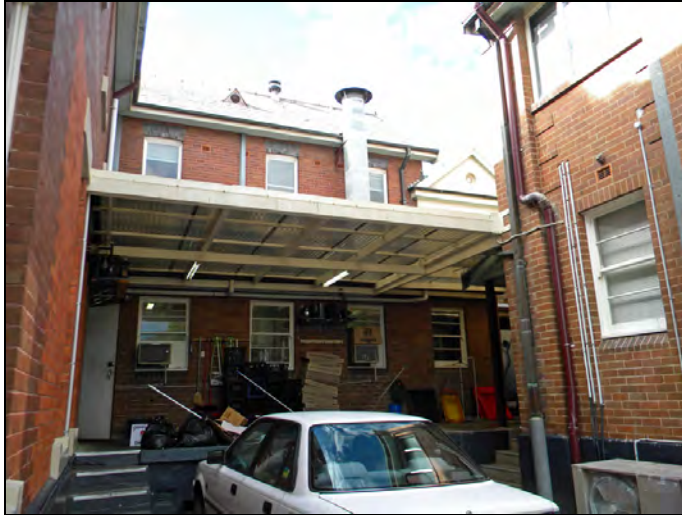
Figure 123:
Detail of the end of the villa and
the beginning of the rear wings.

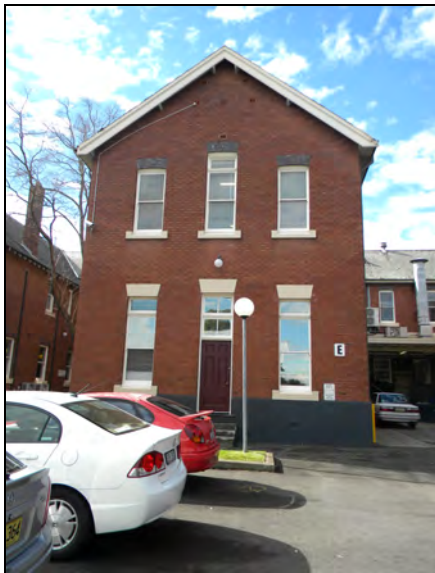
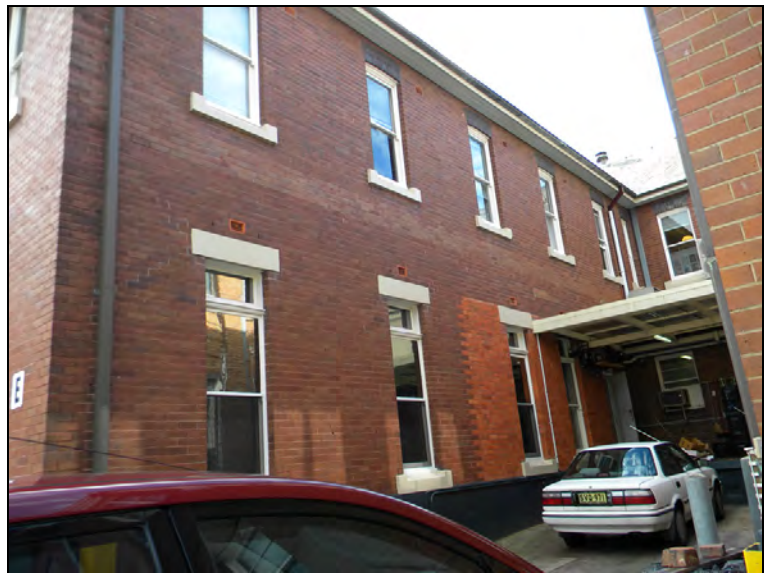
The **central wing** was constructed c.1912. This wing is constructed of face brick work on a rendered base. The presence of two types of brick on the northern and southern elevations provides clear evidence of the 1912 extension of the original billiard room and first floor addition over it. The wing has timber lined eaves and a gable ended slate clad roof. The elevations of this wing are characterised by narrow, timber framed, windows with one pane per sash and rendered sills. The ground floor openings have rendered headers; the first floor windows have contrasting brick headers.

Figure 124: The western elevation of the central wing.
Figure 125: The southern elevation of the central wing.

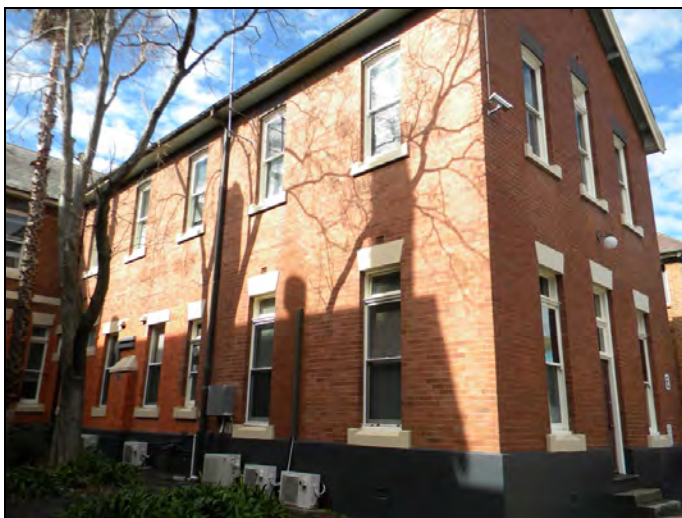
Figure 126:
The northern elevation of the central
wing.

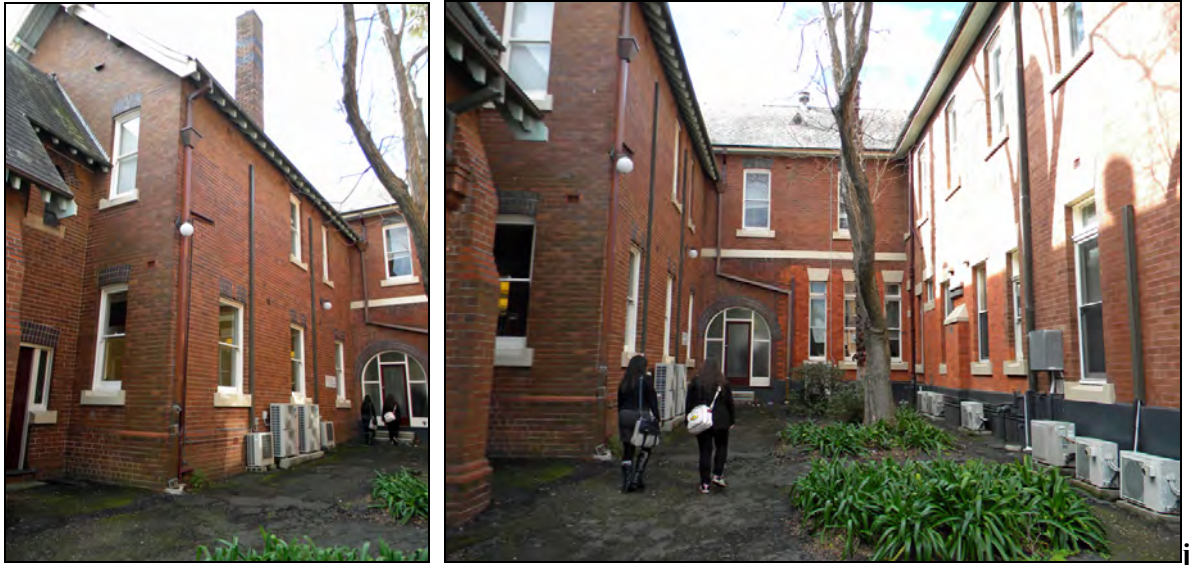
Refer to Figures 127 to 128.

The **northern most wing** projecting from this elevation comprises the 1908-9 extension; the 1908 Chapel is attached to the western end of this wing. This wing is similarly gable ended. The northern elevation was described above and shown by Figure 102. The southern elevation is characterised by rows of double hung timber framed windows with rendered sills and contrasting brick headers above

Figure 127: The southern elevation.

Figure 128: Showing the western wall of the villa.

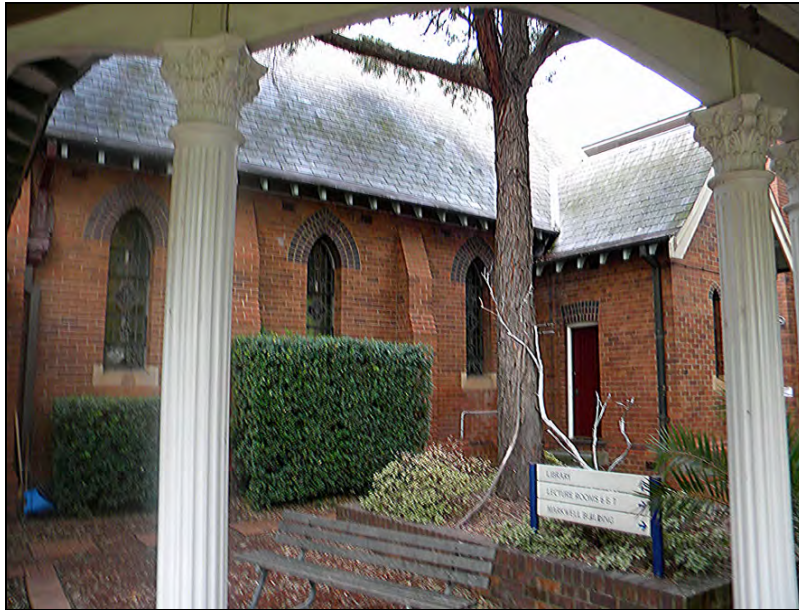
The 1908-9 Chapel is attached to the western end of the 1908-9 wing and separated from it by a small, narrow, entrance porch. The Chapel is a Federation Gothic Style building with walls of face brick and a steeply pitched slate roof. The side elevations are each divided into four bays by shallow brick buttresses. Each bay has a narrow arched stained glass window. The top of each arch is accentuated by the use of contrasting brickwork; the sill of each window is of sandstone. The eaves are timber lined and the ends of the exposed timber rafters are decoratively shaped. There are two entry porches: one at the eastern end, where the Chapel adjoins the 1908-9 wing; and a small enclosed porch extending at right angles from the building on the northern side, at the western end. There is a rounded apse at the western end, with separate, lower roof, nestled under the main roof.

Figure 129: The northern side of the 1908-9 Chapel.

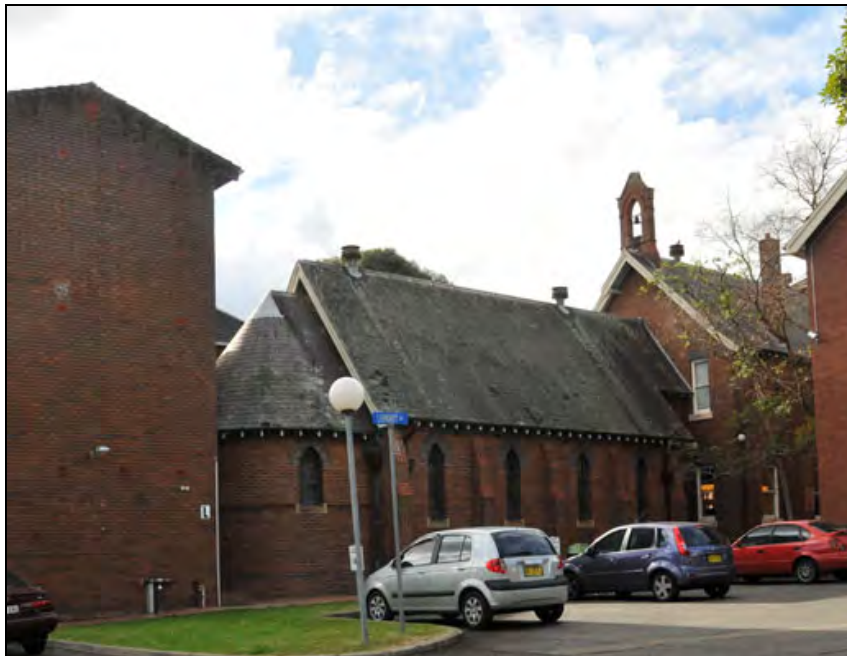
Figure 130: The southern elevation of the Chapel, showing the rounded apse.

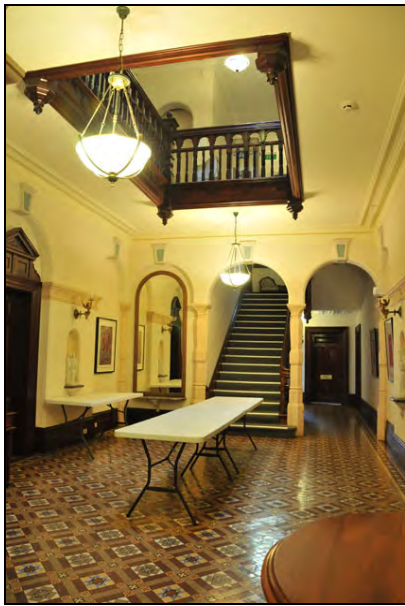
The most significant internal finishes in the building are to be found in the ground floor entrance hall of the original villa. Finishes in this space include highly polished cedar joinery; patterned encaustic tiled flooring, which continues through to the back hall; a finely carved timber staircase; high, moulded, skirting boards and architraves; pediments above four panel timber doors; deep, run in cornices; original gas light brackets; a lantern light; and anaglyptic wallpaper.

Figure 131: Front hall, showing the encaustic tile floor and timber stair in the middle of three arches in the northern wall. The arrangement of three arches was one used by Kent at the near contemporary residence of *Caerleon*.

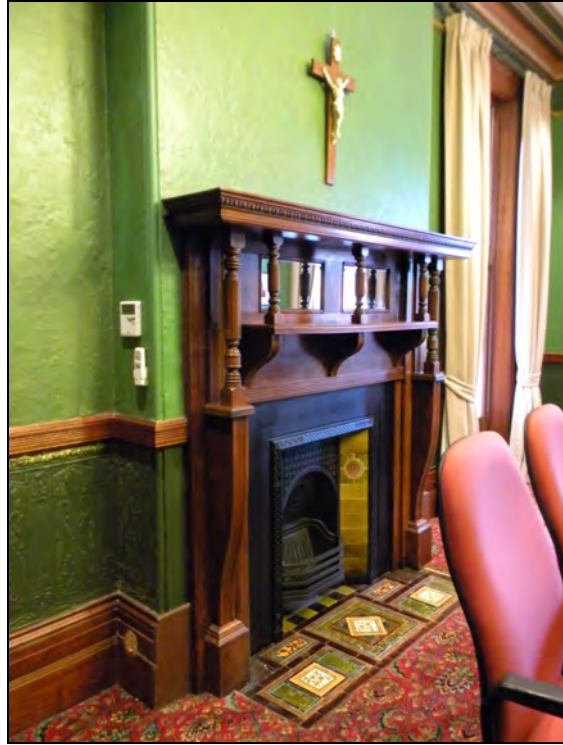
The main rooms within the original section of the villa have all, or a combination of, the following elements: fireplaces with coal grates, timber over-mantles and glazed tiles; high, moulded timber skirting boards and architraves; deep, run-in plaster cornices; and gas roses. Not all the extant fabric is original. In the largest room on the western side, for example, now Conference Room A, the dado rail is a recent replacement, while the fireplace is comprised of original hearth tiles (repaired), a replacement coal grate and side tiles and a replacement timber overmantel.

Figure 138: Detail of the replacement mantle piece and coal grate in Conference A. The tiles are original and have been repaired.

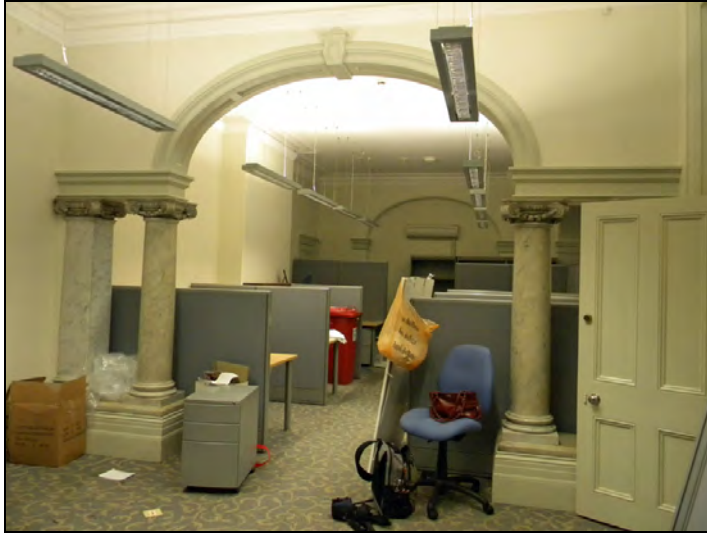
The original drawing room, shown by the historic photograph, Figure 16, is located on the eastern side of the villa. This room retains the original marble columns, but is currently divided into semi-open cubicles half height partitioning. The timber mantelpieces remain; the openings are boarded up.

Figure 140: Main room on the eastern side, showing the original marble pillars and dividing arch.

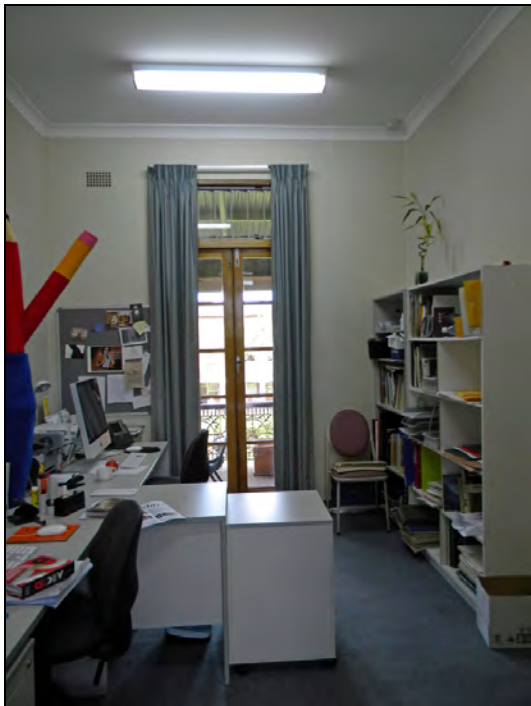
Figure 154: French door, first floor of the ballroom wing. The fanlight has been fitted with louvres turned on their side.

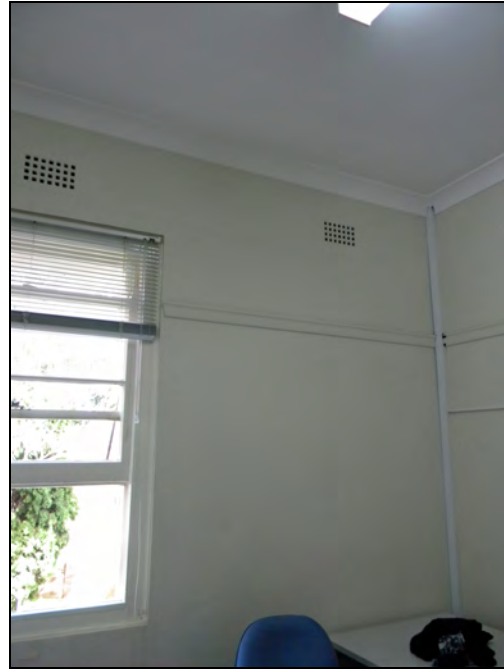
The ground floor of this wing was not inspected, but comprises offices and store rooms. At first floor level, the wing comprises small rooms opening off a central corridor. Finishes are typical of the interwar period. These rooms have narrow, dark stained, panel doors, typical of the interwar period, quad cornices and picture rails. The timber skirtings are low, with a simple rounded top; door and window architraves are similarly simple in profile. The bathroom at the western end of this wing has a c.1920s-1940s fit out. Refer to Figures 155 to 158.

Figure 156: Showing quad cornicing, wall vents and simple picture rails in a typical room within this wing.

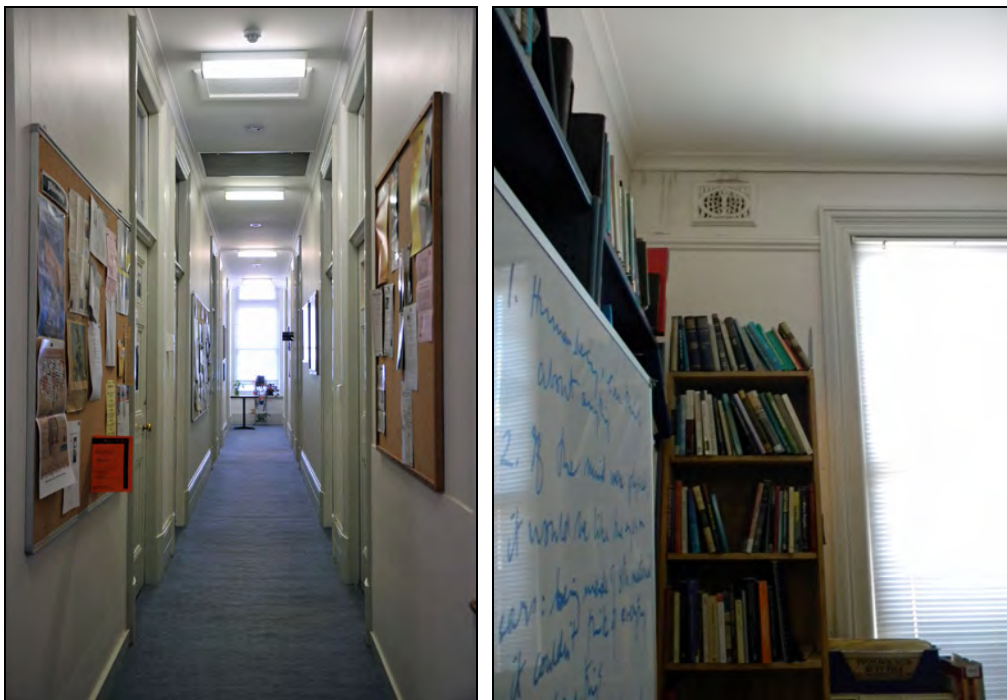
Figure 159: First floor hallway within the middle wing. Note the large fanlights above the doors.

Figure 160: Detail of window joinery and decorative wall vent in a typical room.

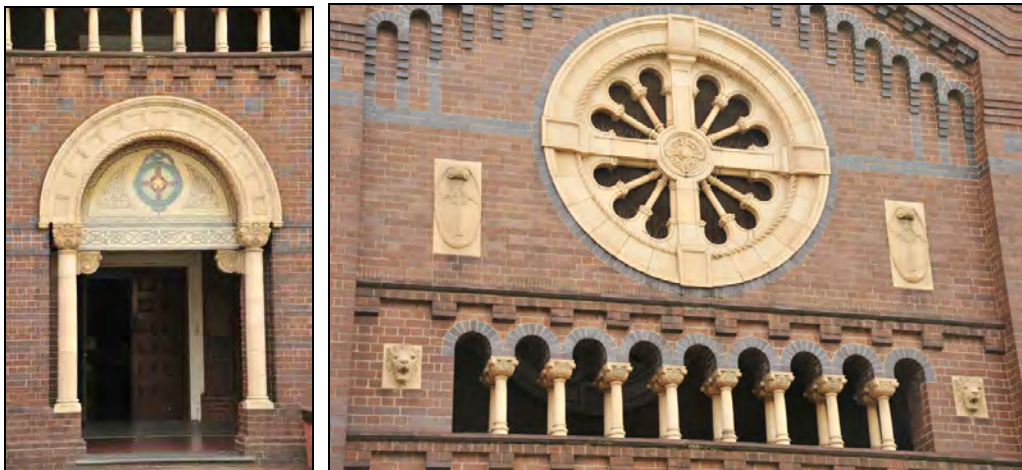
The main entrance is inset behind a porch. The porch lies beneath a stone coloured terracotta arch supported by pillars; the top of the arch is filled with a mosaic design. Above this arch, and corresponding with the first floor of the brick arcades which run to either side of the Chapel, is a row of smaller arches with stone coloured terracotta columns and decorative capitals. A large stone coloured terracotta framed circular window dominates the upper third of the elevation.

Figure 168: Stone coloured terracotta work to the porch entrance. The double doors leading into the Chapel are just visible. There are memorial plaques to either side of the door.

Figure 169: Arched openings with stone coloured terracotta capitals and columns at first floor level and a detail of the rose window. Note also the matching terracotta reliefs.

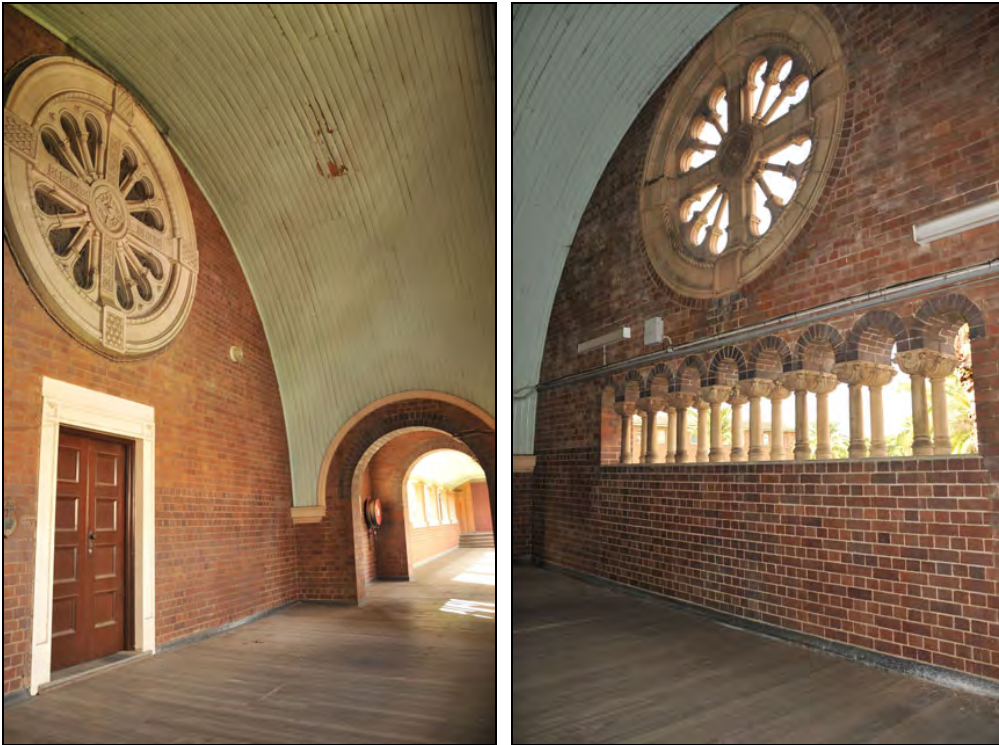
The ground floor entrance porch is tiled with small red tiles laid in a herringbone pattern with black in the border; the roof is timber lined. The porch runs into the ground floor of the brick arcades to either side. Similarly, the brick arcades are connected at either side at first floor level. The arcade, as it passes in front of the Chapel is lit by light coming through the arches and circular window that dominate the southern elevation. This part of the arcade ceiling is barrel vaulted and timber lined.

Figures 170 and 171:
First floor level, behind the arches. Note the corresponding rose window in the front wall of the Chapel and the barrel vaulted timber lined ceiling.

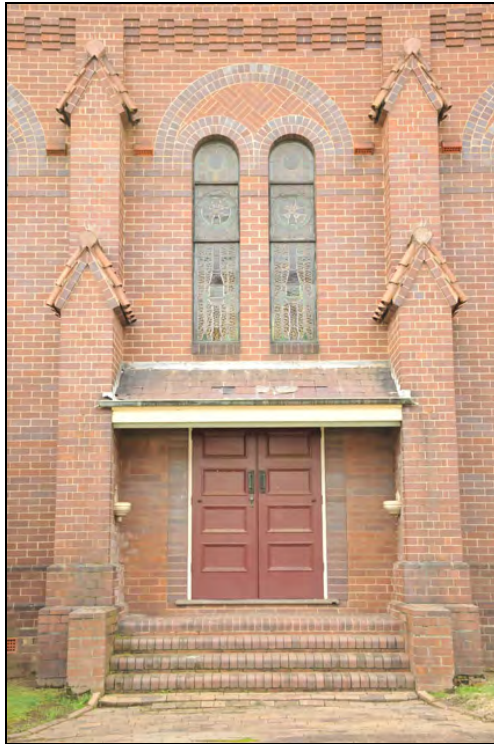
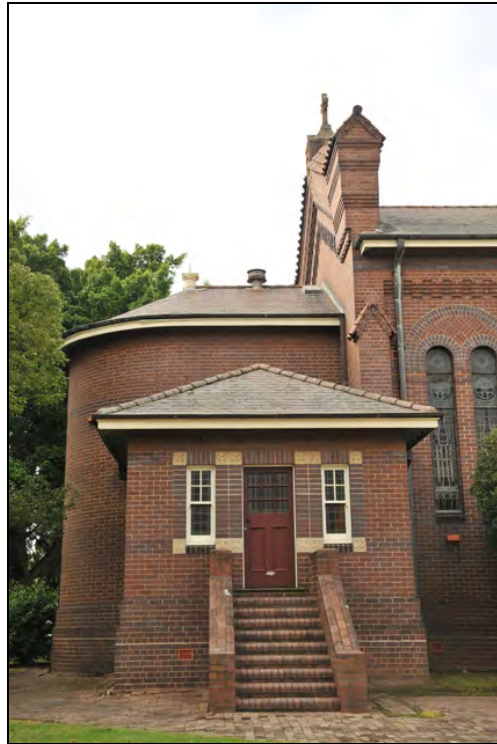
The eastern and western elevations of the building are divided into seven bays by shallow buttresses with tile caps. Each bay has two narrow arched windows. As for the main elevation, these elevations are characterised by fine, decorative, two-tone brickwork and use of moulded bricks. There is a double timber door set halfway along each elevation. Brick stairs lead up to the door, which is protected by a sloping slate clad roof. There is a single storey brick vestry to either side at the northern end of the building. The vestries have hipped slate clad roofs with terracotta ridge capping and small timber framed double hung windows with multi-pane top sashes. Brick stairs lead up to the entrance into the vestries on the eastern/western side respectively.

Figure 174: Detail of the double doors leading into the Chapel on the western side, showing the use of coloured and special bricks and tile capping.
Figure 175: Detail of the vestry on the western side.

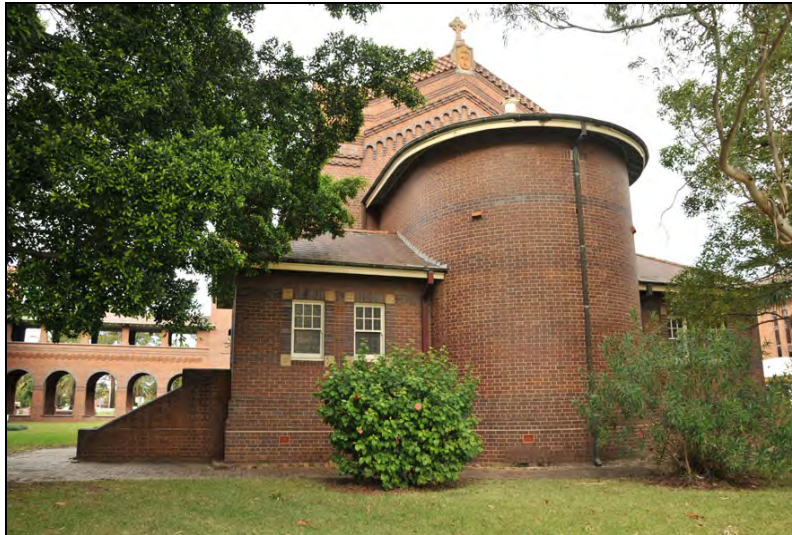
Refer to Figure 177.

The northern elevation rises to the same height as the southern elevation. The top of the parapet is detailed to match the southern parapet. A rounded apse, with a lower, separate slate clad roof, completes the elevation. The walls of the apse are blind. The northern elevations of the vestries to either side have two timber framed, double hung windows, detailed to match the vestry windows on the eastern and western sides.

Figure 177: The northern elevation of the Barron Memorial Chapel.

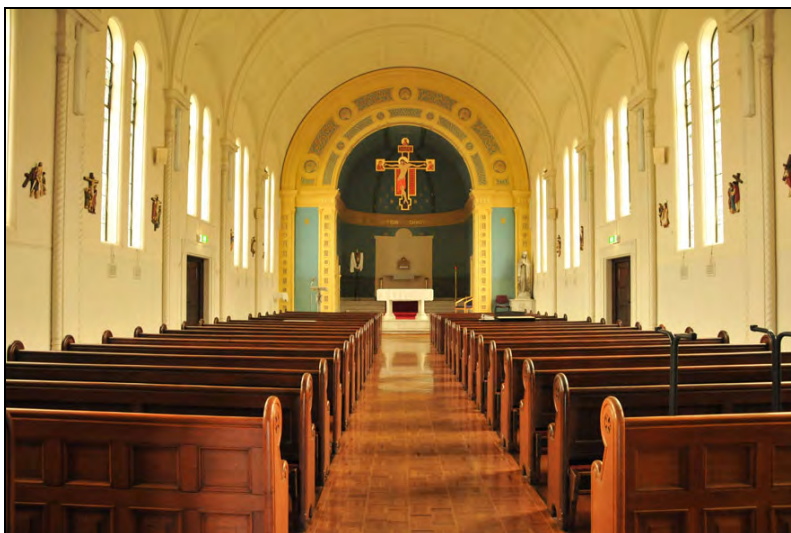
The main body of the Chapel comprises a double height space. Finishes in the Chapel include parquetry flooring; barley twist columns to the walls; the elaborately painted altar within the apse; timber work to the southern wall, pews and choir loft; and Celtic design motifs in the leadlight of the windows. The white marble altar piece originally came from the 1908-9 Chapel and, as noted in the history above, was later modified.

Figure 178: Looking north into the main body of the Chapel from the entrance foyer. The parquetry floor in the aisles and foyer is not continued under the pews; the floor under this pews is a simple timber board floor.
