## GEOTECHNICAL INVESTIGATION EVELEIGH STREET, REDFERN PEMULWUY PROJECT

DEICORP PTY LIMITED

**PROJECT NO. 17772/8146B**  
**REPORT NO. 10/0811**

**AUGUST 2010**

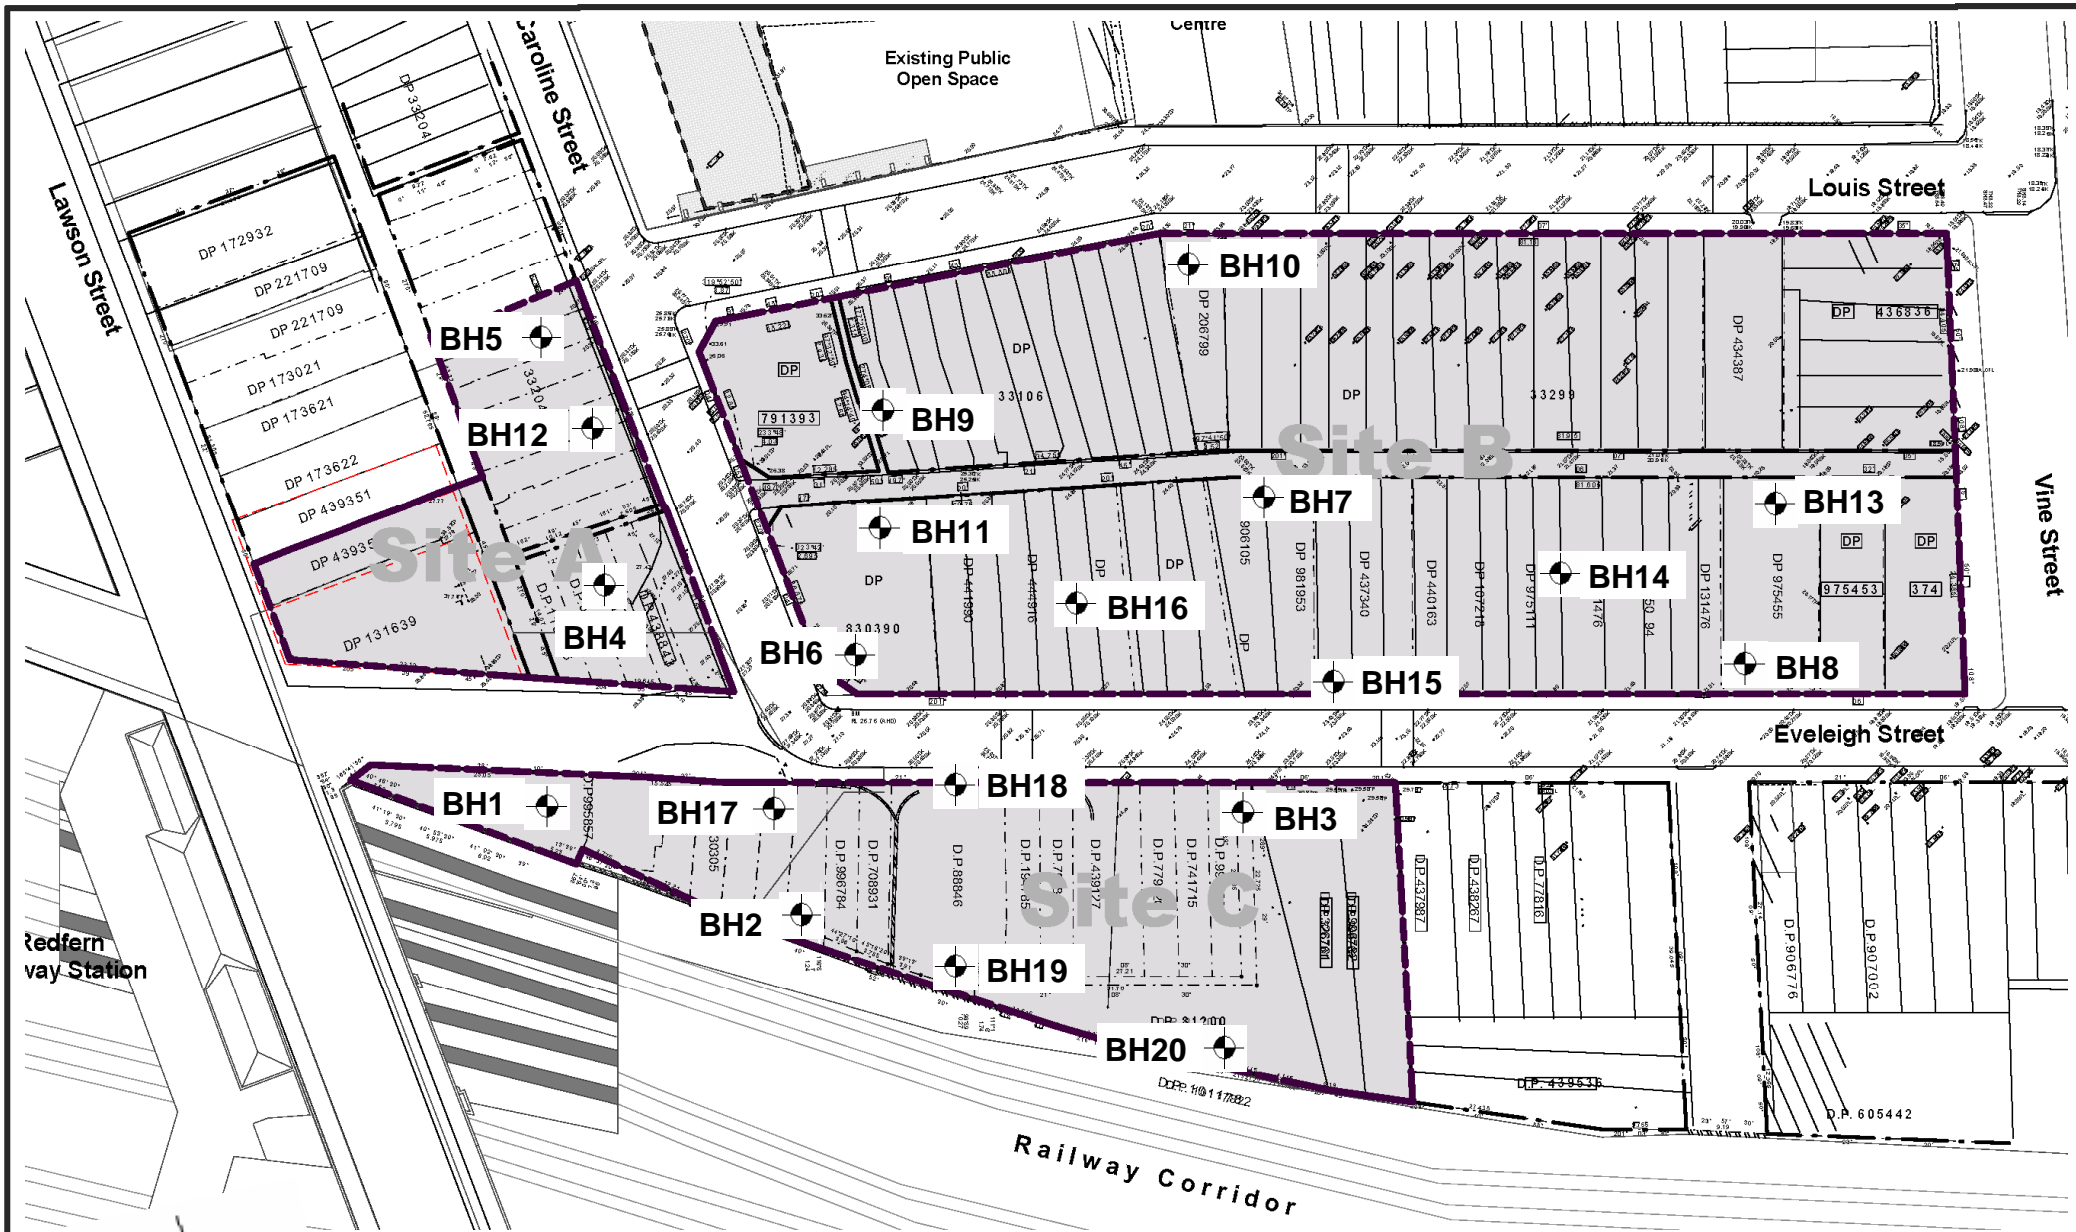
DRAWING NO. 10/0811 : BOREHOLE LOCATIONS

Twenty boreholes numbered BH1 to BH20 were drilled to depths of between 3.9 and 20.0 metres at the locations shown on Drawing No. 10/0811. They were drilled between July 12 and 19, 2010. BH1, BH2, BH3, BH6, BH7, BH8 and BH9 were advanced using a Hydropower drilling rig owned and operated by Terratest Pty Limited. These locations were nominated by the client. The fieldwork was directed by one of our experienced senior technical officer who chose the borehole locations and logged the subsurface conditions encountered. In order to determine soil strengths Standard Penetration Tests (SPTs) were periodically carried out in each of the boreholes. When the rock was of sufficient strength, it was cored with a diamond encrusted cutting shoe. BH4, BH5 and BH10 to BH20 were drilled using the SMEC Testing Services (STS) Christie drilling rig. Dynamic Cone Penetrometer (DCP) testing was carried out adjacent to these holes. This testing provided a measure of the strength of the soils encountered. These were drilled by our senior technical officer.
