## **Soils Assessment**

### **Riverside**

### **Tea Gardens**

Prepared for: Crighton Properties Pty Ltd

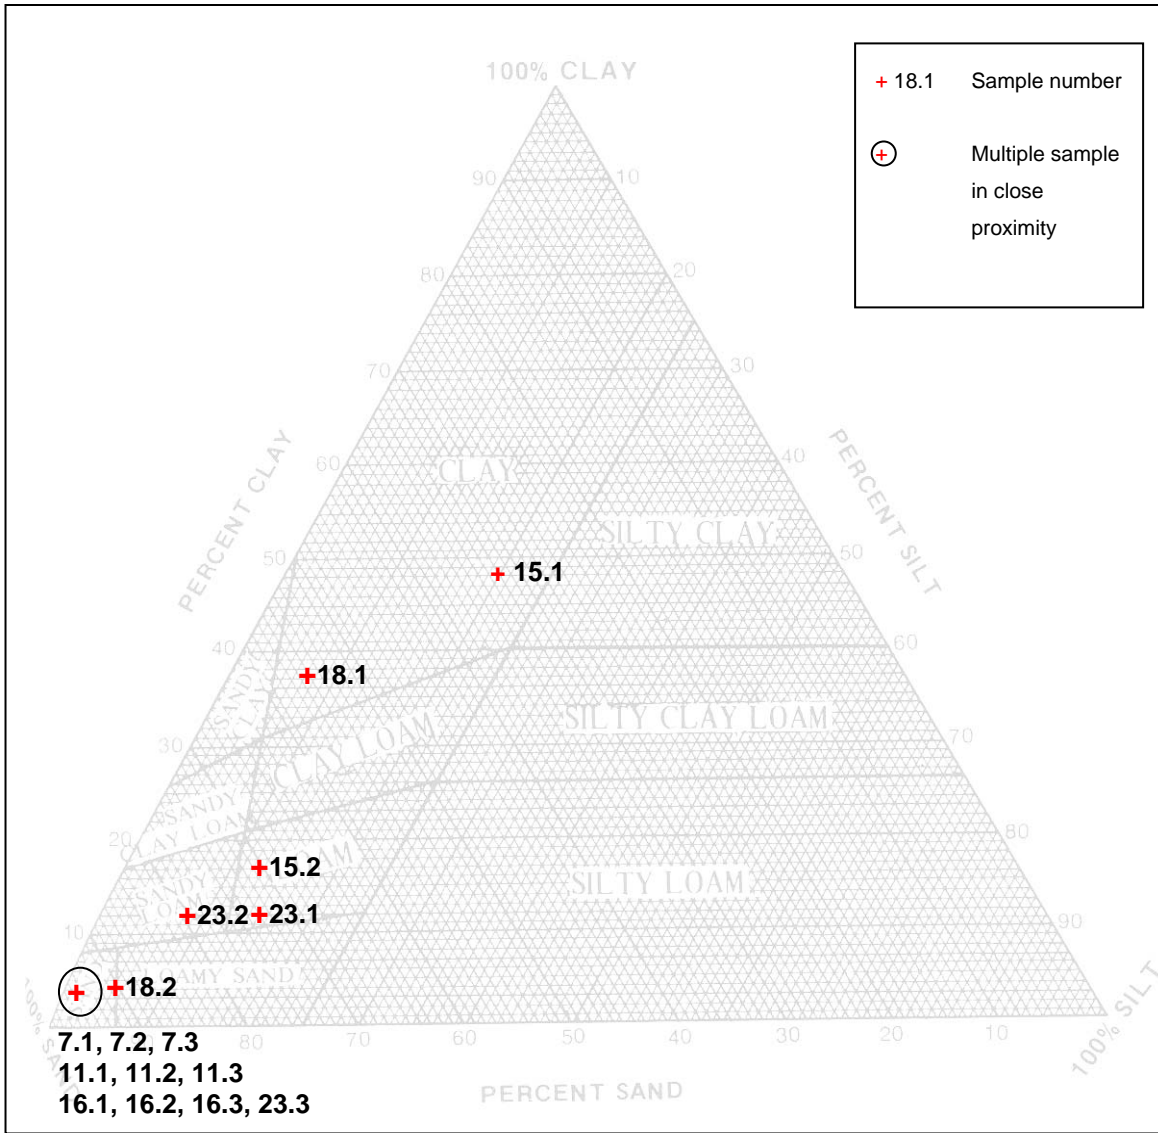
Figure 2 Soil Textures

A preliminary analysis of the Riverside soils was made on field texture characteristics, as described in Section 4.0 above. Laboratory analysis of the soil particle size distribution

has been undertaken to determine the soil texture category of the soils in test pits 7, 11, 15, 16, 18 and 23. The results are presented in Figure 2.

Test pit 7 field log records the soils as sandy loam overlying a clay loam sand over a sand. The laboratory analysis classifies all these horizons as sands. The grain analysis demonstrates that the sands have characteristics comparable with the beach barrier sands of test pit 16. Test pit 7 is therefore considered to fall into the Tea Gardens soil landscape unit.

Test pit 11 field log records the soils as loamy sand overlying a clay loam sand, over a sand and a clay loam sand. The laboratory analysis classifies these horizons as sand. The grain analysis demonstrates that these sands have characteristics of the beach barrier sand of test pit 16. Test pit 11 is therefore considered to fall into the Tea Gardens soil landscape unit.

Test pit 23 field log records the soils as loam overlying a clay loam sand, overlying a clayey sand. The laboratory analysis classifies these horizons as loam, sandy loam and sand respectively. Test pit 23 does not fit the profile of any of the proposed soil landscape units exactly. The grain analysis indicates that sand fraction of this soil is significantly different to the sands of the Tea Gardens and Bobs Farm soils landscape units. The predominance of mudstone and siltstone grains indicates that these grains have not been transported a significant distance. Pindimar Road soil landscape is an erosional soil developed on mudstone and siltstone parent rock. The presence of grains of these materials in the soil at test pit 23 leads to this soil profile being considered to form part of the Pindimar Road soil landscape unit.
